Memorandum

Florida Department of Environmental Protection

SUBJECT: Onyx Environmental CDI

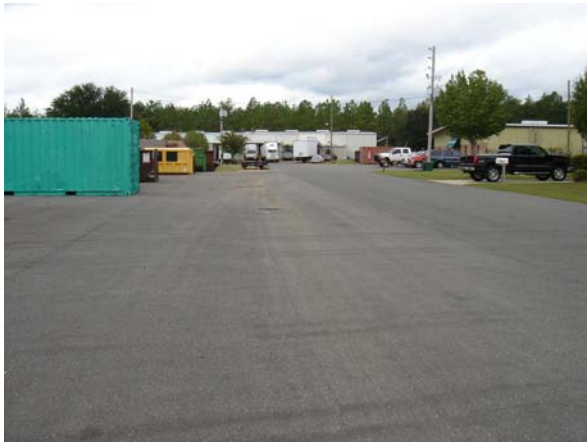
Picture A

On October 20, 2005, I met with Mr. Phil Ditter to discuss and further investigate alleged violations cited in the facility's self-reporting letter of September 20, 2005. Mr. Ditter described the events relating to the discovery of the facility's un-permitted storage of hazardous waste in further detail. He explained that the storage area was not off-road parking area immediately adjacent to the facility as depicted in picture A, but an area completely across the industrial park in its southeast corner as depicted in picture B.

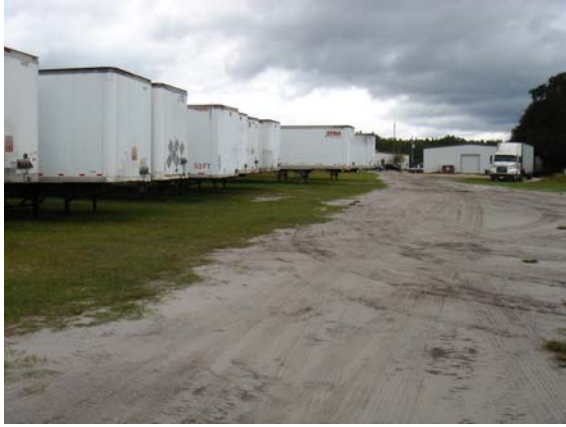
Picture C

The storage location was an un-surfaced parking area for tractor-trailers, picture C. Onyx typically has 20 plus trailers (vans) and 5 tractors available for transport over-the-road. The trailers not being used for active transport are either parked at this location or at the facility for unloading, picture D. Mr. Ditter indicated that the loaded trailers maybe temporarily parked at this location awaiting its turn for unloading at the facility's dock. This delay in unloading could be greater than 24 hours and usually less than 10 days. At the time of the discovery of the un-permitted storage, four additional vans (not road worth) had been parked in this area and the excess of 400 containers of mercury containing materials were found there. The vans utilized for this activity had already been removed from the location and their contents properly transported to three other ONYX facilities for proper processing. Manifests and shipping documents attached.
