WARNING LETTER

HAZARDOUS WASTE INSPECTION REPORT

FACILITY NAME Perma-Fix of Orlando, Inc. EPA ID # FLD980559728

Lab Pack and Bulking Consolidation Building: 4/19/06

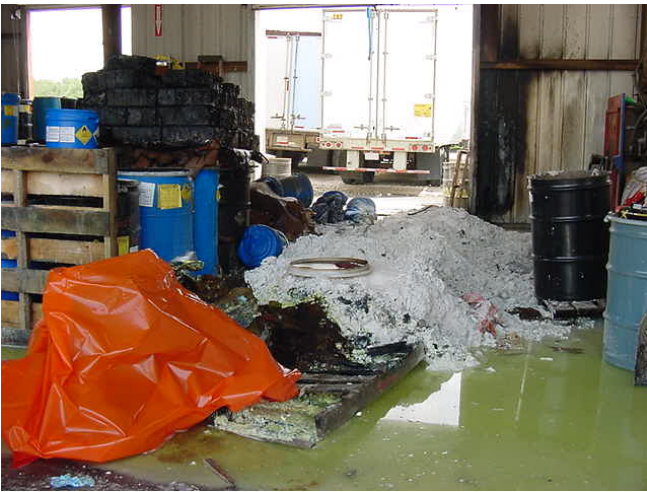
Figure 1: Consolidation Building west side
Calcium hypochlorite in center, lithium batteries
on left; green water from FD and fire suppression

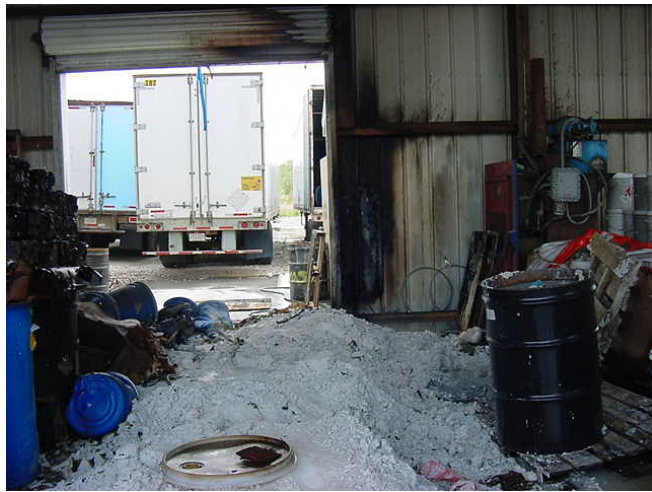
Figure 2: Consolidation Building west side
Fire started next to door, up wall

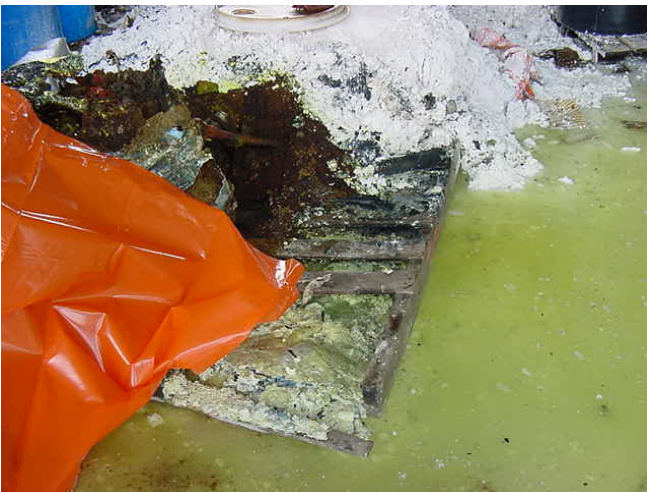
Figure 3: Leftover 55-gallon drum waste

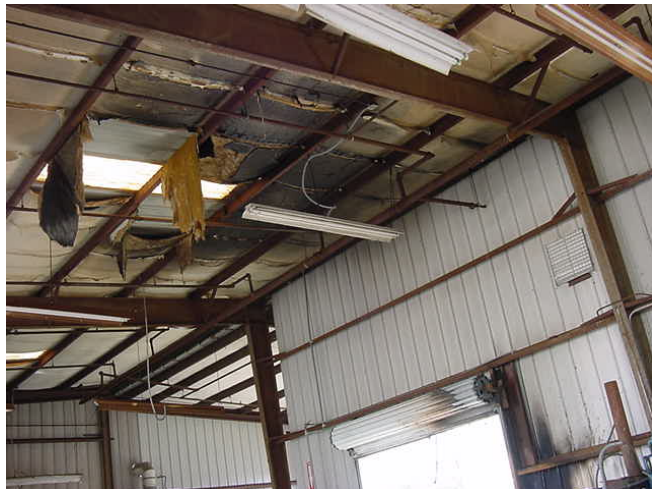
Figure 6: Roof affected by fire

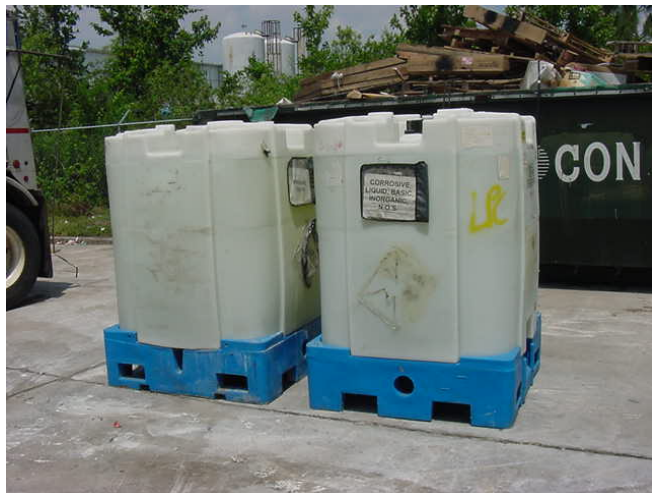
Figure 8: Liquid waste from fire water (D002,F006)

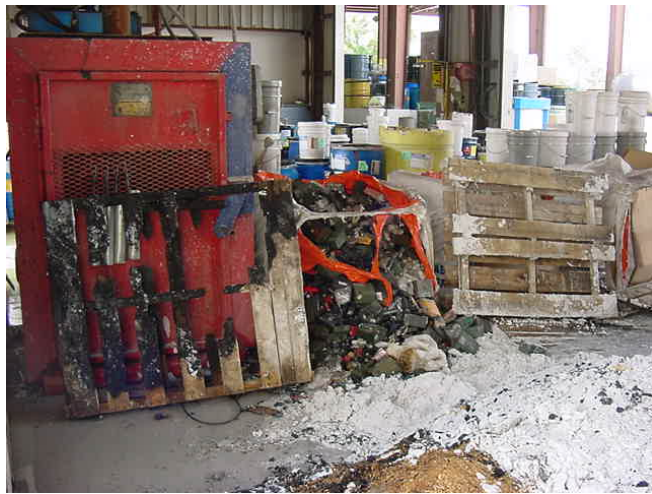
Detective Bill Newman, State Fire Marshall investigating the case, was called to discuss the incident. According to Detective Newman, case # 06-1318, was caused by “accidental poor storage”. Although, Detective Newman could not identify the exact cause of the fire, he stated the fire started on the east side of the Lab Pack and Bulking Consolidation Building next to the roll up door. He believes the fire started on top of the pallet containing the sawdust and subsequently spread to other containers.

Figure 10: Location of fire, east side

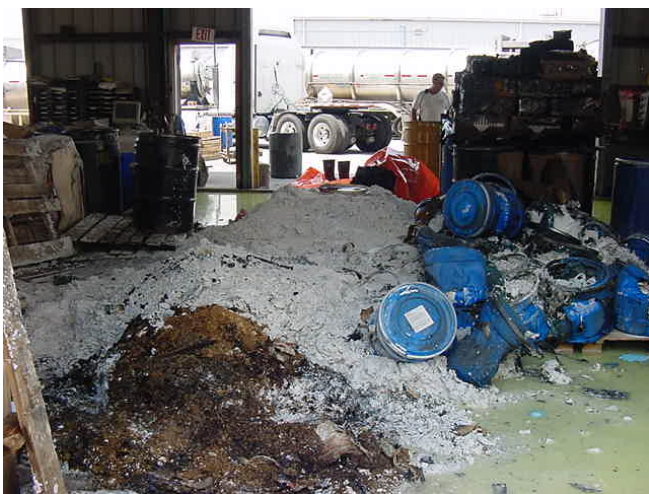
Detective Newman ruled out arson or faulty electrical systems as the cause and speculates the sawdust reacted with a chemical, contributing to the fire [**Permit Conditions-Part 1, Specific Condition 14–Maintenance and Operation/ 40 CFR 264.31**].

Figure 11: Fire started near sawdust pile, east side
blue drums contain calcium hypochlorite

Corrective Action: Perma-Fix shall immediately cease storing incompatible hazardous waste or materials within close proximity and institute Standard Operations Procedures to ensure spill clean up. Within 30 days of receipt of this Warning Letter, Perma-Fix shall submit to the Department a written plan to address storage of incompatible materials and incompatible chemicals, and documentation that all employees have been trained on the plan.

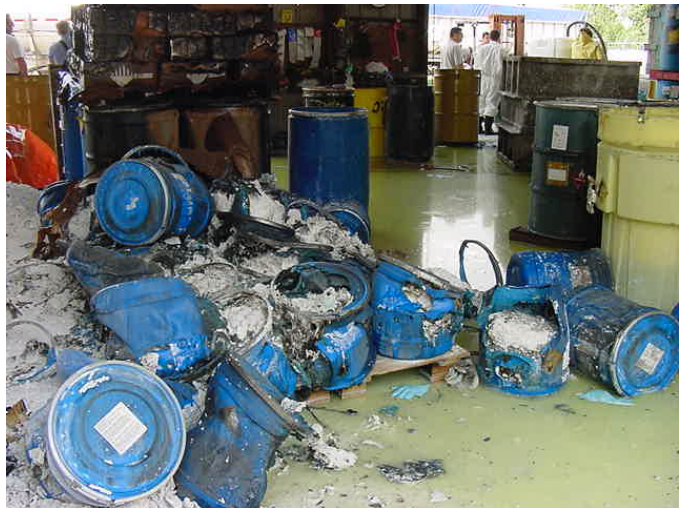
Figure 12: Blue containers of calcium hypochlorite

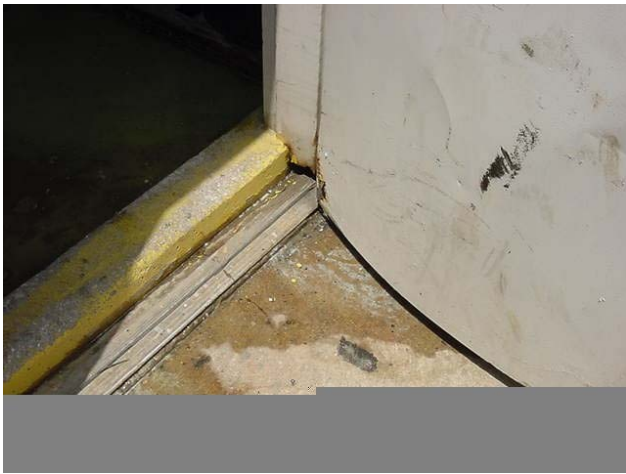
On the east side of the building, the containment in the Lab Pack and Bulking Consolidation Building had failed and released wastewater [**Permit Conditions-Part 1, Specific Condition 14–Maintenance and Operation/ 40 CFR 264.31**] to the ground (Figures 13-14).

Facilities must be maintained and operated to minimize the possibility of a fire, explosion, or any unplanned sudden or non-sudden release of hazardous waste or hazardous waste constituents to air, soil, or surface water, which could threaten human health or the environment. Specifically, Perma-Fix allowed a fire to occur due to improper storage and/or management of incompatible hazardous waste and allowed wastewater from the fire to be released to the environment.

Figure 13: Containment in Consolidation Building leaking

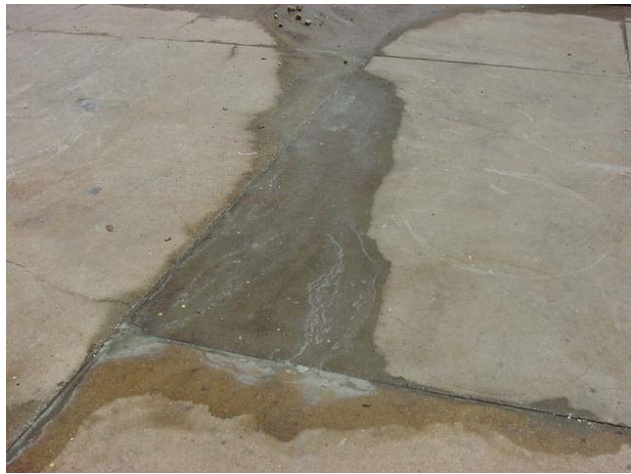
Figure 14: Release out of Consolidation Building to soil under trailer

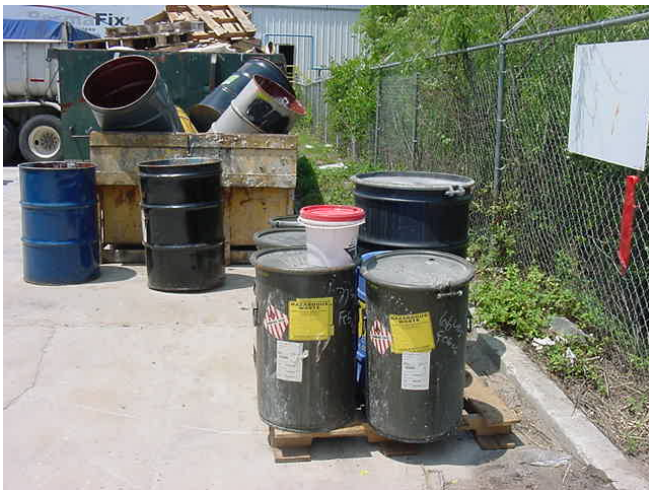
Perma-Fix personnel were cleaning each container in the area and temporarily storing hazardous waste outside the building or moving the containers to the permitted storage area (Figures 15-16).

Figure 15: HW Stored outside

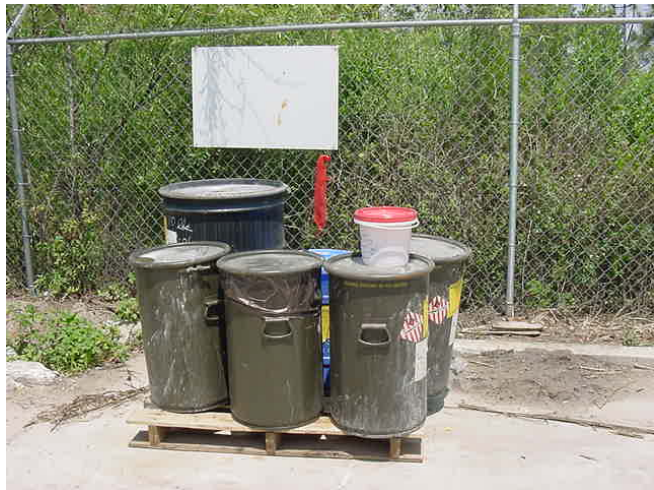
Figure 16: HW stored outside

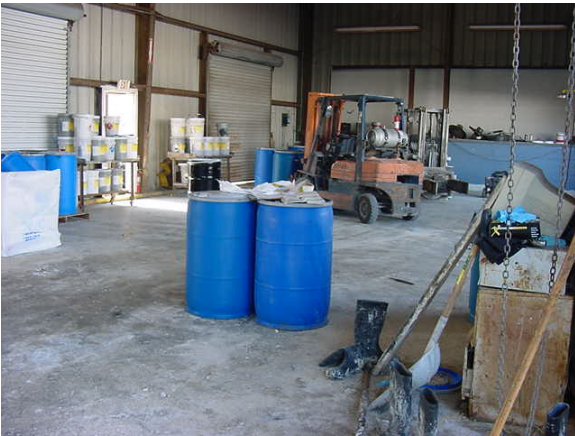
Figure 1: Lab Pack and Consolidation Bulking Building looking south

The facility was still in the process of cleaning the Lab Pack and Bulking Consolidation Area but had pumped all of the wastewater from the area (Figures 1-4). The solid calcium hypochlorite involved in the fire had been repackaged and was being stored in 55-gallon drums. Containers from the area were still being stored outside the building or in the permitted storage area.

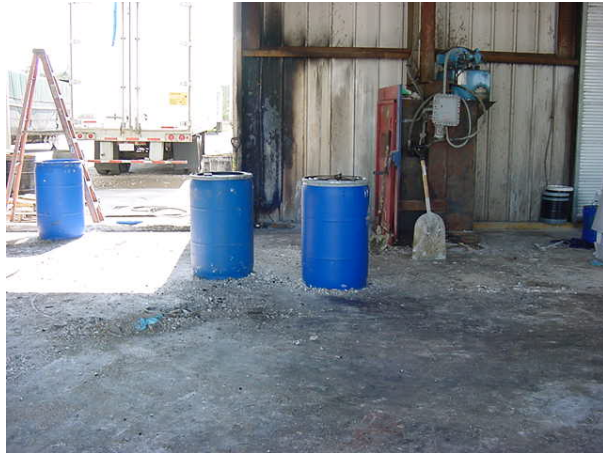
Figure 2: Location of fire after removal of waste

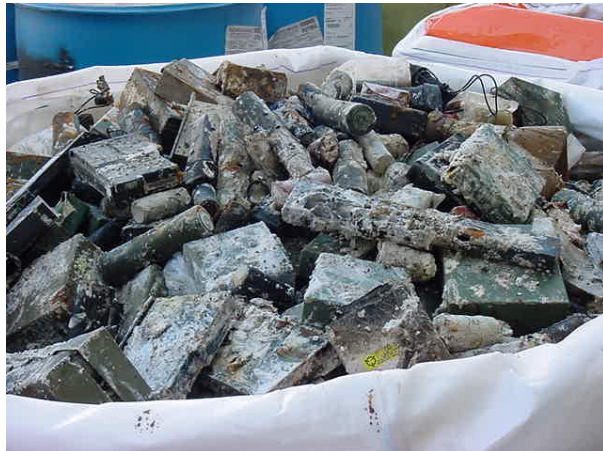
Figure 4: Batteries affected by the fire
