HAZARDOUS WASTE INSPECTION REPORT

FACILITY NAME: Terminal Service Company **DEP/EPA ID #:** FLD980848758

ADDRESS: 2778 West Tharpe Street, Tallahassee, Florida, 32303

COUNTY: Leon **PHONE:** (850) 576-1221 **DATE:** 2/28/07 **TIME:** 12:15 P.M.

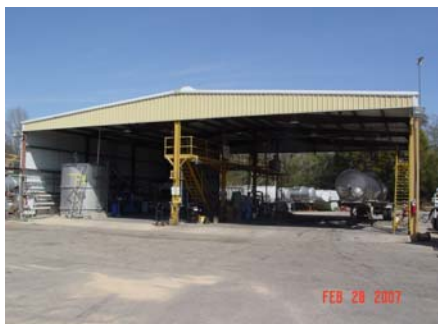
Interior/Exterior Washing

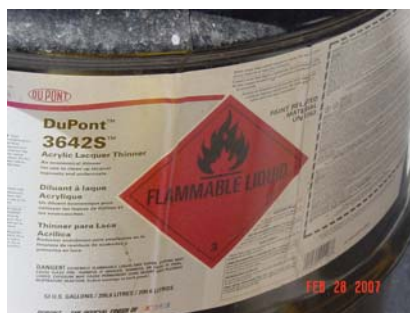
Solvent Used for #6 Oil

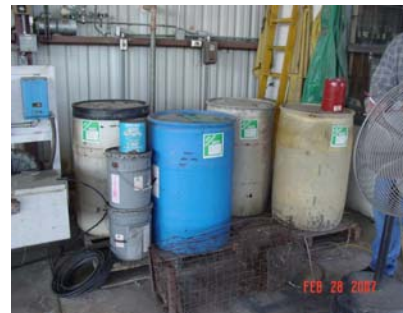
Drums Labeled Caustic Soda

Also located in this area were four 55-gallon drums that were labeled "Non Hazardous Waste" with dates of January 13, 2005 and May 6, 2005 labeled with the words "Caustic Soda". We asked Mr. Wier what was in the drums and why it was labeled non hazardous waste and he stated that he did not know. We asked Mr. Wier if he had any pH paper that we could use to try and identify the substance and he stated that he did not. Alan Annicella indicated that he had pH paper, a pH test was conducted and the pH of the contents of the drums revealed a pH of two (2). We then all agreed that this could not be "Caustic Soda". These drums were under a roof, open and not properly labeled. In addition to these drums, there was one 55-gallon drum labeled "Antifreeze" and two 55-gallon drums labeled "Waste Diesel & Waste Gas". Mr. Wier identified these drums as waste and stated that these drums are usually shipped by Texpar

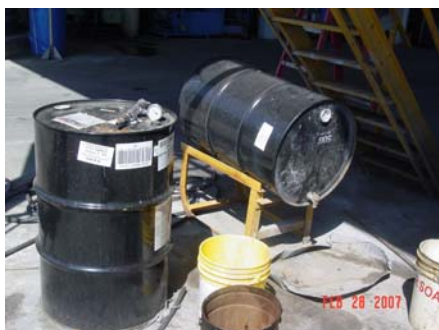
Solvent Drums

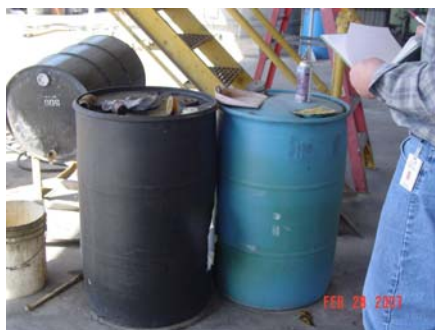
Waste Diesel & Waste Gas

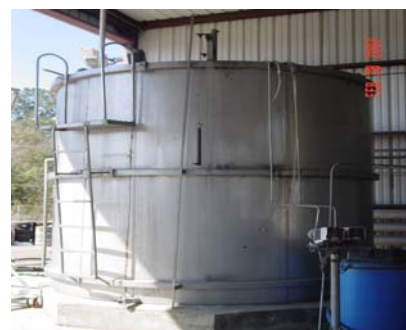
5000-Gallon WW Tank

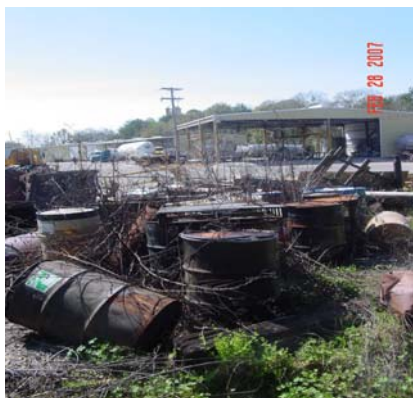
Our next areas of inspection were directly behind, and on both sides, of the washing facility. A visual inspection of these areas revealed approximately 70 containers of various sizes (55-gallon, 30-gallon and 5-gallon drums/buckets). There were several drums of used oil that were not labeled, open, not located in secondary containment and some were discharging used oil to the environment. There were also several 55-gallon drums that contained waste gas, diesel, oil or a mixture of both. Some drums were labeled but most were not labeled. Also, throughout these areas were several drums that contained oil dry and concrete.

Several Waste Drums

- f) TSC needs to conduct a hazardous waste determination/characterization on all waste drums located adjacent to the washing facility. The analysis should be sent to the FDEP for review before disposal occurs.

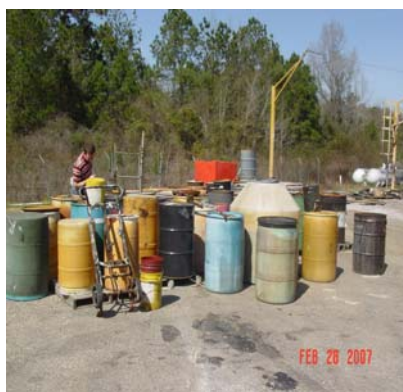
Several Waste drums

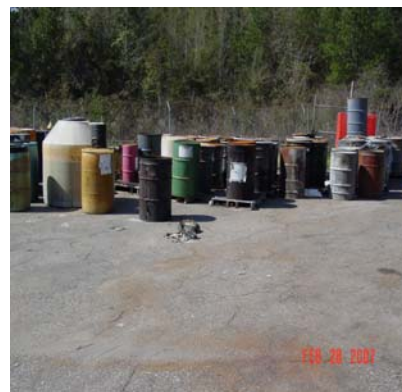
Several Waste Drums

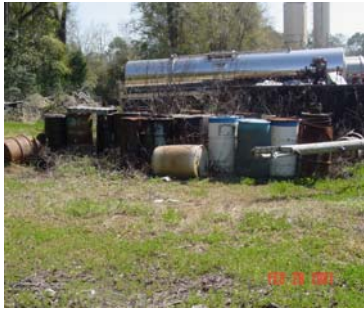
Several Waste Drums

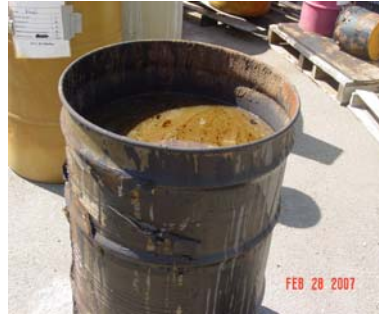
Open Drum- Oil/Water

- c) TSC needs to ensure that all containers that contain used oil, used oil filters, petroleum contact water or petroleum waste are closed or otherwise protected from the weather, labeled, and properly disposed.

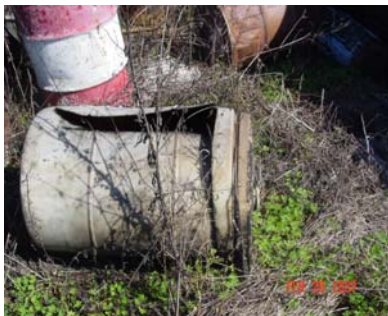
Some of the drums were stored on asphalt but many were being stored on the ground with several discharges throughout the area. A visual observation of ongoing discharges was a 55-gallon drum of what appeared to be used oil. One drum that was leaking its contents onto the ground was up-righted and Mr. Wier was informed that all drums that were in disrepair or discharging their contents to the ground should be repaired and corrected, with the contaminated media being properly addressed. Many of the drums' contents could not be identified and Mr. Wier indicated that many would have to have a waste characterization completed before proper disposal could occur. Some of the drums that were discharging their contents to the ground were labeled gas, diesel or oil.

Used Oil Discharged

TSC failed to ensure that its containers that were stored outside were in good condition, closed and the drums contents were not being discharged to the environment. There were several used oil containers that were discharging their content during this inspection in areas adjacent to the Interior/Exterior Washing Facility and the Diesel Tank Fueling Station. There were several visual stains where discharges had apparently occurred in the past.

- e) TSC needs to assess, remove, analyze and properly dispose of all contaminated soils that were identified during this inspection in accordance with Chapter 62-780 F.A.C., Contaminated Site Cleanup Criteria. Analysis should be sent to the FDEP for review before disposal occurs.

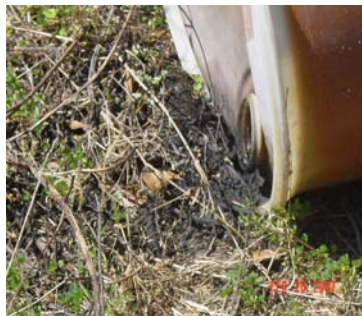
Used Oil Discharged

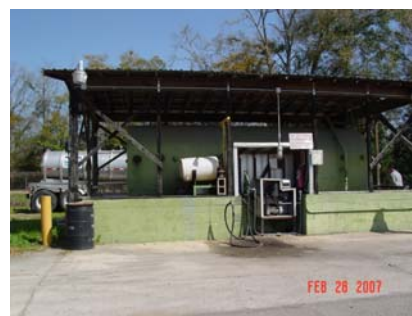
Tank Fueling Facility

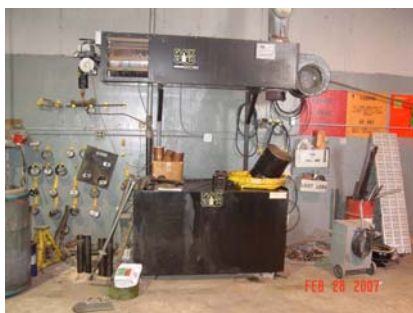
Black Gold Heater/furnace

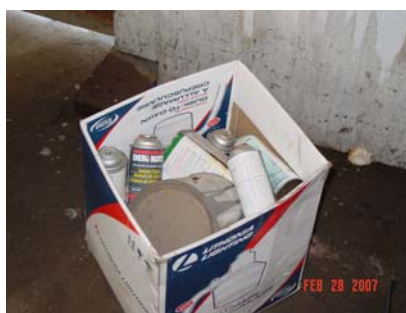
Waste Aerosol Cans

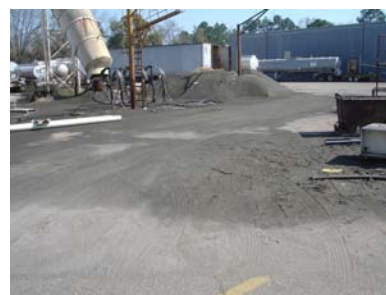
TSC also conducts sandblasting activities. This inspection revealed that TSC performs sandblasting outside and allows spent sandblasting media to pile-up and disperse on the surrounding asphalt pavement. When asked if TSC had ever performed a hazardous waste determination on spent sandblasting media, Mr. Wier stated "yes". Mr. Wier identified the sandblast media as "Black Beauty". When asked if any disposal of the media had occurred Mr. Wier stated "No". We informed Mr. Wier that analysis should be conducted before disposal to ensure the media waste was below RCRA regulatory limits.

Black Beauty Blast Media

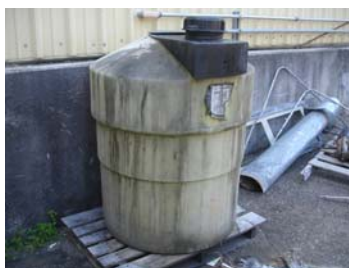
Used Oil Tote
