HAZARDOUS WASTE INSPECTION REPORT

FACILITY NAME: Terminal Service Company DEP/EPA ID #: FLD980848758

ADDRESS: 2778 West Tharpe Street, Tallahassee, Florida, 32303

COUNTY: Leon PHONE: (850) 576-1221 DATE: 2/28/07 TIME: 12:15 P.M.

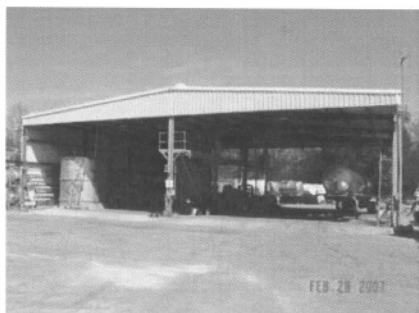
Interior/Exterior Washing

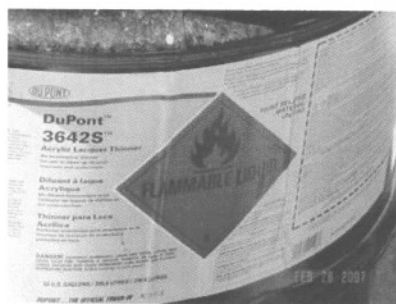
Solvent Used for #6 Oil

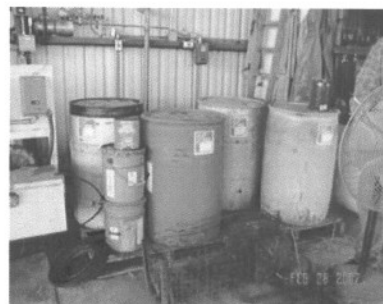
Drums Labeled Caustic Soda

Also located in this area were four 55-gallon drums that were labeled "Non Hazardous Waste" with dates of January 13, 2005 and May 6, 2005 labeled with the words "Caustic Soda". We asked Mr. Wier what was in the drums and why it was labeled non hazardous waste and he stated that he did not know. We asked Mr. Wier if he had any pH paper that we could use to try and identify the substance and he stated that he did not. Alan Annicella indicated that he had pH paper, a pH test was conducted and the pH of the contents of the drums revealed a pH of two (2). We then all agreed that this could not be "Caustic Soda". These drums were under a roof, open and not properly labeled. In addition to these drums, there was one 55-gallon drum labeled "Antifreeze" and two 55-gallon drums labeled "Waste Diesel & Waste Gas". Mr. Wier identified these drums as waste and stated that these drums are usually shipped by Texpar

3 DRUMS - ALUMINUM
TSC failed to make a hazardous waste determination on numerous containers that did not have labels during this inspection. These containers include: four 55-gallon drums that were labeled "Non Hazardous Waste" at the Interior/Exterior Washing Facility; two 55-gallon drums of unknown wastes located behind the Interior/Exterior Washing Facility; approximately 70 containers of various sizes (55-gallon, 30-gallon and 5-gallon drums/buckets) at the Adjacent Areas near the Interior/Exterior Washing Facility; the numerous 55-gallon drums located north of the Diesel Tank Fueling Station; and one 5-gallon bucket of waste paint related material in the Paint Booth.

- f) TSC needs to conduct a hazardous waste determination/characterization on all waste drums located adjacent to the washing facility. The analysis should be sent to the FDEP for review before disposal occurs.

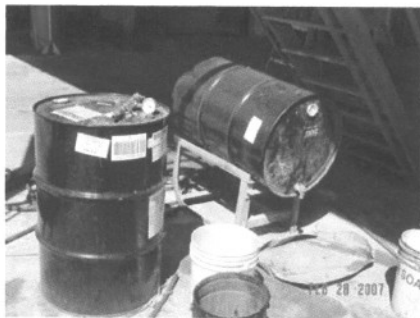
Solvent Drums

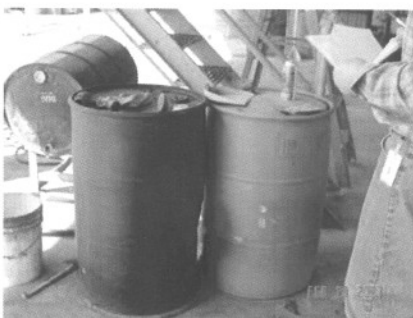
Waste Diesel & Waste Gas

1 DRUM
TSC allowed some waste gas and waste diesel drums to be discharged onto the ground in areas adjacent to the Interior/Exterior Washing Facility and the Diesel Tank Fueling Station. Additionally, one 5-gallon bucket of paint waste located in the paint booth was not closed and it appeared that the contents had been evaporating.

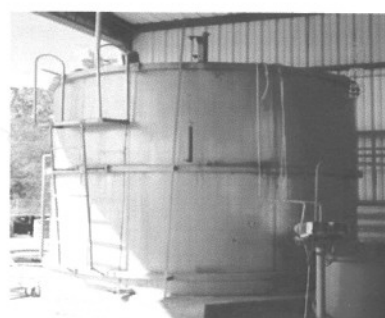
Energy located in Bainbridge, Georgia. TSC generates wastewater from their truck wash-out facility. Mr. Wier stated that wastewater is processed through an on-site oil/water separator. The wastewater is accumulated on-site in one 5,000 gallon wastewater treatment tank and discharged to the City of Tallahassee sewer system. Mr. Wier stated that the pH is tested before being discharged to the sewer system and that the City conducts quarterly sampling to ensure standards are met.

5000-Gallon WW Tank

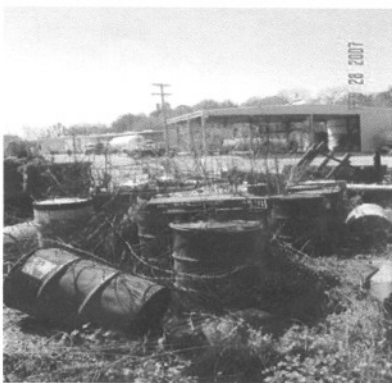
Our next areas of inspection were directly behind, and on both sides, of the washing facility. A visual inspection of these areas revealed approximately 70 containers of various sizes (55-gallon, 30-gallon and 5-gallon drums/buckets). There were several drums of used oil that were not labeled, open, not located in secondary containment and some were discharging used oil to the environment. There were also several 55-gallon drums that contained waste gas, diesel, oil or a mixture of both. Some drums were labeled but most were not labeled. Also, throughout these areas were several drums that contained oil dry and concrete.

Several Waste Drums

TSC failed to label numerous used oil drums with the words "Used Oil". Numerous containers (greater than fifteen 55-gallon drums) located outside in areas adjacent to the Interior/Exterior Washing Facility and north of the Diesel Tank Fueling Station were not labeled and many drums open and/or had leaked their content onto the ground. There was no secondary containment provided for any of the drums or tanks located outside throughout the facility. There were many 5-gallon buckets that contained both water and used oil that was not labeled, closed or in secondary containment that were located throughout the facility.

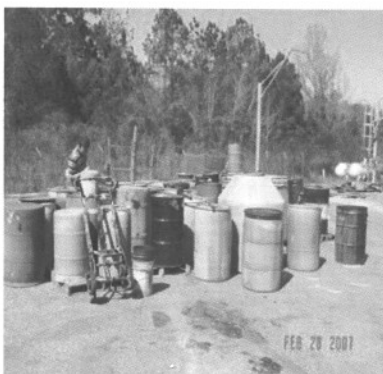
Several Waste drums

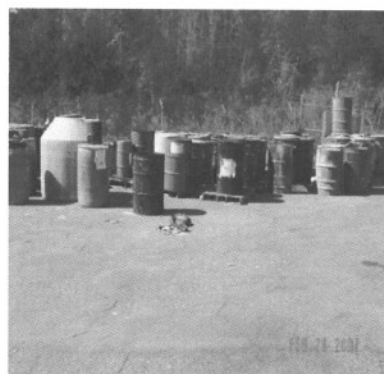
Several Waste Drums

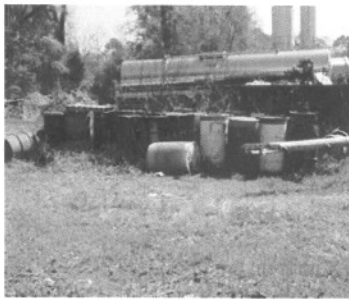
Several Waste Drums

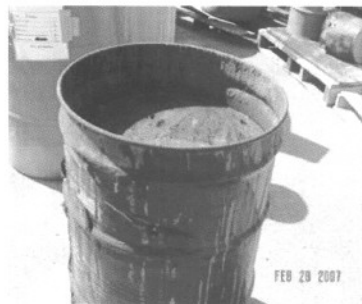
Open Drum- Oil/Water

- c) TSC needs to ensure that all containers that contain used oil, used oil filters, petroleum contact water or petroleum waste are closed or otherwise protected from the weather, labeled, and properly disposed.

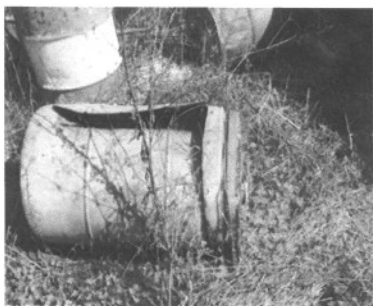
Some of the drums were stored on asphalt but many were being stored on the ground with several discharges throughout the area. A visual observation of ongoing discharges was a 55-gallon drum of what appeared to be used oil. One drum that was leaking its contents onto the ground was up-righted and Mr. Wier was informed that all drums that were in disrepair or discharging their contents to the ground should be repaired and corrected, with the contaminated media being properly addressed. Many of the drums' contents could not be identified and Mr. Wier indicated that many would have to have a waste characterization completed before proper disposal could occur. Some of the drums that were discharging their contents to the ground were labeled gas, diesel or oil.

Used Oil Discharged

TSC failed to ensure that its containers that were stored outside were in good condition, closed and the drums contents were not being discharged to the environment. There were several used oil containers that were discharging their content during this inspection in areas adjacent to the Interior/Exterior Washing Facility and the Diesel Tank Fueling Station. There were several visual stains where discharges had apparently occurred in the past.

- e) TSC needs to assess, remove, analyze and properly dispose of all contaminated soils that were identified during this inspection in accordance with Chapter 62-780 F.A.C., Contaminated Site Cleanup Criteria. Analysis should be sent to the FDEP for review before disposal occurs.

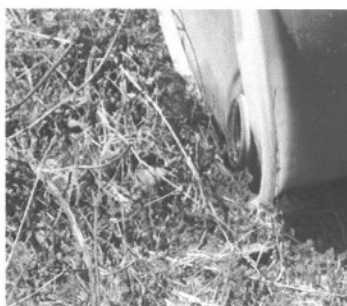
Used Oil Discharged

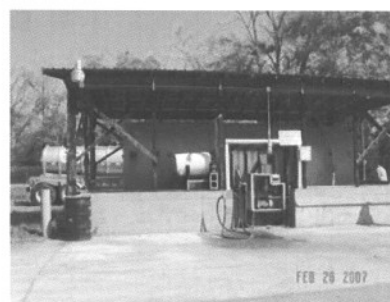
Tank Fueling Facility

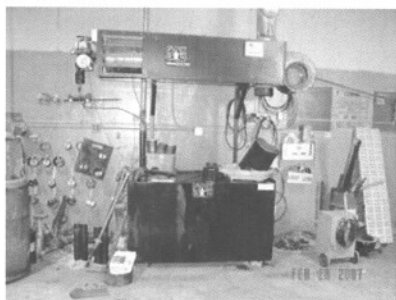
Black Gold Heater/furnace

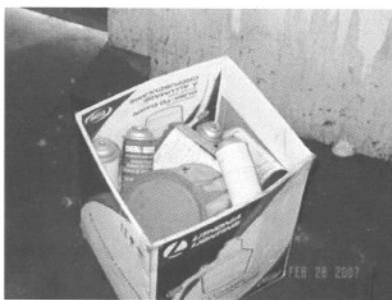
Waste Aerosol Cans

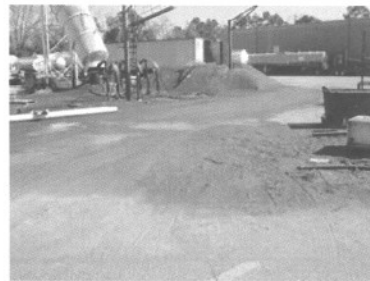
TSC also conducts sandblasting activities. This inspection revealed that TSC performs sandblasting outside and allows spent sandblasting media to pile-up and disperse on the surrounding asphalt pavement. When asked if TSC had ever performed a hazardous waste determination on spent sandblasting media, Mr. Wier stated "yes". Mr. Wier identified the sandblast media as "Black Beauty". When asked if any disposal of the media had occurred Mr. Wier stated "No". We informed Mr. Wier that analysis should be conducted before disposal to ensure the media waste was below RCRA regulatory limits.

Black Beauty Blast Media

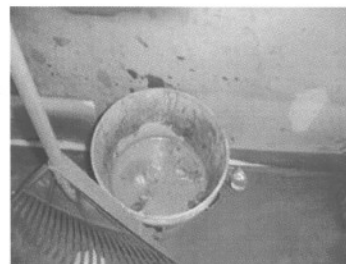
We inspected the paint booth and found a small bucket with paint waste located inside. This bucket was not labeled nor closed. We asked Mr. Wier how the paint waste and paint waste filters were being managed/disposed. Mr. Wier stated that he did not know what was in the bucket or how the paint waste or waste filters were being managed.
