NON-COMPLIANCE LETTER

**Florida Department of
Environmental Protection
Hazardous Waste Inspection Report**

Facility Name: Veolia ES Technical Solutions LLC

On-Site Inspection Start Date: 08/28/2008

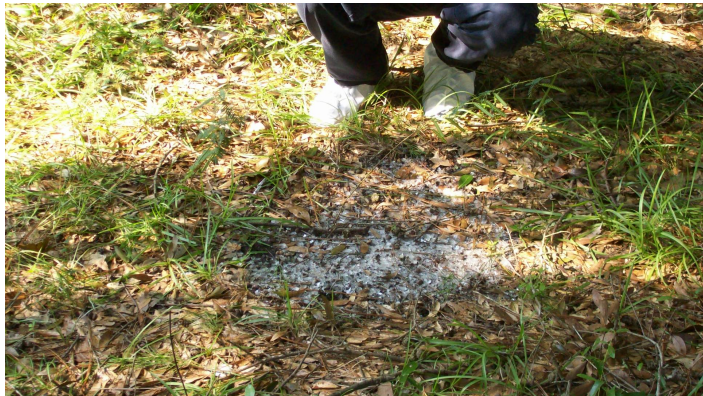
Grass area with circular pattern

Type:	Violation
Significance Level:	SNC
Harm Level:	Major
Deviation:	Minor
Rule:	265.173(b), 265.173, 264.173(b)
Question Number:	12.6
Explanation:	At the extreme northern end of this storage area, it appeared that an open, circular container holding broken glass and possibly Hg containing wastes had been turned upside down in the grass covered area. See picture below.
Corrective Action:	Perform a contamination assessment of the area in which the possible release of Hg containing material occurred.

Rule Number	Area	Date Cited	Explanation
TSD Containers Checklist			
265.173(b), 265.173, 264.173(b)	A. Outside North Storage	08/28/2008	At the extreme northern end of this storage area, it appeared that an open, circular container holding broken glass and possibly Hg containing wastes had been turned upside down in the grass covered area. See picture below.

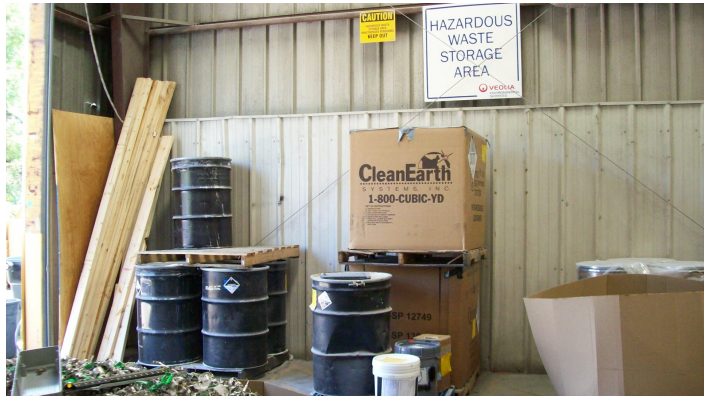
HW Storage Area

Explanation: At the time of this inspection, Veolia had combined the storage of HW containers from both its permitted 90-Day Accumulation Area and its TSD (phosphor powder and MCD materials to be processed in the facility's retort) HW Storage Area. Both types of HW containers were being stored on the east side of the facility.

Corrective Action: Maintain two separate storage areas in accordance with operating permit for the 90-Day Accumulation Area and the HW Storage Area.
