**Florida Department of
Environmental Protection
Hazardous Waste Inspection Report**

Facility Name: McKenzie Tank Lines Inc

On-Site Inspection Start Date: 06/08/2009

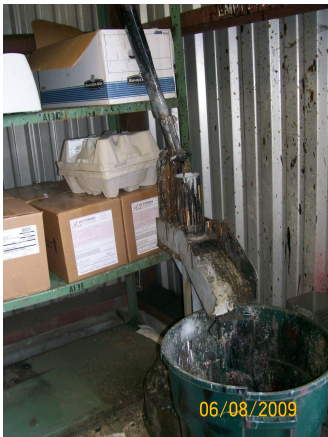
Aerosol Can Puncturing Device

Aerosol cans are collected throughout the facility and punctured in this area. The punctured cans are managed as scrap metal. An employee in the area said that approximately three cases of cans are punctured per week.

Explanation: The residues and gases generated when the cans are punctured are not being collected. They are released into the environment. The residue and gases may be listed or characteristic hazardous waste.

Corrective Action: MTL needs to use an aerosol can puncturing device designed to collect the residue and filter the gas released when the cans are punctured unless a hazardous waste determination is made for each type of aerosol can punctured to demonstrate that the residue / gas released is not regulated hazardous waste. The filter on this device will need to be replaced according the manufacturers recommendations and records of maintenance maintained on-site. The collected residue will need to be managed as hazardous waste.
