**Florida Department of
Environmental Protection
Hazardous Waste Inspection Report**

Facility Name: Veolia ES Technical Solutions LLC
On-Site Inspection Start Date: 12/07/2010 **On-Site Inspection End Date:** 12/07/2010
ME ID#: 6716 **EPA ID#:** FL0000207449
Facility Street Address: 342 Marpan Ln, Tallahassee, Florida 32305-0904
Contact Mailing Address: 342 Marpan Ln, Tallahassee, Florida 32305-0904
County Name: Leon **Contact Phone:** (850) 877-8299

Inspection Date: 12/07/2010

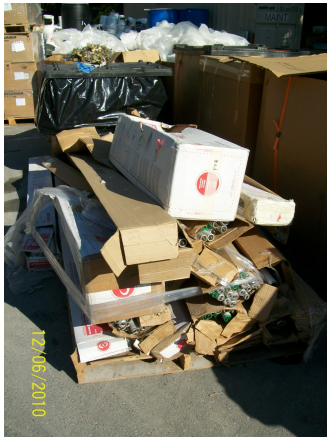
Open boxes of SMCLs outside

Type:	Violation
Rule:	403.727(1)(c), 62-737.800(9), 264.1(b)
Explanation:	This is an apparent violation of Specific Permit Condition 2.8, as required in 403.727(1)(c) Fl. Stat. Veolia had a pallet of fluorescent lamps and two plastic bins of HID lamps being kept outside that were not properly containerized. The fluorescent lamps had multiple boxes opened with the lamps exposed to the elements and have a possible release to the environment. The HID containers were not closed to prevent the possible breakage and a possible release to the environment. Veolia also had approximately six pallets of mixed universal wastes being stored on paved portion of the northern storage area. The pallets had been delivered to this area by FEDEX.
Corrective Action:	Veolia needs to ensure that all unprocessed materials are properly containerized and stored inside according to the facility Specific Permit Condition 2.8 and 62-737.800(9). "Owners and operators shall store processed and unprocessed materials in closed containers; and for broken or damaged unprocessed lamps and devices, and residuals, store these in closed, covered and sealed containers or in enclosed areas of the facility conforming to paragraph 62-296.417(1), F.A.C., to prevent mercury emissions. They shall store unprocessed materials, ampoules, phosphor powder and other mercury-containing residuals indoors to prevent breakage of lamps or devices prior to further processing and to prevent a release of hazardous materials to the environment".

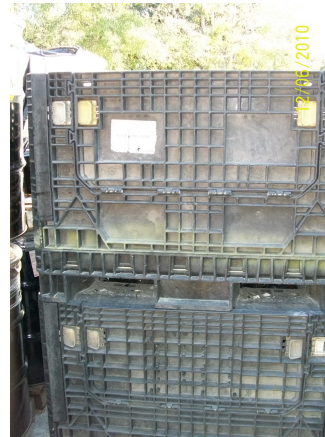
Plastic bins of HID lamps

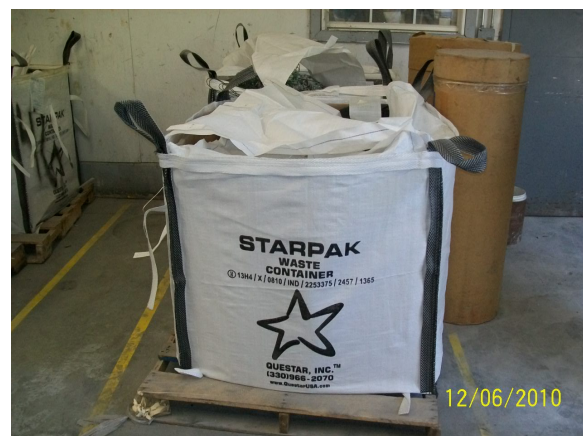
Metal Endcaps

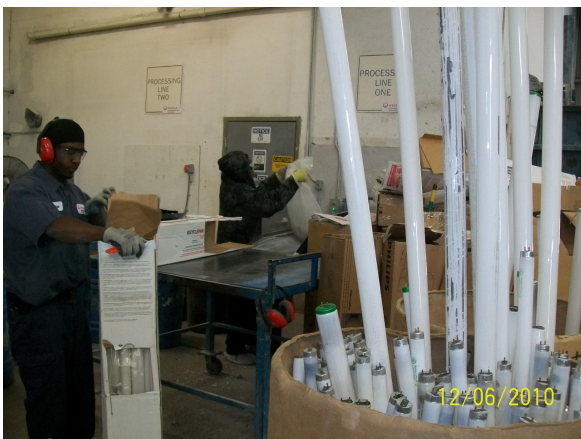
Fluorescent Lamp Processing Line

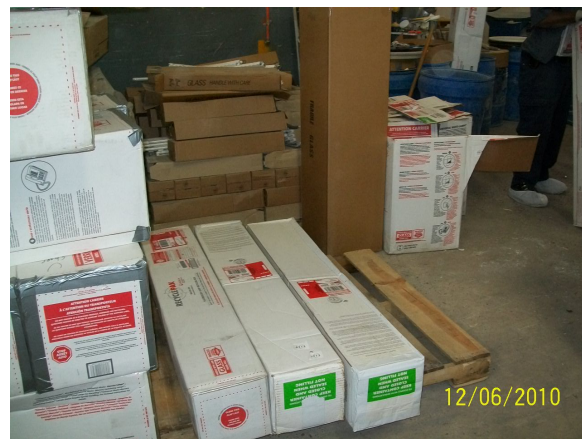
Fluorescent Lamps Staging Area

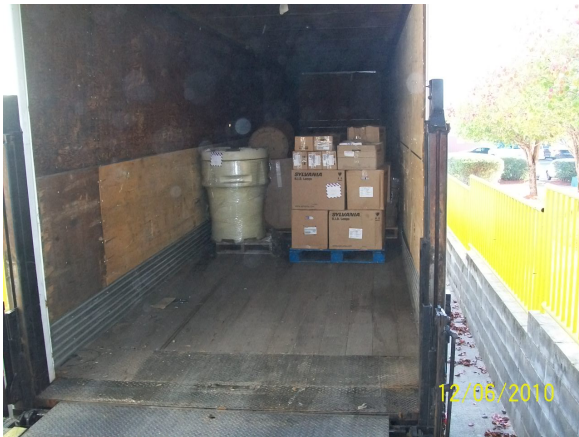
Loading Dock

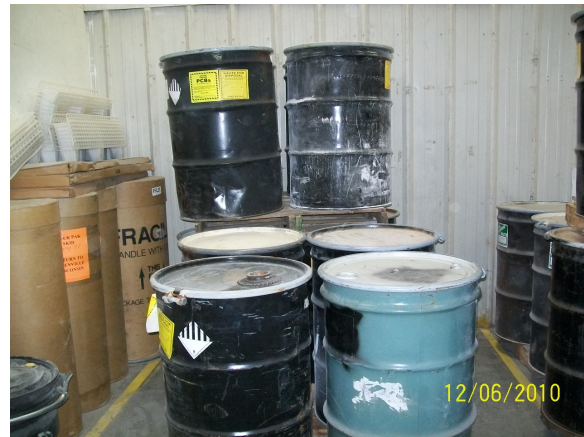
During the inspection of the facility, Department and Agency staff observed approximately 20 drums total of post-retort phosphor powder, hazardous waste (pre-retort powder from long and compact fluorescent lamps) and PCB-ballasts being stored in this area. Ms. Dunwoody explained that the hazardous waste drums are normally stored in the designated area, but that they had been moved to this area temporarily due to the HWS Area being cleaned.

Multiple Drums in Area
