SUBJECT: Short Form Consent Order
Proposed Settlement of Veolia ES Technical Solutions, L.L.C.
OGC File No.: 11-0801-37-HW

**Florida Department of
Environmental Protection
Hazardous Waste Inspection Report**

Facility Name: Veolia ES Technical Solutions LLC
On-Site Inspection Start Date: 12/07/2010 **On-Site Inspection End Date:** 12/07/2010
ME ID#: 6716 **EPA ID#:** FL0000207449
Facility Street Address: 342 Marpan Ln, Tallahassee, Florida 32305-0904
Contact Mailing Address: 342 Marpan Ln, Tallahassee, Florida 32305-0904
County Name: Leon **Contact Phone:** (850) 877-8299

Inspection Date: 12/07/2010

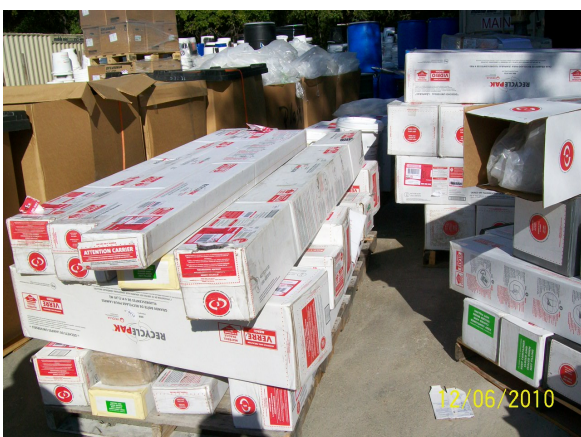
FedEx Pallets

During the inspection, two FEDEX trucks delivered 6-7 pallets of universal waste to this area. There were also two large plastic crates of unprocessed HID arc tubes beside the 20-yard roll-offs and approximately 40 drums of PCB-ballasts and lamps combined. A circular area of broken glass was observed on the bare ground in the central portion of this area. Ms. Dunwoody explained that the glass had come from a drum that had been moved to this area and had fallen over and glass that had been stuck to the inside of the drum had fallen out. Ms. Dunwoody said that it happened as she was moving the drum outside for disposal because the drum had deteriorated beyond safe use.

Type:	Violation
Rule:	403.727(1)(c), 62-737.800(9), 264.1(b)
Explanation:	This is an apparent violation of Specific Permit Condition 2.8, as required in 403.727(1)(c) Fl. Stat. Veolia had a pallet of fluorescent lamps and two plastic bins of HID lamps being kept outside that were not properly containerized. The fluorescent lamps had multiple boxes opened with the lamps exposed to the elements and have a possible release to the environment. The HID containers were not closed to prevent the possible breakage and a possible release to the environment. Veolia also had approximately six pallets of mixed universal wastes being stored on paved portion of the northern storage area. The pallets had been delivered to this area by FEDEX.
Corrective Action:	Veolia needs to ensure that all unprocessed materials are properly containerized and stored inside according to the facility Specific Permit Condition 2.8 and 62-737.800(9). "Owners and operators shall store processed and unprocessed materials in closed containers; and for broken or damaged unprocessed lamps and devices, and residuals, store these in closed, covered and sealed containers or in enclosed areas of the facility conforming to paragraph 62-296.417(1), F.A.C., to prevent mercury emissions. They shall store unprocessed materials, ampoules, phosphor powder and other mercury-containing residuals indoors to prevent breakage of lamps or devices prior to further processing and to prevent a release of hazardous materials to the environment".

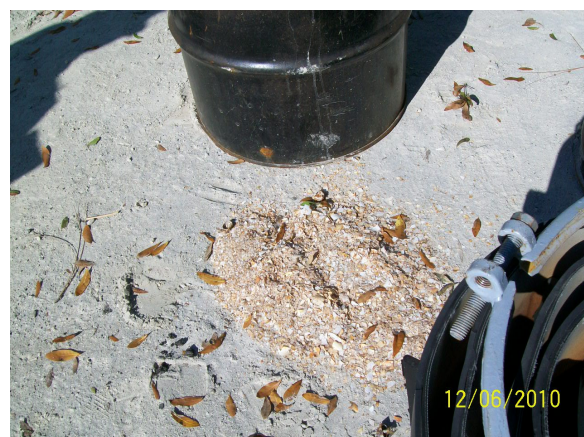
Broken glass on the ground

Type:	Violation
Rule:	262.11
Explanation:	It appears that Veolia failed to conduct a hazardous waste determination on a solid wastestream. Department and Agency staff observed an area of bare ground that had broken fluorescent tube pieces on it. The glass was from a 55-gallon drum that had been deemed compromised by the facility and was being moved for eventual disposal. The drum had fallen while being moved and the glass that was in the container fell out.
Corrective Action:	Veolia needs to ensure that the glass and surrounding soil are sampled for contamination and properly disposed of according to state and federal regulations.

Type:	Violation
Rule:	264.51(b)
Explanation:	Department and Agency staff observed an area of bare ground that had broken fluorescent tube pieces on it. The glass was from a 55-gallon drum that had fallen while being moved and the glass that was in the container fell out. It appears the facility failed to carry out immediately the provisions of the contingency plan in accordance with Specific Permit Condition 2.5(a) of its operating permit for the apparent release of hazardous waste or hazardous waste constituents which could threaten human health or the environment.
Corrective Action:	Veolia needs to ensure that the glass and surrounding soil are sampled for contamination and properly disposed of according to state and federal regulations. 40 CFR 273.60(a) requires the facility to comply with requirements of 40 CFR 264.

Veolia has removed all unprocessed materials from the ONSA to the interior of the facility. Glass from broken lamps on the bare ground in the ONSA observed during the December inspection had been removed and processed at the facility. Veolia sampled and analysed the soils in the affected area. The results were received by the Department on January 21, 2011, and found within regulatory limits. The area appeared to be in compliance.

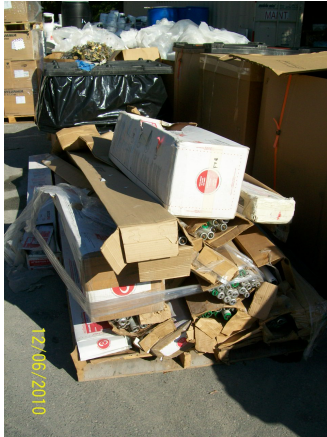
Open boxes of SMCLs outside

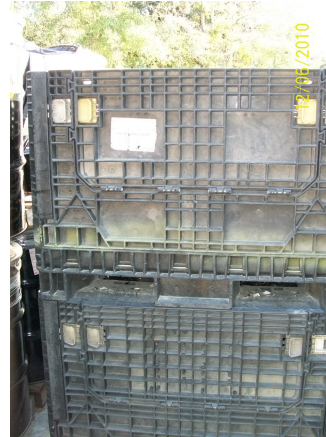
Plastic bins of HID lamps

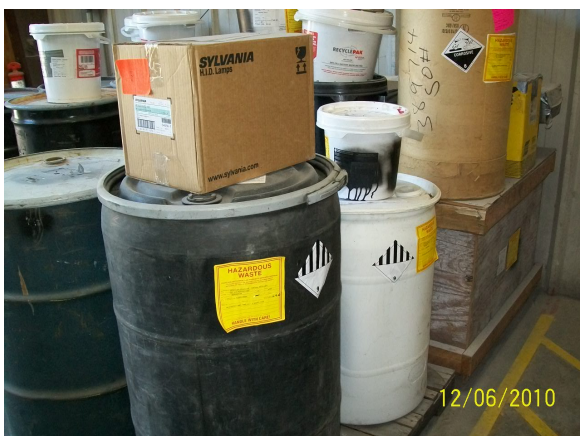
HWS AREA

At the time of this inspection, Ms. Dunwoody explained that the HWS Area was being cleared out to be cleaned. In the HWS Area, there were four drums of HW. One drum was not labeled, one drum was poorly labeled, and the other two drums were labeled with the oldest date being October 21, 2010. There were three boxes of waste belting from the HID automated process with the oldest date being August 31, 2010. There were three 5-gallon containers, one 2-gallon container, a cylindrical cardboard container and a cardboard box of dental amalgam, thermometers, and other mercury containing materials stored in this area as well. There were two boxes and a 55-gallon drum that were labeled "Hazardous Waste", but did not have the accumulation start date written on them. Ms. Dunwoody was able to locate the correct dates during the records review. She printed new labels with the dates on them and had them affixed to the containers during the inspection. The 90-Day accumulation area had four containers of post-retort metal end caps.

Type:	Violation
Rule:	262.34(a)(2)
Explanation:	It appears Veolia failed to clearly mark the initial date of accumulation which is visible for inspection on each HW container. Veolia had two boxes, and one 55-gallon drum in HWS area that were labeled "Hazardous Waste" but did not have the accumulation start date on them. It appears that the 55-gallon drum missing its accumulation start date is in violation of 40 CFR 262.34(a)(2) and the two boxes missing their accumulation start dates are in violation of 40 CFR 268.50(a)(2)(i).
Corrective Action:	Veolia needs to ensure that the accumulation start date is clearly marked on all containers stored in the HWS area.

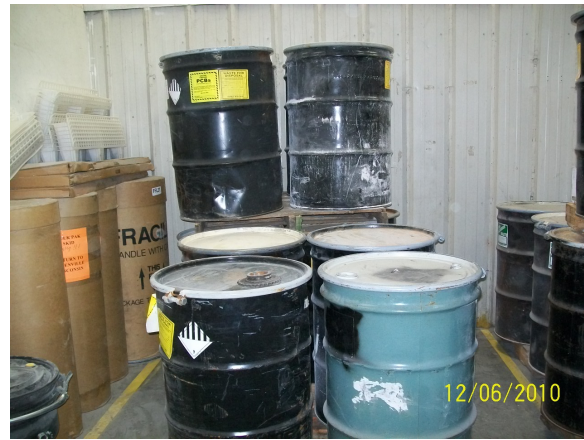
During the inspection of the facility, Department and Agency staff observed approximately 20 drums total of post-retort phosphor powder, hazardous waste (pre-retort powder from long and compact fluorescent lamps) and PCB-ballasts being stored in this area. Ms. Dunwoody explained that the hazardous waste drums are normally stored in the designated area, but that they had been moved to this area temporarily due to the HWS Area being cleaned.

Multiple Drums in Area

The Department recommends that Veolia designate a tracking system and an area within the building for Hazardous Waste Transfer Activities (a less than 10-day storage area) to ensure compliance with state and federal regulations. The system can be analogous to the system used for Universal Waste Transfer Area Activities.

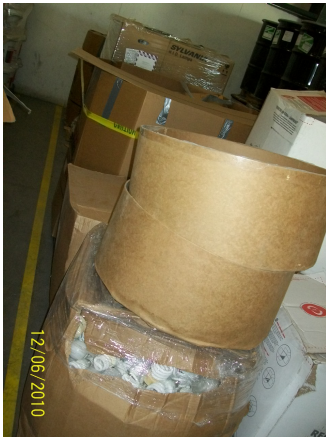
Pre-Process UW Lamp Storage

At the time of this inspection, this storage area appeared to be near capacity. There was one pallet that had several open boxes and some broken glass in front of it. Ms. Dunwoody explained that some containers arrive with broken lamps inside and the contents sometimes fall out in pre-process sorting.

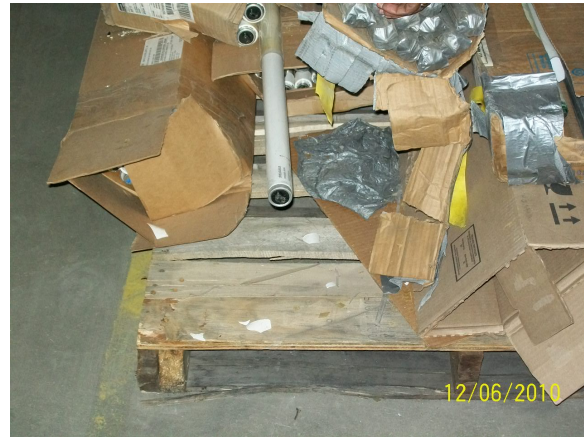
Open Boxes with broken lamp

Type:	Violation
Rule:	264.171, 403.727(1)(c), 264.173(a), 62-737.800(9)
Explanation:	This is an apparent violation of Specific Permit Condition 2.8, as required in 403.727(1)(c) Fl. Stat. Veolia had a pallet of universal waste lamps that had several open and not properly stored boxes on it. There were pieces of broken lamp on the floor in front of the pallet and on the pallet itself.
Corrective Action:	Veolia needs to ensure that any materials being stored within the Inbound Universal Waste Storage area are properly containerized and closed unless being actively processed. "Owners and operators shall store processed and unprocessed materials in closed containers; and for broken or damaged unprocessed lamps and devices, and residuals, store these in closed, covered and sealed containers or in enclosed areas of the facility conforming to paragraph 62-296.417(1), F.A.C., to prevent mercury emissions. They shall store unprocessed materials, ampoules, phosphor powder and other mercury containing residuals indoors to prevent breakage of lamps or devices prior to further processing and to prevent a release of hazardous materials to the environment".

Type:	Violation
Rule:	264.51(b)
Explanation:	Department and Agency staff observed one pallet in the Inbound Universal Waste Area that had several open boxes and some broken glass in front of it. The facility indicated that some containers arrive with broken lamps inside and the contents sometimes fall out in pre-process sorting. It appears the facility failed to carry out immediately the provisions of the contingency plan in accordance with Specific Permit Condition 2.5(a) of its operating permit for the apparent release of hazardous waste or hazardous waste constituents which could threaten human health or the environment.
Corrective Action:	Veolia needs to ensure that broken glass/lamps are containerized to ensure no release of hazardous waste or hazardous waste constituents which could threaten human health or the environment.

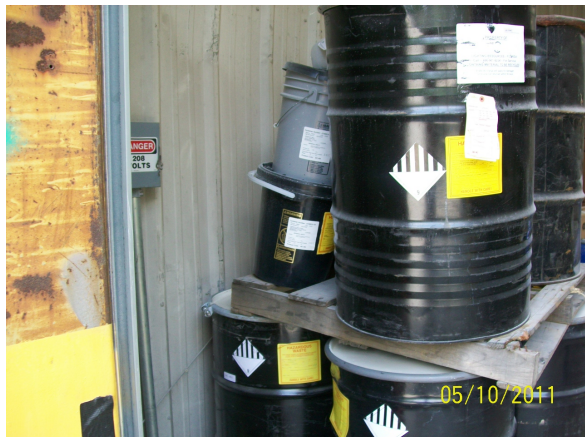
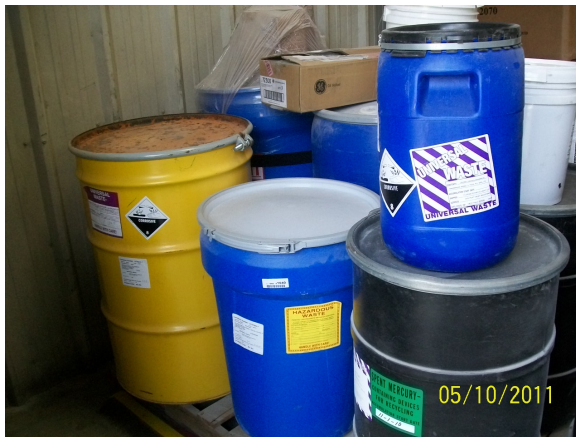
HW Storage

Hazardous waste containers in this area were dated and labeled. The oldest accumulation date observed was February 15, 2011 and the area appeared to be in compliance.

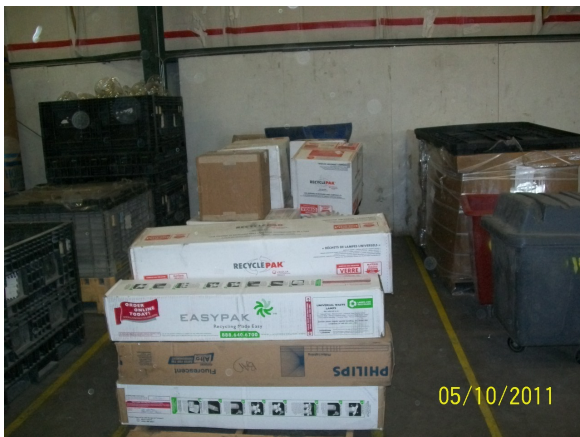
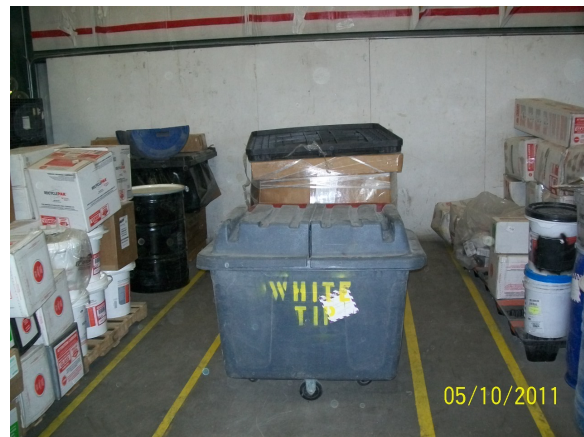
UW Lamp Storage

The Inbound Universal Waste Storage area had containers properly closed, labeled, in good condition and appeared to be in compliance.
