INTERIM RCRA FACILITY ASSESSMENT

SAFETY-KLEEN CORPORATION
Tampa, Florida

EPA I.D. No. FLD980847271

December 1989

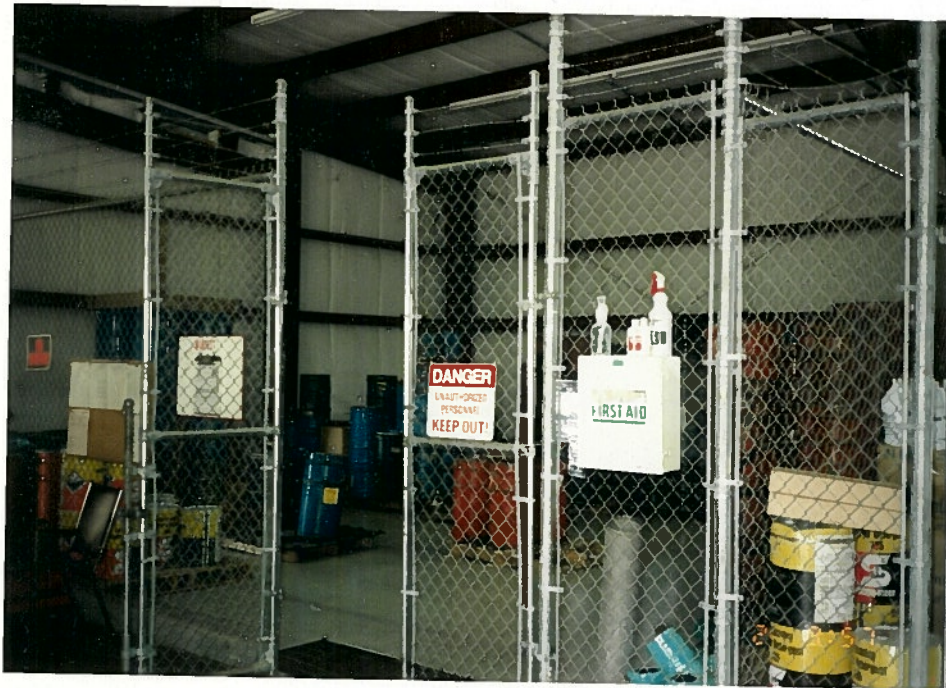
COMMENTS: The unit was observed to be in good condition during the VSI. It is located indoors and has secondary containment. Hence, the potential to all media was assessed as low.

Photo 1a. Service Center Drum Storage Area (SWMU 1)

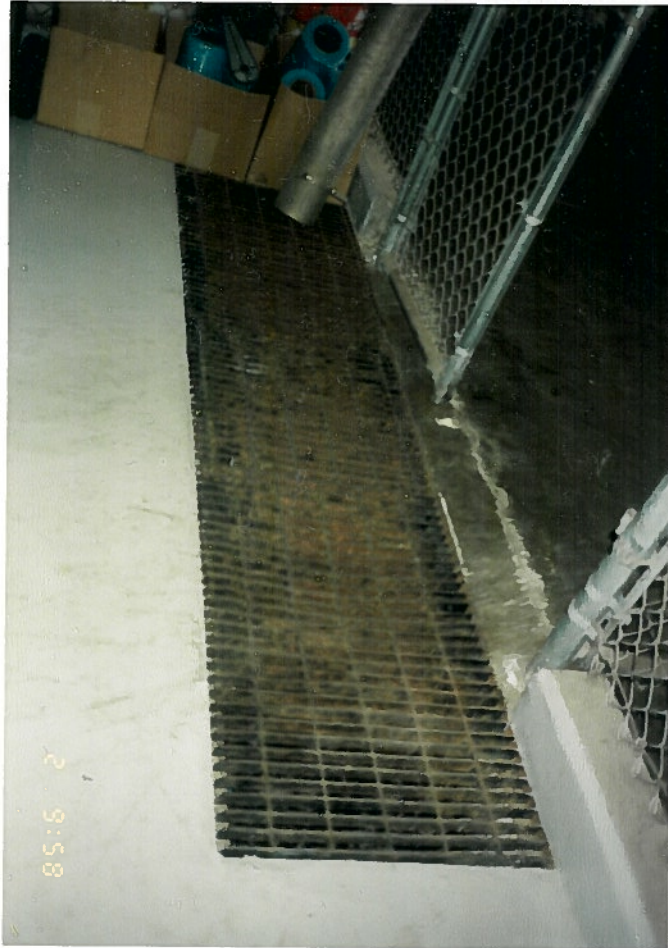
Photo 1b. Containment trench located in front of the Service Center Drum Storage Area (SWMU 1) gate.

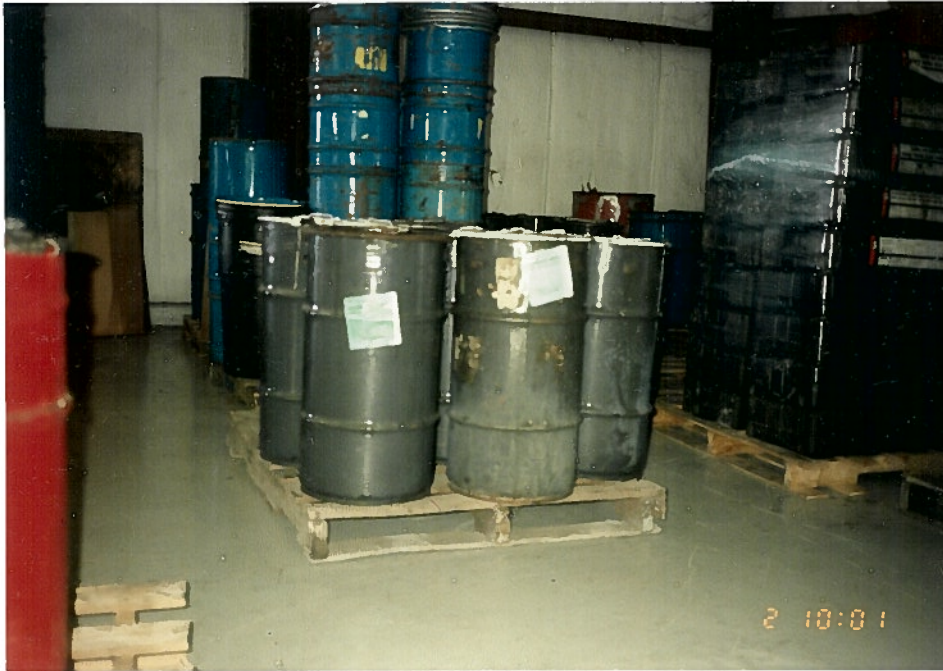
Photo 1c. Drums of waste within the Service Center Drum Storage Area (SWMU 1). The drums were positioned on wooden pallets and the epoxy-coated floor was in good condition. Note height of stacked waste drums.

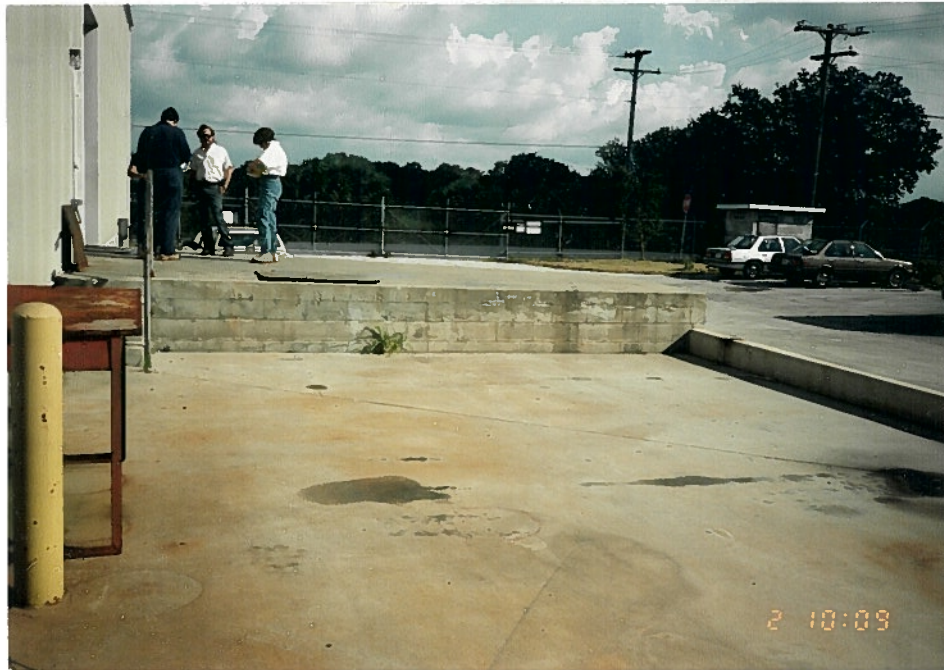
According to the available file material, only a single release of five gallons of mineral spirits sludge occurred on this loading dock. The release was contained and cleaned up with absorbent towels. Stains and small cracks in the concrete were observed during the VSI.

COMMENTS: Although the unit was observed during the VSI to have minor staining and small cracks, the potential for release from this unit was assessed to be low. It is concrete and has secondary containment structures. The potential for release to all media is low.

Photo 2. A view of the Drummed Dry Cleaning and Paint Waste Unloading Dock (SWMU 2), facing north. Note stains on the concrete pad below the loading dock.

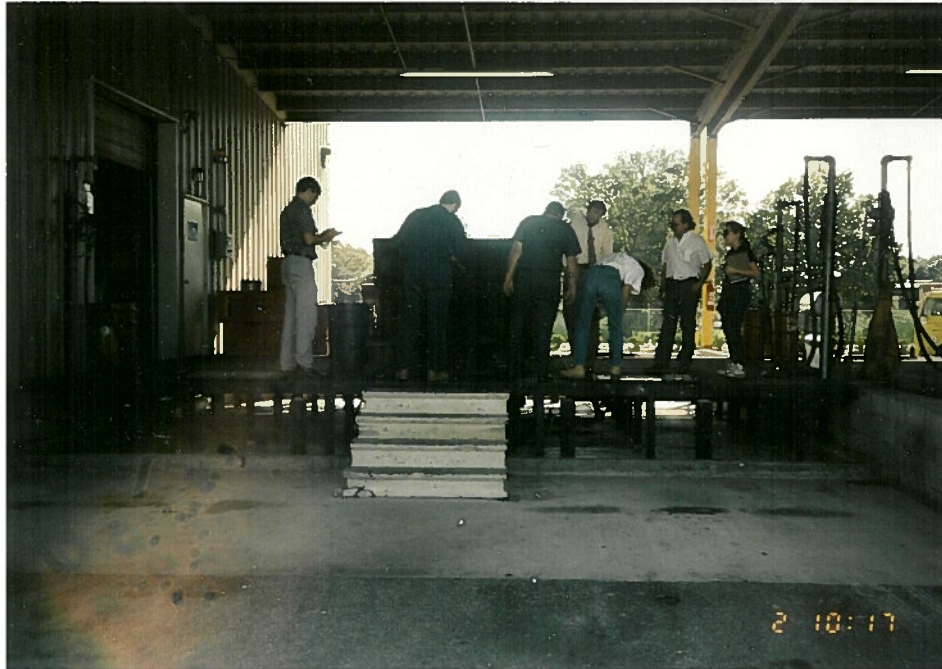
Photo 3. View of an open Solvent Return Wet Dumpster (SWMU 3).

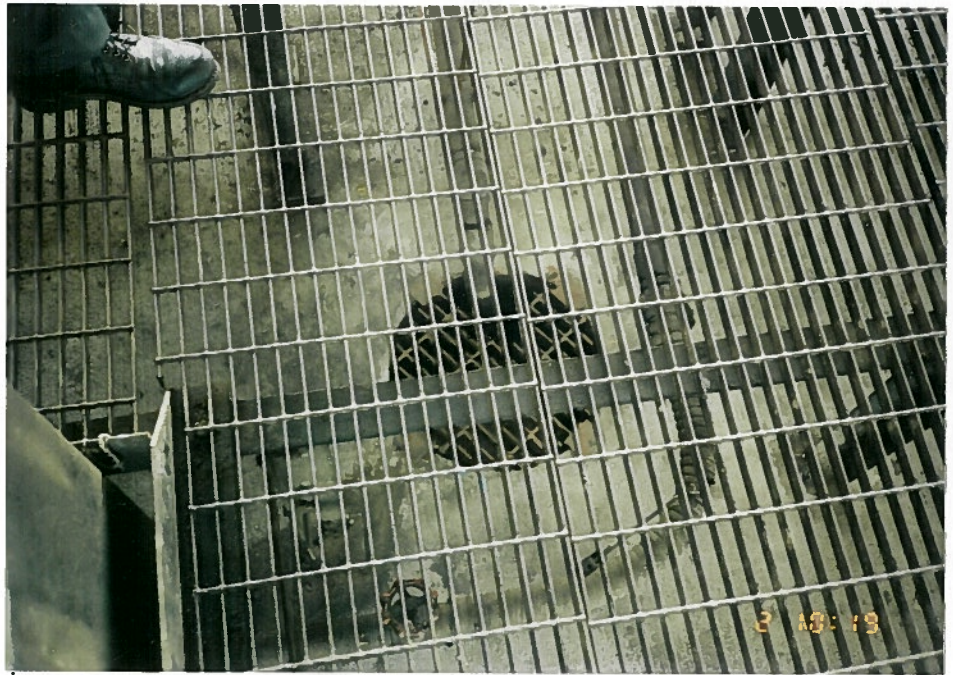
Photo 4a. Overview of the facility's solvent return fill shelters. The Solvent Return Wet Dumpsters (SWMU 3) are located here, and the Spill Containment Area Below the Fill Shelters (SWMU 4) can be seen beneath the metal grate platform.

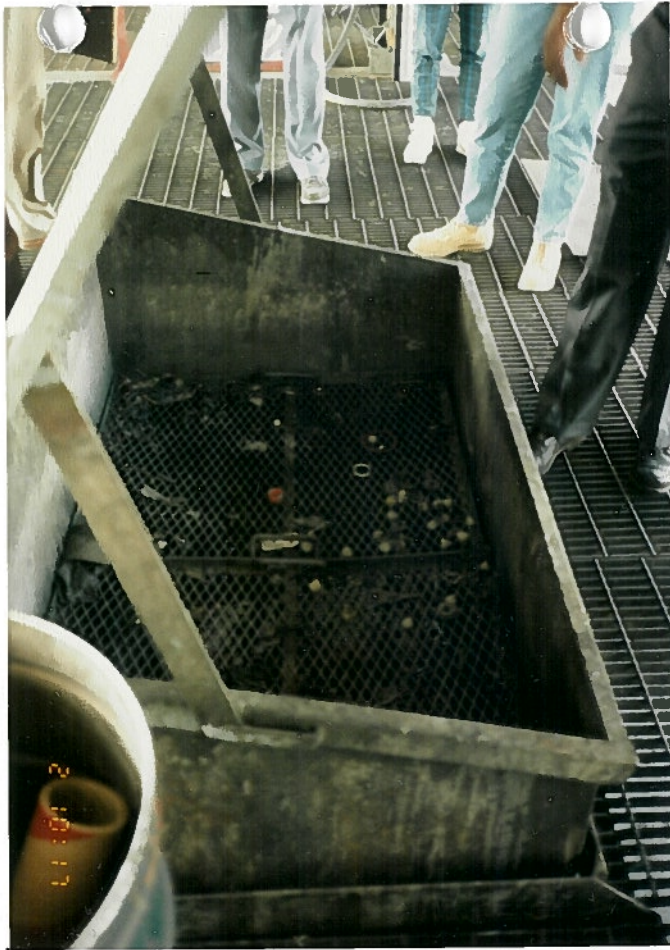
Photo 4b. This sump is located in the Spill Containment Area below the Fill Shelters (SWMU 4).

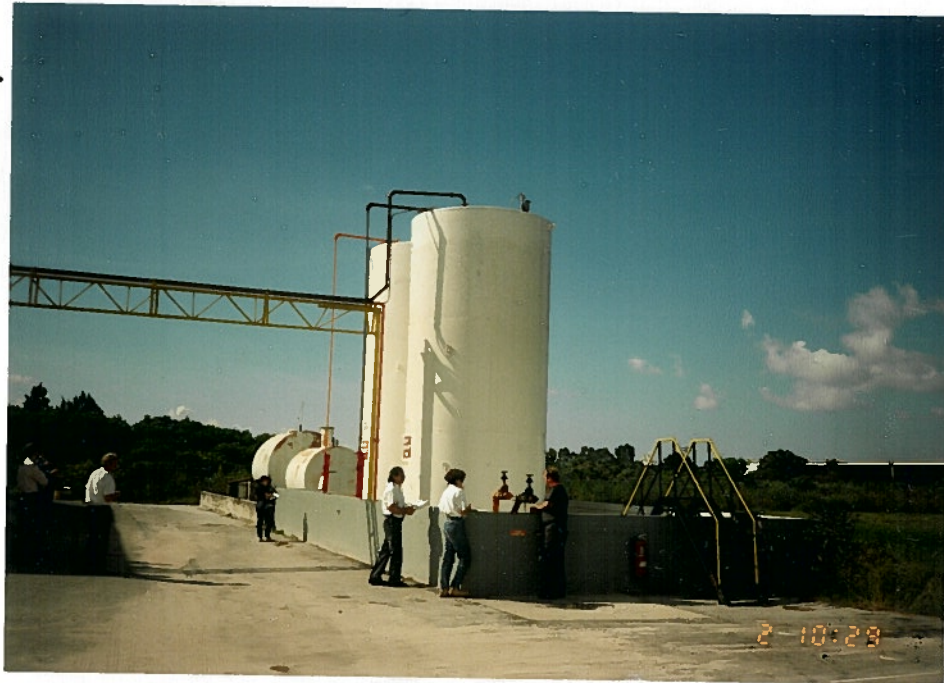
COMMENTS: The tank was observed to be in good condition during the VSI. It is RCRA-regulated and has secondary containment and a high level alarm. The potential for release to all environmental media is low.

Photo 6a. Overview of the Waste Solvent Storage Tank area (SWMU 6), facing south. Note overhead piping to the tanks from the fill shelters.

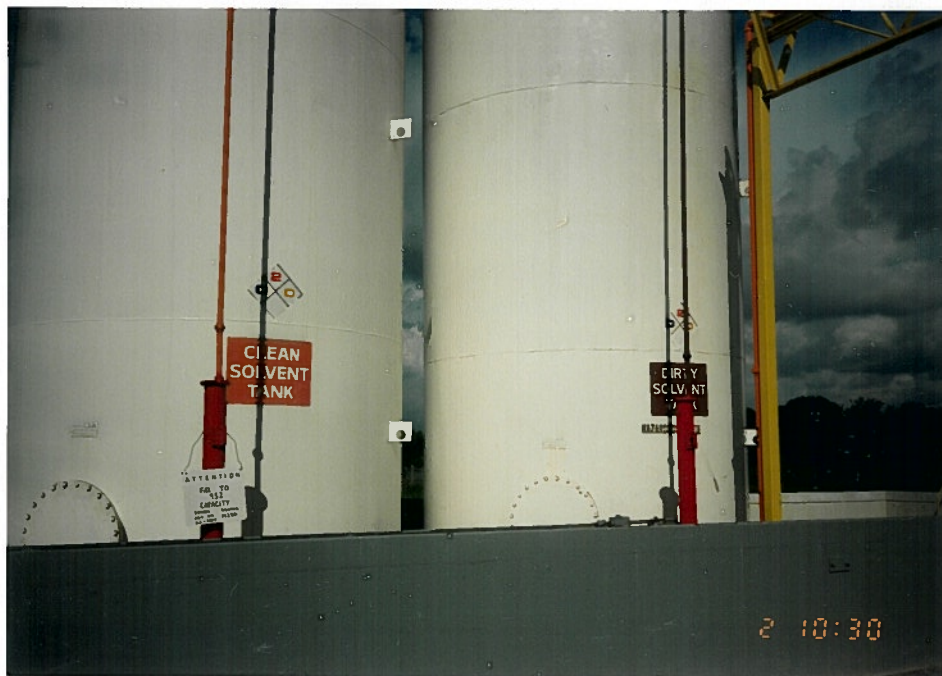
Photo 6b. Close-up of the product tank and the Waste Solvent Storage Tank (SWMU 6).

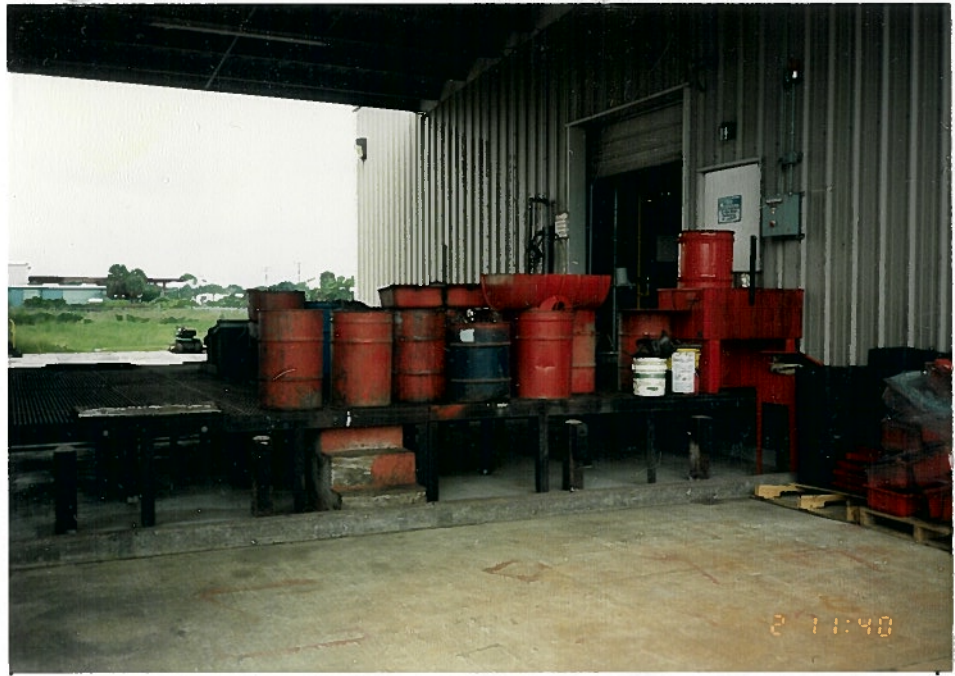
Photo 5a. Overview of the Drum Rinsing Area (SWMU 5). The drum-washing apparatus is the 55-gallon drum that has a halved 55-gallon drum positioned lengthwise over it. This area is located above the Spill Containment Area Below the Fill Shelters (SWMU 4).

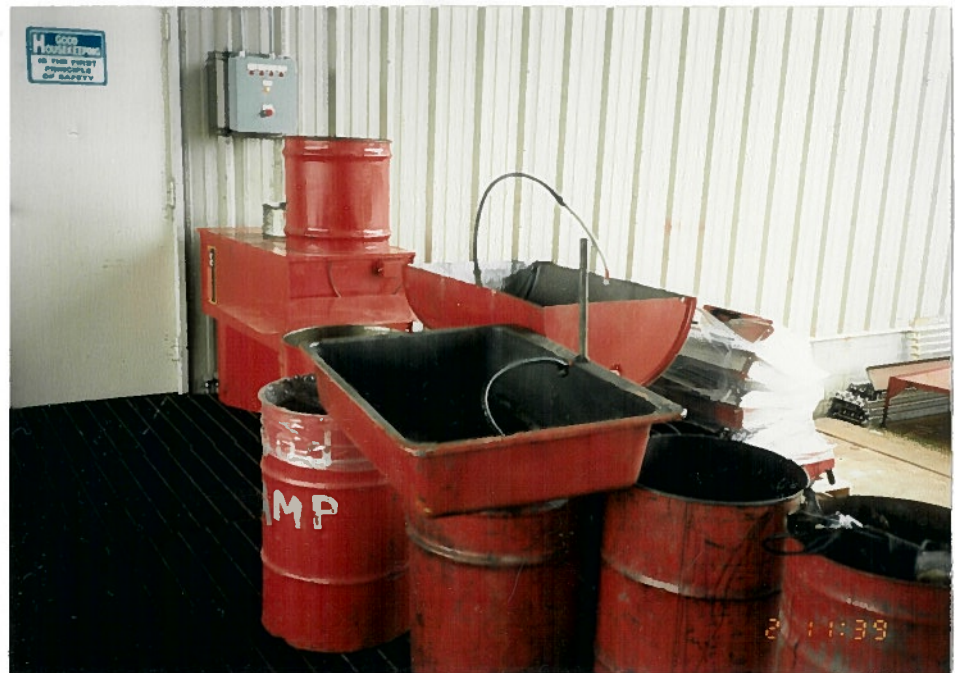
Photo 5b. Close-up view of the Drum Rinsing Area (SWMU 5).

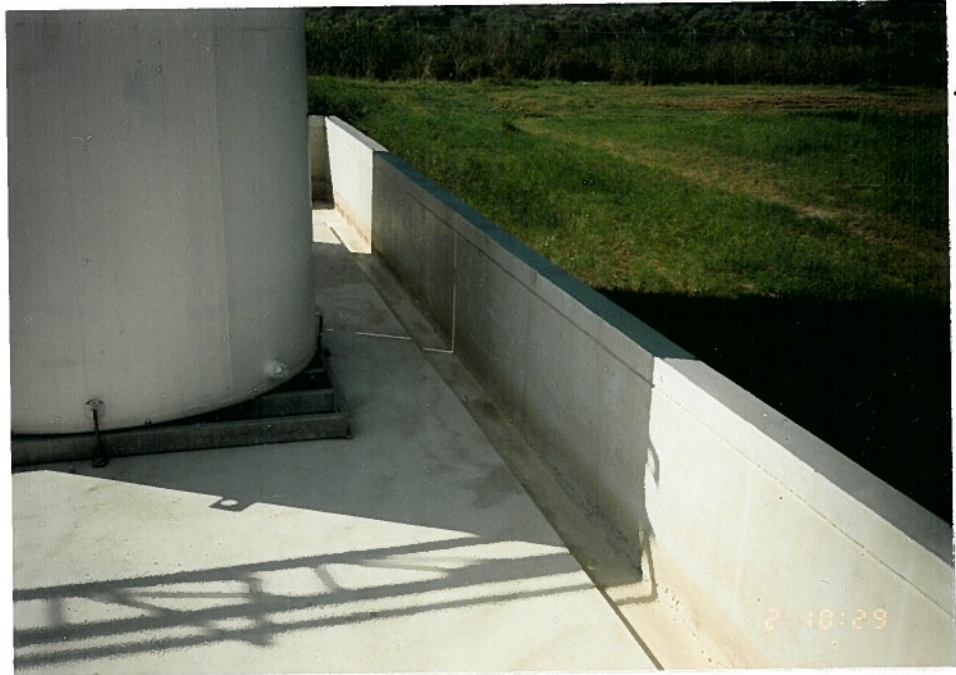
Photo 6c. Epoxy-coated concrete pad and cinder-block dike that surround the Waste Solvent Storage Tank area (SWMU 6). This view is facing south.

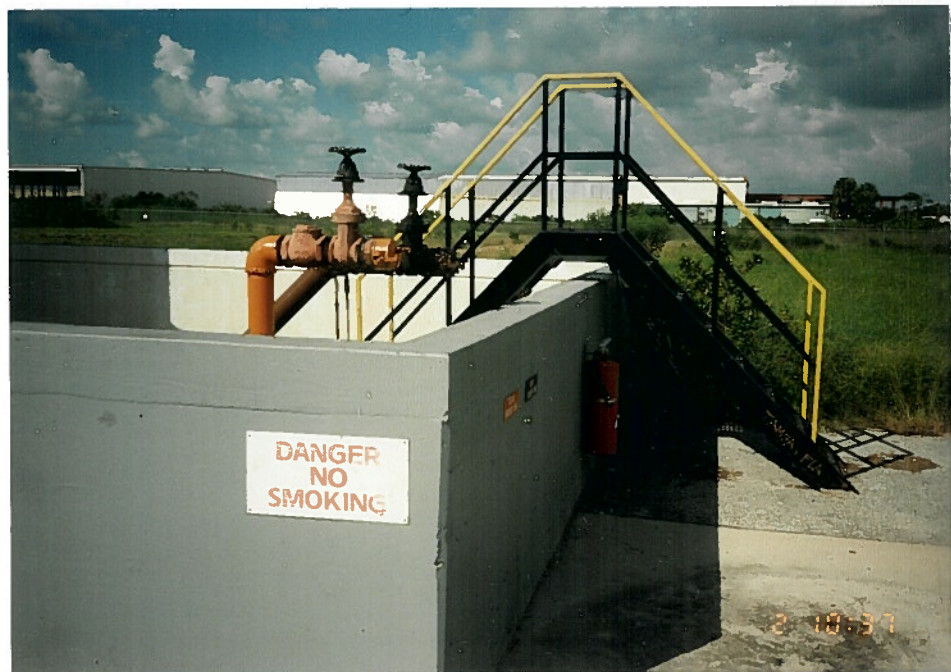
Photo 6d. The tanker truck hookup pipes and valves for waste solvents (brown pipe, to the right) and clean solvents (orange pipe, to the left). These pipes are used for transferring solvents to and from a tanker truck.

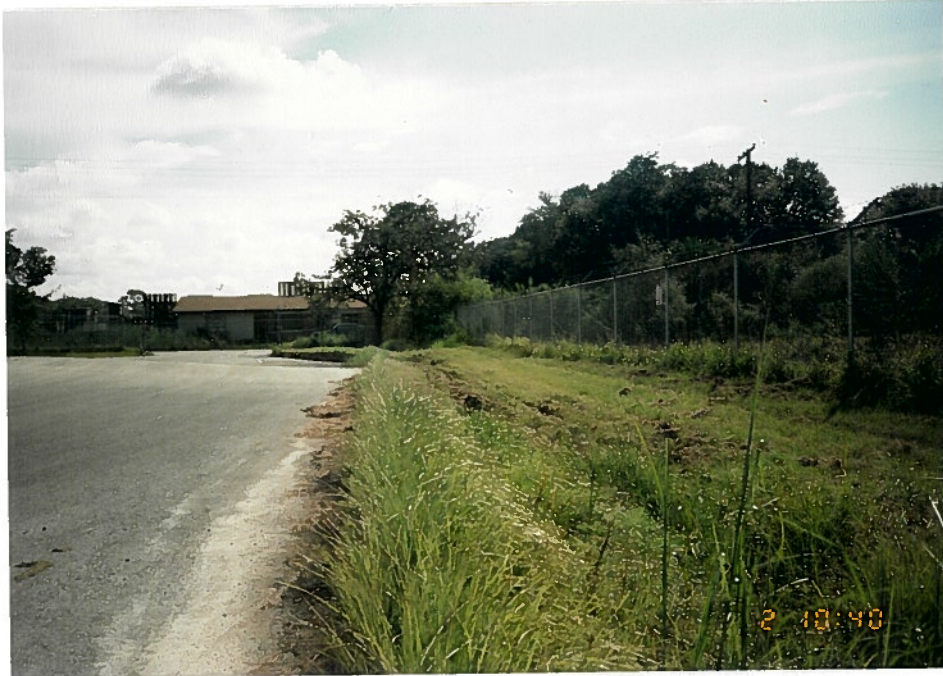
Photo 7. View of the Stormwater Ditch (SWMU 7), facing east. The chain-link fence to the right is the facility's southern border.

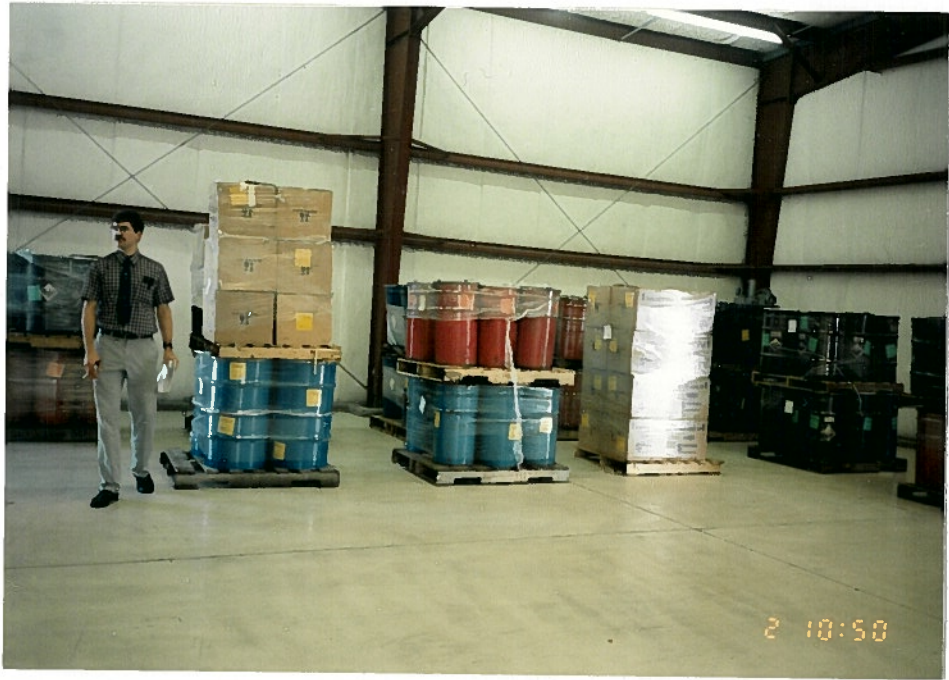
Photo 8a. The Accumulation Center Drum Storage Area (SWMU 8).

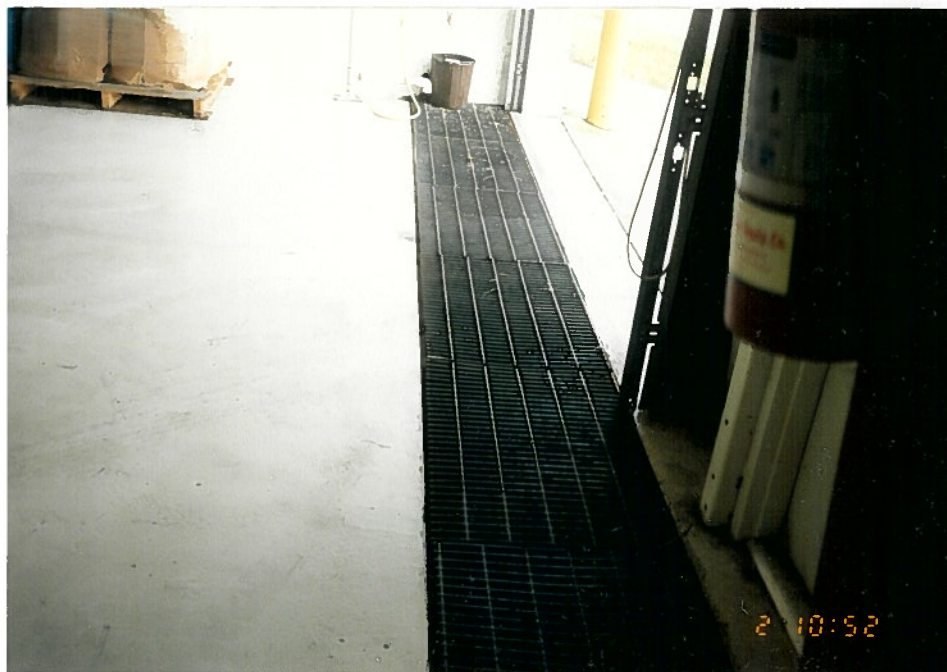
Photo 8b. Trench located in front of the Western doors within the Accumulation Center Drum Storage Area (SWMU 8).

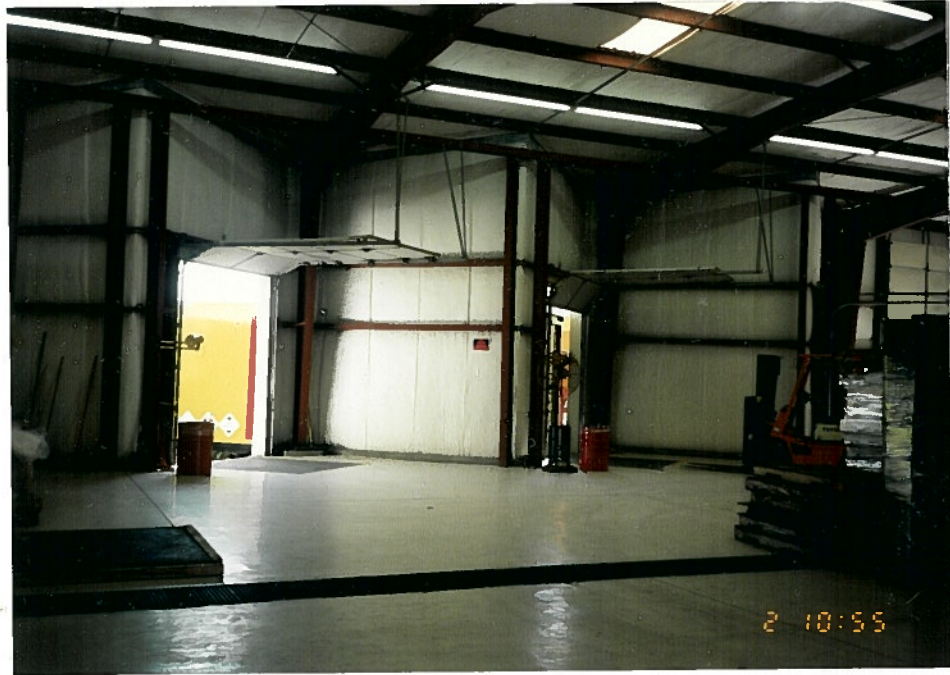
Photo 9a. Two of the three Drummed Waste Loading Docks (SWMU 9). The third loading dock is to the right, just outside this photo. The floor is epoxy-coated in this area.

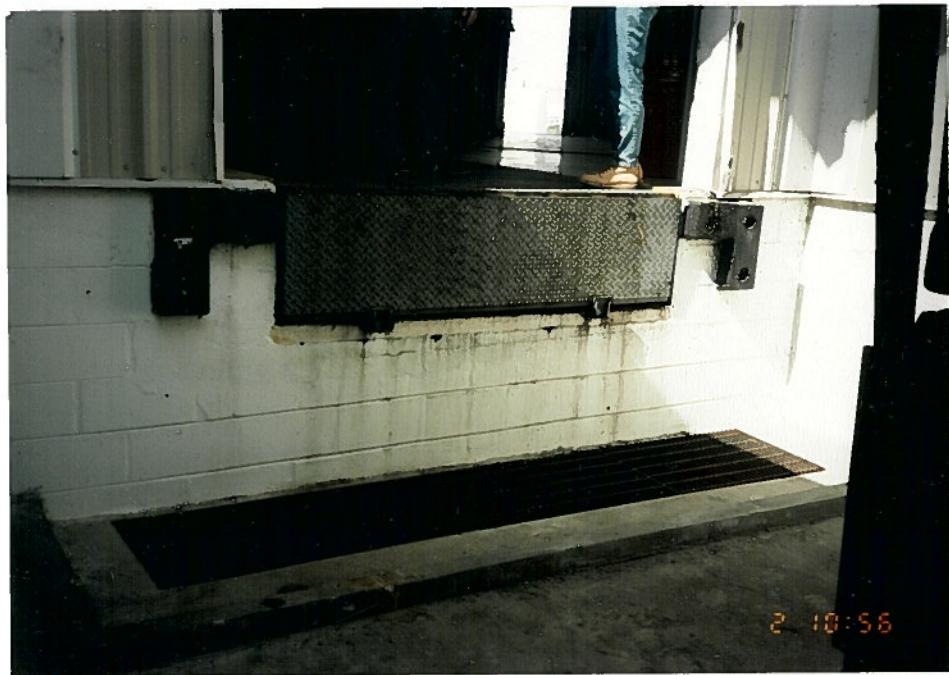
Photo 9b. This sump is located outdoors within one of the Drummed Waste Loading Docks (SWMU 9). The other two loading docks also have sumps positioned in similar layouts.

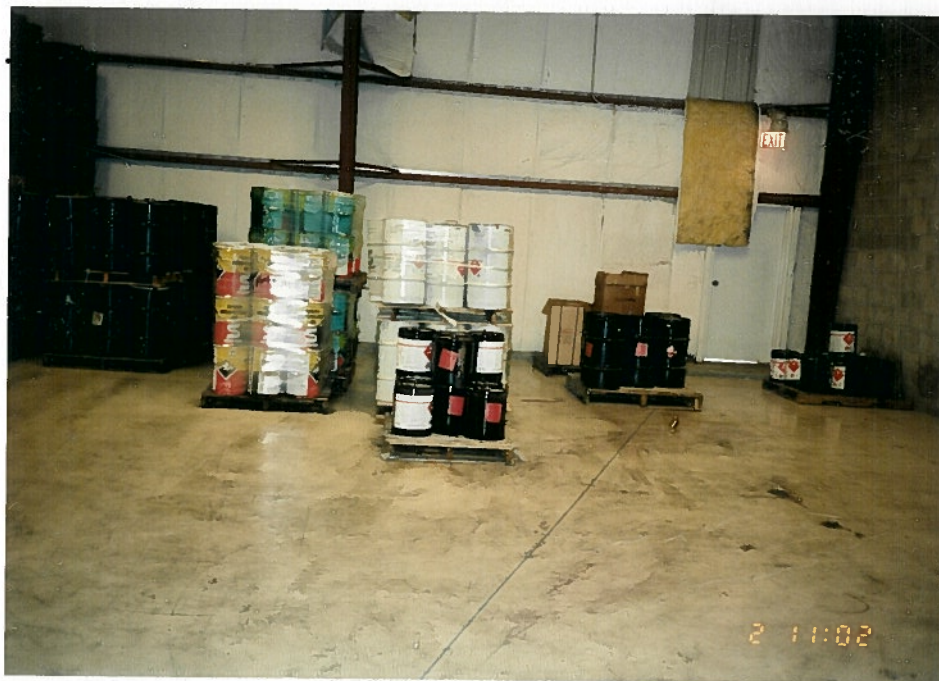
Photo 10a. The Drummed Flammable Waste Storage Room (SWMU 10). All drums were positioned on wooden pallets. Note that drummed waste to the left is stacked four drums high.

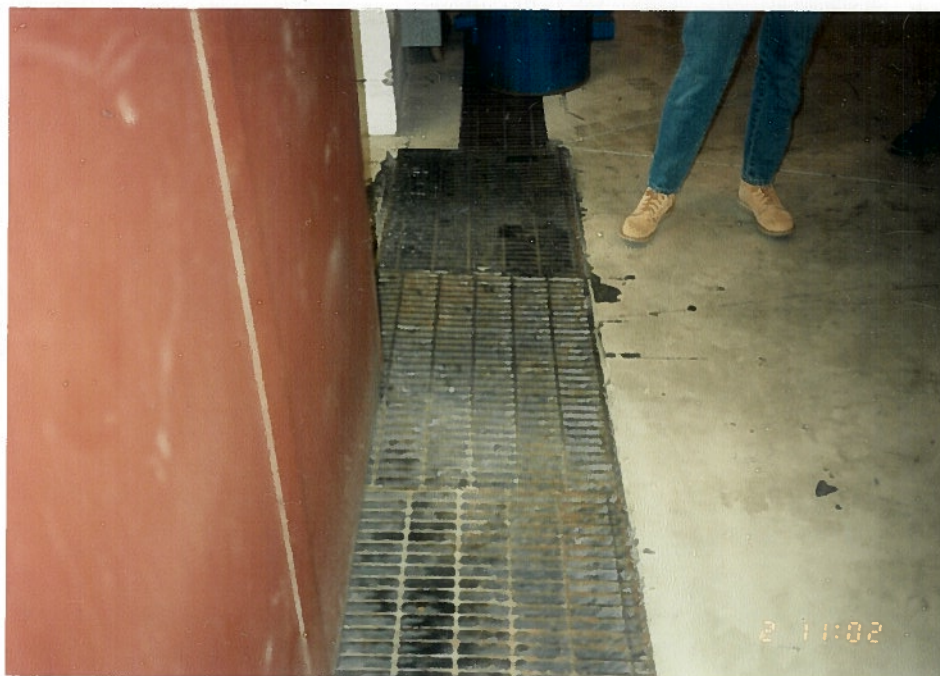
Photo 10b. Trench within the Drummed Flammable Waste Storage Room (SWMU 10). This trench is positioned in front of the sliding door to the Drummed Flammable Waste Storage Room (SWMU 10).

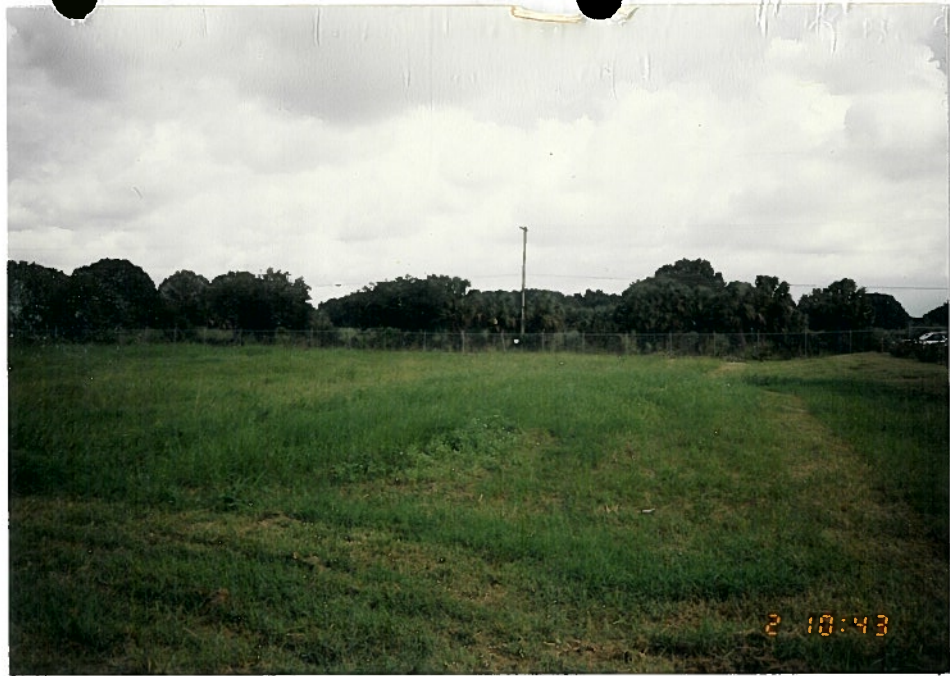
The unit consists of an area of approximately one acre near the western boundary of the property. At present the area is unused and was observed to be covered with vegetation. According to facility representatives, prior to 1986, this area was used for dumping household and office trash. Facility representatives also indicated that no hazardous wastes or chemicals were disposed of in this area although there was no documentation available to substantiate this. No additional information was available regarding the source of this waste or past ownership of the property.

COMMENTS: No documentation regarding the actual use of this area prior to 1986 was available. The potential for release to soil and groundwater is high due to the unlined nature of the unit if hazardous constituents are present. The potential to release to all other environmental media is low.

Photo 11. View of the Old Dumping Ground (SWMU 11), facing north.

RECOMMENDATION: No Further Action ()
RFA Phase II Sampling (X)
RFI Necessary ()

<u>No.</u>	<u>Unit Name</u>	<u>Dates</u>	<u>Suggested Sampling</u>	<u>Evidence of Releases (Yes/No)</u>
11	Old Dumping Ground	Prior to 1986	Soil sampling is suggested to determine the presence of hazardous waste or hazardous constituents. Surface and sub-surface soil samples should be collected from areas where dumping has been suspected or where wastes may have been stored. Samples should be analyzed for Appendix IX constituents.	No

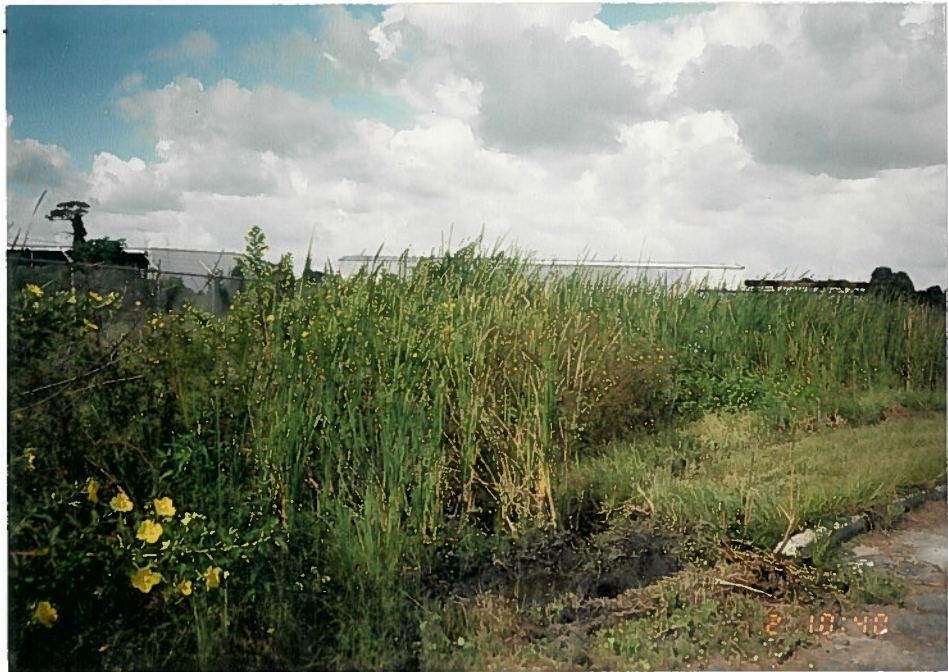
Photo 12. View of the Stormwater Retention Pond (SWMU 12), facing west. Tall grass and cattails are growing in this pond.
