Cliff Berry, Incorporated Environmental Services

Re: FDEP inspection of the CBI Miami Facility October 27, 2011 ME ID#: 51668

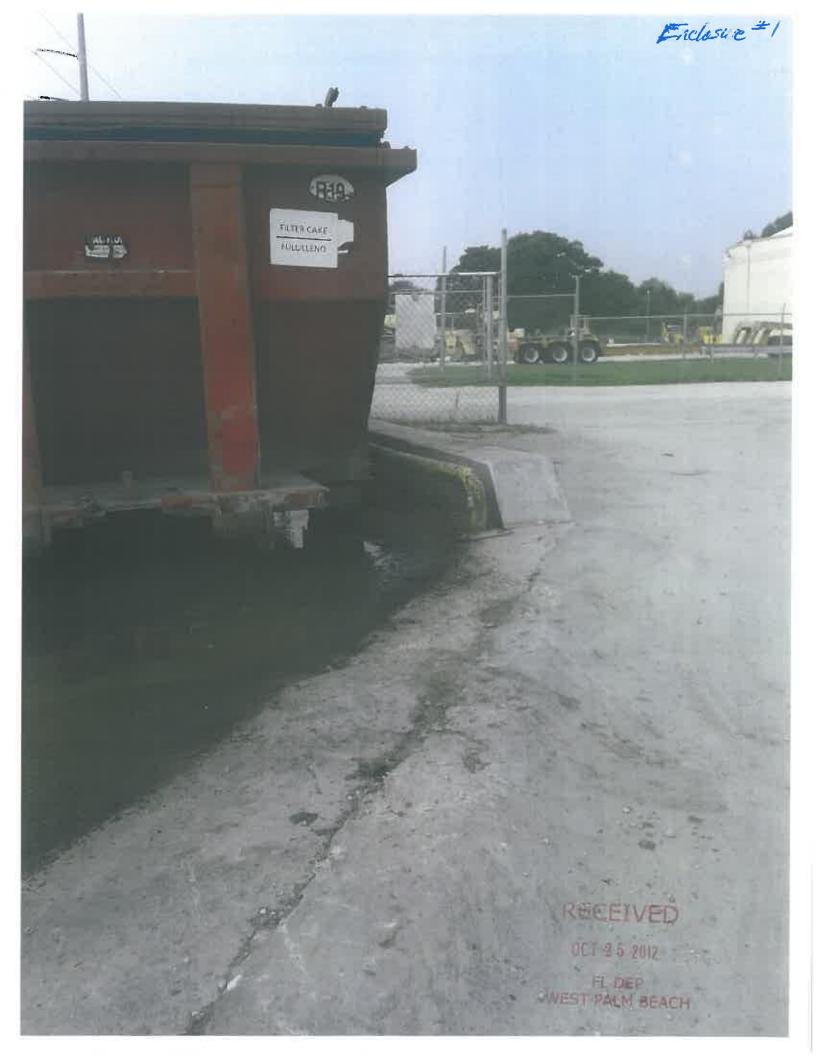
Oily Waste Storage Area: The oily waste storage area has been designed as a storm water catchment with sump and tank. It is not designed to meet a volumetric calculation typical of a containment area (e.g. 110% of the largest container). The waste held in this area is primarily filter cake set inside a roll off box. The storage area basin is simply there to aid in retention of rain water so that when the water mingles with drips from the roll off box it does not run off the property. The space is sloped to the northeast corner (away from the wall that was damaged) toward a sump which is mechanically pumped to a 1,760 gallon tank.

The oily waste storage area was originally designed as a sloped area with only an earthwork on the southeast side (where the wall is today). It was later improved with a horizontal pipe about six inches off the ground acting as bumper for the forklift that carries oily waste to the roll off box. The pipe became damaged over time so it was further improved with cement blocks. When the cement blocks became damaged, as noted on the October 2011 inspection, they were removed and the wall rebuilt with reinforced concrete that can been observed today. Again, the purpose of the wall is to stop the forklift from colliding with the side of the roll off box. Although the wall surrounding the oily waste storage area appears similar to a containment wall, it simply acts as a means to delineate the edge of the storm water retention area and should not be held to the higher standard of a containment wall. Photos showing the latest iteration of the wall are attached.

ncl: 1. Oily waste area photo showing curb elevation above ground and berm

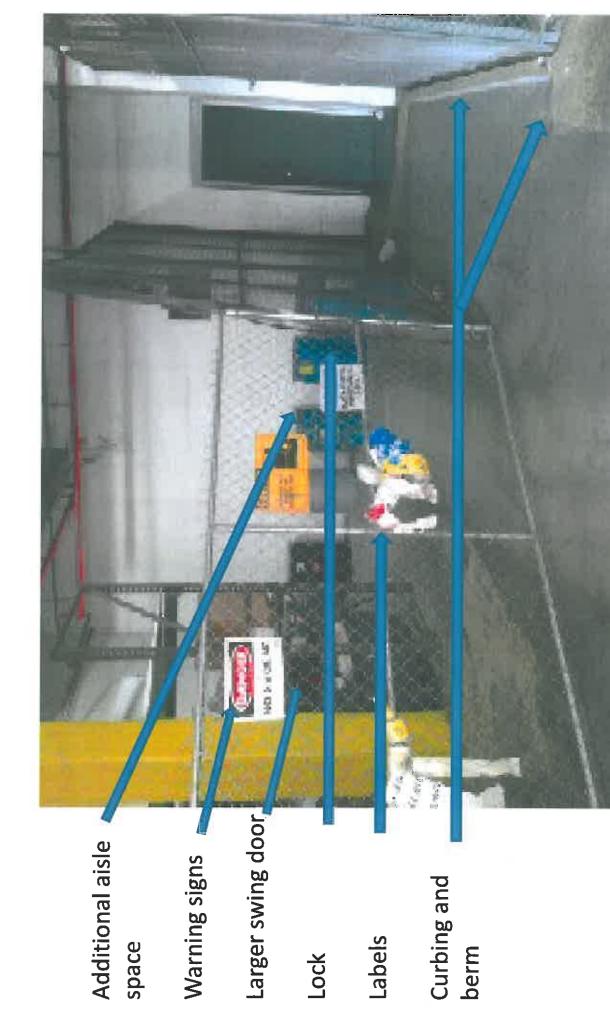
CBI Miami Facility - Hazardous Waste Transfer Area (Oct. 19, 2012) **Improvements**

Hazardous Waste Transfer Area (HWTA): The HWTA has been moved back to its original location. The attached photo was taken October 19, 2012. Pointers have been added to showcase additional measures taken by CBI to safeguard materials placed in the HWTA, including an extended berm to segregate materials, extended spacing between containers, a large swing door with lock, warning signage and rolls of replacement labels. The successful transition also places containers inside the HWTA and beyond the nearby traffic pattern to better protect materials.
