DIRTY MINERAL SPIRITS STORAGE TANK - ORANGE PARK, FLORIDA

SAFETY-KLEEN CORP.

OUT OF SERVICE INSPECTION
DIRTY MINERAL SPIRITS
STORAGE TANK

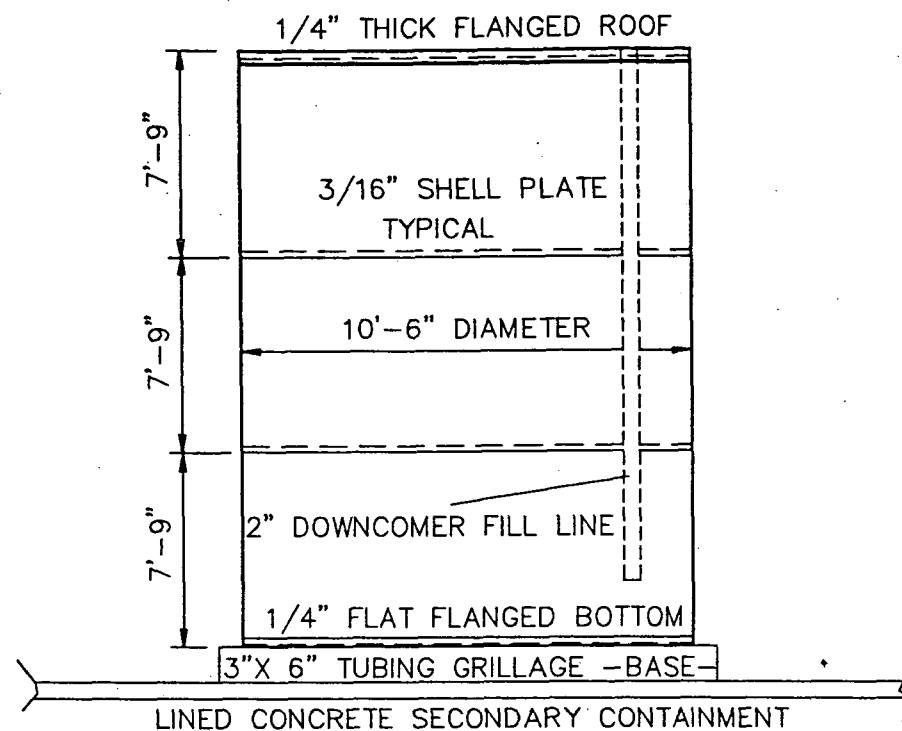
ELEVATION

1. SHELL RUSTING BEHIND UL 142 NAMEPLATE LOCATED ABOVE MANWAY.
2. SHELL COATING IN GOOD CONDITION - COATING BEGINNING TO FAIL ON UPPER SHELL COURSE.
3. U-T READINGS DO NOT INDICATE ANY INTERIOR CORROSION.
4. NO INTERNAL CORROSION FOUND DURING INTERIOR INSPECTION.
5. NO VISIBLE SIGNS OF TANK LEAKAGE.
6. TANK IS IN GOOD CONDITION BASED ON THIS INSPECTION

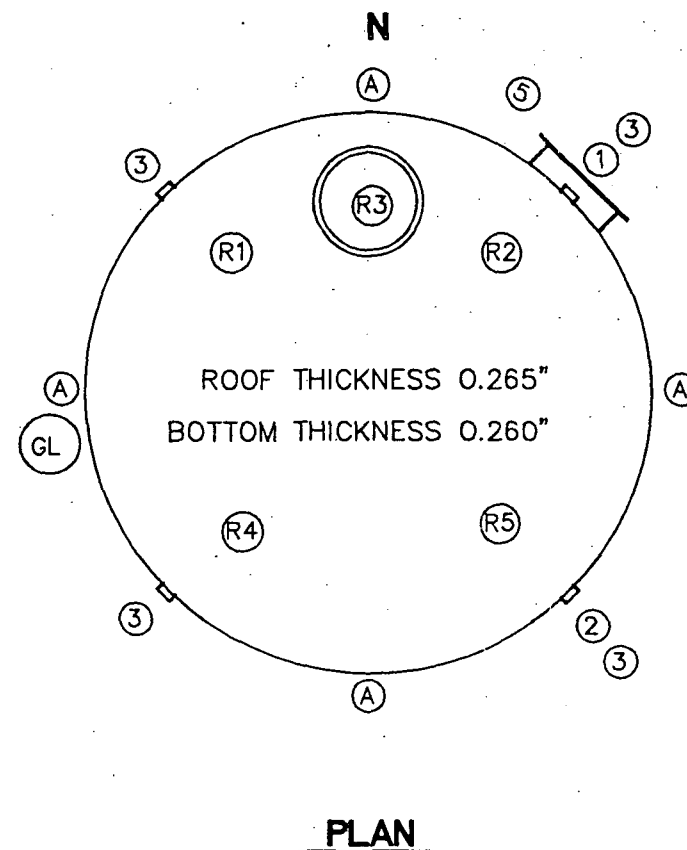
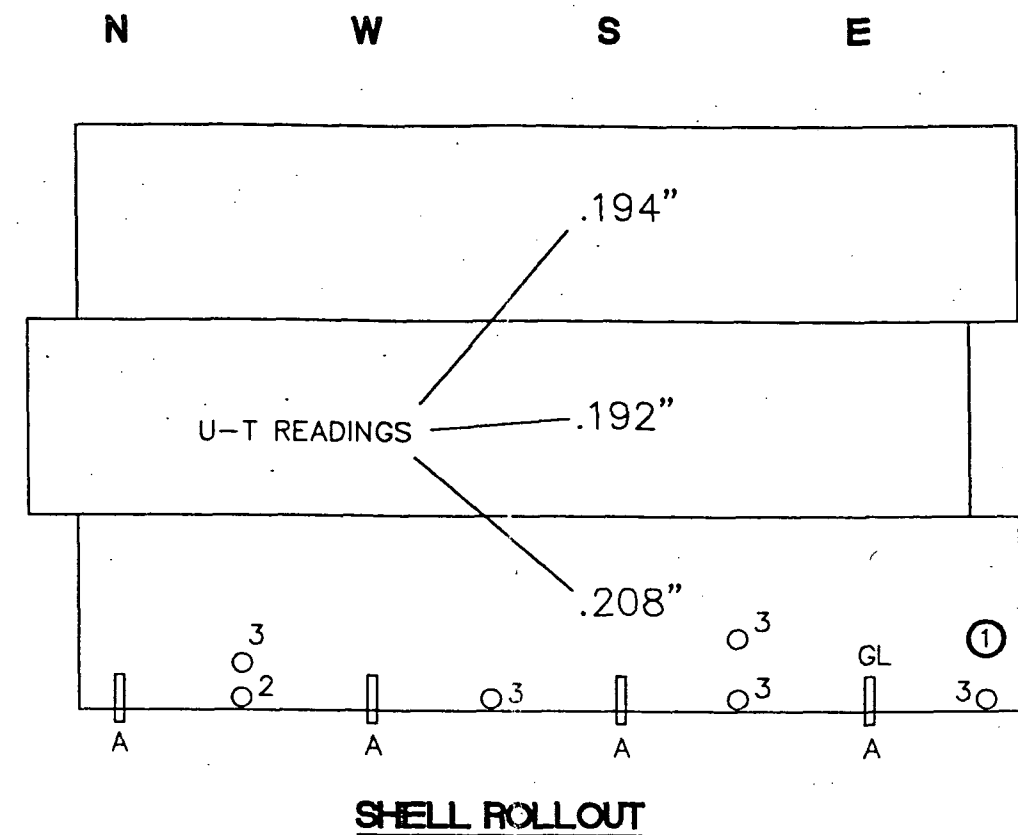
NOZZLES, FITTINGS AND ACCESSORIES

SYMBOL	DESCRIPTION	INSPECTION NOTES
1	24" SHELL MANWAY	GOOD CONDITION
2	4" COUPLING - INLET/OUTLET	GOOD CONDITION
3	4" COUPLING - SPARE NOZZLES	GOOD CONDITION
GL	GROUNDING LUG	GOOD CONDITION
A	TANK ANCHORS	HAVE COATING FAILURE AT BOLTS
R1	4" COUPLING/2" FILL PIPING - ROOF	GOOD CONDITION
R2	4" COUPLING/2" LEVEL GAUGE PIPING	GOOD CONDITION
R3	24" ROOF MANWAY	LONG BOLT CONFIGURATION - NFPA 30 - GOOD
R4	4" COUPLING W/2" P/V VENT	MORRISON FIG. 548 2oz. 20,200 CFH @ 0.5psi
R5	4" COUPLING W/2" ALARM	GOOD CONDITION
