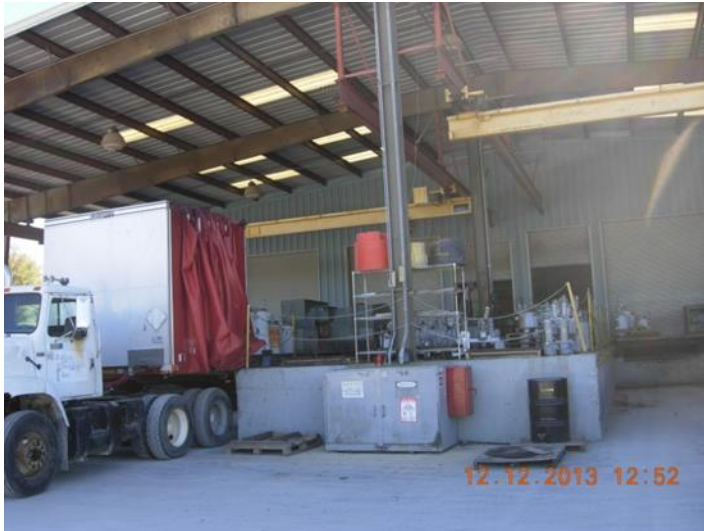
Picture 1: In-Processing Area Dock Doors lacking PCB Markings

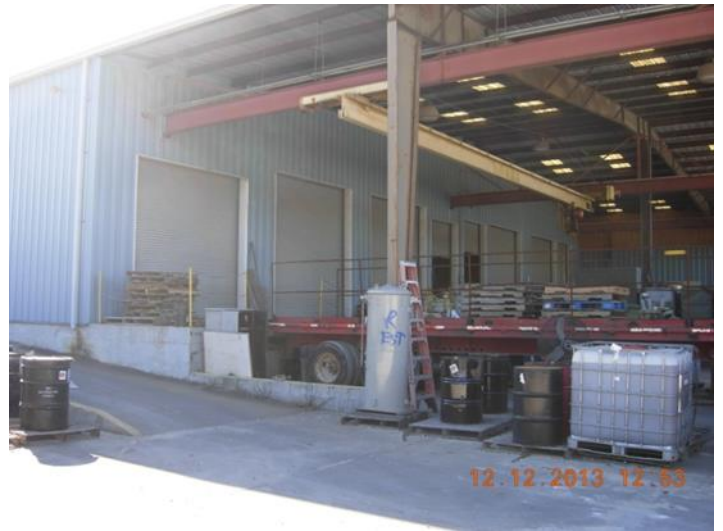
Picture 2: In-Processing Area Dock Doors lacking PCB Markings

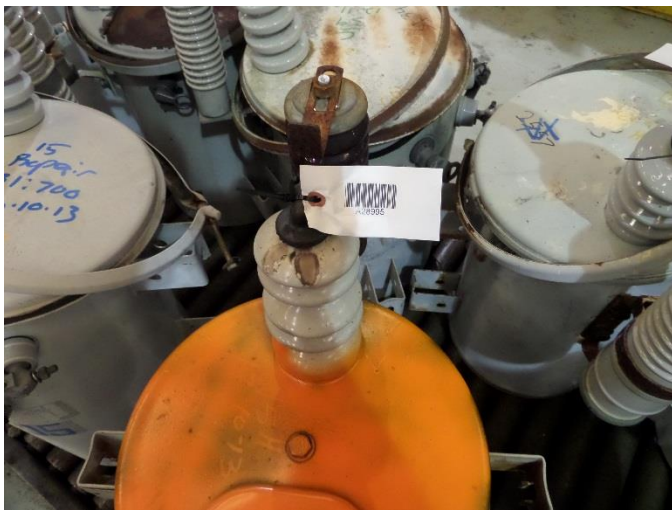
Picture 3: PCB contaminated transformer in the In-Processing Area

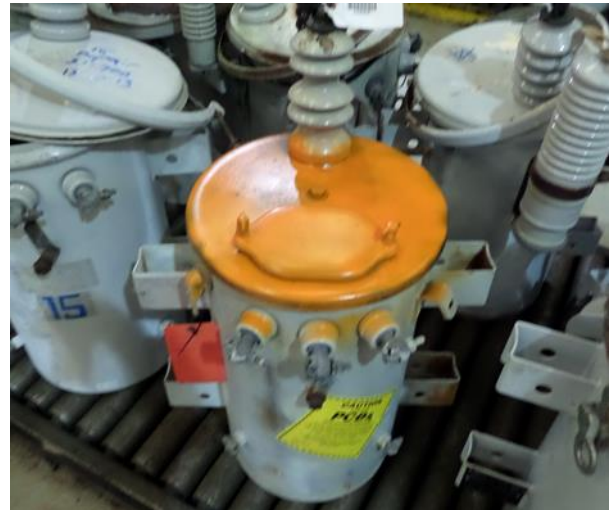
Picture 4: PCB contaminated transformer (ID #A28995) in the In-Processing Area

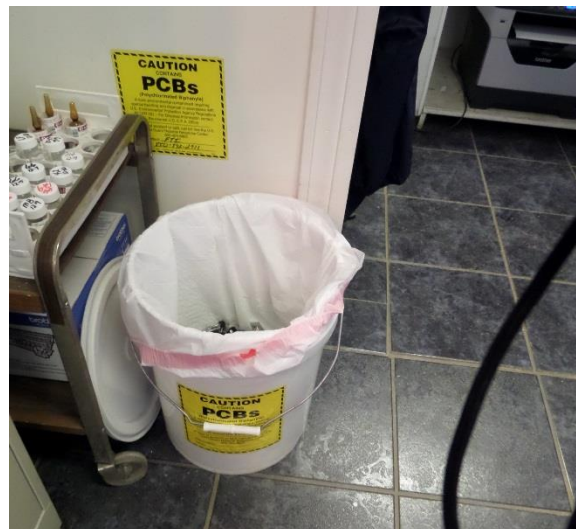
Picture 8: Container for the accumulation of laboratory RCRA regulated waste and PCB regulated waste

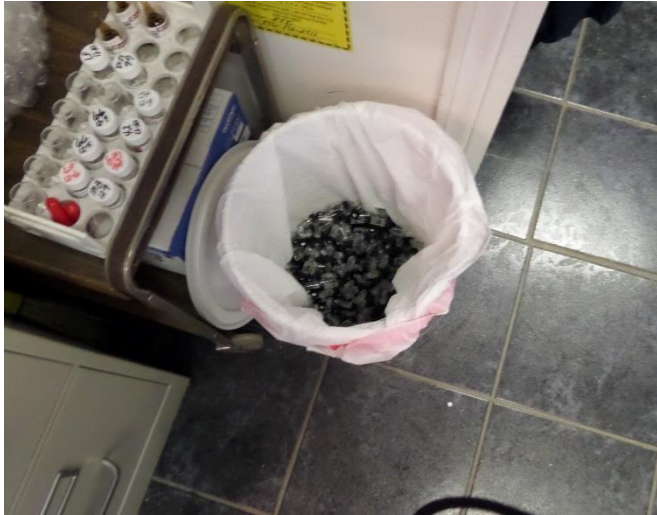
Picture 9: Container for the accumulation of laboratory RCRA regulated waste and PCB regulated waste

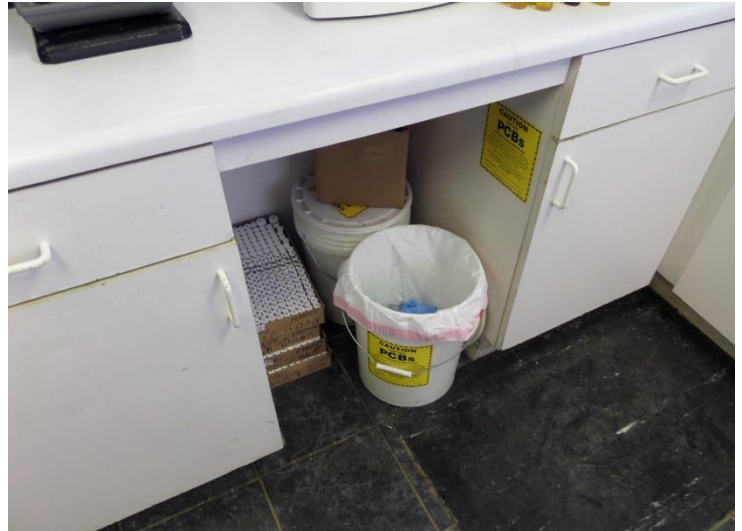
Picture 10: Container for the accumulation of laboratory RCRA regulated waste and PCB regulated waste

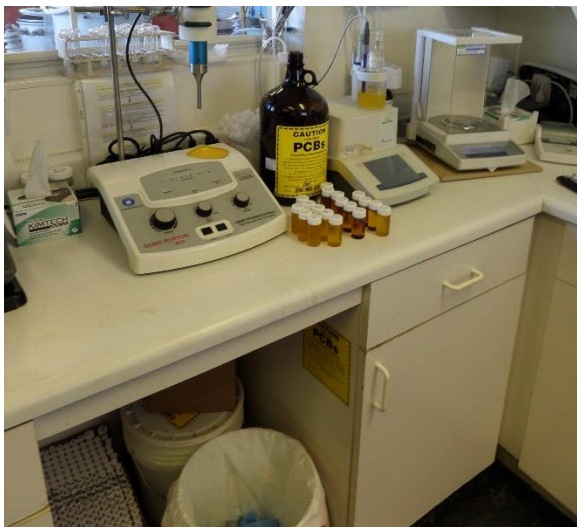
Picture 11: Container for the accumulation of laboratory RCRA regulated waste and PCB regulated waste

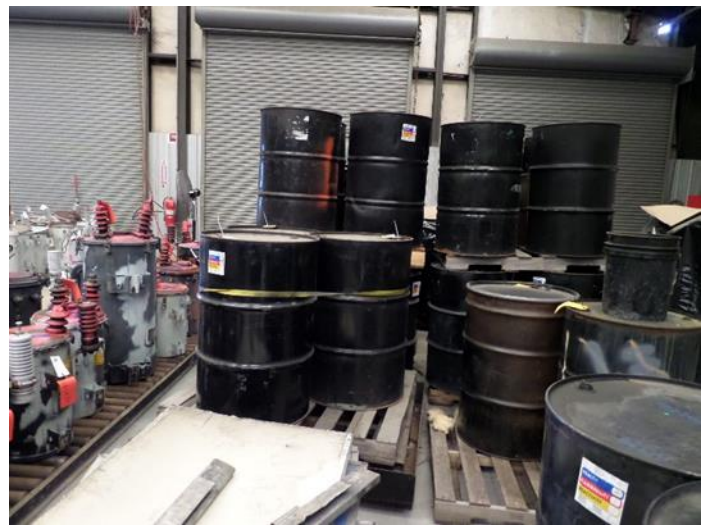
Picture 12: Redragon hazardous waste sludge containers and spent solvents in the PCB Ancillary Storage Area

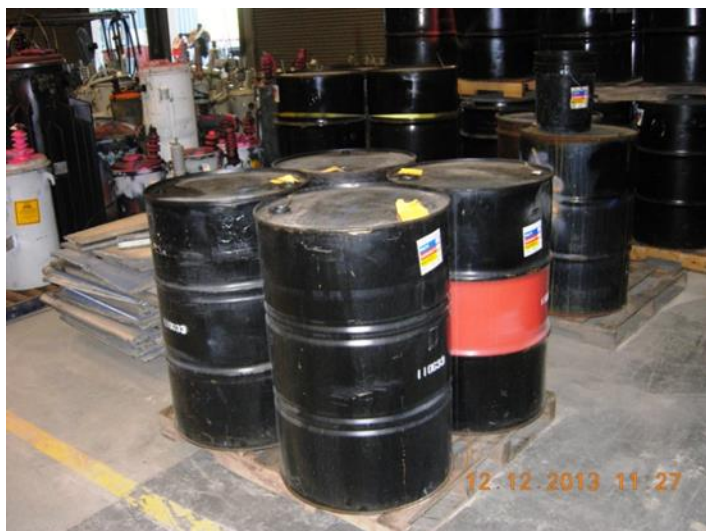
Picture 13: Redragon hazardous waste sludge container in the PCB Ancillary Storage Area

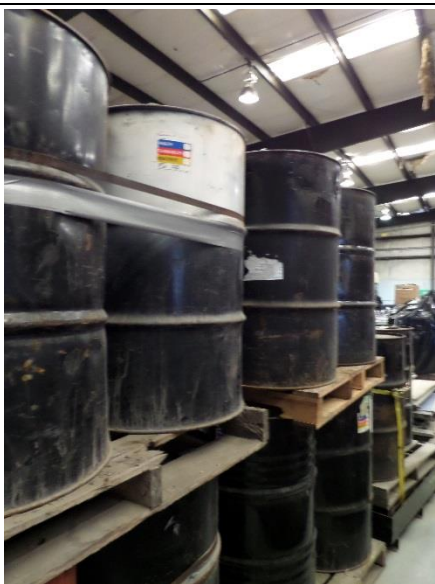
Picture 15: Hazardous waste containers (Redragon sludge and spent solvents) in the PCB Ancillary Storage Area

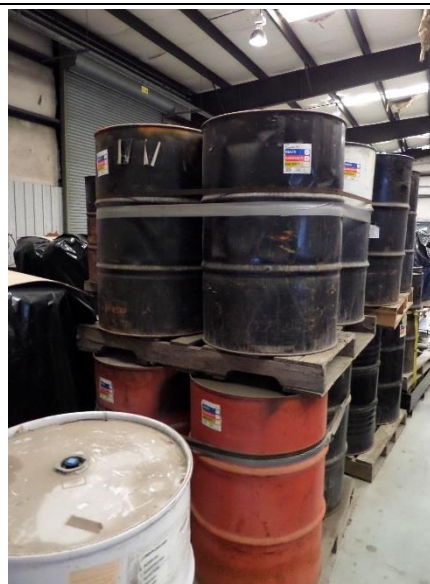
Picture 16: Hazardous waste containers (Redragon sludge and spent solvents) in the PCB Ancillary Storage Area

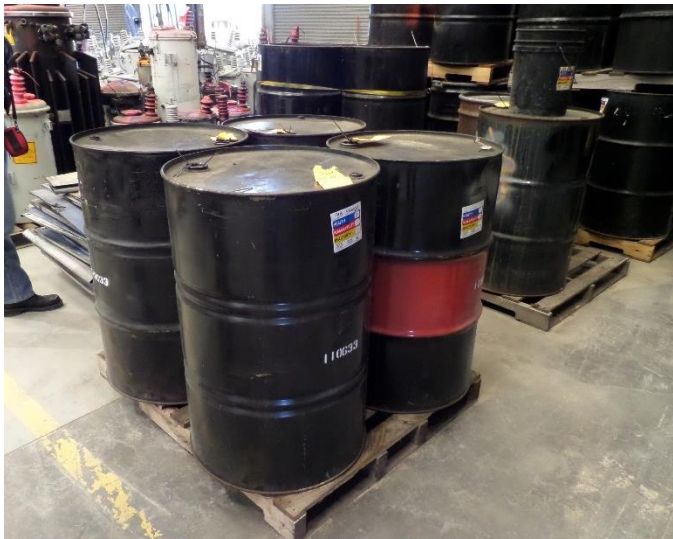
Picture 17: Redragon hazardous waste sludge container in the PCB Ancillary Storage Area

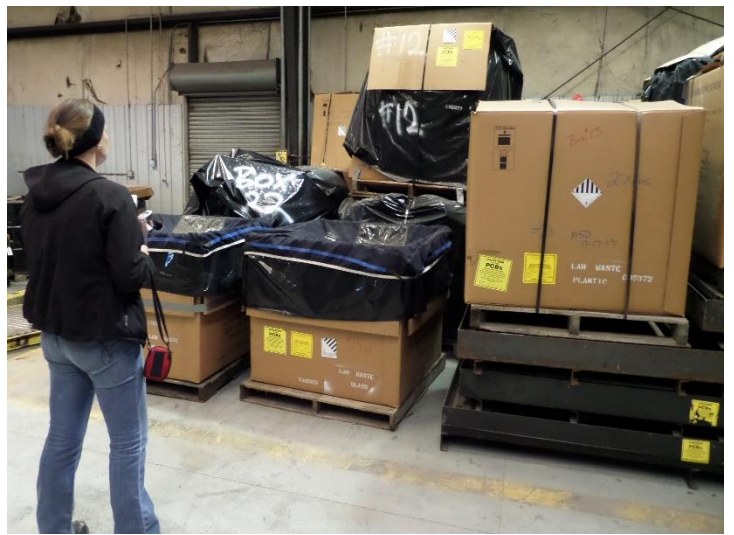
Picture 18: PCB and RCRA regulated hazardous waste containers in the PCB Ancillary Storage Area

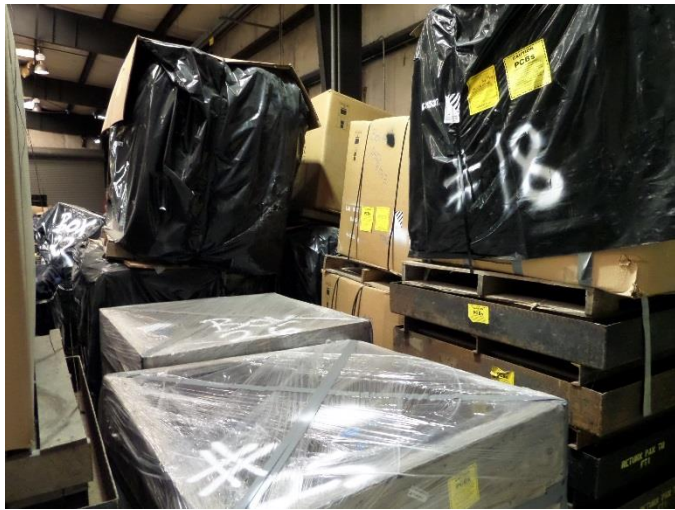
Picture 19: PCB and RCRA regulated hazardous waste containers in the PCB Ancillary Storage Area

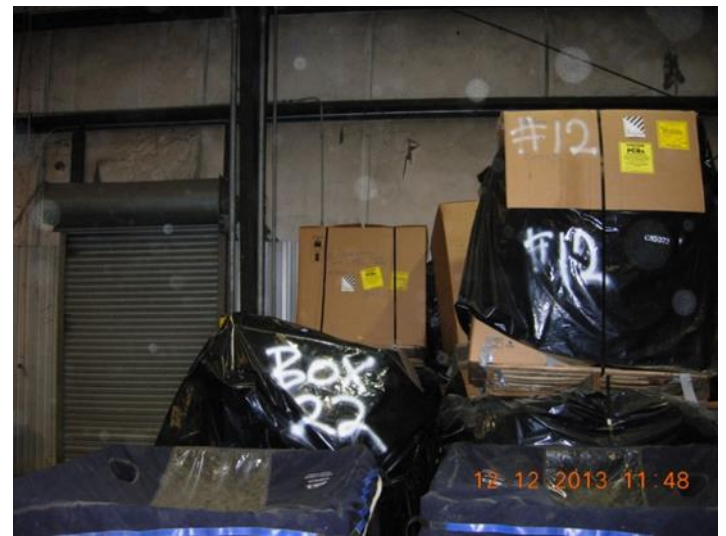
Picture 20: PCB and RCRA regulated hazardous waste containers in the PCB Ancillary Storage Area

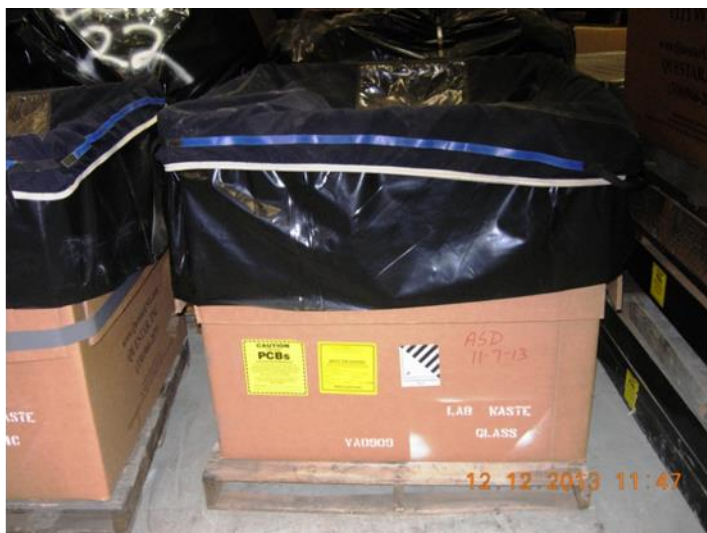
Picture 21: PCB and RCRA regulated hazardous waste containers in the PCB Ancillary Storage Area

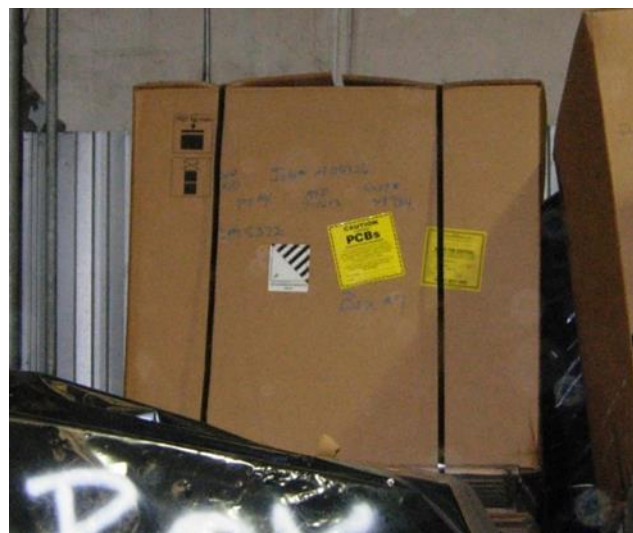
Picture 22: PCB and RCRA regulated hazardous waste containers in the PCB Ancillary Storage Area

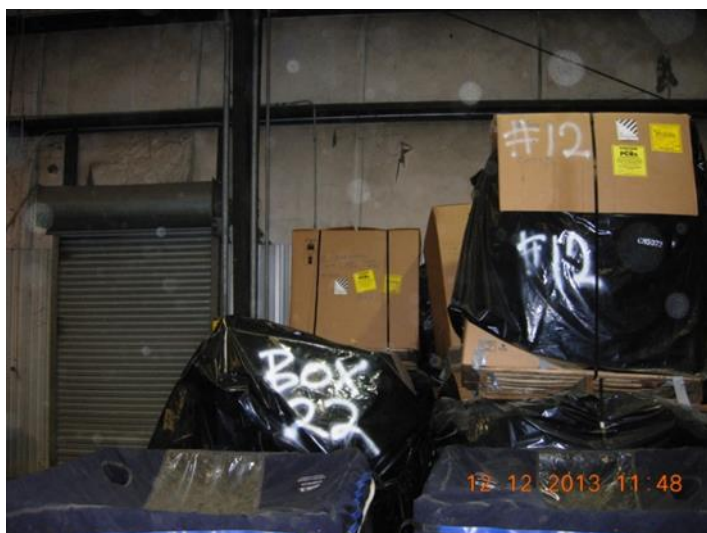
Picture 23: PCB and RCRA regulated hazardous waste containers in the PCB Ancillary Storage Area

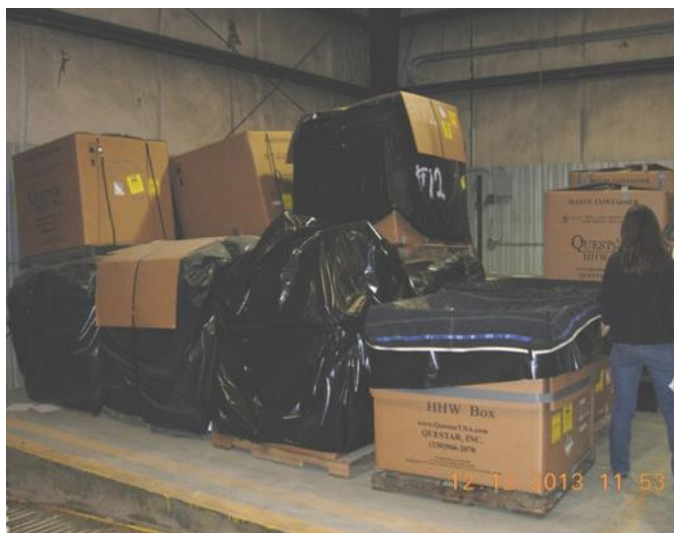
Picture 24: PCB and RCRA regulated hazardous waste containers in the PCB Ancillary Storage Area

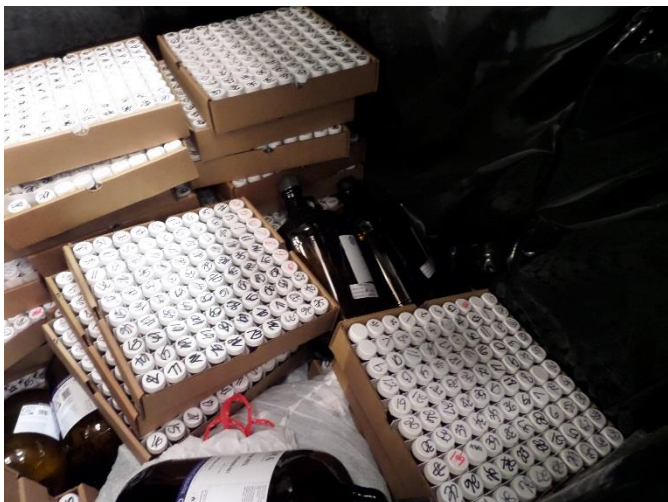
Picture 25: View of the laboratory waste (PCB and RCRA regulated waste) inside the cardboard containers in the PCB Ancillary Storage Area

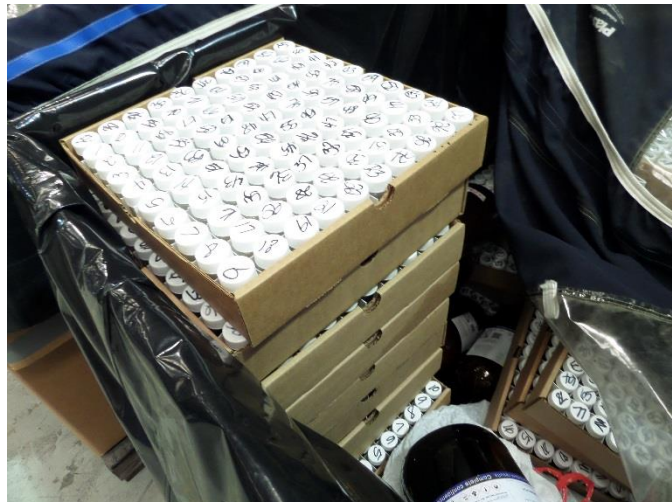
Picture 26: View of the laboratory waste (PCB and RCRA regulated waste) inside the cardboard containers in the PCB Ancillary Storage Area

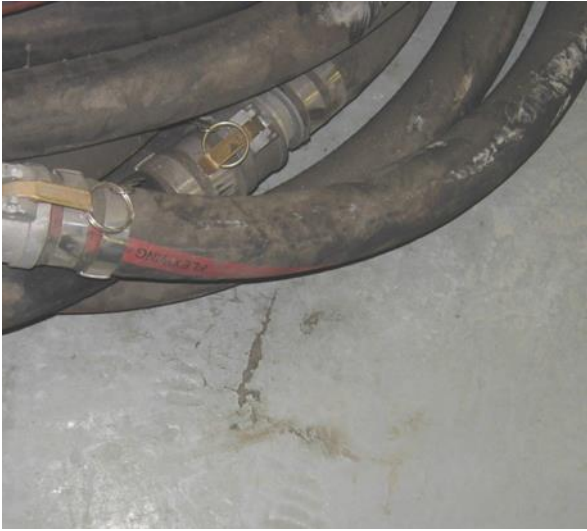
Picture 29: Cracks on the epoxy coating of the PCB Room concrete floor

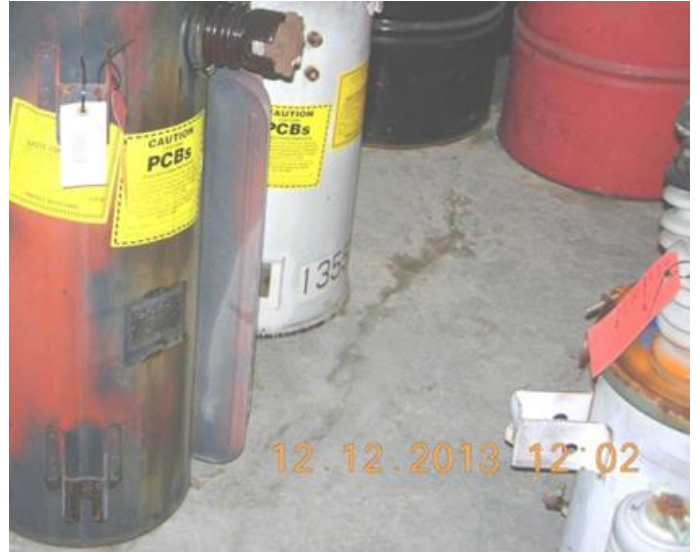
Picture 30: Cracks on the epoxy coating of the PCB Room concrete floor

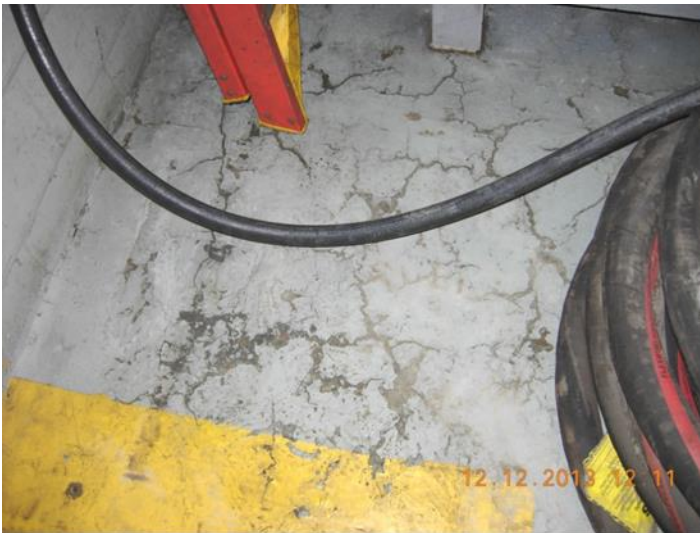
Picture 31: Cracks on the epoxy coating of the PCB Room concrete floor

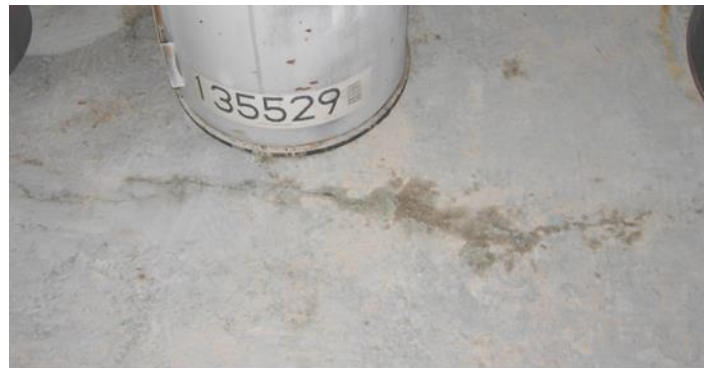
Picture 32: Cracks on the epoxy coating of the PCB Room concrete floor

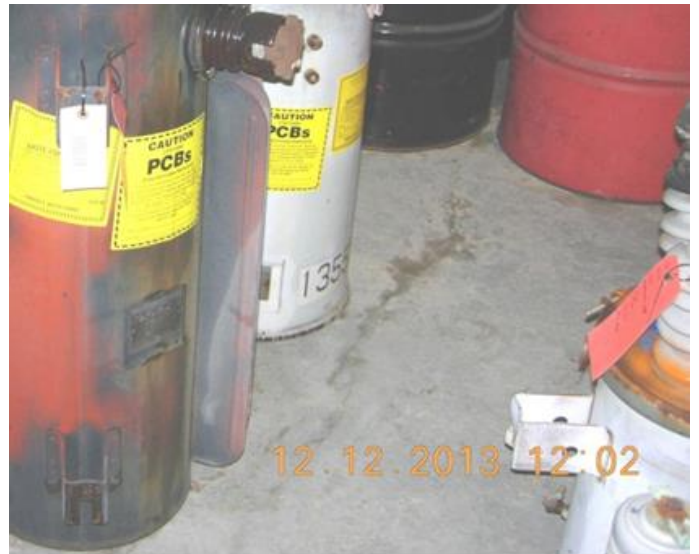
Picture 34: Cracks on the epoxy coating of the PCB Room concrete floor

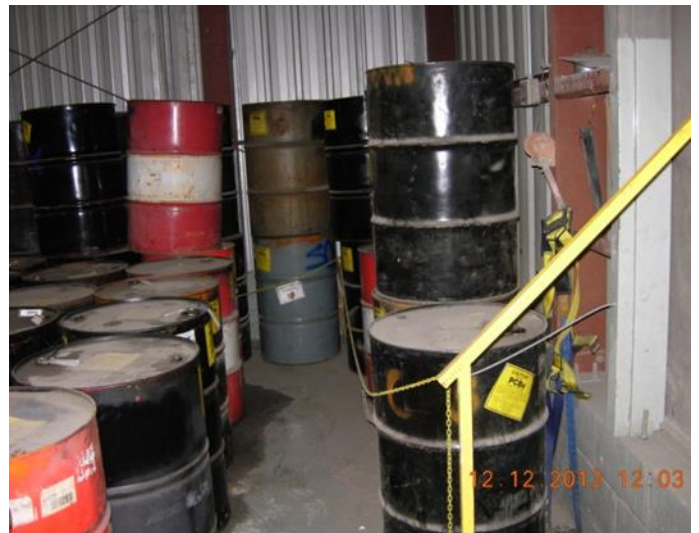
Picture 36: View of PCB containers in the PCB Room and wet stain on the concrete floor

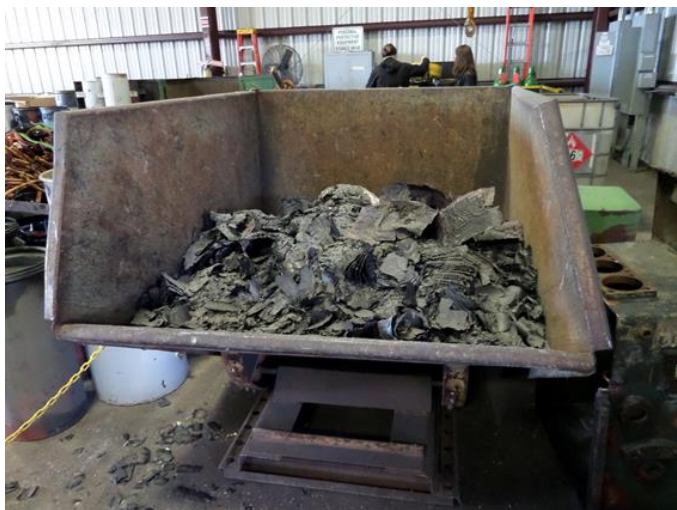
Picture 43: Ash from the SRMO in the accumulation container kept in the SRMO Area

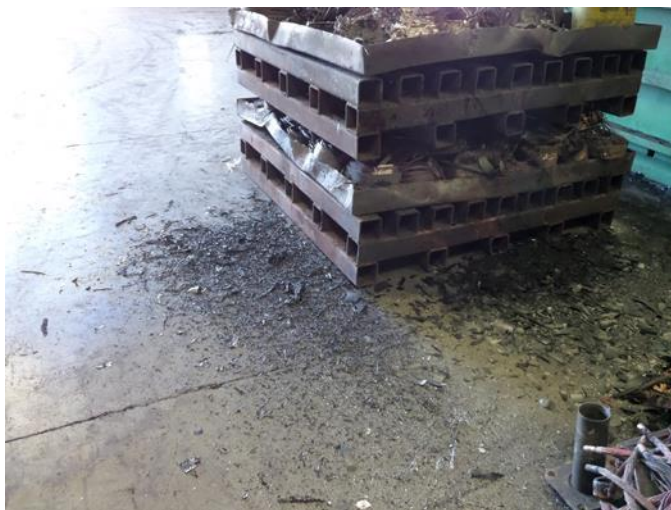
Picture 44: Ash from the SRMO on the floor at the SRMO Area

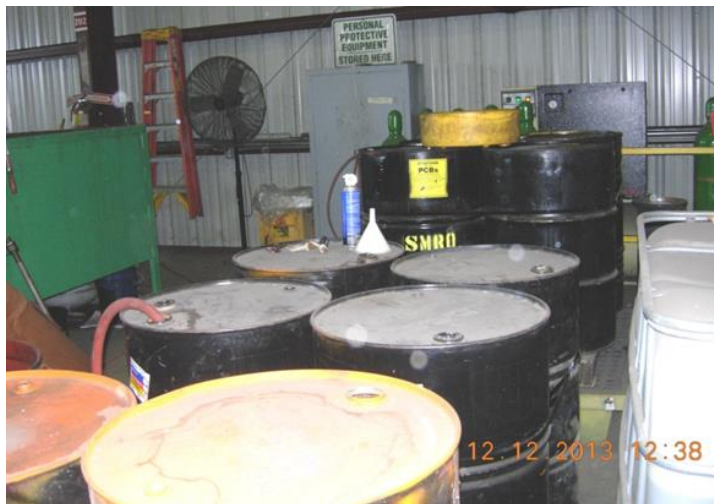
Picture 45: Contaminated PCB oil open containers stored in the SRMO Area

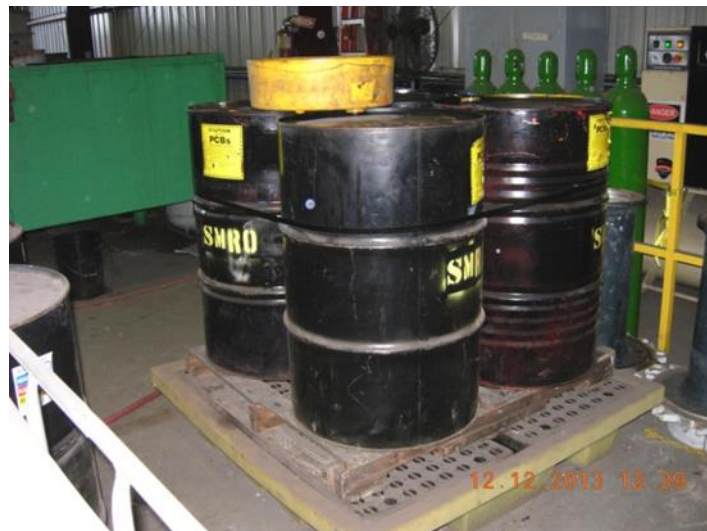
Picture 46: Contaminated PCB oil open containers stored in the SRMO Area

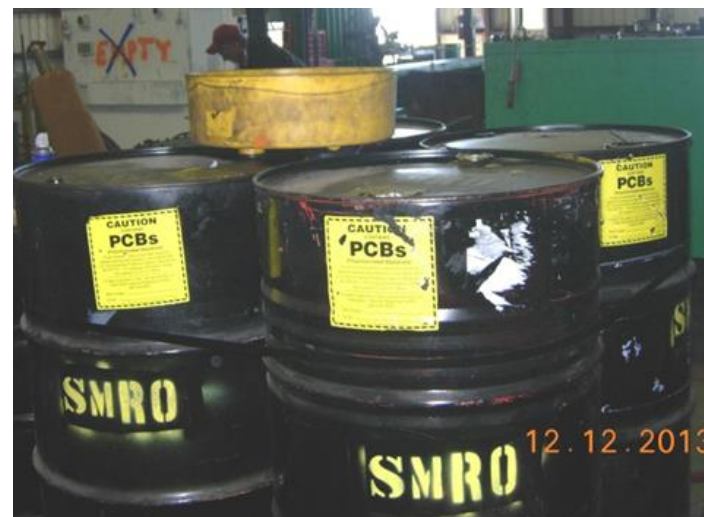
Picture 48: Contaminated PCB oil open containers stored in the SRMO Area

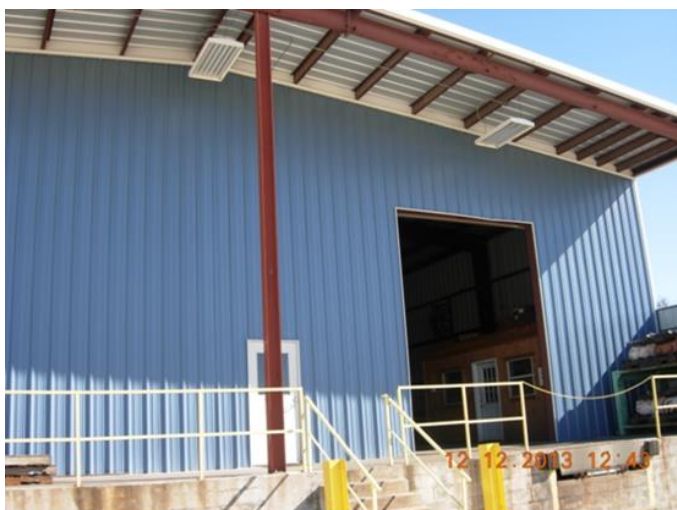
Picture 49: Exterior wall of the SRMO Area with no PCB markings

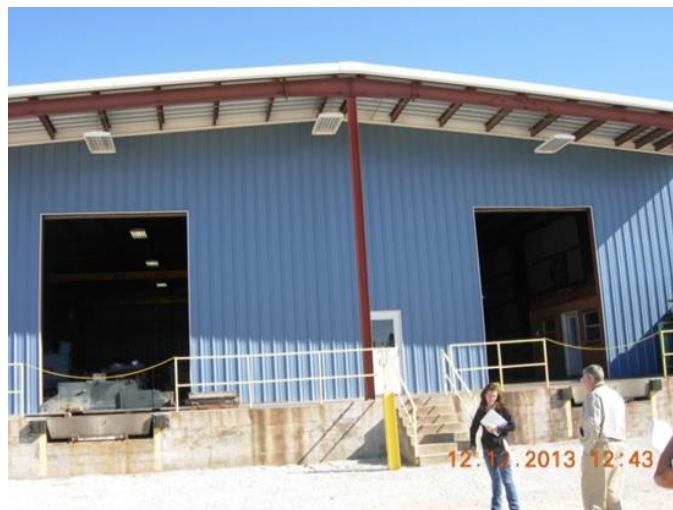
Picture 50: Exterior wall of the SRMO Area with no PCB markings

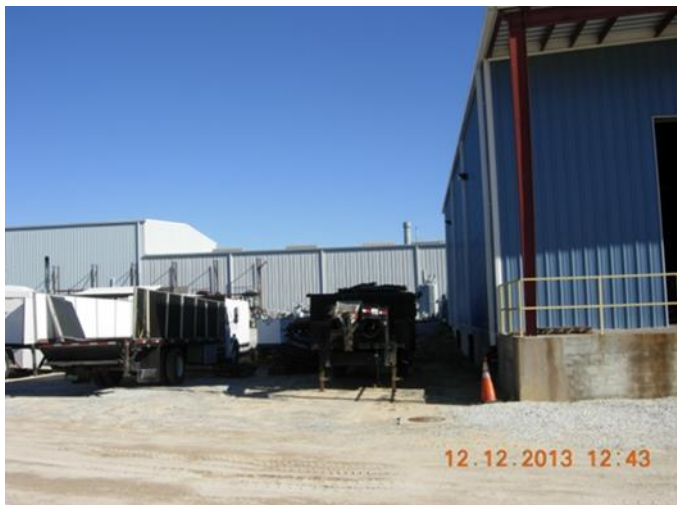
Picture 51: Exterior wall of the SRMO Area with no PCB markings

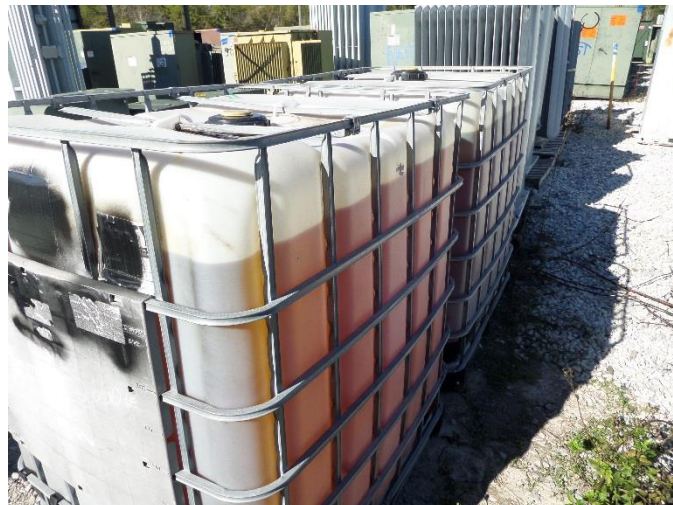
Picture 52: Unlabeled used oil container stored in the Outside Transformer Area

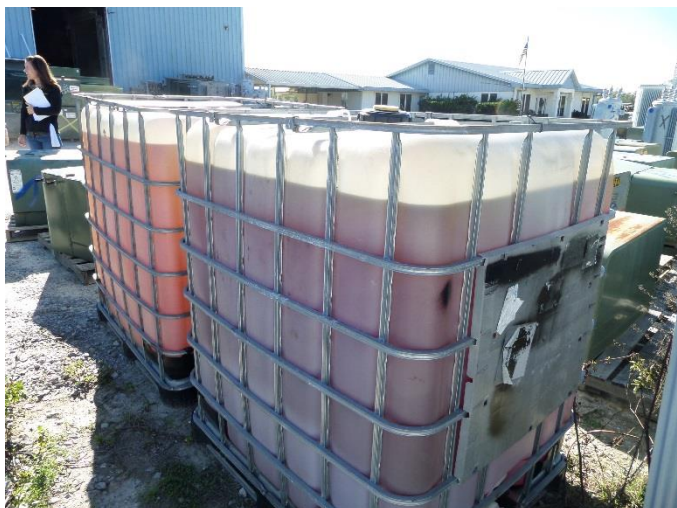
Picture 53: Unlabeled used oil container stored in the Outside Transformer Area

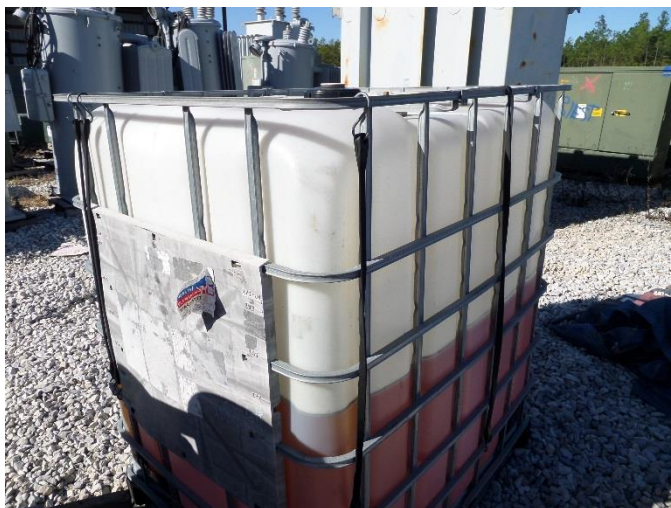
Picture 54: Used oil container stored in the Outside Transformer Area with faded "Used Oil" label

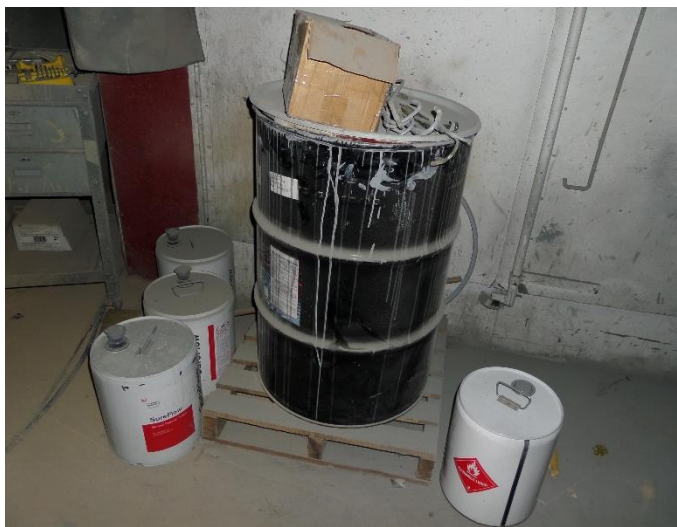
Picture 55: Paint waste SAA container in the Paint Area lacking hazardous waste marking and not properly closed

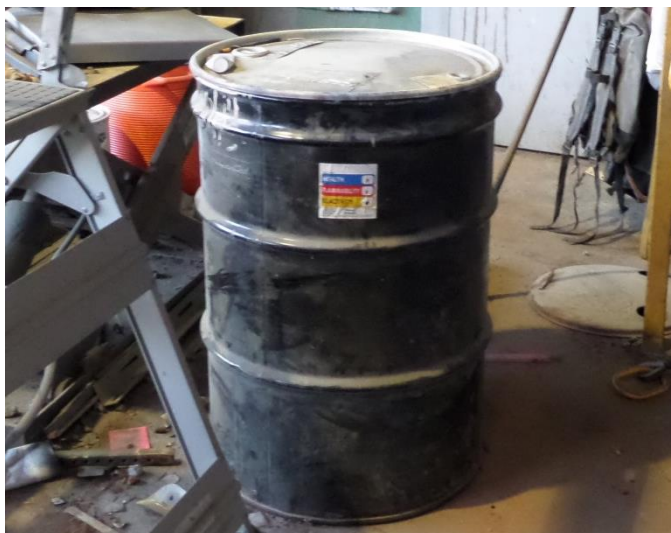
Picture 56: Unlabeled Paint SAA container stored near the outside paint booth

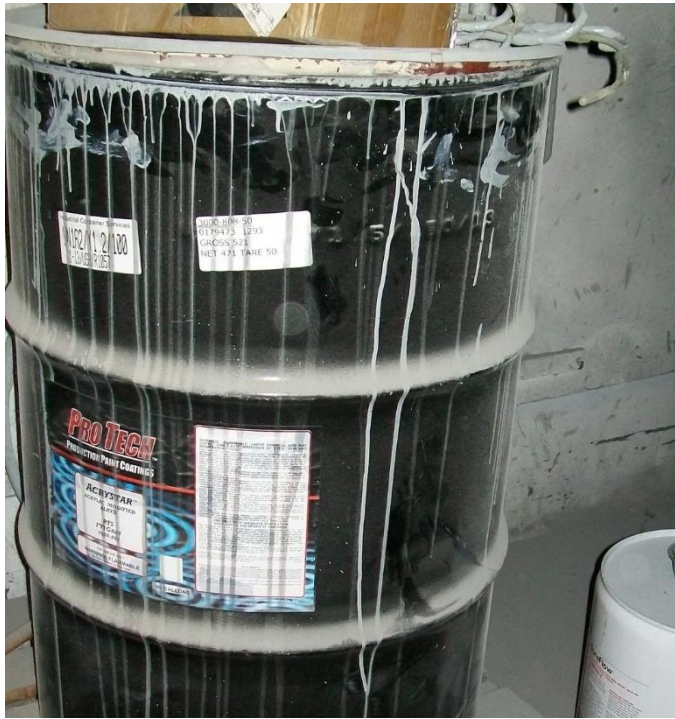
Picture 57: Paint waste SAA container in the Paint Area lacking hazardous waste marking and not properly closed

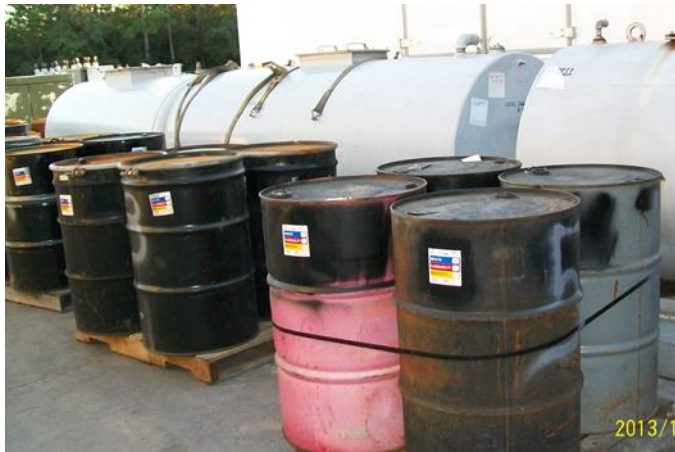
Picture 59: Undated and unlabeled Redragon residue 55-gallon containers stored near the Redragon Oil Processing Unit

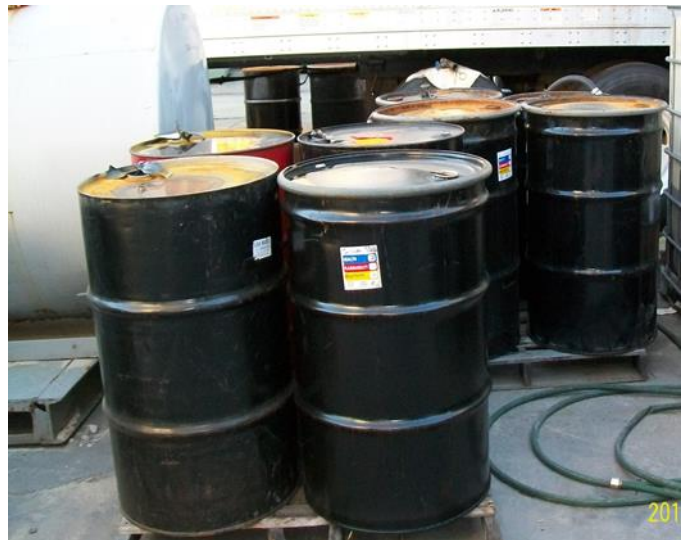
Picture 60: Undated and unlabeled Redragon residue 55-gallon containers stored near the Redragon Oil Processing Unit

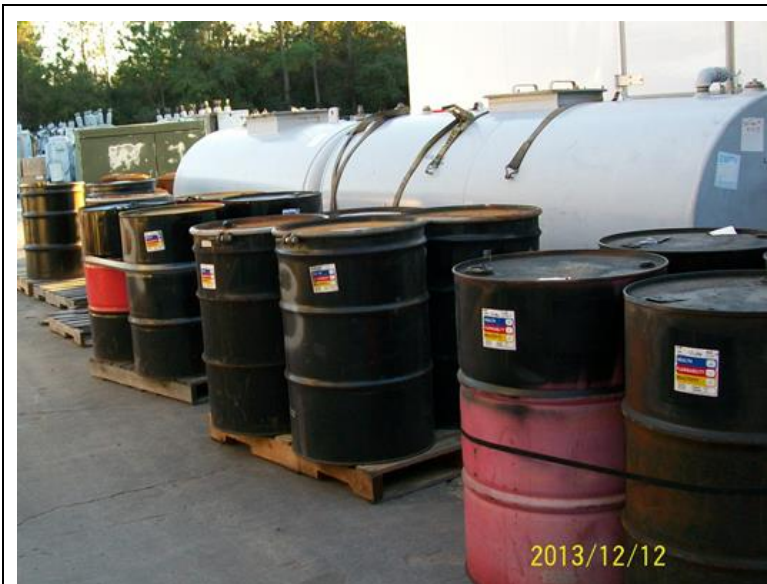
Picture 61: Undated and unlabeled Redragon residue 55-gallon containers stored near the Redragon Oil Processing Unit
