## Florida Department of Environmental Protection

**Florida Department of  
Environmental Protection  
Hazardous Waste Inspection Report**

**Facility Name:** Tampa Transflo Terminal

# Department of Environmental Protection Industrial Stormwater Inspection Report

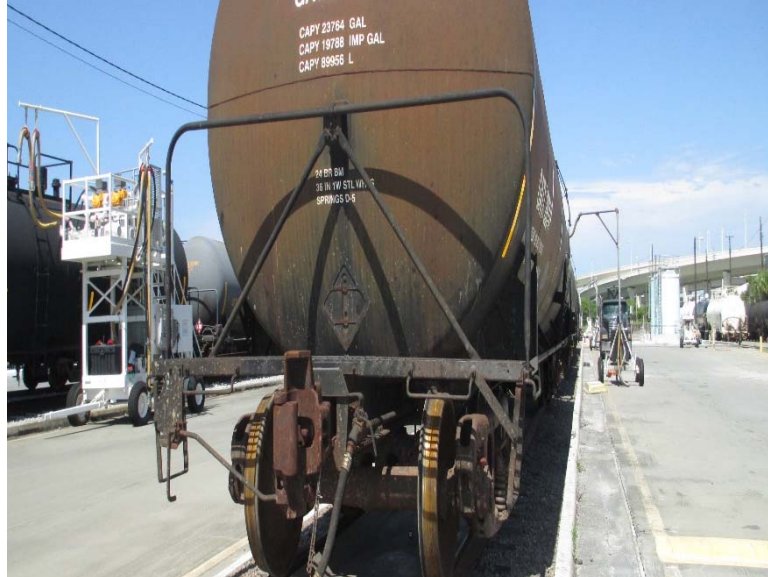
Photo 1:

Inspector Comments: Used Oil Tank Car with Track Pan

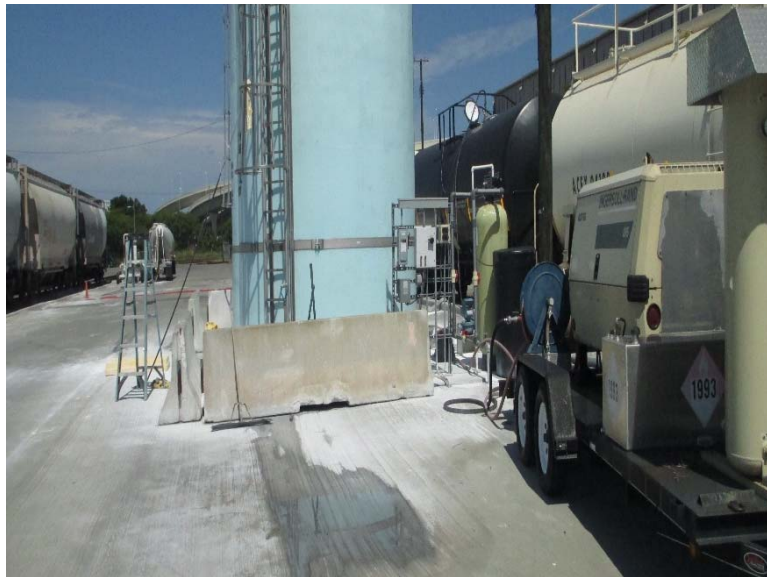
Photo 2:

Inspector Comments: Magnesium Hydroxide Slurry mixing

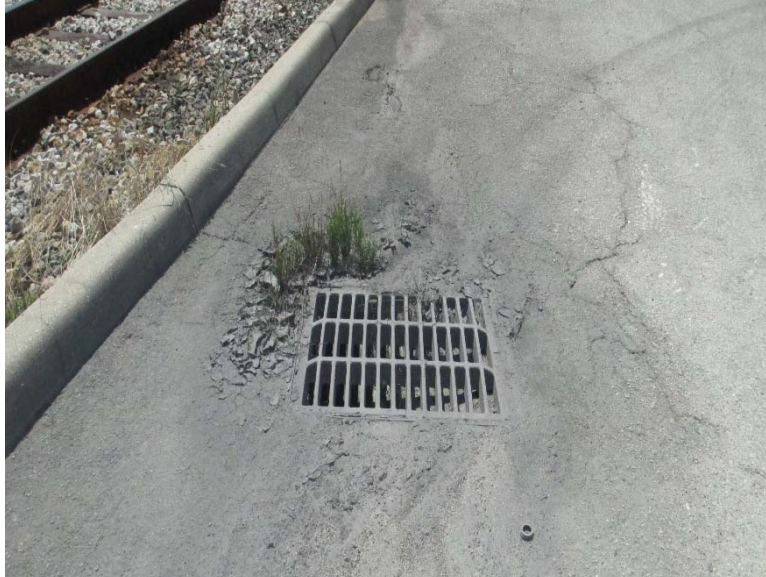
Photo 3:

Inspector Comments: Catch Basin in paved area

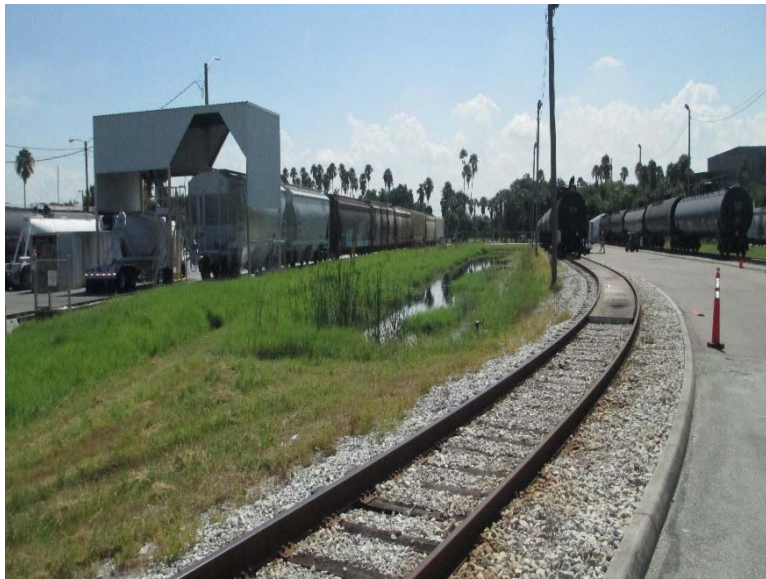
Photo 4:

Inspector Comments: North pond and hopper car unloading area.

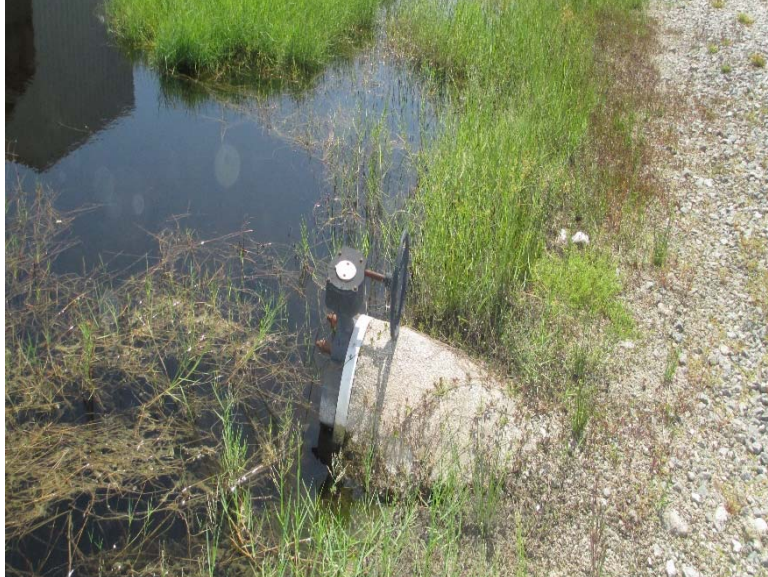
Photo 5:

Inspector Comments: Influent pipe with gate valve - north pond

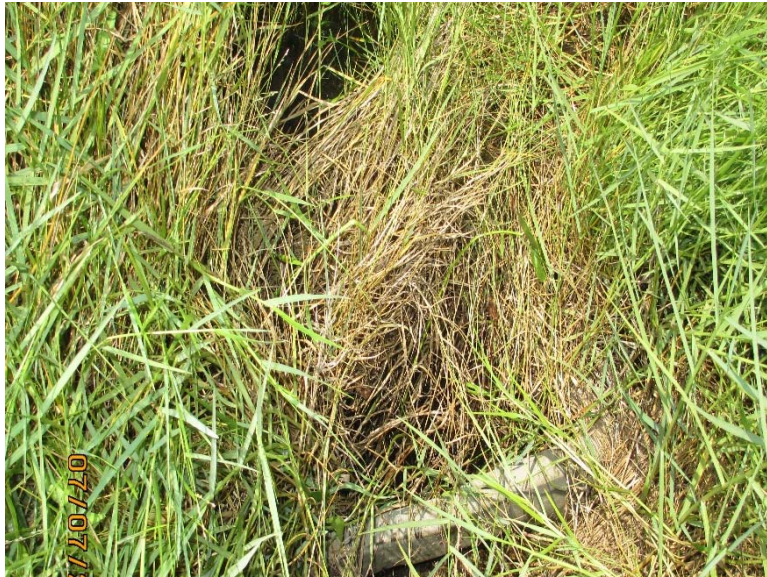
Photo 6:

Inspector Comments: Outfall pipe from north pond

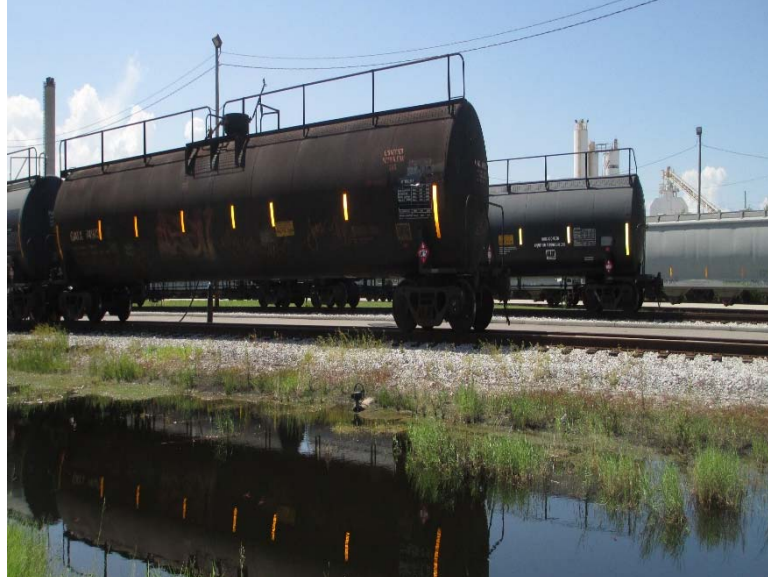
Photo 7:

Inspector Comments: Looking south from the north side of the northern retention pond. A valve from a drain is visible in the center of the photo.

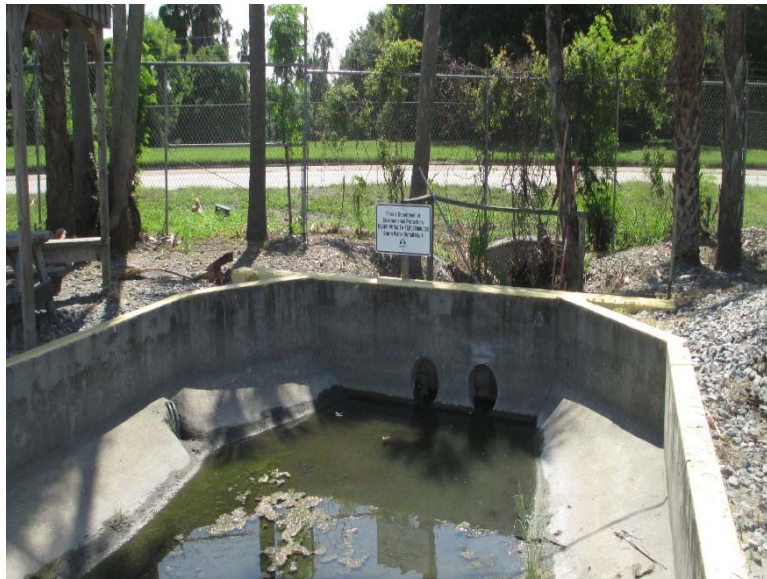
Photo 8:

Inspector Comments: Outfall 001 - bottom of basin was clearly visible, fish were swimming in the water

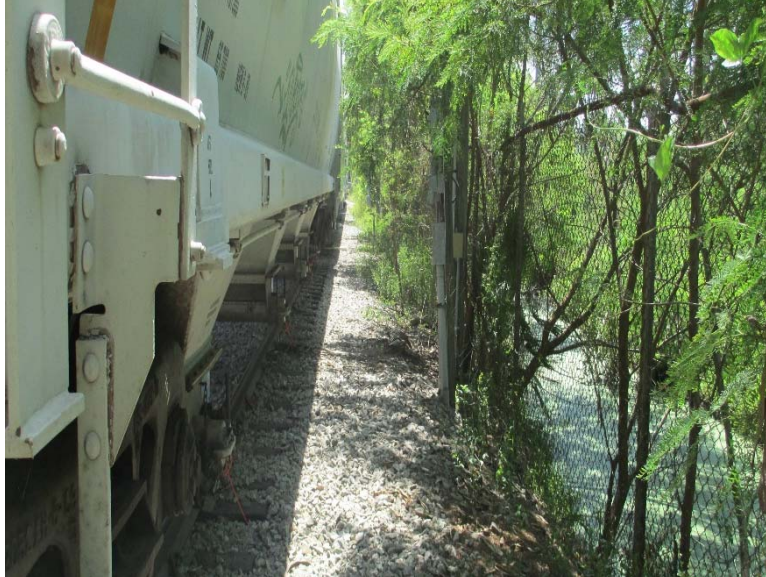
Photo 9:

Inspector Comments: Sheet Flow from siding to south ditch. Granite ballast is clean and free from dust. Unloading hatches closed and secured with seals.

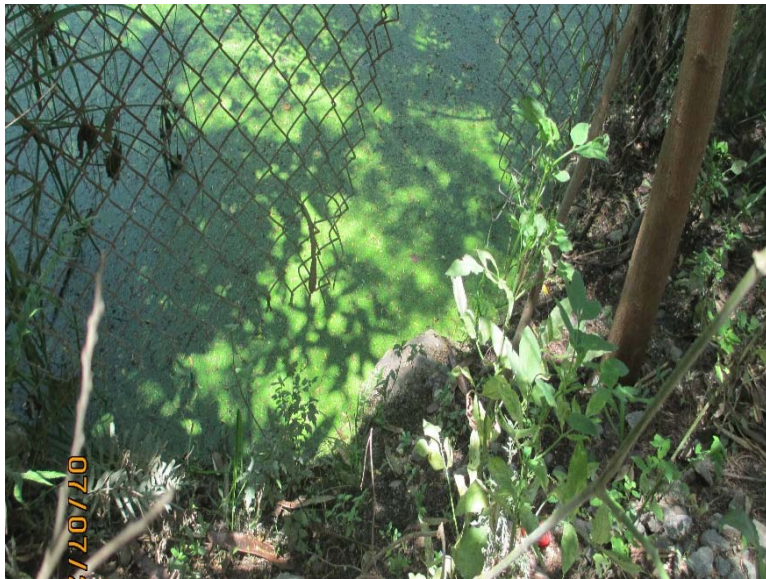
Photo 10:

Inspector Comments: Outfall 002 into the south ditch from the south retention area. Ditch has a large amount of duckweed, but where visible, the water was clear.
