UNITED STATES ENVIRONMENTAL PROTECTION AGENCY

SUBJ: RCRA Compliance Evaluation Inspection

Perma-Fix of Florida, Inc.

EPA I.D. Number FLD 980 711 071

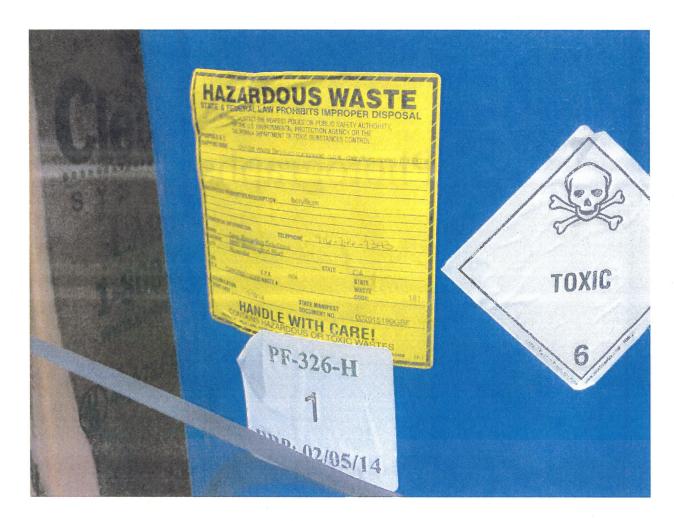
Photo 1 – Container in the LSV Processing and Waste Storage Building

Three containers were observed without a storage start dates marked on their labels. These containers were as follows:

One 35 gallon drum, identified as PF-326-H (Photo 1), was dated 2/5/14.

PFF appeared to be in violation of 40 C.F.R. § 268.50(b) for storing land disposal restricted hazardous wastes in excess of one year.

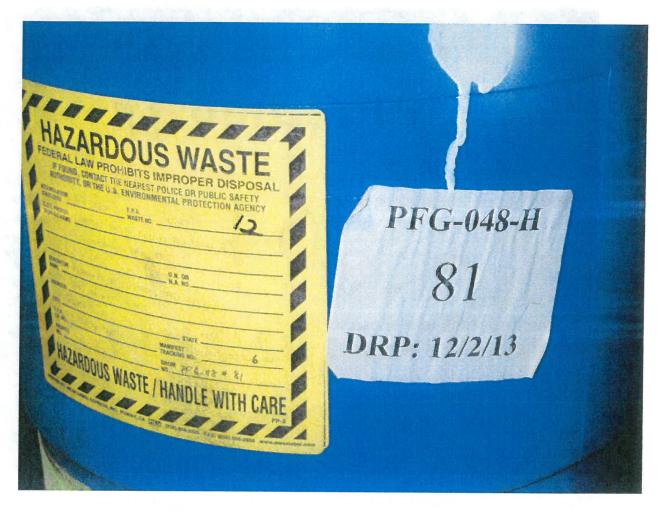
Photo 2-Container in the LSV Processing and Waste Storage Building

One 35 gallon drum, identified as PFG 048-H (Photo 2), was dated 12/2/13.

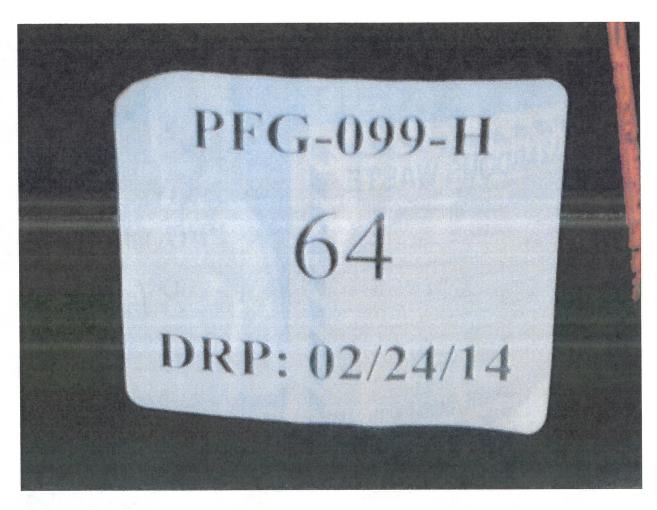
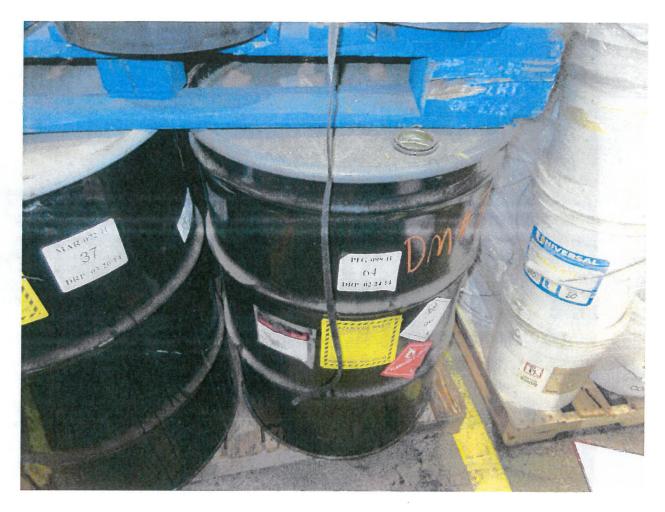
One 55 gallon drum, identified as PFG 099-H (Photos 3 and 4), was dated as 2/24/14.

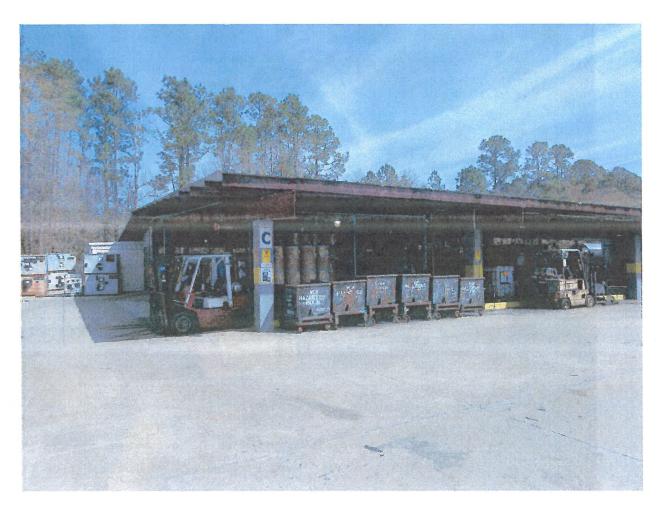
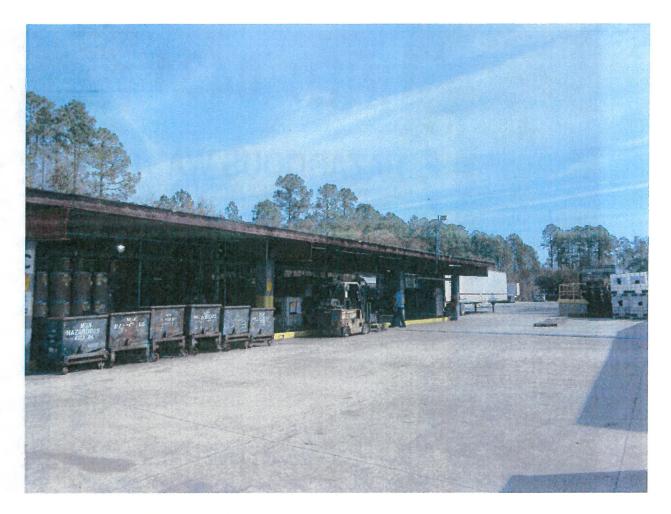
This area is permitted for up to 72,115 gallons of container storage of hazardous wastes with a maximum container size of 718 gallons. The area is under roof on a curbed concrete pad (Photos 5 and 6).

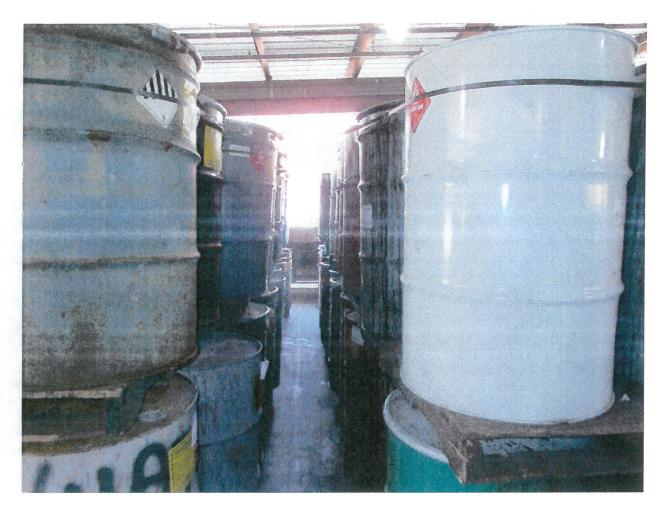
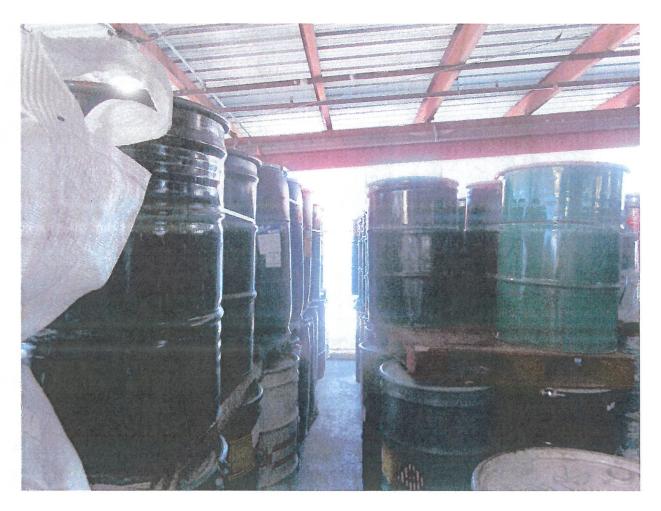
At the time of the inspection, two aisles (Photos 8 and 9) were observed to have marginal space between the rows of containers. More space was added immediately during the inspection. It is recommended that adequate aisle space be maintained between rows of containers at all times.

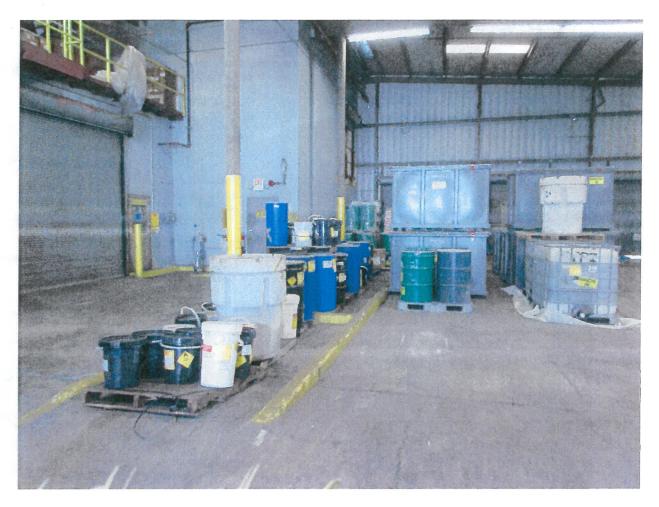
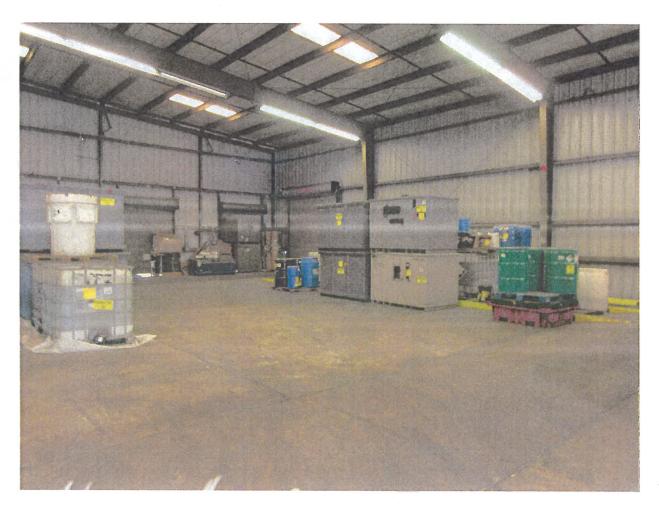
This area is permitted for up to 35,200 gallons of container storage of hazardous wastes with a maximum container size of 718 gallons. The area is under roof on a curbed concrete pad (Photos 10 and 11) and equipped with spill dry equipment and fire extinguishers. This area utilizes seven storage zones to separate incompatible hazardous wastes. At the time of the inspection, this area was within its volume capacity limit.

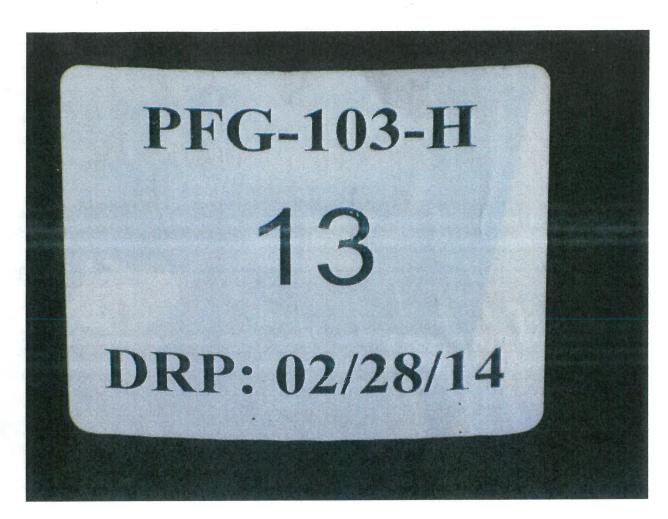
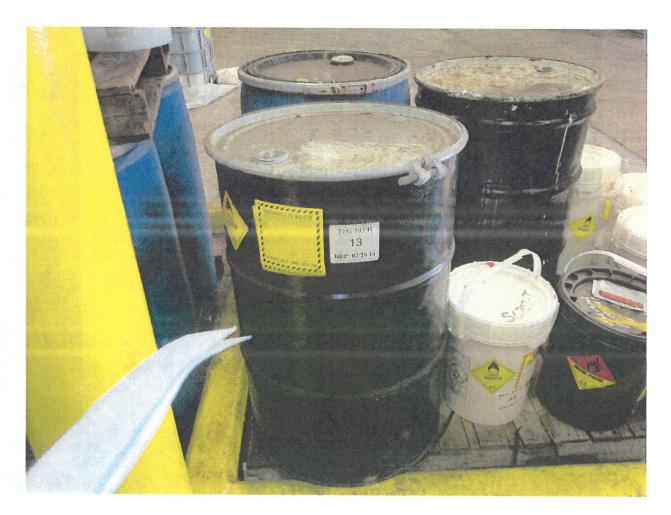
At the time of the inspection, one container (Photos 12 & 13) identified as PFG-103-H was dated 2/28/14. It was subsequently determined that the actual start date of this container was 5/12/14.

PFF appeared to be in violation of 40 C.F.R. § 268.50(a)(2)(ii) for storing land disposal restricted hazardous wastes without being marked with a storage start date.

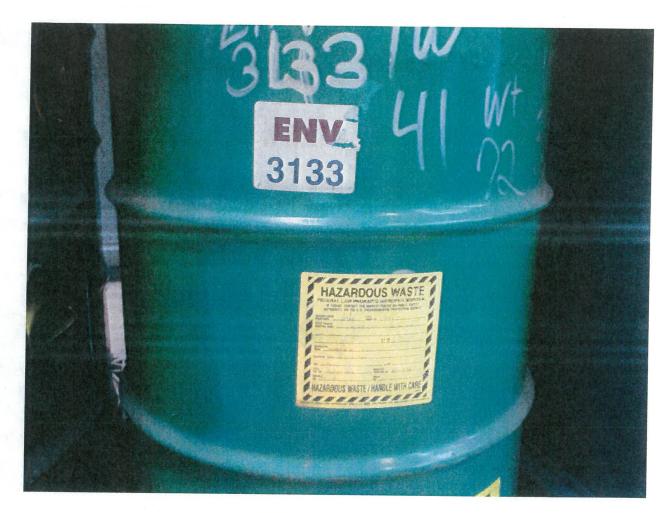
Photo 14 – Container in the Treatment and Operations Building

At the time of the inspection, one container (Photo 14) identified as ENV 3133, was observed with a storage start date of 3/19/13 on its label. The container was subsequently marked with its storage start date of 1/5/15.

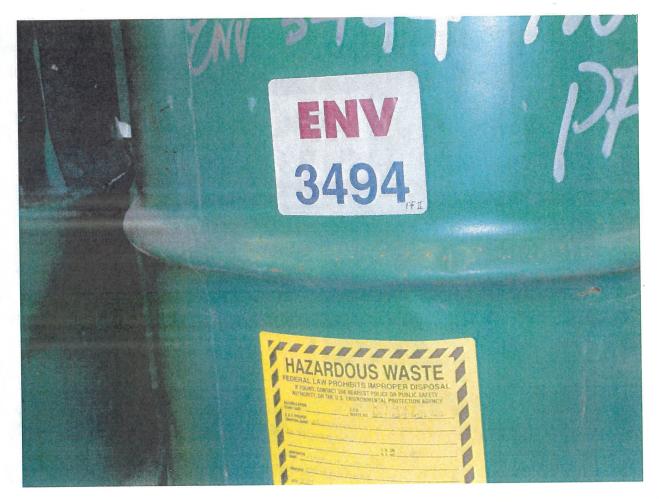
Photo 15 - Container in the Treatment and Operations Building

At the time of the inspection, one container (Photo 15) identified as ENV 3494, was observed without a storage start date on its label. The container was subsequently marked with its storage start date of 9/9/14.
