**From:** Lucas Barroso-Giachetti <lucas@gleassociates.com>  
**Sent:** Thursday, March 10, 2016 4:43 PM  
**To:** Choi, Juchan  
**Cc:** hjasph  
**Subject:** RE: Notification of failure to follow up on compliance requests - H&J Asphalt Inc. FLD984205765  
**Attachments:** Comment No. 3 - Hose Leak Area with New Concrete Pad.jpg; Comment No. 7 - Oil Pans - New Disposal Drums in Garage Area.jpg; Comment No. 8 - Maintenance Area - Spill Removed.jpg; Comment No. 9 - Pipe Leak Area.jpg; Comment No. 10 - Pit Pumped Out.jpg; Comment. No. 11 - Oily Rags Removed.jpg

**From:** Choi, Juchan [mailto:[Juchan.Choi@dep.state.fl.us](mailto:Juchan.Choi@dep.state.fl.us)]  
**Sent:** Thursday, March 03, 2016 3:05 PM  
**To:** Lucas Barroso-Giachetti  
**Cc:** hjasph  
**Subject:** RE: Notification of failure to follow up on compliance requests - H&J Asphalt Inc. FLD984205765  
**Importance:** High

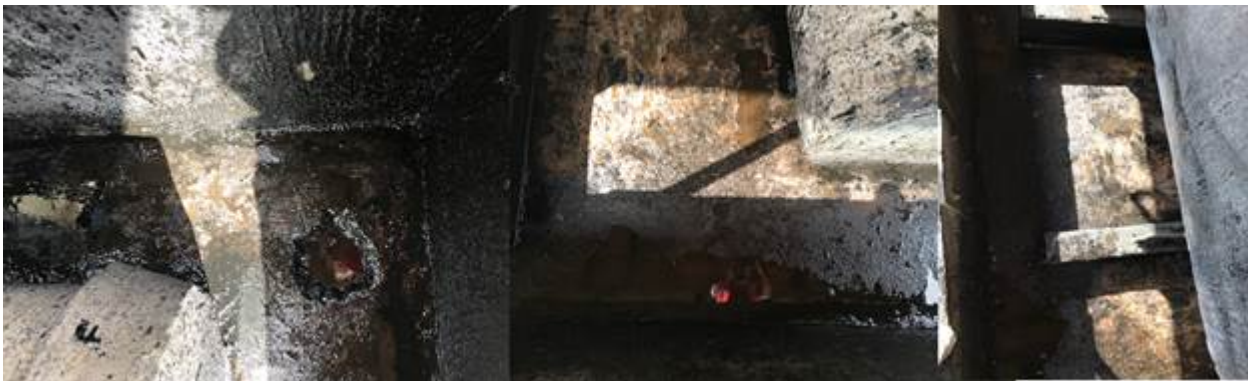
1. This is photos you sent to the Department for the clean-up your facility made to secondary containment used oil tank area (acceptable).

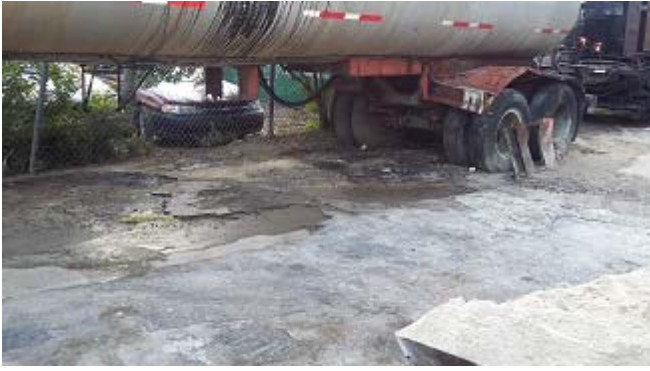
2. Another submitted photo showing that the tanker underneath is cleaned and free of spills (acceptable).

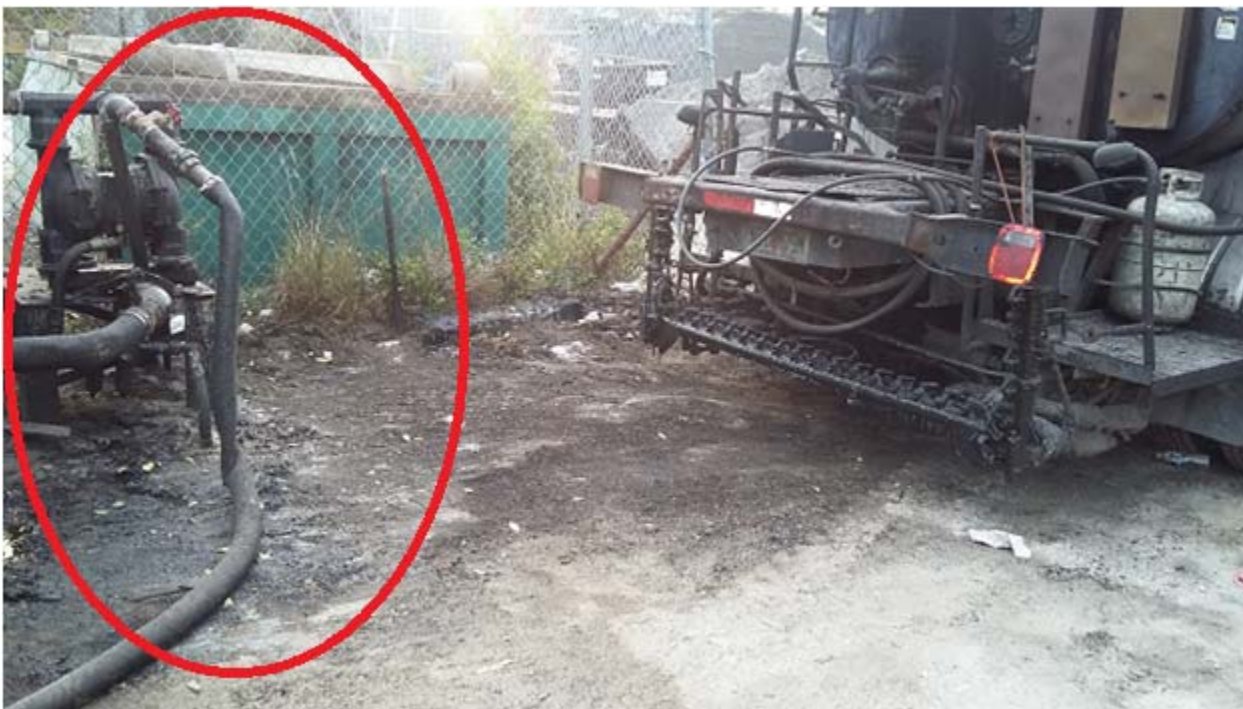
3. This photo your facility sent showed that oily buckets were removed. However, as you can see it from the photo, oil spills are still visible on the ground left of this photo below. Please clean up the soils being contaminated and properly dispose it (send to the Department picture). Another concern is whether the hose connected into tanker may cause the spill every time it's being used. (red circled area) Please explain how the faculty operates this area. If spill occurs every time it's being used, please address the deficiency and send the Department photo and explain how it is addressed.

- Comment No. 3 – Tanker Hose with New Concrete Pad – In response to the Department’s comment, H&J has installed a concrete pad surrounding the tanker hose to address this compliance area and prevent spills from impacting surrounding soils. A photo of new pad at the tanker hose area is attached.

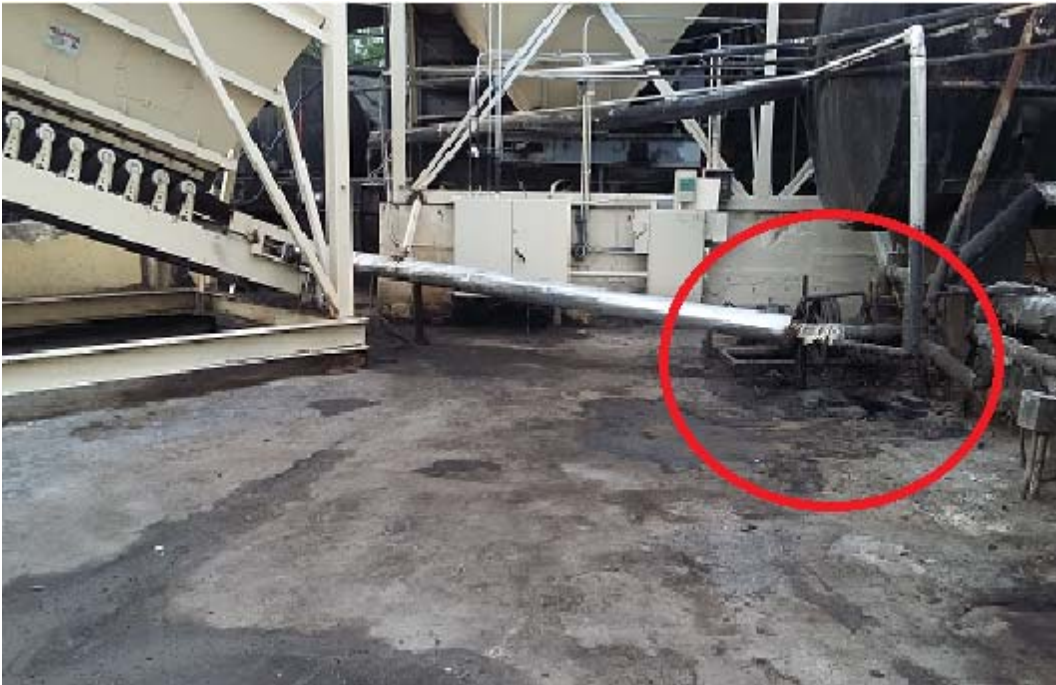
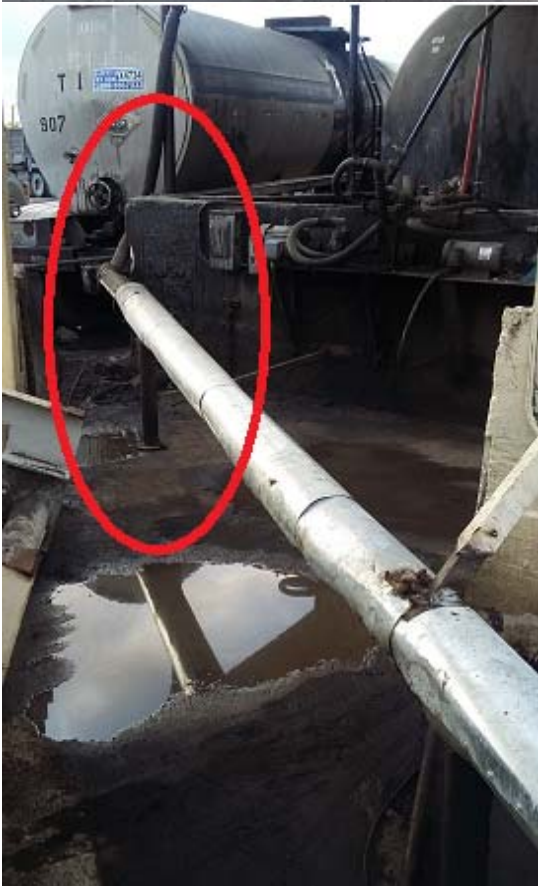
4. These photos your facility sent showed that the pipes are newly covered with metals to avoid any extra spills. However I want to know how H&J will address area where spill actually occurs (hose connect & pipe connect). Please see the circled area below and explain how you will address the spill.

- Comment No. 4 - H&J is conducting maintenance of these pipes to prevent future oil leaks.
- Comment No. 5 - H&J is conducting maintenance of associated equipment to prevent future oil leaks.

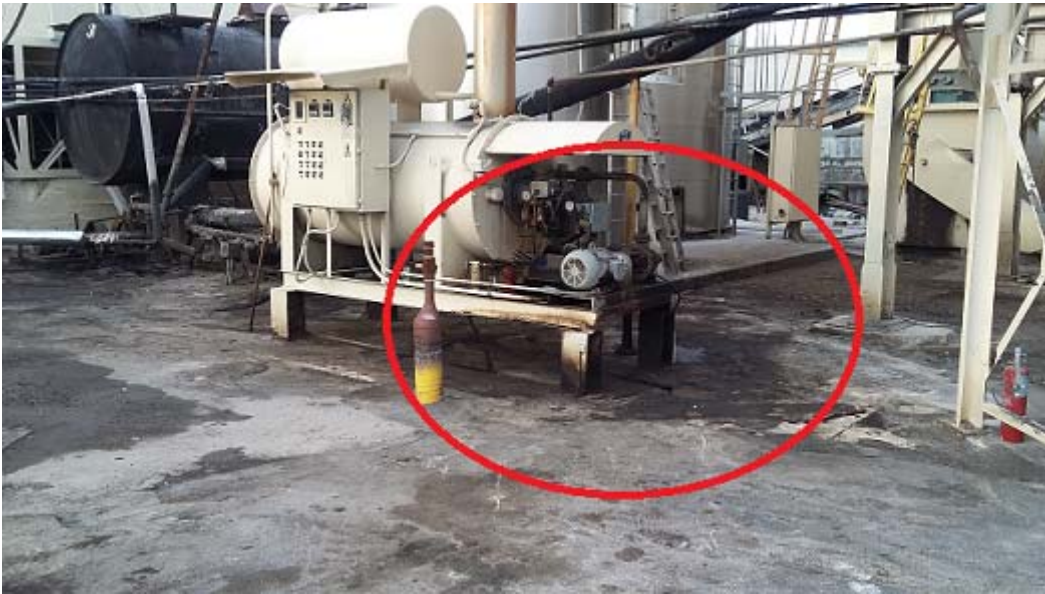
5. This is the photo your facility sent. The below photo showed that the oily buckets were removed. However, I would like to know whether the facility has fixed issue in the area where spill occurs. Please see circled area and explain how it is addressed.

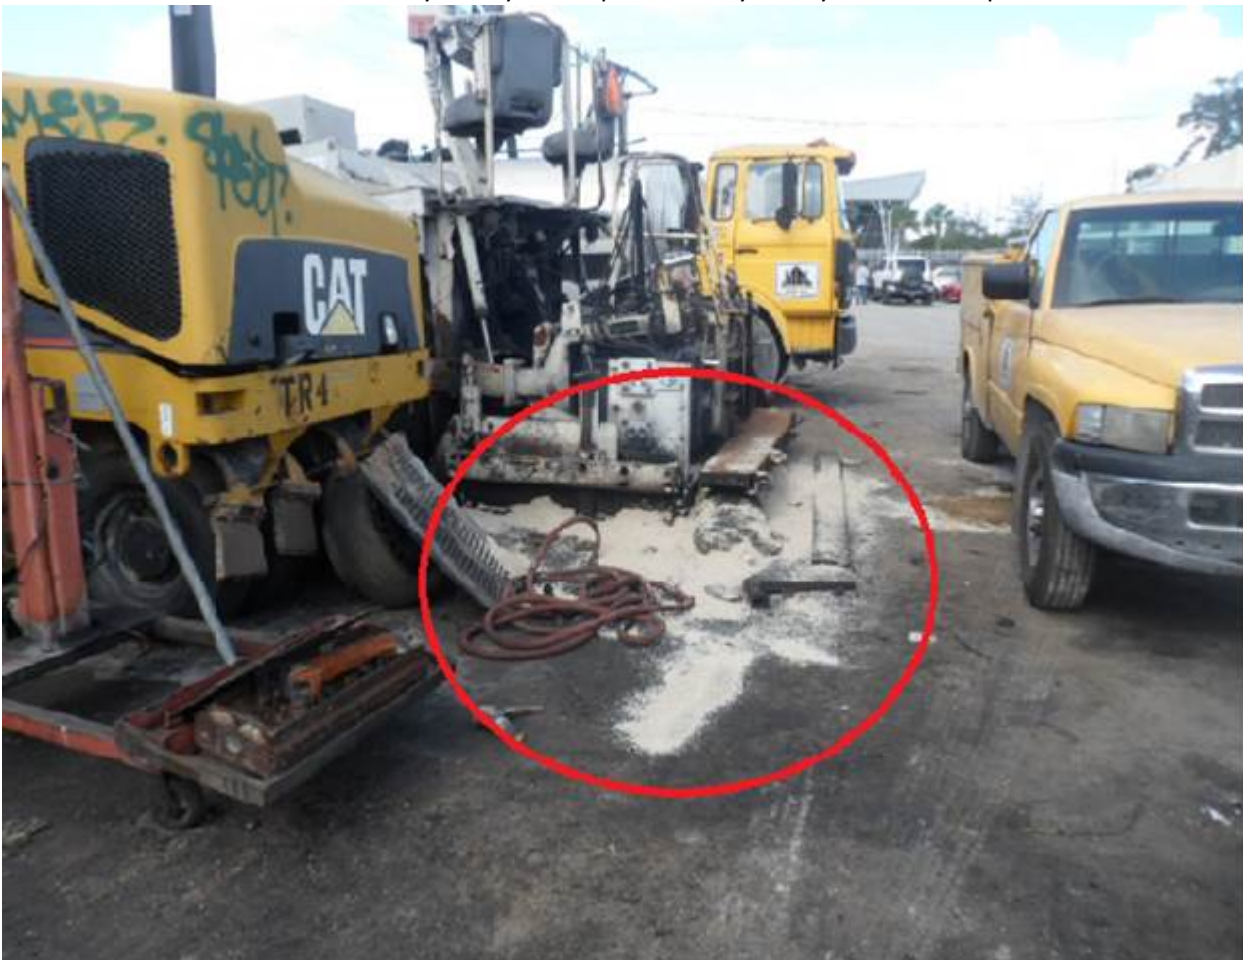
6. This photo below is taken by me. I saw many spots were placed with these dirty oil dry and being not picked up. Please establish a container for dirty oil dry. Pick up these dirty oil dry and send us photos returned in compliance.

- Comment No. 6 – The area with dirty oil dry has been cleaned and the sand placed in the newly implemented 55-gallon disposal drums.
- Comment No. 7 – As requested, the pans and buckets have been removed and the used oil properly containerized. A photo showing the area with the newly installed disposal drums is attached. In addition, oils/liquids in the parts washer have been removed. Please note that the facility does not generate a large volume of waste oil and typically conducts disposal pickups approximately every 6 months.

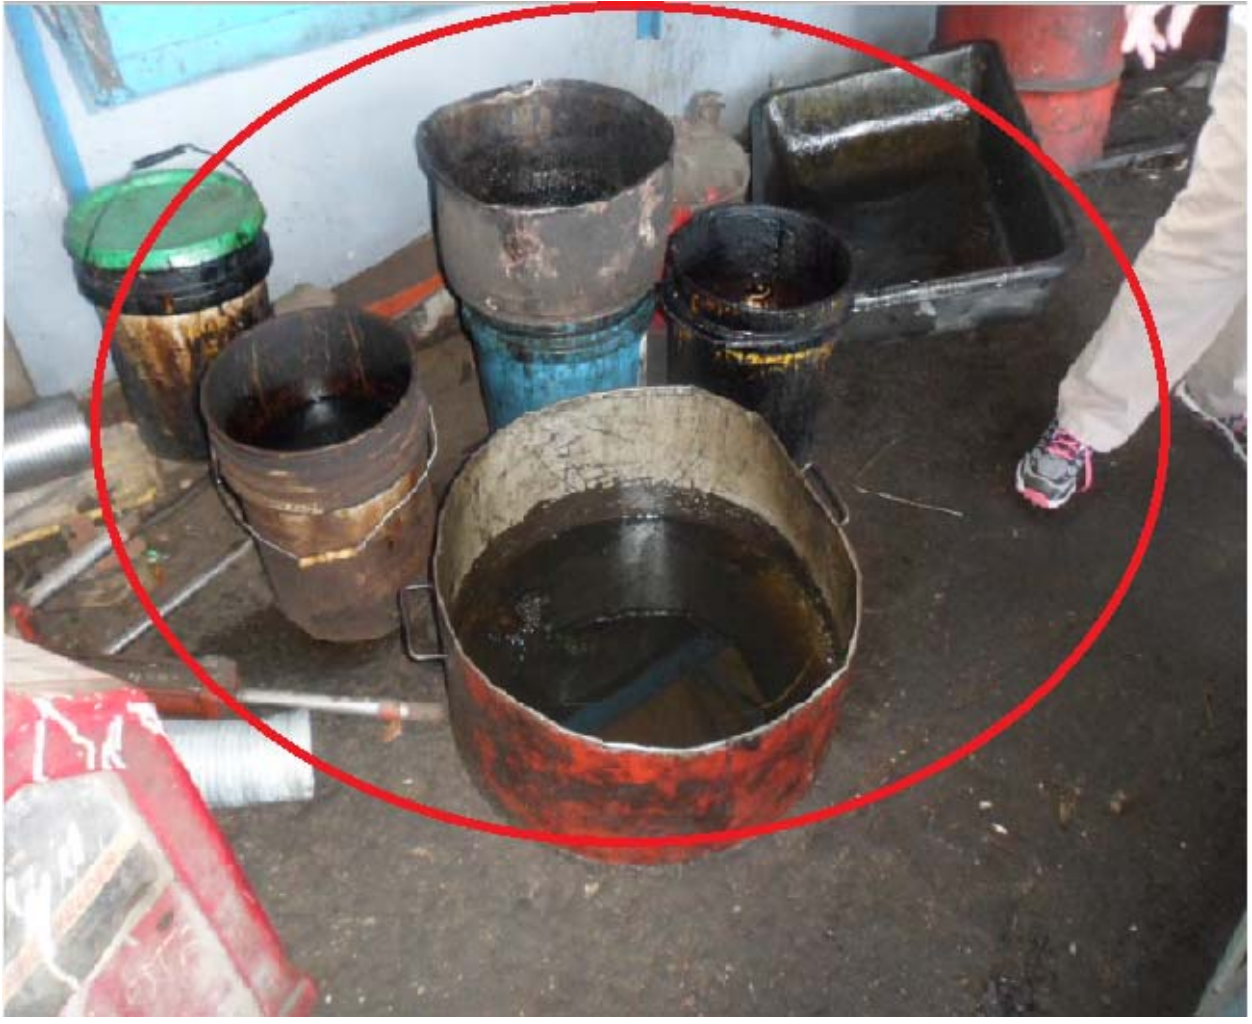
7. This photo below was taken in the mechanics maintenance area. The photo shows that transfer pans and buckets for used oil were not properly labeled. Please note that used oil generators are required to label containers and tanks storing used oil with the words "Used Oil." The labeling on container and tank should be legible and clearly visible by approaching individuals. The facility should inspect their shop, maintenance areas, or any areas where used oil would be generated or stored looking for containers holding used oil to ensure that all containers, tanks, or fill pipes are properly marked. Please label any transfer pans and buckets for used oil and provide to the Department photos returned in compliance.

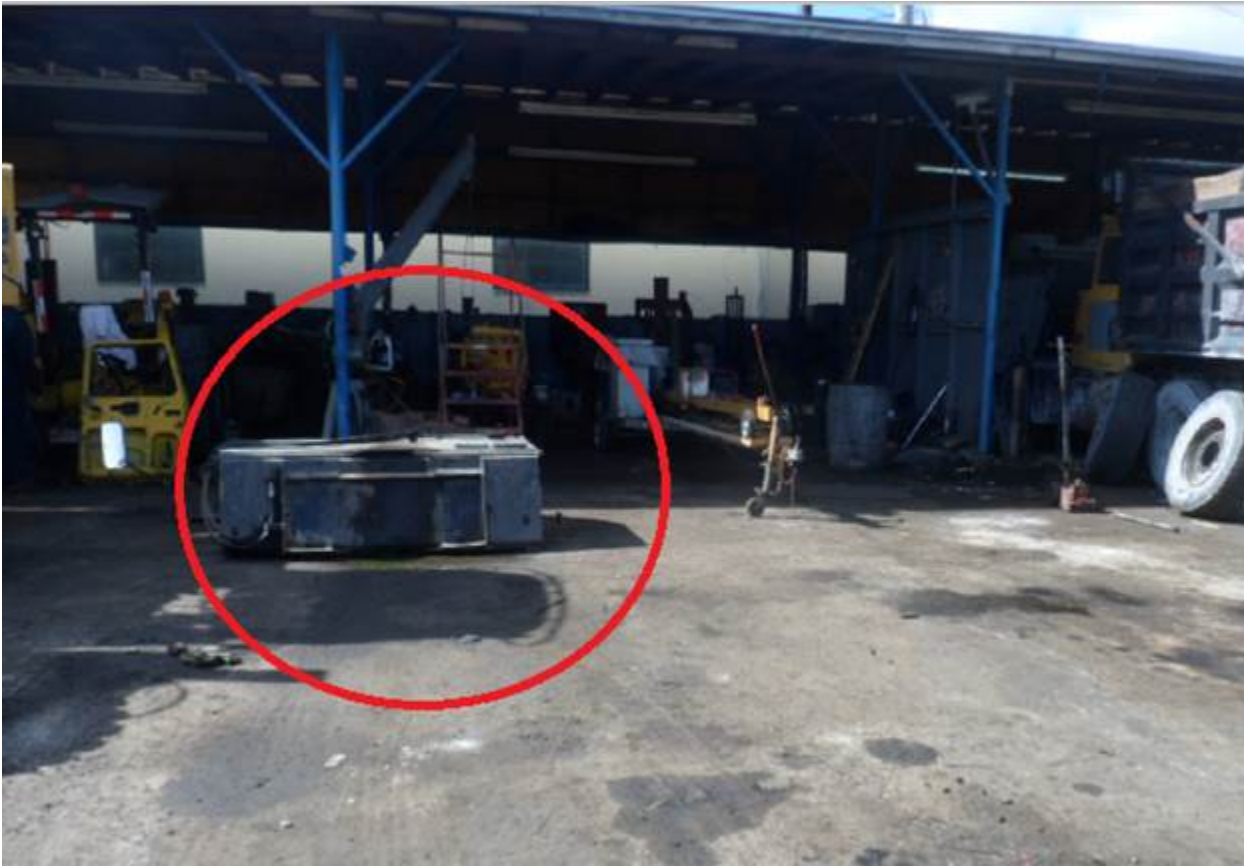
8. This photo below was taken in front of the mechanics maintenance area. Please see the red circled area. I spotted an antifreeze spill there. The facility must avoid spills and leaks. If spill occurs, it must be immediately collected and properly managed. Please promptly address this spill in the area and provide photos returned in compliance.

- Comment No. 8 – The spill area has been addressed. Please see attached photo.
- Comment No. 9 – Pipe Leak – A photo of the former leak area is attached. H&J is planning further maintenance of these pipes to prevent future oil leaks.

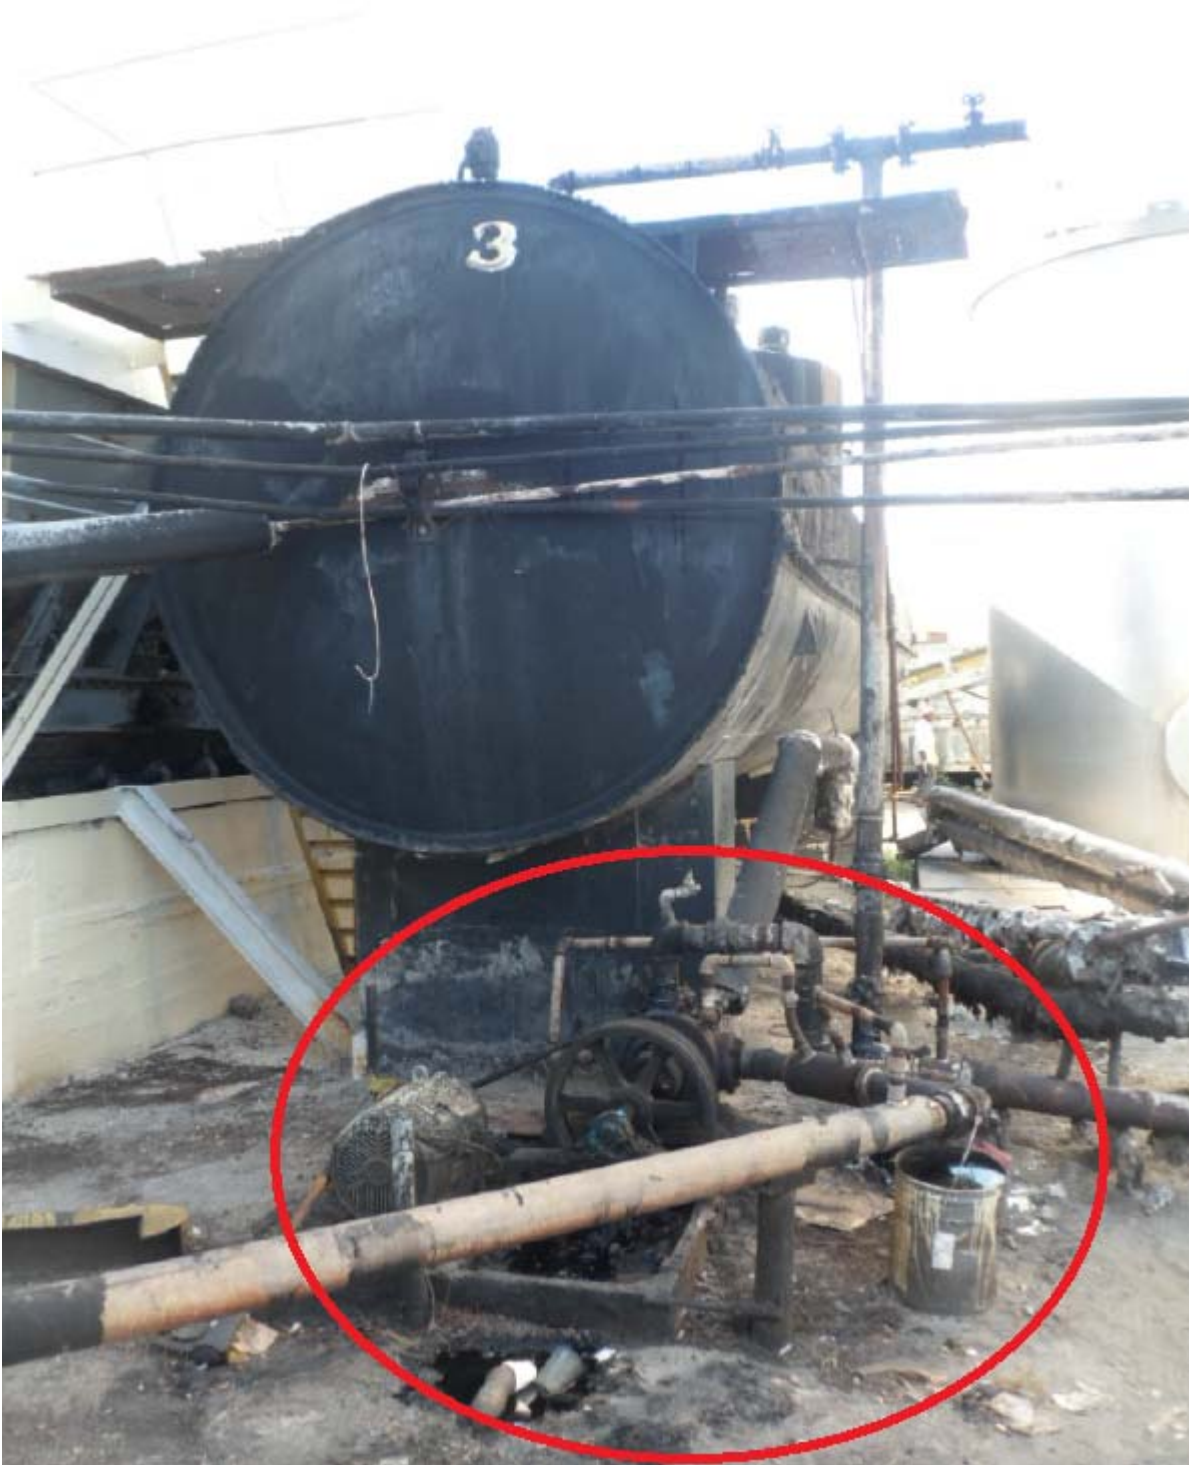
9. The photo below is area where oil leak occurs. Please fix the pipe where leak is happening and send us photo returned in compliance. Please also explain to the Department how corrections will prevent any future oil leaks.

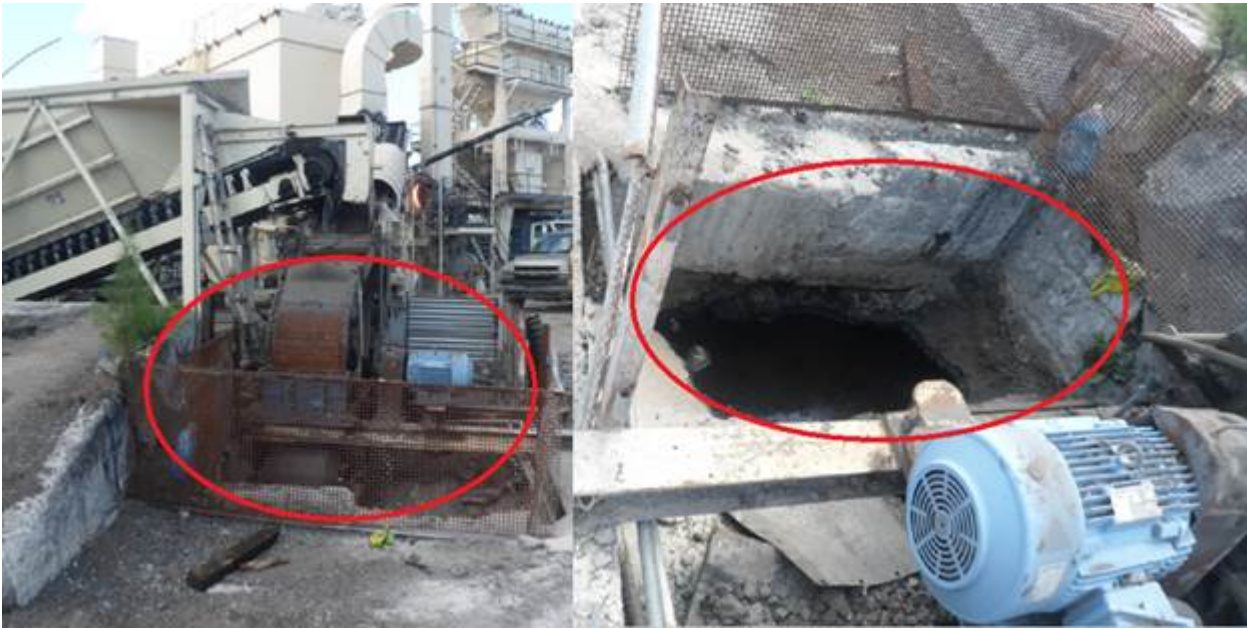
10. The photo below is taken at the paved pit area in front of the conveyor belt. There is pit approximately 2 x 5 ft sized filled with oily liquid inside. Please pump out the oily liquid and provide photos returned in compliance.

- Comment No. 10 – Pit Area Liquids – As requested, the paved pit area has been pumped out. A photo of the pit taken this week is attached.

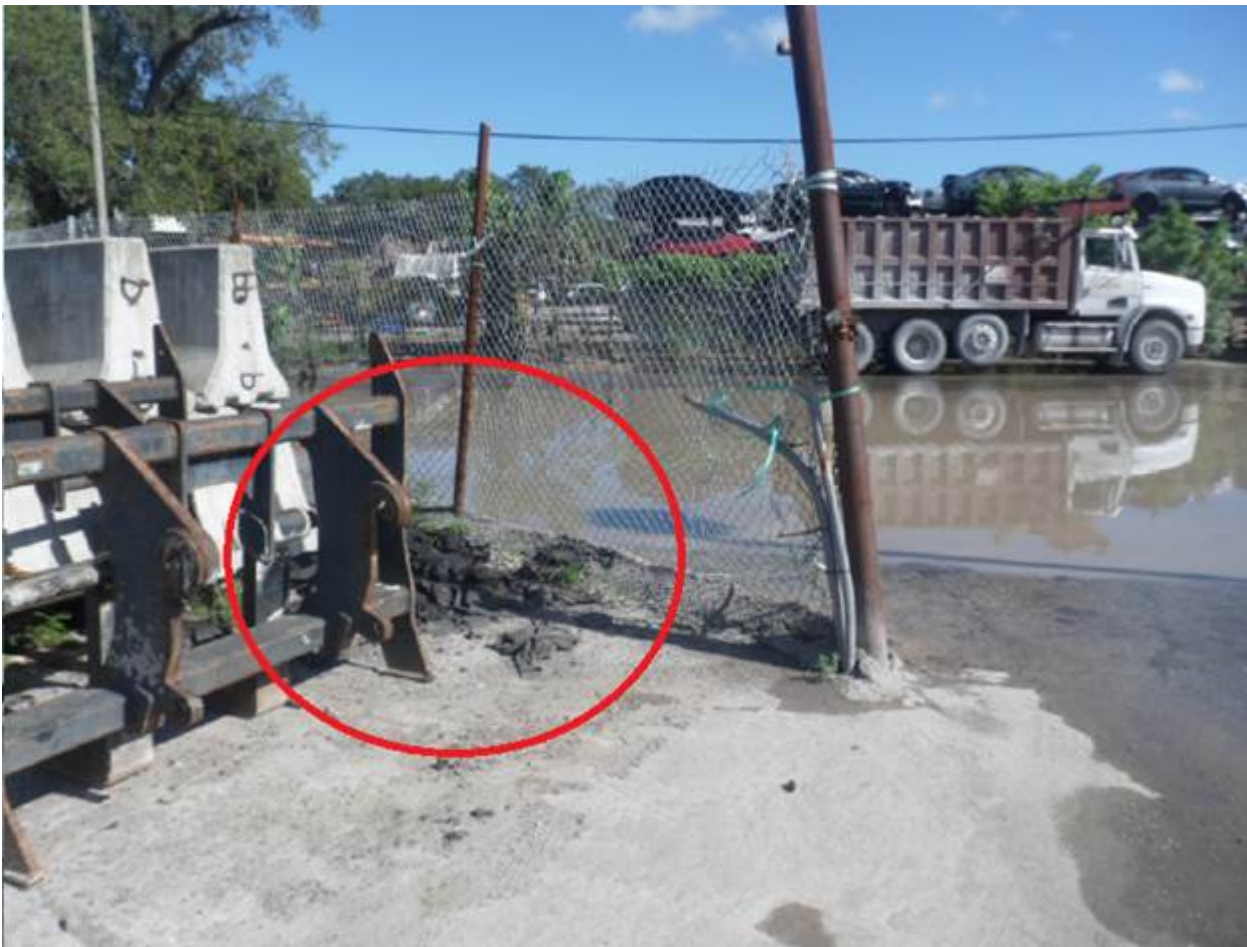
11. The photos below was taken at the east entrance along the fence line. There was pile of oily rags left on the ground. Please pick up/remove these pile of oily rags and properly dispose them. Please provide photos returned in compliance and a copy of receipts for proper disposer.

- Comment No. 11 – Oily rags along fence line – As requested, the oil rags have been removed from this area and have been containerized in the newly implemented 55-gallon disposal drums pending disposal. A photo of the area with the rags removed is attached.
