Subject: RE: Inspection follow up.

Clean Harbors Florida LLC

Subject: Inspection follow up.

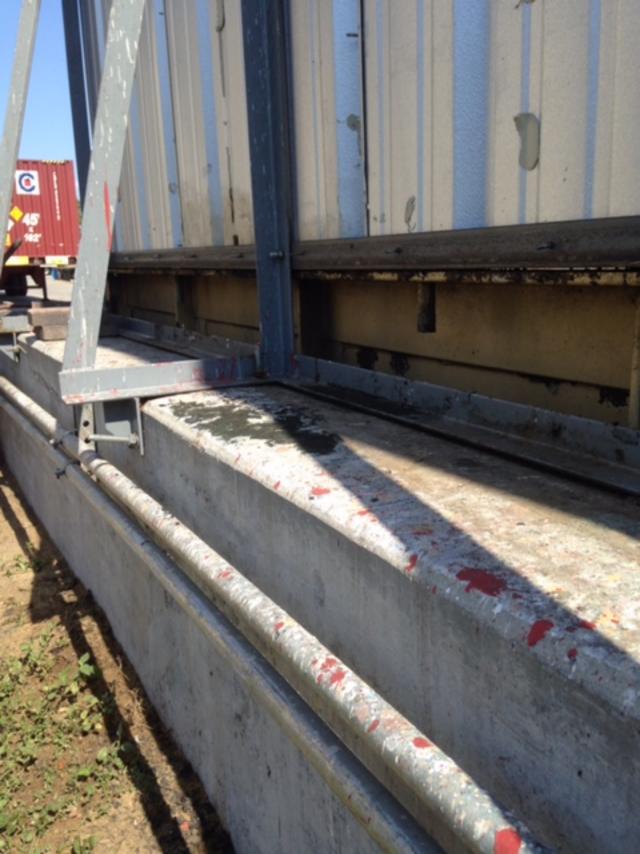
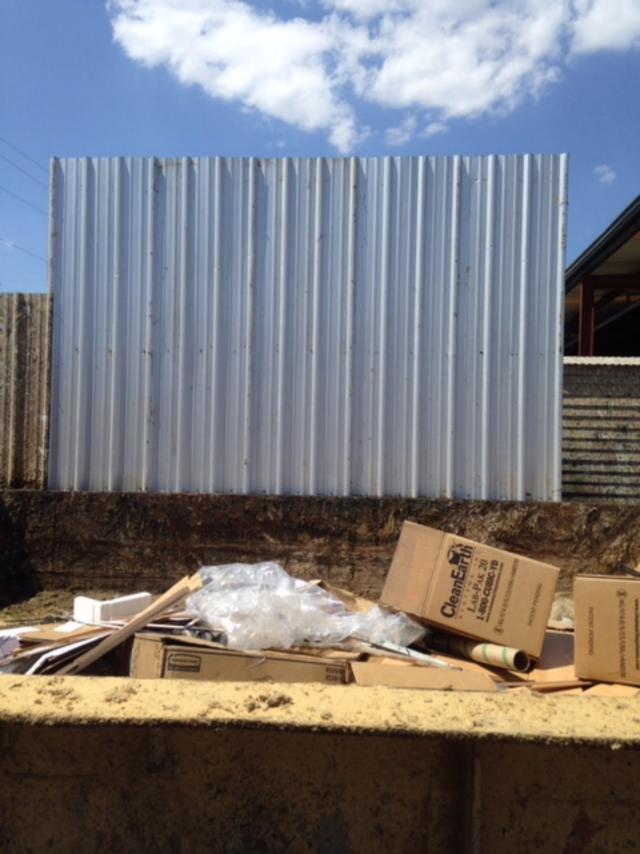
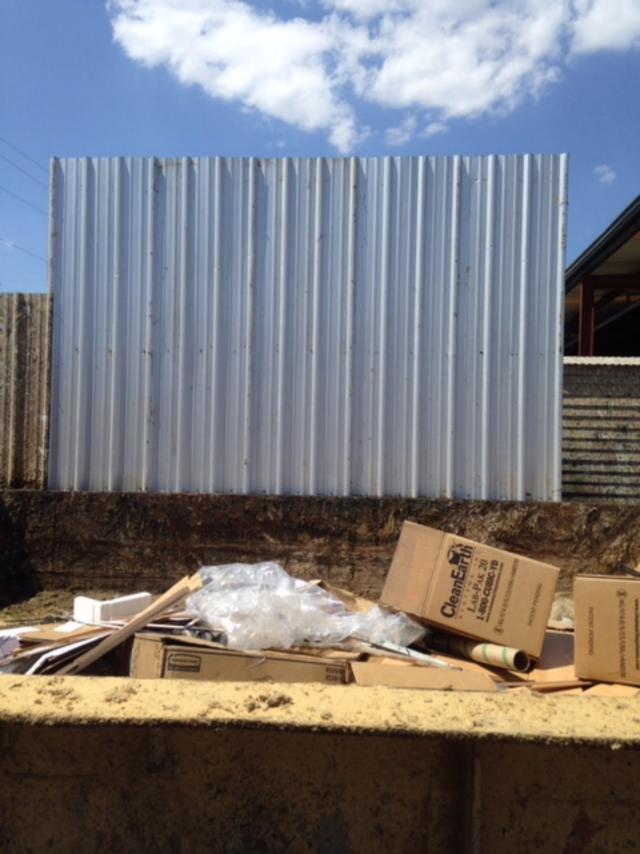
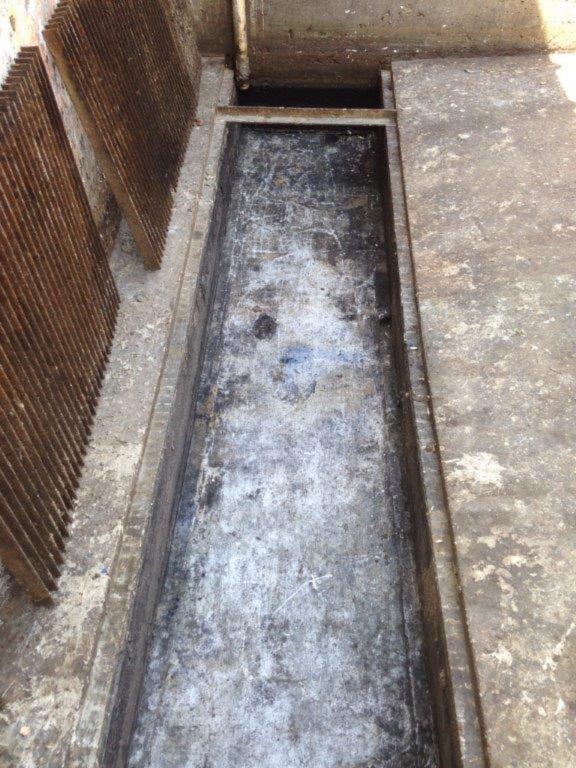
John – I spoke with our solid waste folks about the issues I observed around the mix tub. Can you send me verification that the issues we observed in the solid waste processing area have been corrected? Photos of the north side and back of the containment, along with a photo of the sump area would be helpful.

- Per the permit, the leachate collection system and sump are supposed to be cleaned out at least once per operating day.
- The waste outside the containment walls needed to be cleaned up.
- The gaps between the concrete and metal, and between the metal panels need to be sealed so that waste will not leak out.

I just returned from vacation so pardon the delay in getting back with you. Here are the requested photos of the inspected items and the resolution. The mix tub trench was cleaned out by the close of business the day of the inspection, as well as the material removed from the gap beneath the wall.
