RE: August 30, 2018 Implementation of Contingency Plan

Type of Incident: Arc flash incident within the Retort Oven

Exhibit A
Photo Documentation

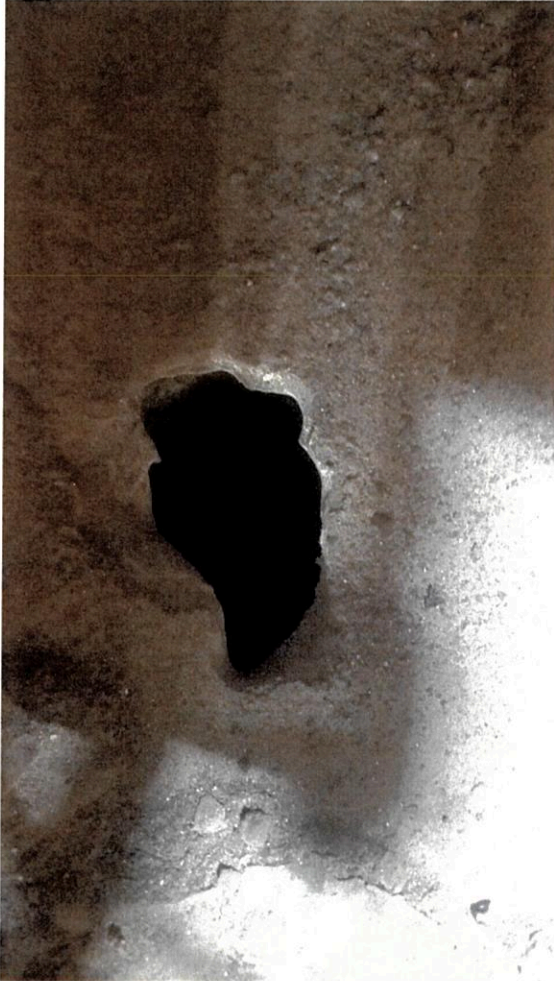
Initial monitoring on August 31, 2018, with the Jerome meter, indicated levels had returned to normal and lamp processing was resumed. Retort staff inspected the oven in an effort to determine the nature and cause of the incident. Initial inspection of the oven revealed that two heating elements in the lower bank of elements were damaged. A hole in the base of the oven was also found in the vicinity of the damaged heating elements. The hole was approximately 2 inches wide by 3 inches long. A picture of the hole was taken and forwarded to EH&S. Phillip Ditter and Wayne Bulsiewicz reviewed the picture and data with personnel from Veolia's other mercury retort facilities. Based on the review of the picture and the observations of facility staff, it was determined that the most likely cause of the incident was an arc flash occurring from a failed heating element shorting to ground on the housing of the oven.

The heating elements operate on a 480 volt circuit. The heating elements are on a dual fuse circuit. An arc flash on a 480 volt circuit will have sufficient energy to melt/burn stainless steel and will cause an instantaneous pressure wave. This instantaneous pressurization would exceed the capacity of the vacuum blower and would force vapors and fumes out of the newly created hole as well as forcing these vapors and fumes through the door seal. These vapors and fumes would be a combination of mercury

Based on the results of our incident investigation we are unable to definitively determine the cause of the heating element failure. The two most likely scenarios are either a defect in the element that shorted to ground or the presence of dirt and debris on the element. The presence of dirt or debris on the element typically would not impact the performance of the element; however, it is possible that it created uneven heating and cooling of the element, stressing the element and causing a premature failure.

Picture of hole burned through base of the oven

To address each of these possibilities Veolia is updating the retort procedures to include a documented inspection during the loading of each retort batch. This inspection will include visually inspecting the elements for signs of physical damage or defects and inspecting the oven for the presence of dirt and debris in the bottom of the oven or on the heating elements.
