**Florida Department of
Environmental Protection
Hazardous Waste Inspection Report**

Facility Name: Photographic Waste Control Inc

On-Site Inspection Start Date: 02/07/2019

Routine Inspection for Hazardous Waste Transporter facility

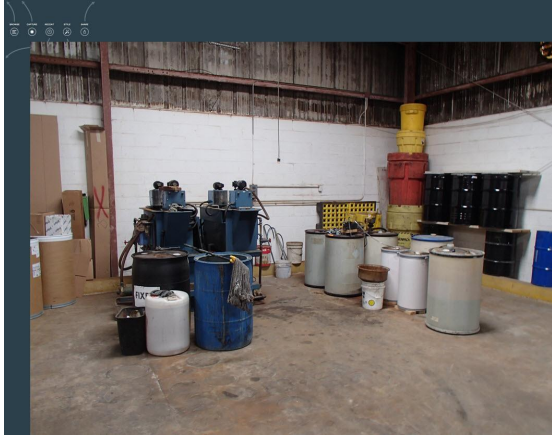
1. Silver Recovery System

Spent photographic fixer containing silver is consolidated directly into an electrolytic treatment unit for recovery of the silver (Figure 1). Treated waste water containing lower levels of silver passes from the electrolytic unit to a 55-gallon drum. The drum is connected to a series of two ion exchange cartridges operated in series for recovery of silver. The first cartridge removes most of the silver and the second cartridge removes the remaining silver. When the first filter is no longer able to effectively remove silver, the cartridge is removed and the second cartridge is moved forward to the first position. This allows PWC to use the cartridges more efficiently and for longer periods of time. Waste passing through the cartridges is stored in a 55-gallon drum. The combined waste stream from the drums is transferred to a tote and shipped for off-site disposal. The silver recovery unit only operates every couple of months due to the reduction in the number of companies using photographic fixer. Most x-ray equipment is now digital.

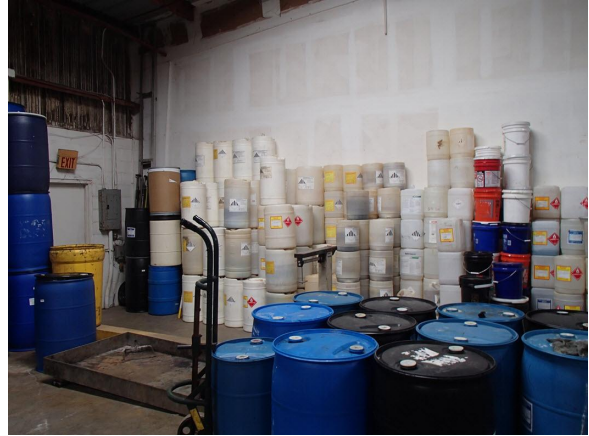
2. Silver Sludge Drying Pan

Solids settling in the silver recovery filters are dried in a shallow, metal pan (Figure 2) before being accumulated in a container and shipped off-site for silver recovery at Hallmark Refining Corporation, Mt. Vernon, Washington.
