**Florida Department of
Environmental Protection
Hazardous Waste Inspection Report**

Facility Name: Ring Power Corp

On-Site Inspection Start Date: 01/30/2019

Facility Street Address: 8040 Philips Hwy, Jacksonville, FL 32256-7406

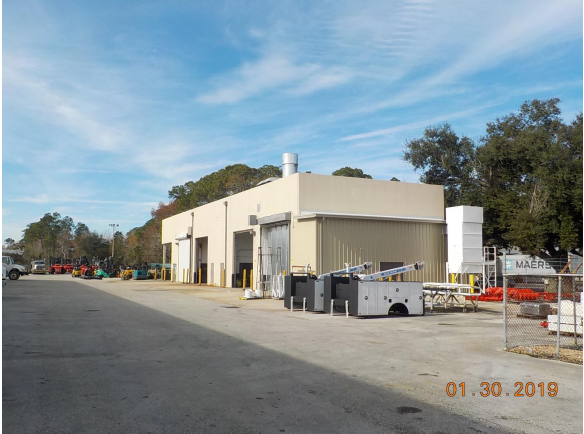
Photo 17

The facility Paint Shop (Photo 17) has two paint areas for prepping and painting equipment and parts. One area services the Forklift Division. The second area services the Utility Truck Division. The utility paint booth was recently installed due to increased production.

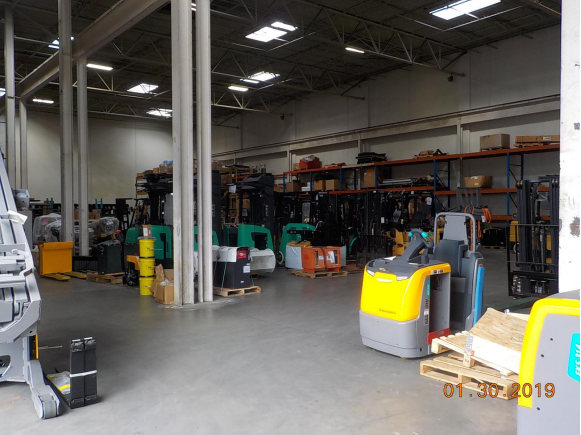
Photo 20

There is a Shipping and Receiving Warehouse (Photo 20) located adjacent to the Service Shop. The only hazardous waste generated in this area would be if a defective aerosol can or other product was discovered.
