# FLORIDA DEPARTMENT OF Environmental Protection

**RE: Warning Letter No. WL19-103 (Significant Non-Complier)**  
**EPA/DEP ID: FLD 984 209 346**  
**Duval County – Hazardous Waste**

**Florida Department of  
Environmental Protection  
Hazardous Waste Inspection Report**

**Facility Name:** Ring Power Corp

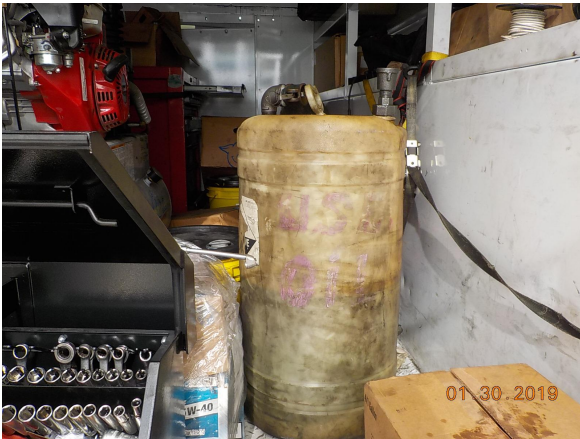
Photo 1

own central collection facility for storage prior to having its used oil picked up by a certified used oil transporter. Used oil is collected in 15-gallon drums maintained on the trucks (Photo 1). The drum of used oil observed on truck 17-4277 was closed and properly labeled. A 5-gallon drum is taken to jobs to collect used antifreeze when used antifreeze will be generated. Used oil filters are typically collected in 5-gallon drums maintained on the trucks. However, one used oil filter was being accumulated in a drip pan that was not labeled "Used Oil Filters" on truck 17-4277 (Photo 2) [62-710.850(5)(a), FAC]. Absorbent mats used to clean-up drips, leaks or spills of used oil are collected in clear plastic bags.

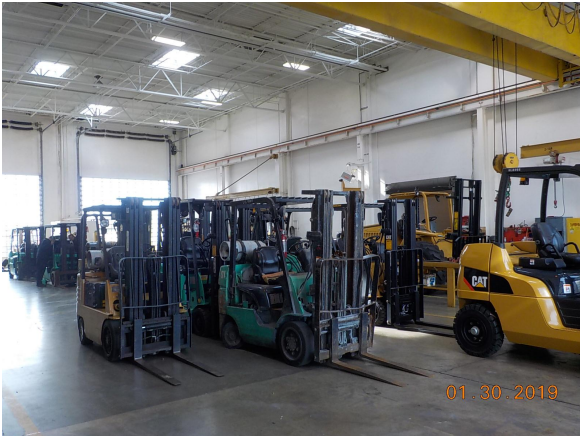
Photo 3

The Service Shop has a Forklift Division and a Utility Truck Division. The Forklift Truck Division area contains four bays for servicing forklifts (Photo 3). The Utility Truck Division has four areas where utility trucks are "up-fitted" by cutting, welding and fitting trucks with pre-fabricated equipment or equipment fabricated on site and then filling the equipment with the necessary hydraulic fluids.

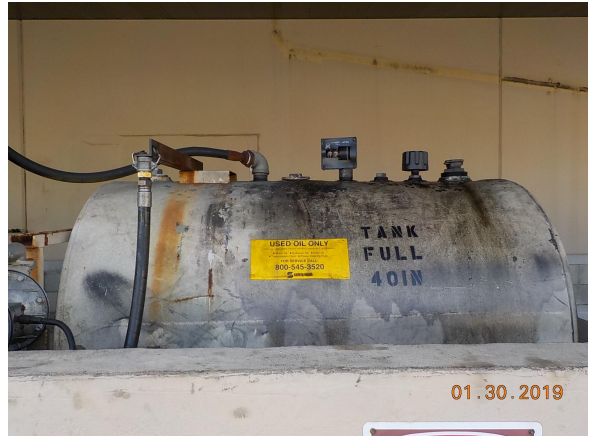
Photo 4

Used oil generated by Service Shop operations is drained into portable drain containers and then pumped into a 400-gallon double-walled tank located outside under an overhang (Photo 4). The used oil tank and most of the used oil drain containers were properly labeled as "Used Oil." Two used oil drain containers were observed that were labeled as "Waste Oil." The facility is reminded that all used oil containers should be properly labeled only with the words "Used Oil."

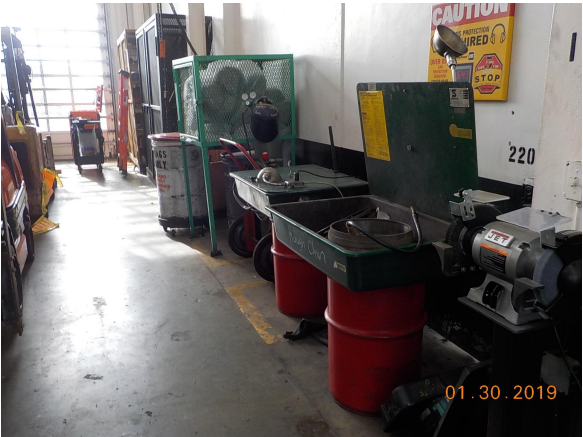
Photo 5

The facility operates two, 15-gallon Safety-Kleen parts washers that use Safety-Kleen Premium Solvent (hydrotreated light petroleum distillates 100%; flash point 148°F) (Photo 5). The units are on an 8-week schedule with Safety-Kleen. Spent solvent is managed as non-hazardous waste, and the last shipment was December 31, 2018. The facility had a sample of this waste stream analyzed, however, the adjusted Method Detection Limits (MDLs) and adjusted Practical Quantification Limits (PQLs) were well above the Toxicity Characteristic Leaching Procedure (TCLP) regulatory limits for the volatile constituents. As a result, the facility has not made an accurate hazardous waste determination on this waste stream [40 CFR 262.11]. The samples should be re-evaluated ensuring the MDLs and PQLs are below the regulatory limits.

Type:	Violation 1
Rule:	262.11
Explanation:	Service Shop: The facility did not make an accurate hazardous waste determination on the spent solvent from two Safety Kleen parts washers.
Corrective Action:	Service Shop: In order to return to compliance, the facility should re-analyze the spent parts washer solvent for volatile organic compound TCLP constituents pursuant to 40 CFR 261.24, via method 8260, ensuring that the MDLs and PQLs are below the regulatory maximum concentrations.
<hr/>	
Type:	Violation 2
Rule:	262.14(a)(5)
Explanation:	Service Shop (Utility Truck): 1. The facility disposed of rags contaminated with Brakleen Brake Parts Cleaner-Non-Chlorinated and Finish Pro General Purpose Lacquer Thinner for paint clean-up in the trash.  2. The facility disposed of one non-empty aerosol can of D001 hazardous waste Brakleen Brake Parts Cleaner-Non-Chlorinated in the trash.  Wash Rack: 3. The 55-gallon aerosol can puncturing drum was open.  4. A 55-gallon drum of punctured aerosol can liquid hazardous waste was open.  Paint Shop: 5. F005 hazardous waste lacquer thinner rags used for paint clean-up in the Forklift Division area and the Utility Division area were being disposed of in the trash.  6. D001 and possibly D005 and/or D035 hazardous waste liquid contained in paint gun liners is allowed to dry for 24-hours before being placed into the trash in the Utility Truck Paint Shop.  7. D001 and possibly D005 and/or D035 hazardous waste liquid paint waste was disposed of in the trash. A D001, and possibly D005 and/or D035, container of hazardous waste paint which had solidified was disposed of in the trash.

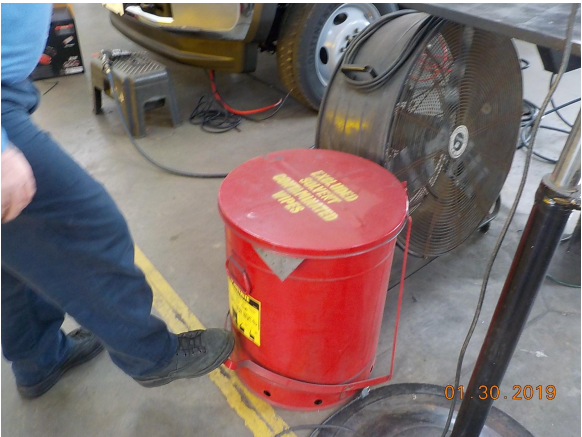
Photo 6

Laundered rags are generated by forklift maintenance activities and may be contaminated with oil, grease or Brakleen Brake Parts Cleaner-Non-Chlorinated (methanol 40-50%, toluene 10-20%, acetone 5-15%, 3-methylhexane 5-10%, carbon dioxide 5-10%, n-heptane 5-10%, methylcyclohexane 3-5%, hydrotreated light naphtha (petroleum) 3-5%, cyclohexane 1-3%, ethylbenzene <0.2%; flashpoint 0° F). Rags are accumulated in closed containers labeled as "Excluded Solvent Contaminated Wipes" (Photo 6). Rags are laundered by Cintas weekly.

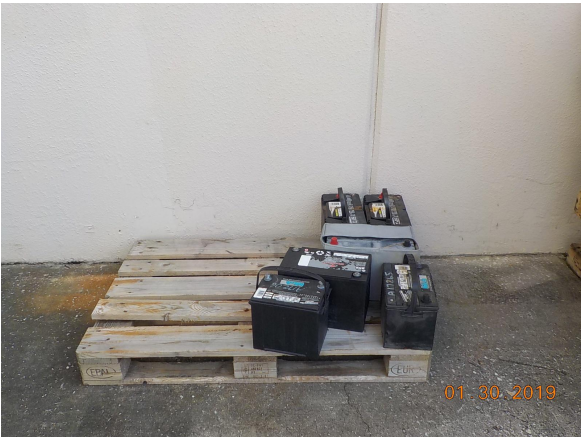
Photo 10

Spent lead acid batteries generated by the Service Shop are stored on a pallet outside of the building (Photo 10). Batteries are picked up as needed by Battery Distributors Southeast, Inc. for recycling.

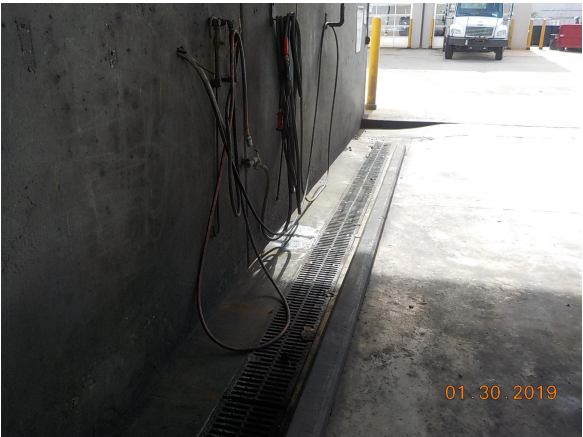
Photo 11

-----  
The Wash Rack (Photo 11), located adjacent to the Paint Shop, is a covered area used to wash equipment potentially contaminated with oil prior to service with Mean Green 9 and/or heated water. Wash water drains to a collection pit and is pumped to a biofiltration unit. The biofiltration unit treats the water with microbes and a defoaming agent, prior to discharge to the POTW. If needed, the filters would be pressure washed in the wash rack area. Sludge from the collection pit and loose dirt swept off the vehicles is accumulated in a roll-off dumpster. The sludge and dirt is disposed of as non-hazardous waste as needed at Evergreen Landfill in Valdosta, Georgia. TCLP metal and volatile constituent analysis has indicated that the waste is non-hazardous. The facility is reminded to ensure that when sampling is conducted that a representative sample is collected and analyzed in accordance with EPA publication SW#846 "Test Methods for Evaluating Solid Waste" 3rd Edition and with Rule 62-160, Florida Administrative Code (FAC). The facility is also reminded to conduct a hazardous waste determination on any waste generated from the biofiltration unit, including TCLP analysis, prior to disposal.

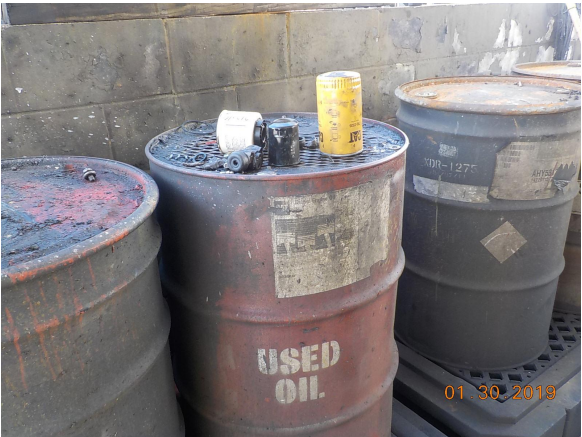
Photo 12

The used oil filters from the Service Shop and field trucks are brought to this area to be drained on top of a 55-gallon drum. The 55-gallon drum of used oil that the used oil filters were being drained into (Photo 12) was labeled "Used Oil" and was stored on a spill pallet, but the pallet was full of liquid, and therefore did not meet the requirement for secondary containment [62-710.401(6), FAC]. Once the filters are drained, they are accumulated in a 330-gallon steel container in this area. The used oil filter container was in good condition

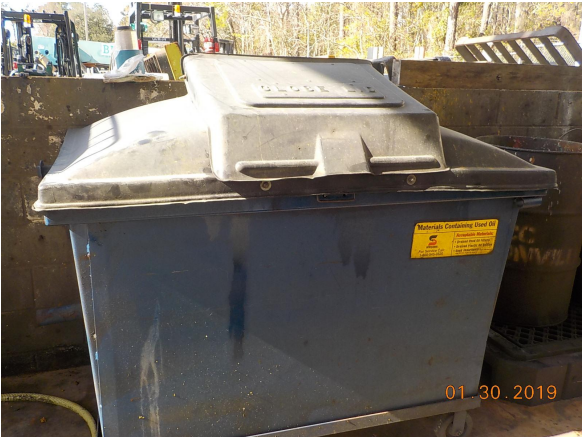
Photo 13

and properly labeled, but was not stored on an oil-impermeable surface due to cracks in the unsealed concrete (Photo 13) [62-710.850(5)(a), FAC].

Wash Rack: One 330-gallon used oil filter container was not stored on an oil-impermeable surface.

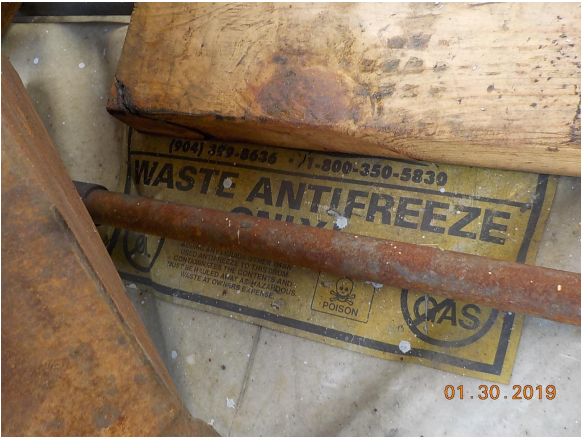
Photo 14

The used antifreeze from the Service Shop and field trucks is brought to this area and transferred into a 250-gallon tote (Photo 14). The tote was labeled as "Waste Antifreeze." The facility is reminded to follow best management practices for managing used antifreeze, including, but not limited to, labeling containers as "Used Antifreeze," using dedicated collection equipment, keeping stored antifreeze free of cross-contamination, keeping containers closed at all times except when emptying or filling and inspecting containers weekly.

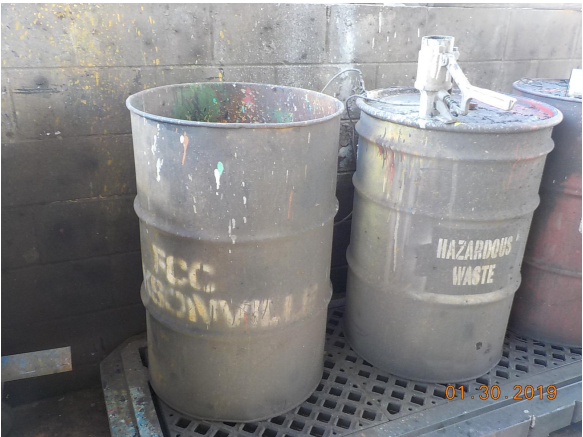
Photo 15

The facility's process indicates that aerosol cans from the facility are supposed to be brought to this area to be punctured and drained into a drum-top aerosol can puncturing device located on top of a 55-gallon drum (Photo 15). The aerosol can puncturing drum was missing the cap on the can puncturing device, which allows the liquid drained from the aerosol cans to evaporate (Photo 15) [40 CFR 262.14(a)(5)]. In addition, there was another unlabeled, 55-gallon drum adjacent to the can puncturing drum which appeared to be one-half full of aerosol can liquid waste. The top of this drum was not completely closed thus allowing the hazardous waste to evaporate (Photo 16) [40 CFR 262.14(a)(5)]. Punctured and drained cans should be recycled as scrap metal according to facility procedures, but some punctured cans were also observed in the trash.

3. No further action is required. The facility returned to compliance via an email dated 4/2/19 that included a photo of the aerosol can puncturing device equipped with a cap.

4. No further action is required. The facility returned to compliance via an email dated 4/4/19 which provided a manifest for the open drum of aerosol can waste showing that the drum had been shipped off-site on 2/15/19.

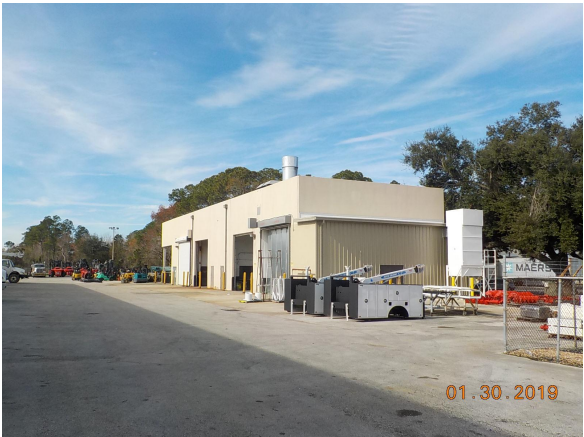
Photo 17

The facility Paint Shop (Photo 17) has two paint areas for prepping and painting equipment and parts. One area services the Forklift Division. The second area services the Utility Truck Division. The utility paint booth was recently installed due to increased production.

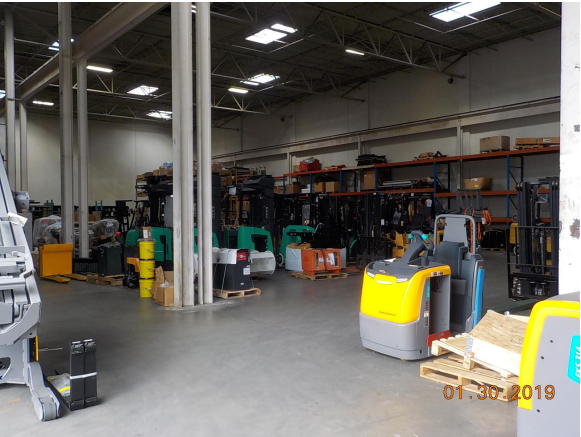
Photo 20

There is a Shipping and Receiving Warehouse (Photo 20) located adjacent to the Service Shop. The only hazardous waste generated in this area would be if a defective aerosol can or other product was discovered.

The parts manager stated that if the can could not be repaired, he would probably throw it away. The facility is reminded that a hazardous waste determination must be conducted on all waste prior to disposal.
