LIGHTING RESOURCES, LLC

1007 SW 16TH PL

OCALA, FL

November 28, 2019 Fire

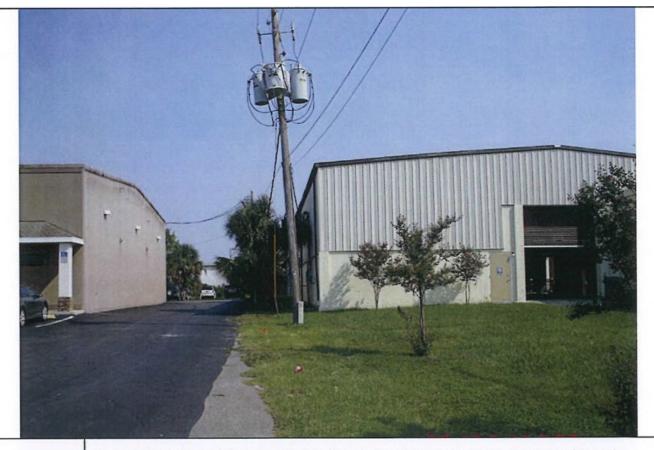
Photo No. 3

DRIVEWAY TO LEFT OF BUILDING

BEFORE.....

Front of Site looking north along western edge of Site property with adjacent property (located to the west of Site) shown on the left.

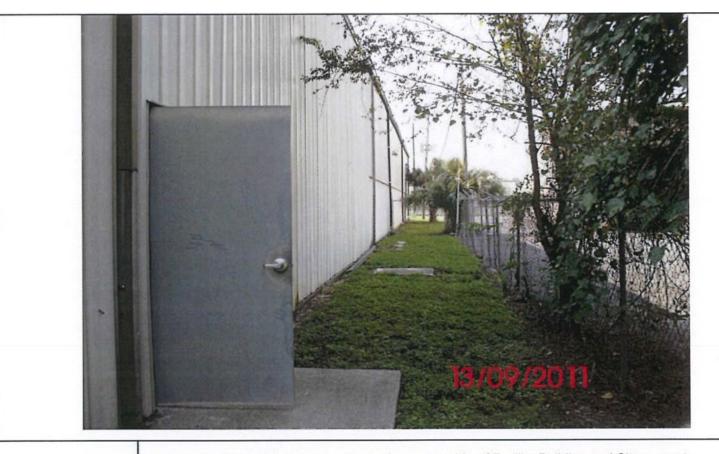
Photo No. 12

Balcan Room Door next to Driveway

Northwest corner of Site looking south along west side of Facility Building and Site property (fencing on the right).

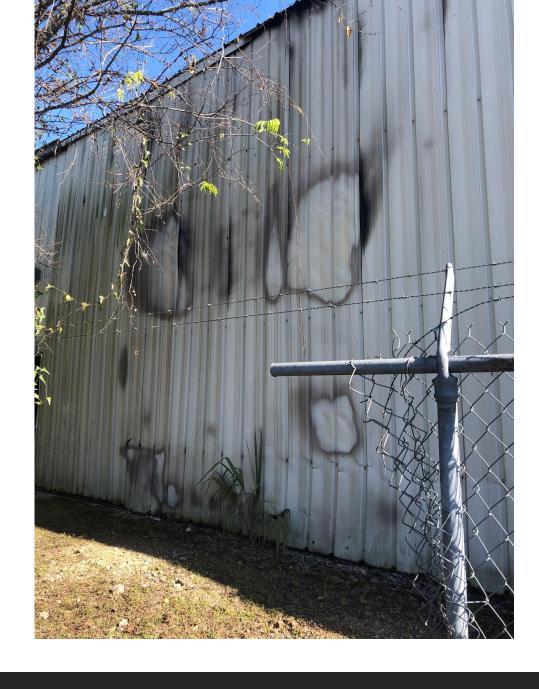
Balcan Room Door next to Driveway -after

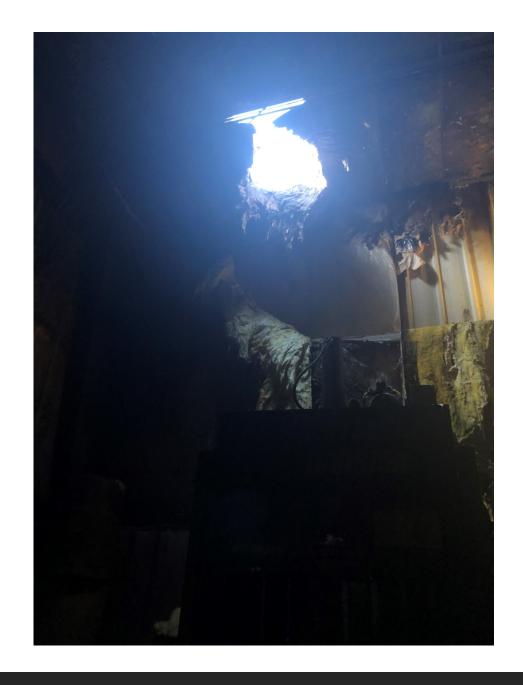
Roof After.....

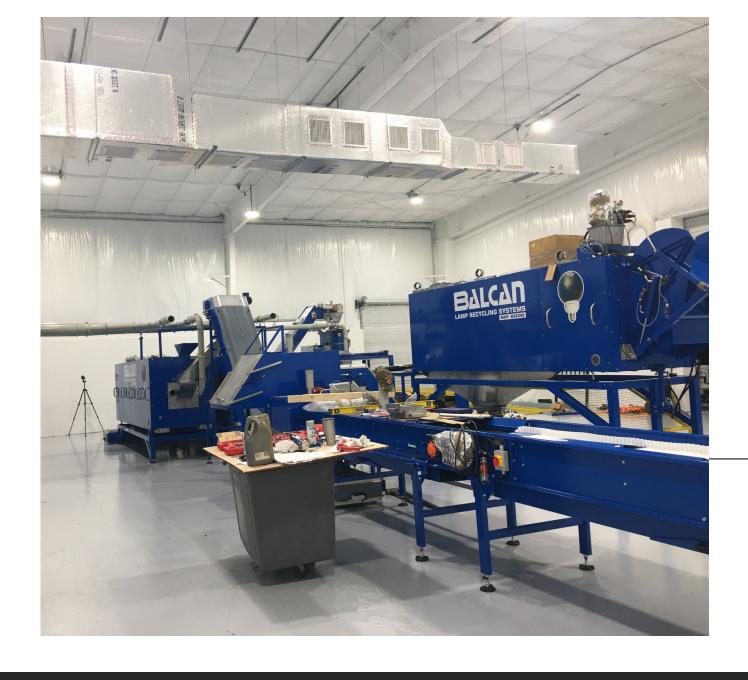
Installing New Balcan

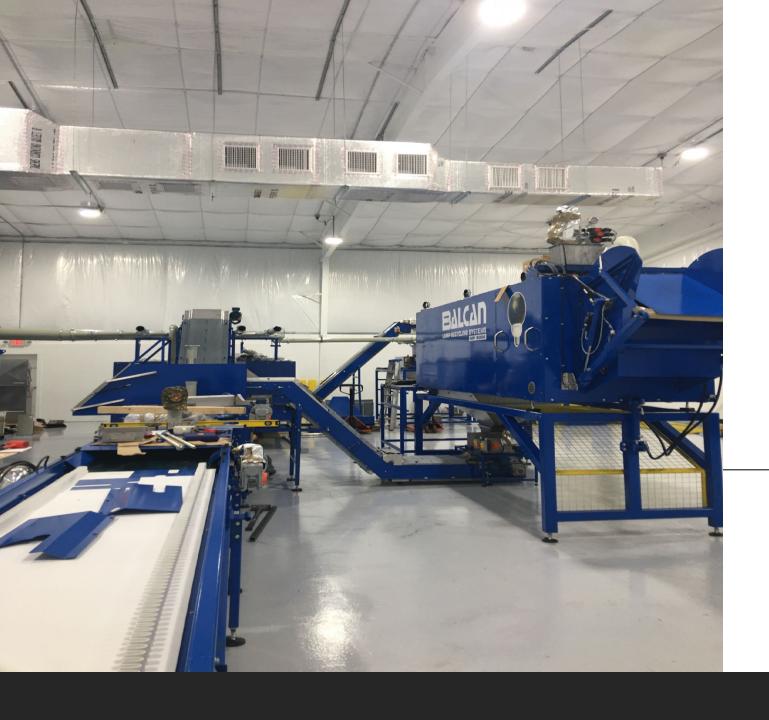
New Balcan Conveyor View

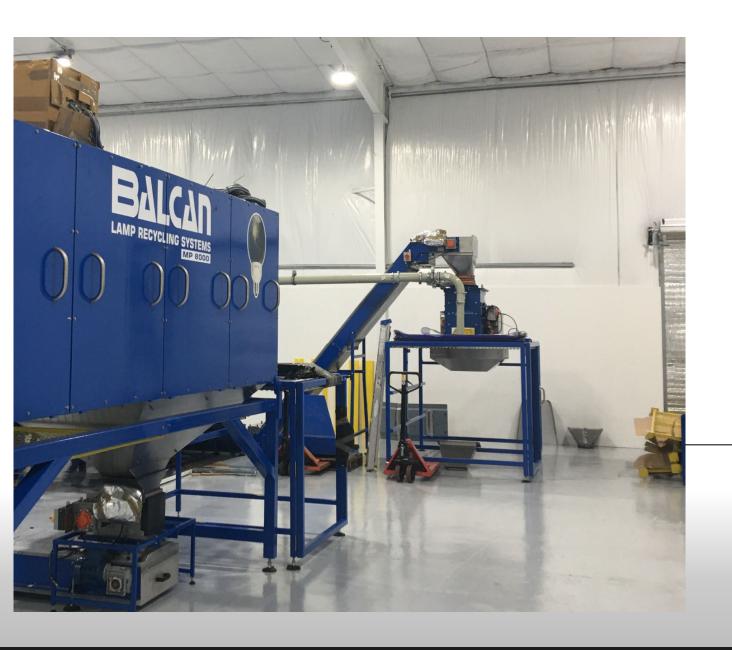
New Conveyor for End Caps

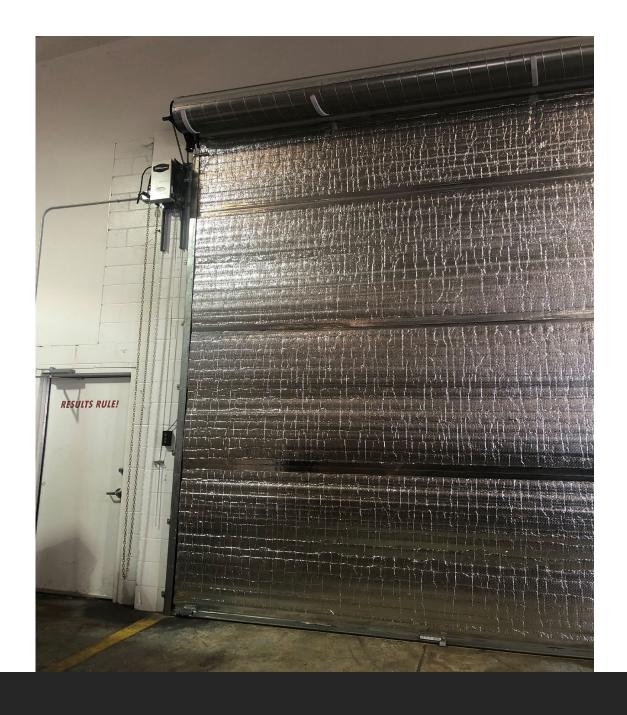
New Overhead door from Warehouse into Balcan Area B

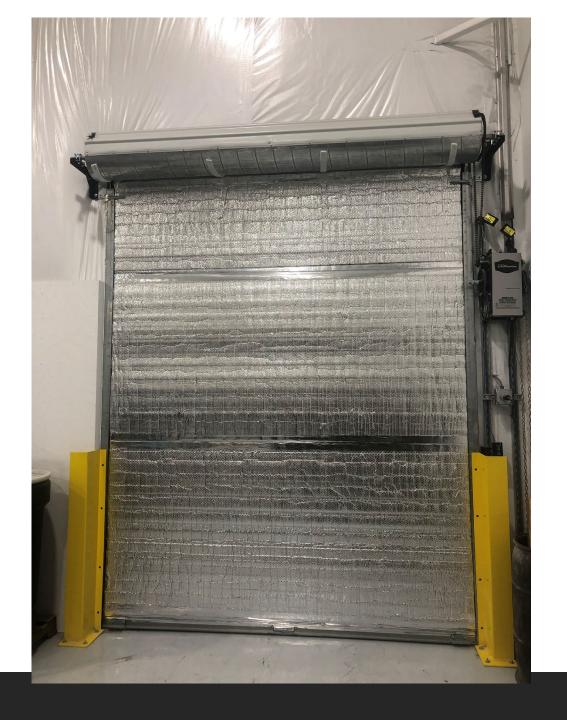
New Overhead Door to Area C from Balcan Processing Room

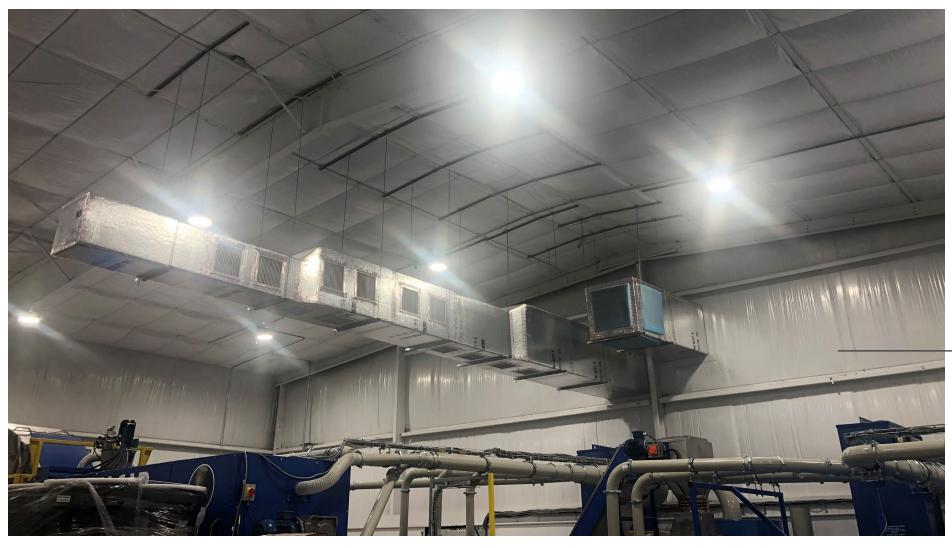
New Interior HVAC and Ceiling and Lights

- Continued to operate sending spent lamps to Lighting Resource Facilities in Fort Worth, Texas and Johnson City, Tennessee
- ➤ Demolition cleared the entire room (Completed February 2020)
- Contractor rebuilt the Walls, Ceiling, HVAC, Lighting, Floor and Electrical.(Completed June 2020)
- Material still stored in trailers offsite at a secure location in Ocala awaiting processing. (July to current)
- New Balcan was received and installed by LR crew. (UK crew was not allowed to travel due to Covid.) (September 2020)
- ➤ Began processing lamps on a continuing basis with single crew. (Reduced staff due to Covid.) (October 2020)
- >Added second shift to tackle the stored trailers. (November 2020)
