**Florida Department of  
Environmental Protection  
Hazardous Waste Inspection Report**

**Facility Name:** Veolia ES Technical Solutions LLC  
**On-Site Inspection Start Date:** 06/15/2022 **On-Site Inspection End Date:** 06/15/2022  
**ME ID#:** 6716 **EPA ID#:** FL0000207449  
**Facility Street Address:** 342 Marpan Ln, Tallahassee, Florida 32305-0904  
**Contact Mailing Address:** 342 Marpan Ln, Tallahassee, Florida 32305-0904  
**County Name:** Leon **Contact Phone:** (850) 877-8299

Routine Inspection for TSD Facility Facility  
Routine Inspection for LQG (>1000 kg/month) Facility

## Veolia ES Technical Solutions LLC Inspection Report

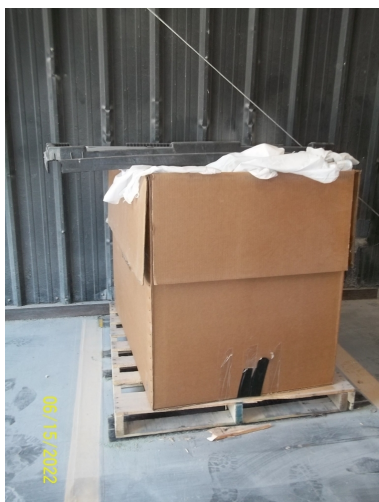
Photo 1: Storage Area #1

- Storage area #1 contained a box for personal protective equipment (PPE) such as Tyvek suits; the container was labeled as non-hazardous special waste. (photo 1)
- Storage area #2 is designated for the storage of phosphor powder or MCMA received from other (Veolia) facilities; this area was empty.
- Storage area #3 contained twelve 55-gallon containers of processed phosphor powder; each container was labeled as non-hazardous special waste. Drums are processed three at a time and are sampled/analyzed once

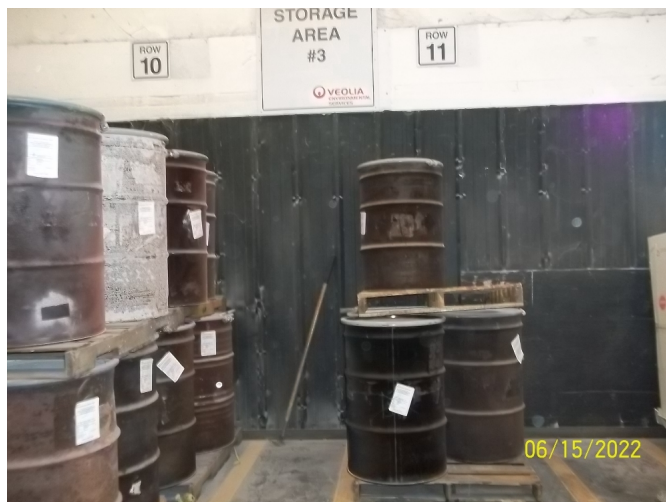
Photo 2: Storage Area #3

cooled prior to off-site shipment for disposal in a Subtitle D landfill. (photo 2)

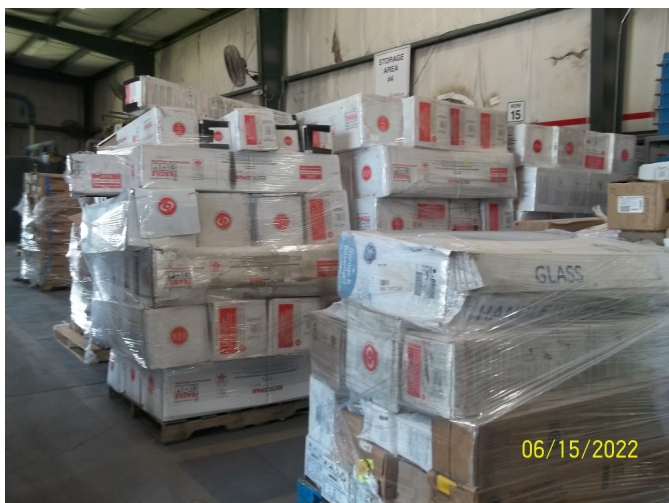
Photo 3: Storage Area #4

- Storage area #4 is the primary lamp storage area immediately adjacent to the (un)loading dock. There were eighteen pallets with lamps. Containers on the pallets appeared appropriately labeled and each pallet also appeared appropriately labeled. (photo 3)
- Storage area #5 contained three boxes individually labeled for halogens, CFLs, and CFL pins; each of the boxes appeared empty.

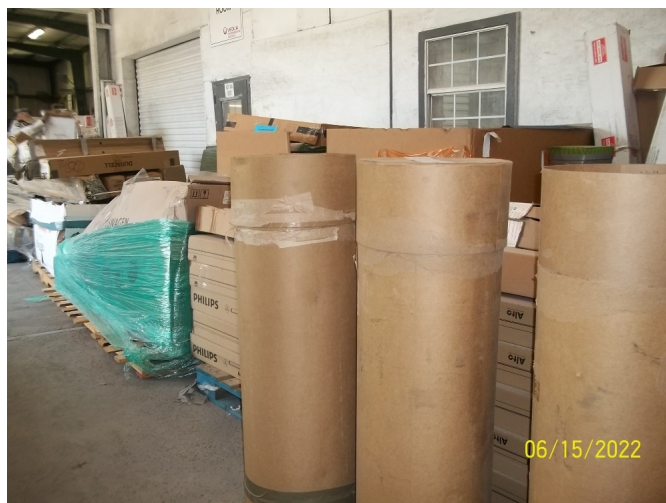
Photo 4: Processing Lamp Staging

Fluorescent lamps ready for processing are staged immediately adjacent to the lamp processing feed belts (photo 4); fluorescent lamps are hand fed into the lamp processing room via the conveyor/feed belt (photo 5). The Fluorescent Lamp Processing Room (labeled as Crush and Separate Room on the Facility Plan), is located in the northwest corner of the facility. It is designed to process approximately 200,000 feet of lamp equivalents per 8-hour shift. Lamps are crushed in a drum crusher and dry-separated into glass, aluminum, and phosphor powder. Phosphor powder is collected by a bag tower and accumulated in 55-gallon drums. There are two processing lines that are used to facilitate this operation. The second processing line is used when there is a need to process a larger volume of materials. At the time of inspection, there were four pallets and six containers of lamps staged for processing. Lamps staged in this area are expected to be processed before the end of the day; if they are not processed they are moved to one of the designated storage areas.

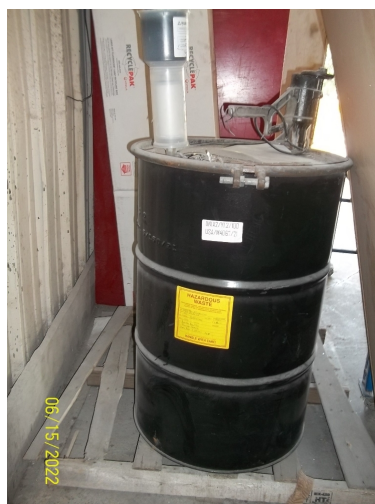
Photo 6: Aerosol Can Puncture Unit SAA

The loading/unloading area consist of two trailer docking areas for forklift transfer of materials to/from transport vehicles. In this area, the facility maintains a satellite accumulation container with an aerosol can puncture unit attached for aerosol can waste generated onsite (photo 6). The drum appeared appropriately labeled. A date of June 2021 was noted on the drum.

On June 20, 2022, through a Teams meeting with Monica Hardin (DEP) and Scott Fulton and Wayne Bulsiewicz (both with Veolia), a closing interview was conducted. We discussed the onsite inspection, waste reported on the Biennial Report, the 8700-12FL notification form, the battery sorting table, priority of processing lamps, the date on the can puncture unit, and the records for review. Mr. Fulton explained the aerosol can puncture unit is managed as a satellite accumulation area with the date used for internal record.

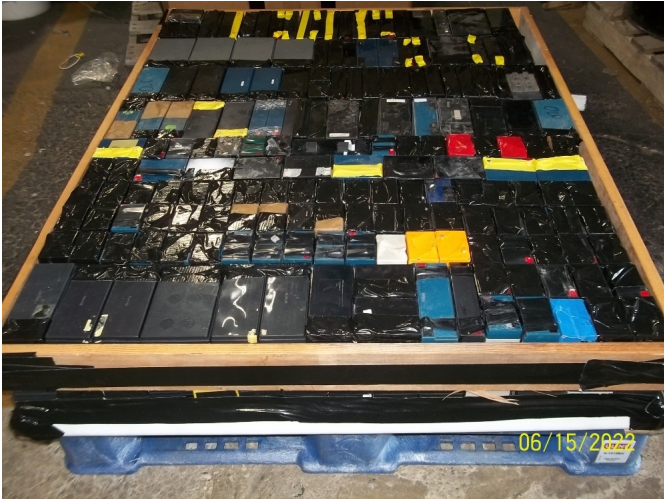
Photo 7: Dry Lead Acid Batteries

The South building is immediately south of the main building and is designated for battery, empty container, e-waste storage, and a maintenance area. No universal or hazardous waste is stored or generated in the container or maintenance areas. The battery storage and e-waste are stored separately for sorting and prepping for shipment. At the time of inspection, in the battery area we observed pallets for dry lead acid batteries, pallets for wet lead acid batteries, pallets of universal waste batteries for shipment, and batteries staged for sorting at the sorting table. Mr. Gavin explained dry lead acid batteries are taped and stacked with cardboard in between (photo 7) while wet lead acid batteries are capped (with plastic caps) and not stacked (photo 8). If any spills occur, a powder is applied to neutralize the acid and the material is placed in the appropriate container. Adjacent to the universal waste battery sorting table, nine pre-labeled battery pack buckets/boxes were staged for sorting (photo 9). Buckets under the table catch the batteries as an employee sorts them by type; prior to the end of the shift, buckets are emptied into their respective drums.
