# THE IMPACT OF HURRICANE ELENA AND TROPICAL STORM JUAN ON COASTAL CONSTRUCTION IN FLORIDA

Beaches and Shores Post-Storm Report No. 85-3

March, 1986

Bureau of Coastal Engineering and Regulation  
Division of Beaches and Shores  
FLORIDA DEPARTMENT OF NATURAL RESOURCES

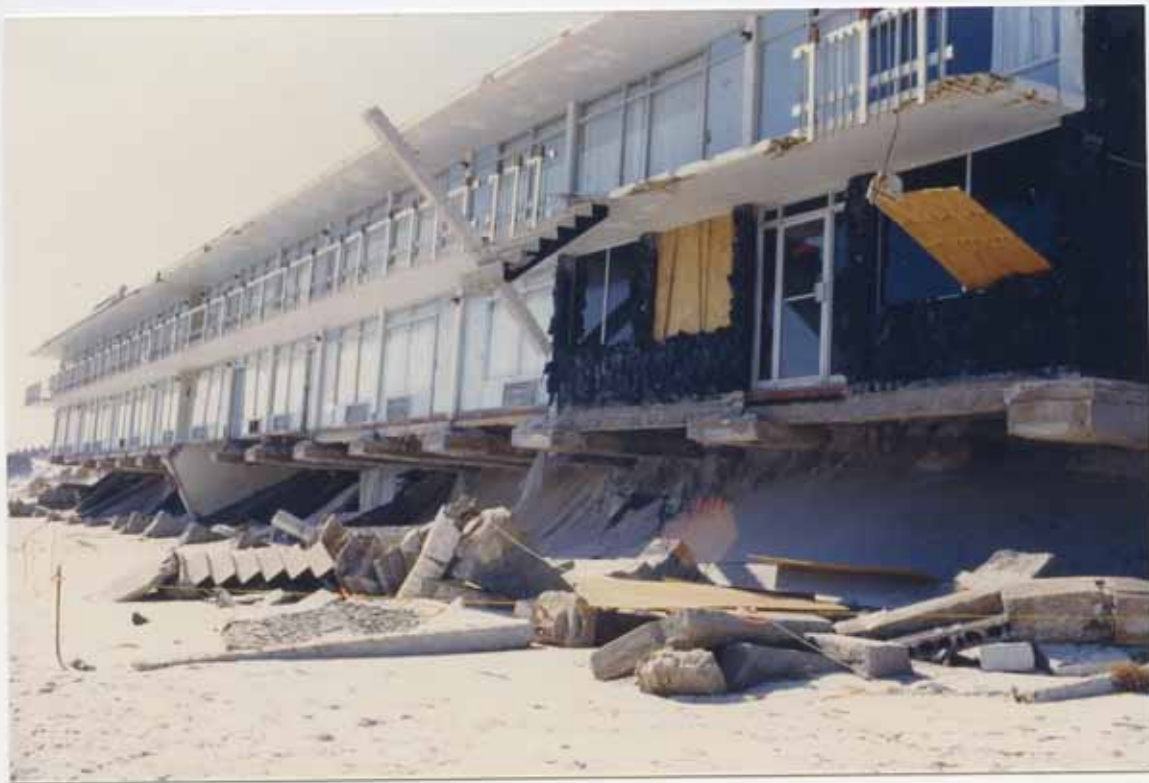
units as it experienced substantial undermining following the failure of its 200 foot long concrete retaining wall during Elena on August 30 (Figure 2). Approximately 8,000 cubic yards of sand fill were placed under the building on an emergency basis in 1979 after hurricane Frederic; however, the storm tide and wave uprush from Elena and Juan removed all the fill that was placed. On October 31, the building was substantially undermined by Juan and destroyed by wave action (Figure 3). The Gulf front 27 units were completely destroyed and the road front 29 units were damaged beyond repair.

FIGURE 2. Dunes Motel damaged by Elena's erosion, Pensacola Beach (D. Dodder)

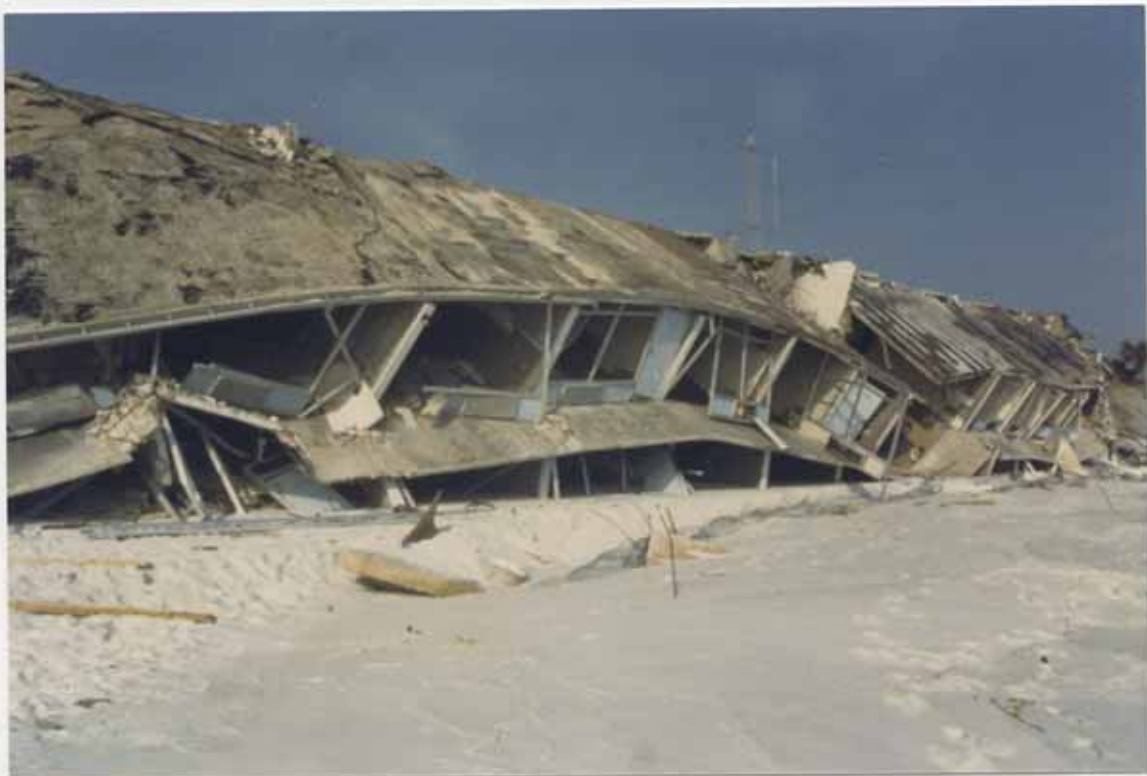
FIGURE 3. Dunes Motel destroyed by Juan, Pensacola Beach (G. L. Hill)

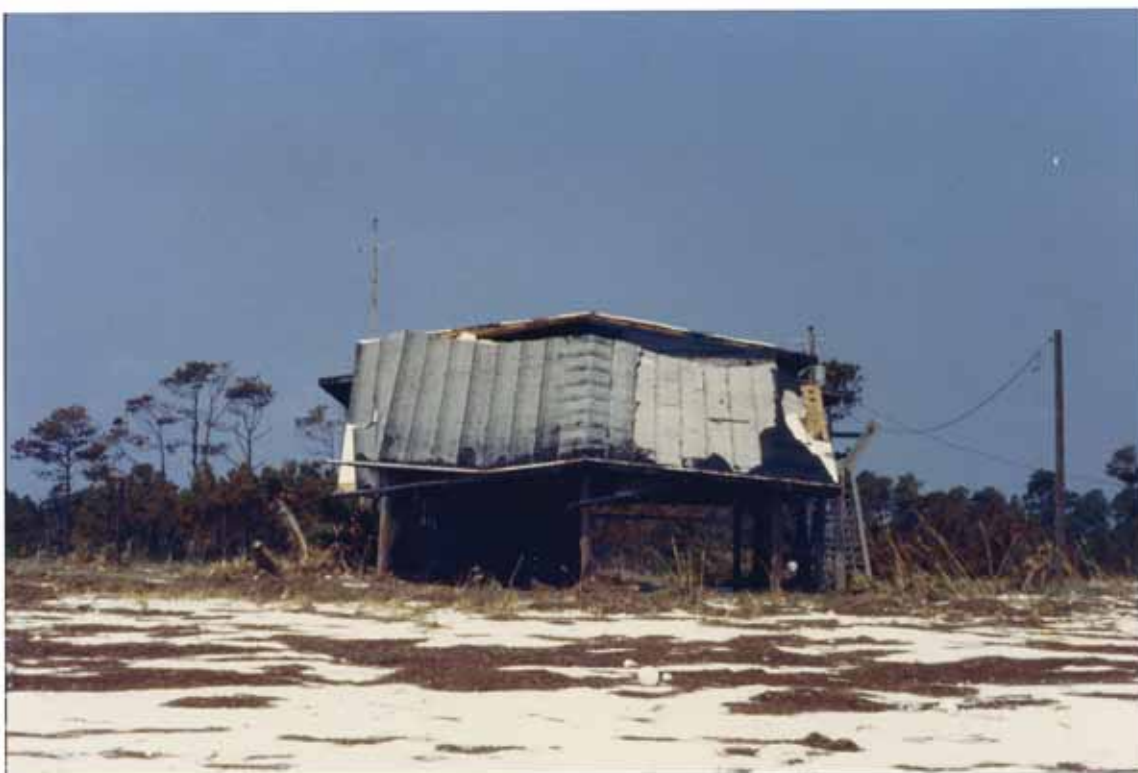
FIGURE 11. Dwelling damaged by Elena's wind, Dog Island  
(G. L. Hill)

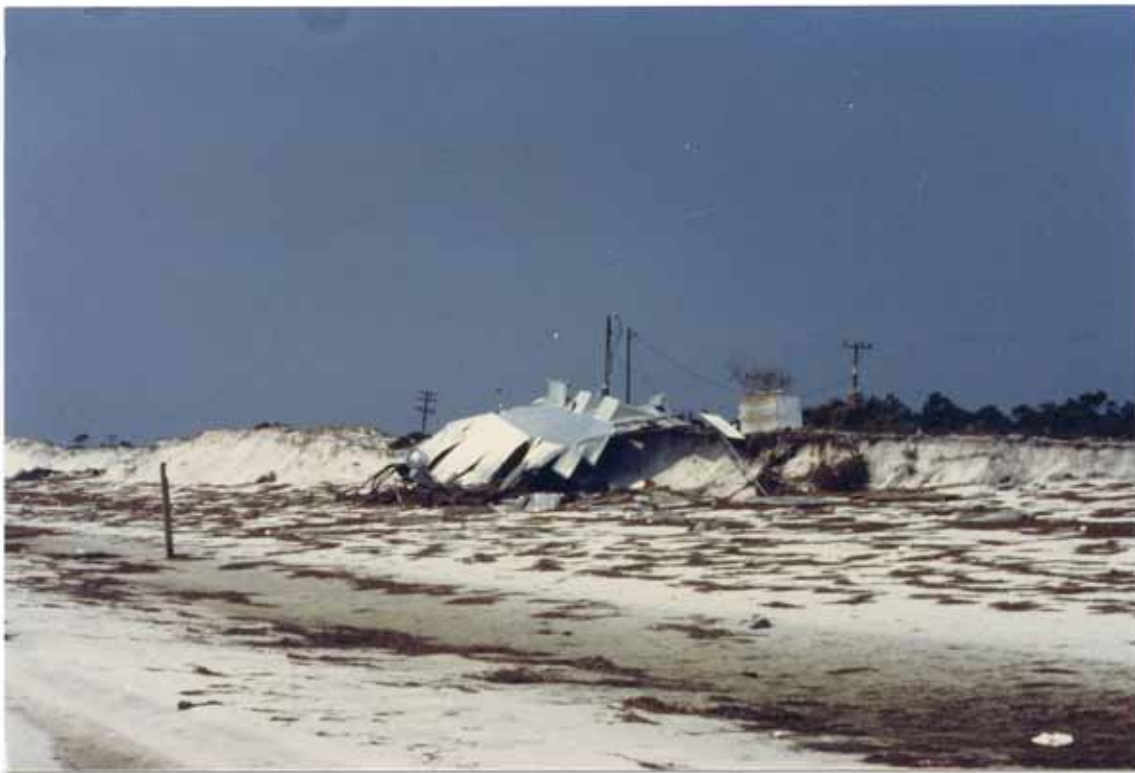
Although accurate surveys of the east tip of St. George Island have never been conducted, at least 500 feet of the east tip was observed to be eroded by Elena. Across a wider East Pass, Dog Island sustained heavy dune erosion along its entire length and storm tide overtopping occurred in the two low narrow areas near the island's west end. Widespread roofing and minor wind damage occurred during Elena and one single family dwelling sustained major wind damage to its roof (Figure 11). The community center, a metal building founded on a concrete slab was totally destroyed by undermining and direct wave attack after it collapsed on the

beach (Figure 12). It is not known whether the structure was damaged on August 30 when Elena initially passed offshore; however, following the erosion event of August 30 the building was certainly placed in imminent danger of collapse from further erosion which did occur on September 1 during the second and most devastating of offshore passes. Nearby, the multi-unit Pelican Inn sustained major deck and walkway damage and the concrete block stairwells on the front of the building were destroyed (Figure 13).

FIGURE 12. Metal community center destroyed by Elena's waves, Dog Island (G. L. Hill)

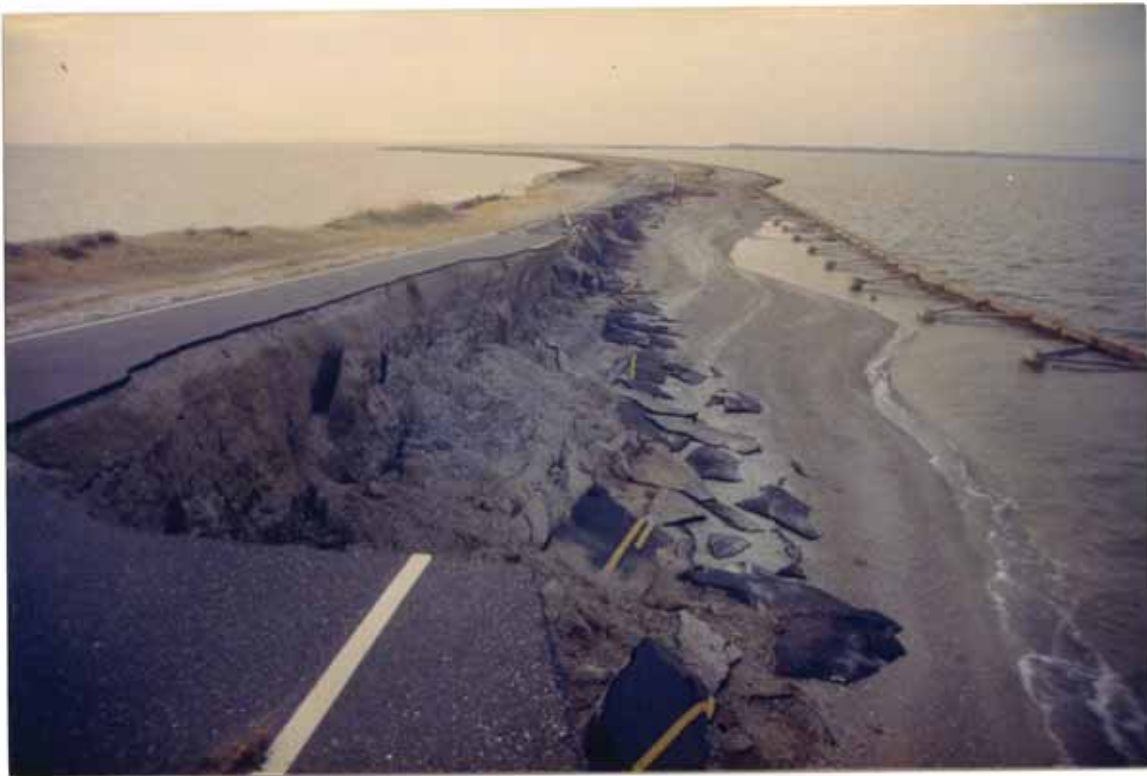
Because of the strong east to southeast winds associated with Elena's west-northwestward track on September 1, a significant setup of the storm tide occurred along the east shoreline of the causeway to St. George Island. Because of this storm tide and the incident storm wave activity which grew over a long fetch length of St. George Sound, major damage to 1,600 feet of the causeway was sustained (Figures 14 and 15). Approximately 830 feet of the concrete bulkhead was destroyed by wave activity and the Intracoastal Waterway bridge abutment sustained major damage due to hydraulic forces of the storm tide. Although the concrete bridges appear to have sustained no major damage, three bridge approaches were destroyed. The erosion loss to the causeway requiring replacement totaled approximately 58,000 cubic yards of fill (Florida Department of Transportation).

FIGURE 15. St. George Island causeway damaged by Elena's waves

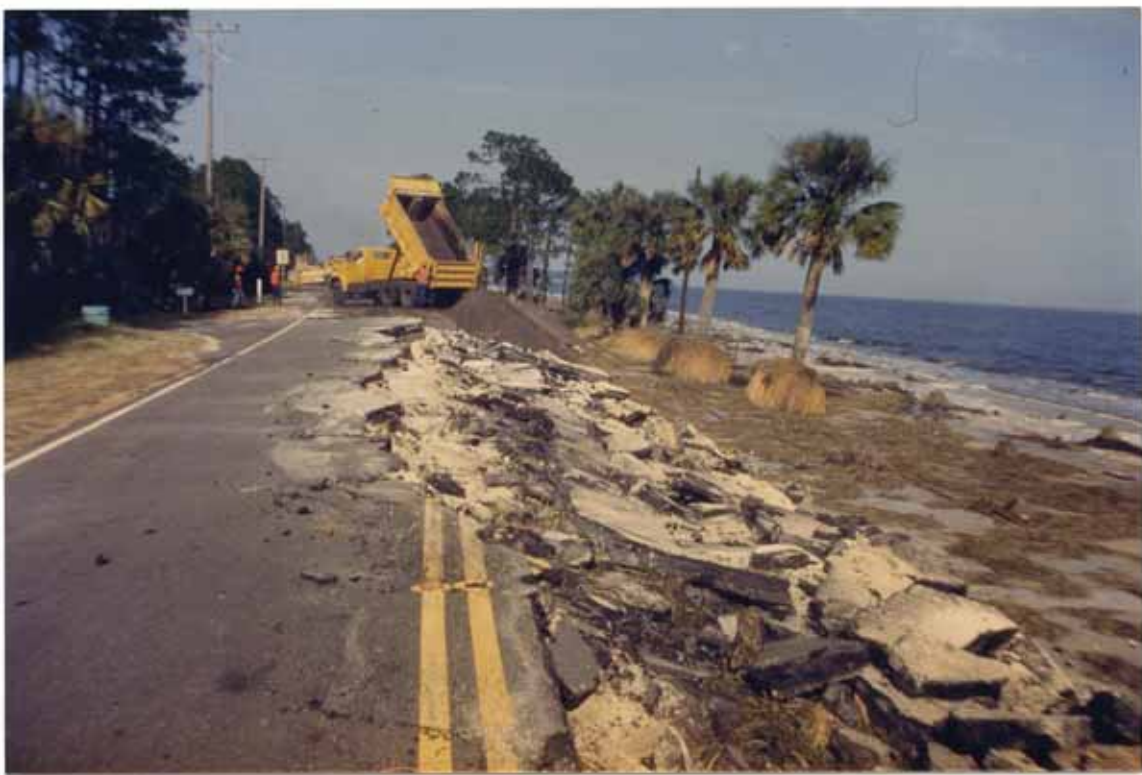
Much of the sandy mainland shoreline along St. George Sound typifies a barrier beach and dune system. There is a high degree of exposure to storm tides and wave activity along the shoreline stretch opposite the open water gap between Alligator Point and Dog Island and adjacent to East Pass between Dog Island and St. George Island. Along a 10 to 12 mile stretch of U. S. Highway 98, the two lane asphalt road is located in close proximity to the shoreline along a considerable distance. Although the shoreline length of damaged road was not determined, after Elena the Florida Department of Transportation measured 123,000 square feet of pavement destroyed and 130,000 cubic yards of fill lost from U.S. Highway 98 (Figures 16 and 17).

FIGURE 16. U.S. Highway 98 damaged by Elena, Carrabelle Beach

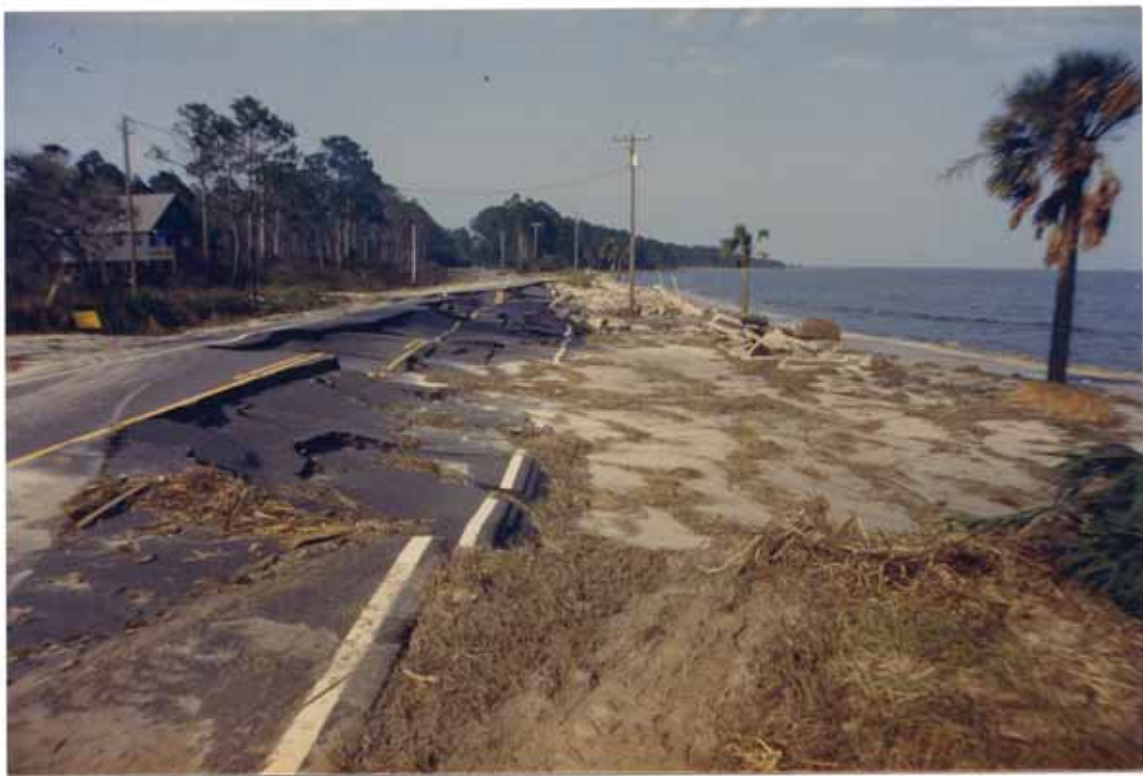
FIGURE 17. U.S. Highway 98 damaged by Elena

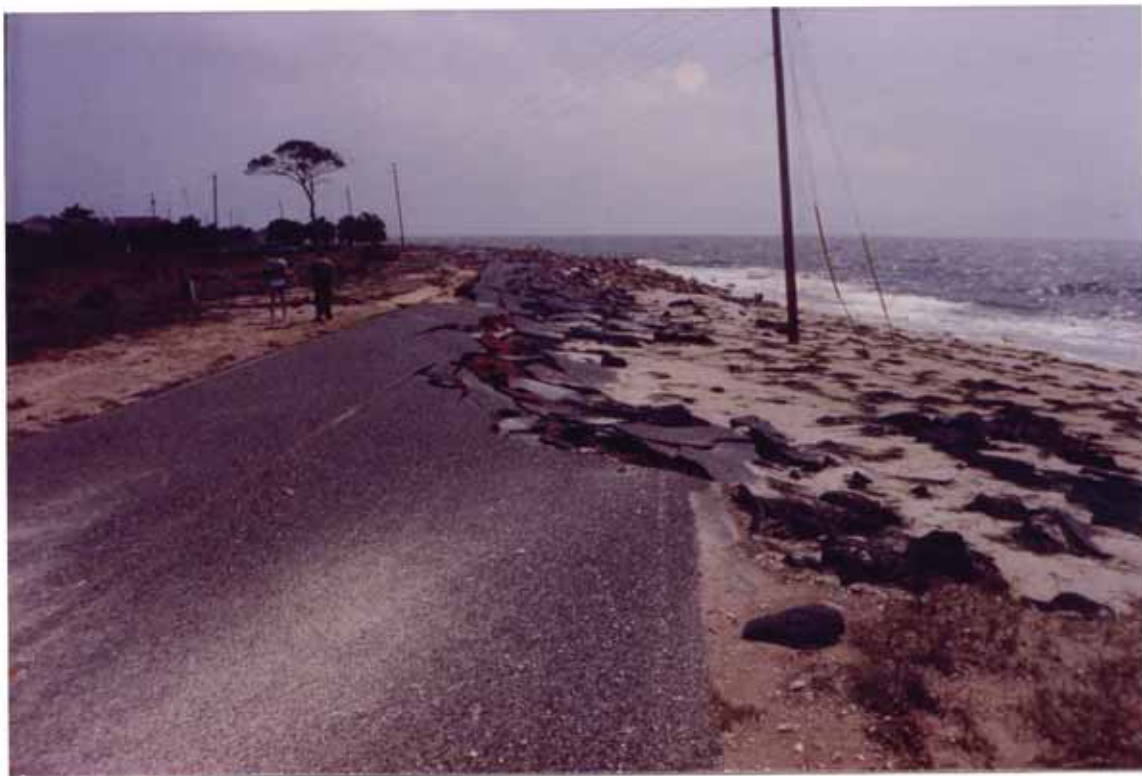
FIGURE 31. Elena's second pass destroyed County Road C370 on September 1

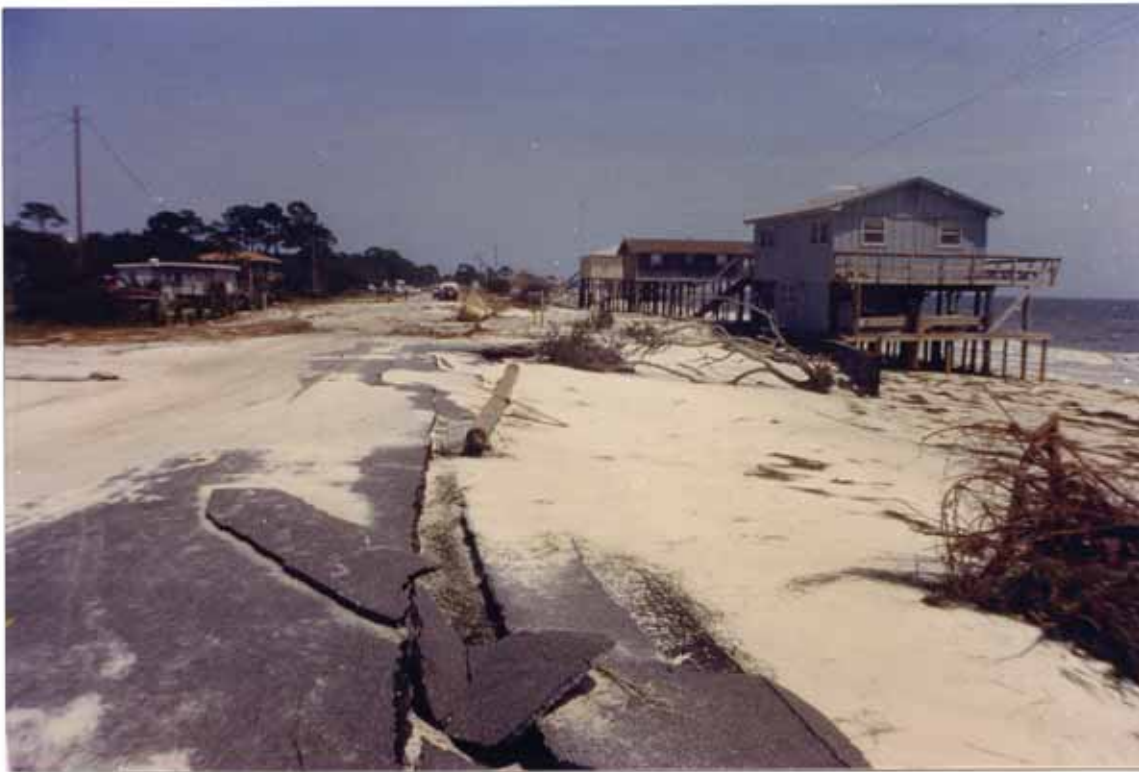
East of the KOA Campgrounds, four pile supported single-family dwellings sustained only light damages as their septic systems, stairways, and utilities were substantially damaged (Figures 32 and 33). One dwelling's fiberglass septic tank was transported approximately 250 feet westward before being deposited along the

FIGURE 32. Elena erosion and damage

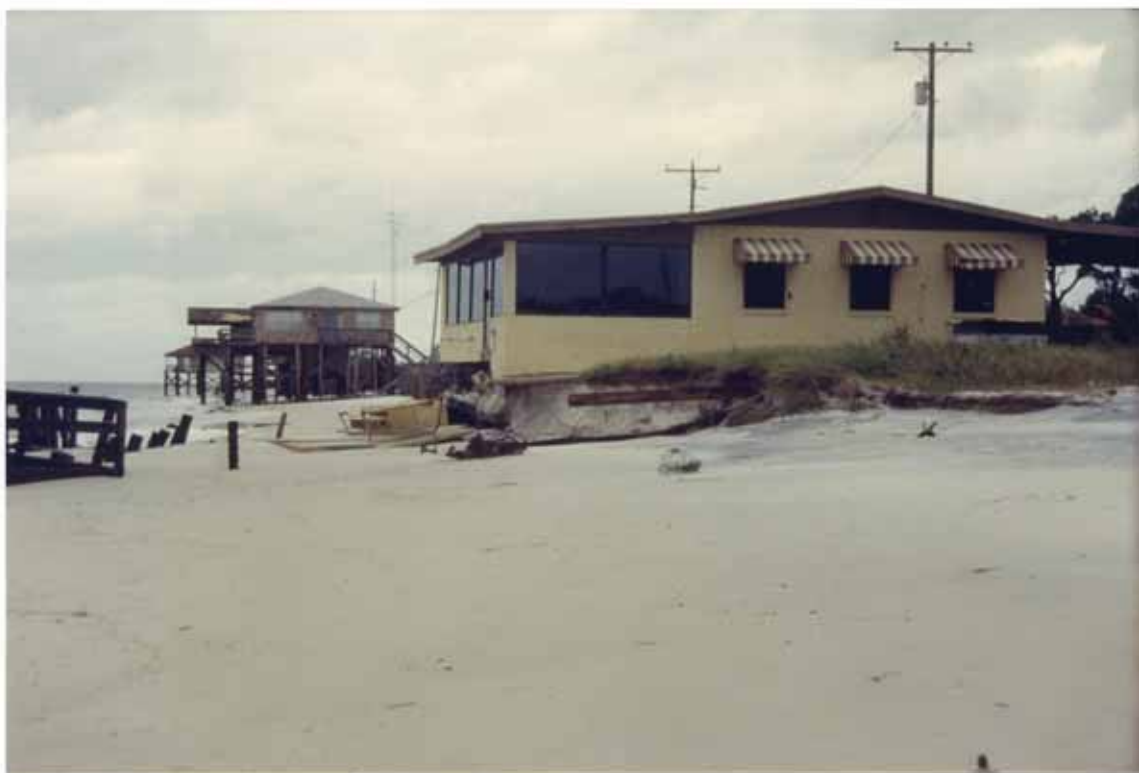
On August 30, at a location 350 feet east of the four pile supported dwellings, a 100 foot long wood bulkhead fronting a dwelling was destroyed and the entire yard seaward of the house was lost to erosion (Figure 34). An inspection of the dwelling on August 31 revealed initial major damage to the front of the structure as the slab had been undermined by several feet. On September 1, the house and its detached garage structure were completely destroyed (Figure 35).

FIGURE 34. Wood bulkhead destroyed and dwelling undermined on August 30 (H. N. Bean)

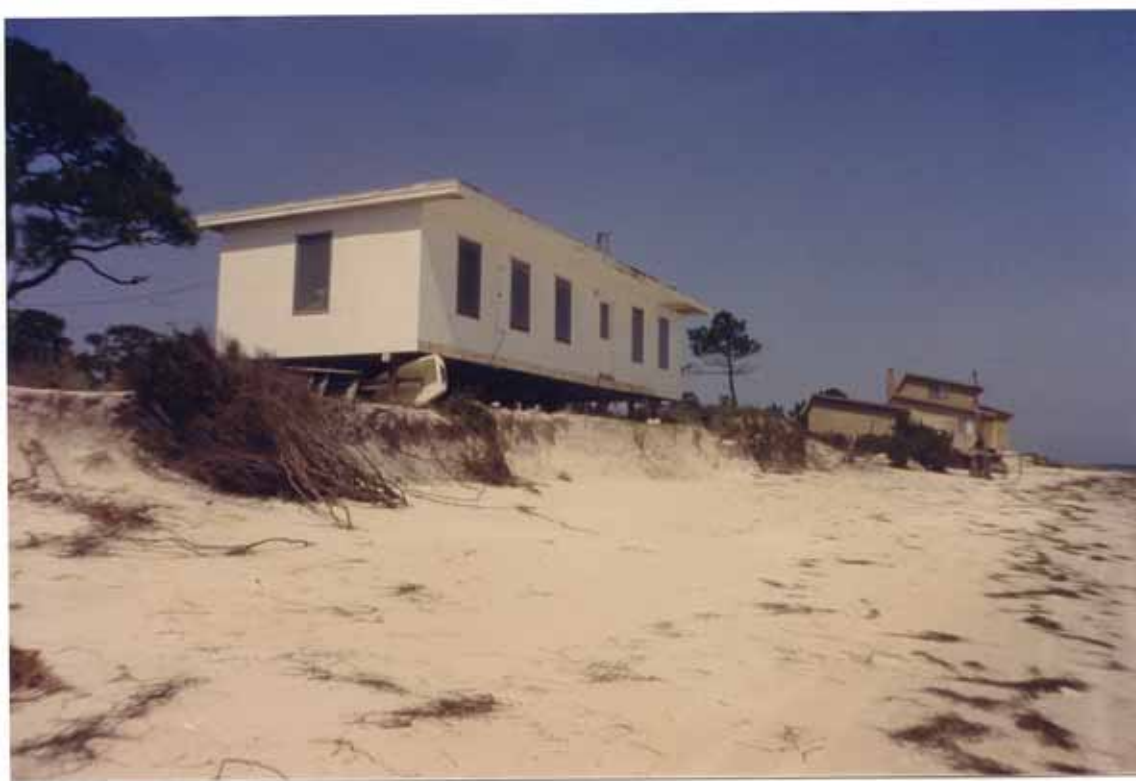
Moderate to heavy dune erosion was sustained eastward to Lighthouse Point. Immediately west of Lighthouse Point the dune recession nearly undermined one dwelling which should have been relocated inland (Figure 41). To its east, a wood frame dwelling on short wood piles and concrete footings, was undermined and sustained major damage to the foundation and floor slab (Figure 42). An inspection of the structure on August 31 revealed the dune recession had reached to within a couple feet of the dwelling overnight, and on September 1 the continued dune recession caused the eventual damage.

FIGURE 41. Lighthouse Point dwelling threatened by Elena's erosion

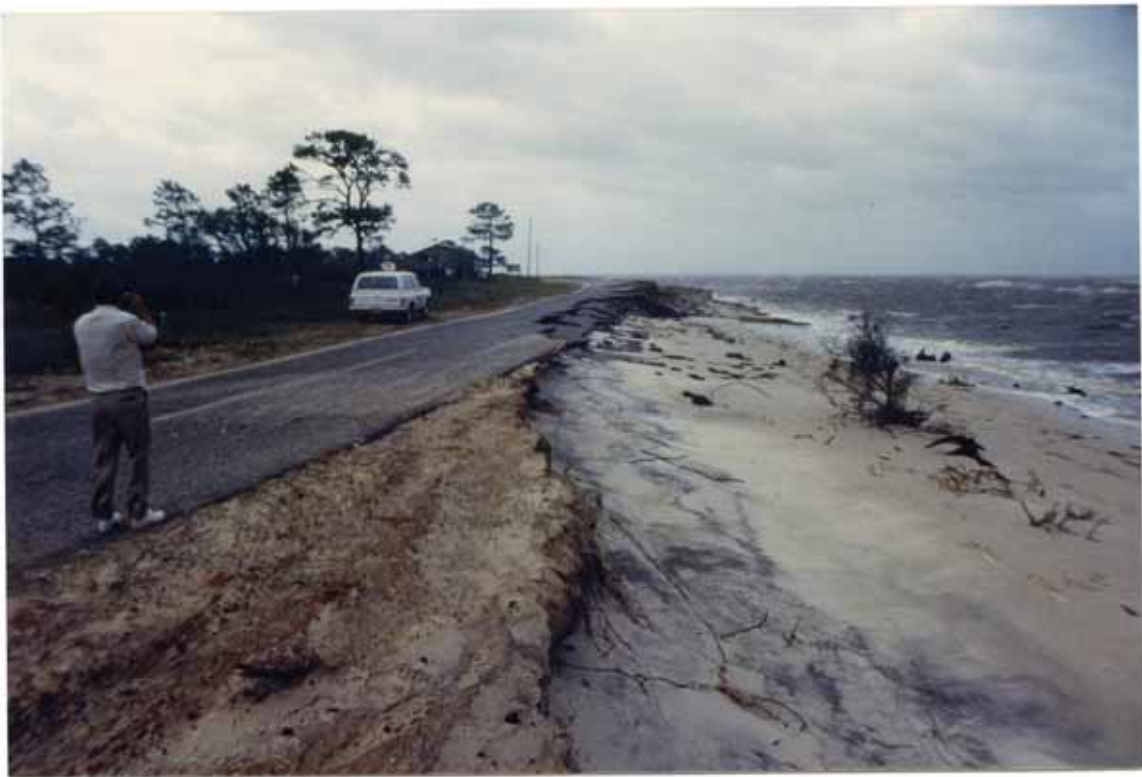
damaged, with the seaward lane and road shoulder being destroyed (Figures 44 and 46). A few hundred feet of concrete bulkhead had also been destroyed by Elena's first pass. On September 1, approximately 2,250 feet of the road was totally destroyed along with 1,400 feet of concrete bulkhead (Figures 45 and 47).

FIGURE 44. Lighthouse Point road damaged on August 30

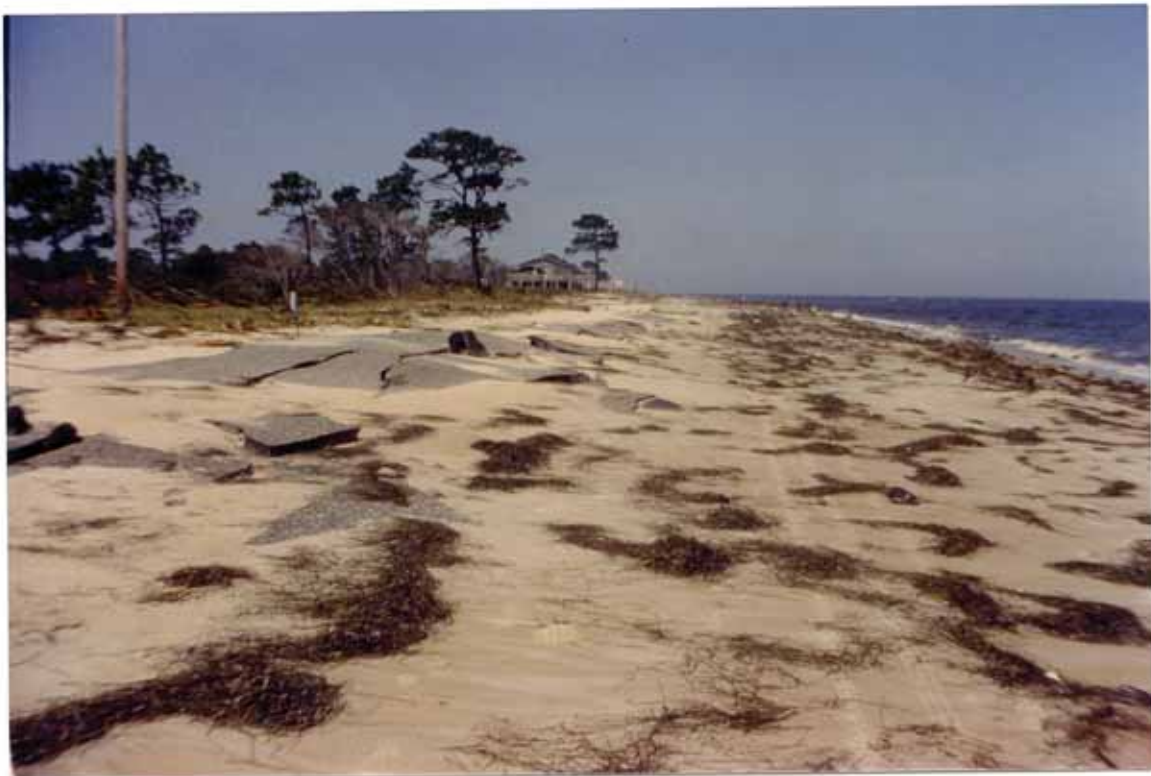
FIGURE 45. Lighthouse Point road destroyed on September 1

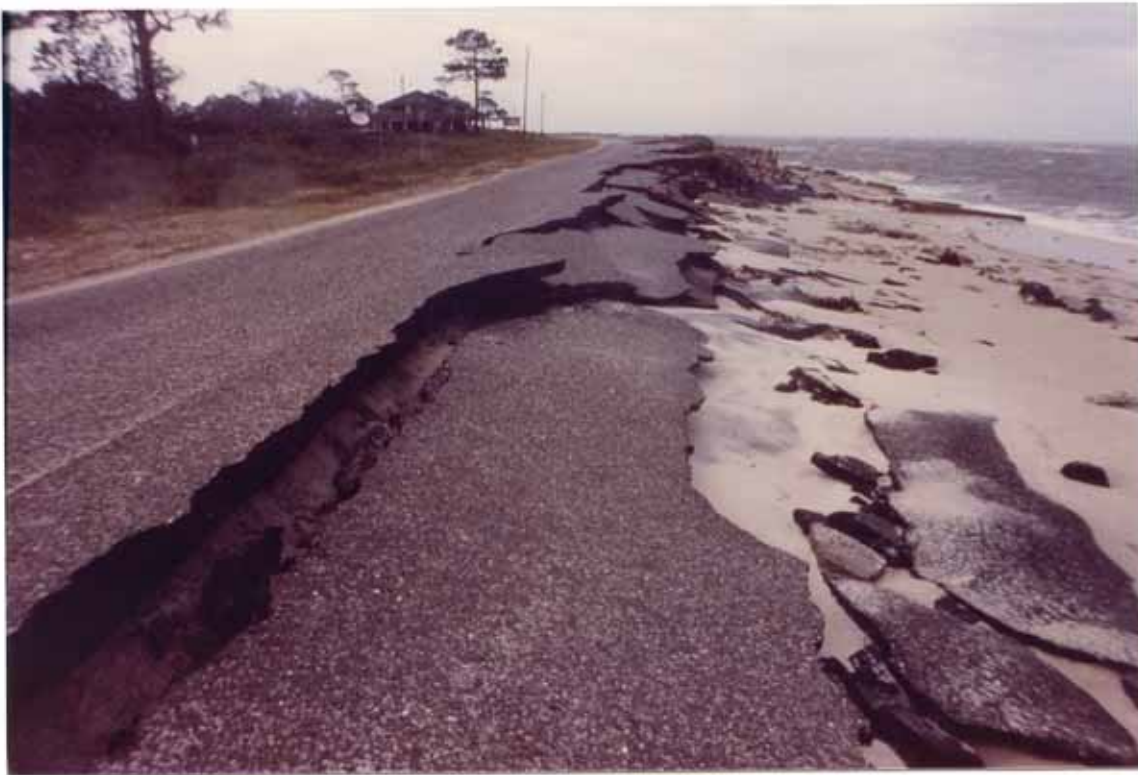
FIGURE 46. Lighthouse Point road damaged on August 30

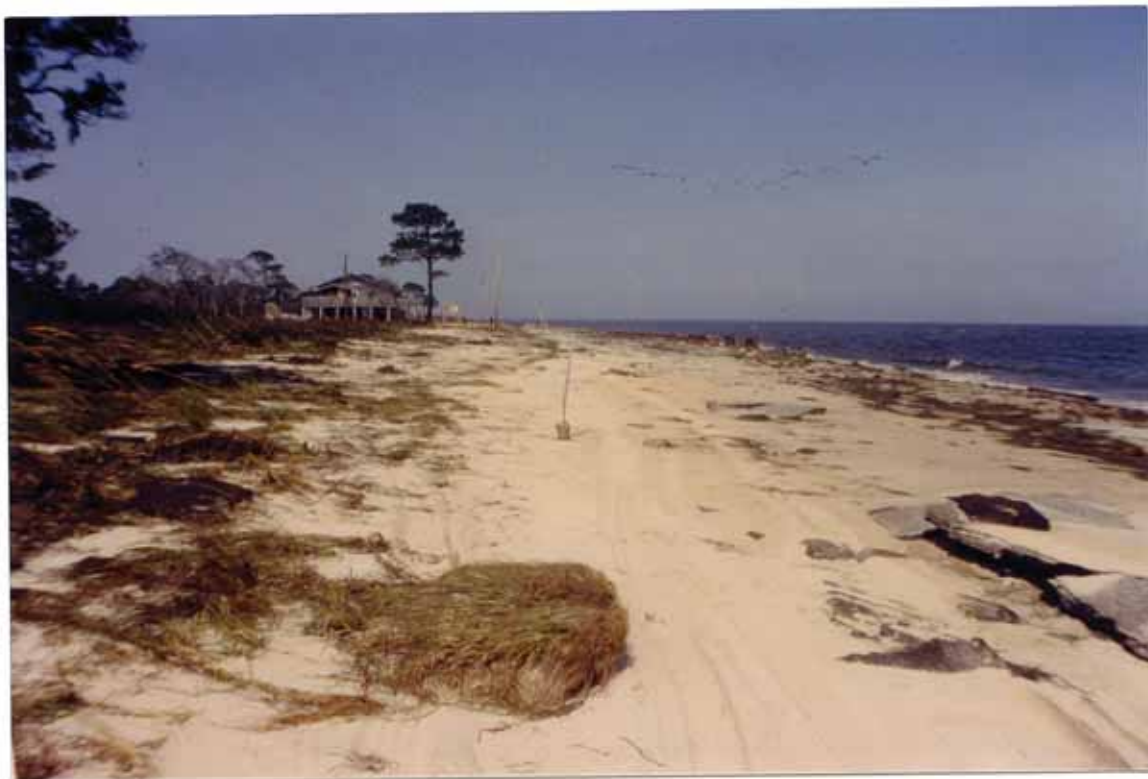
FIGURE 47. Lighthouse Point road destroyed on September 1

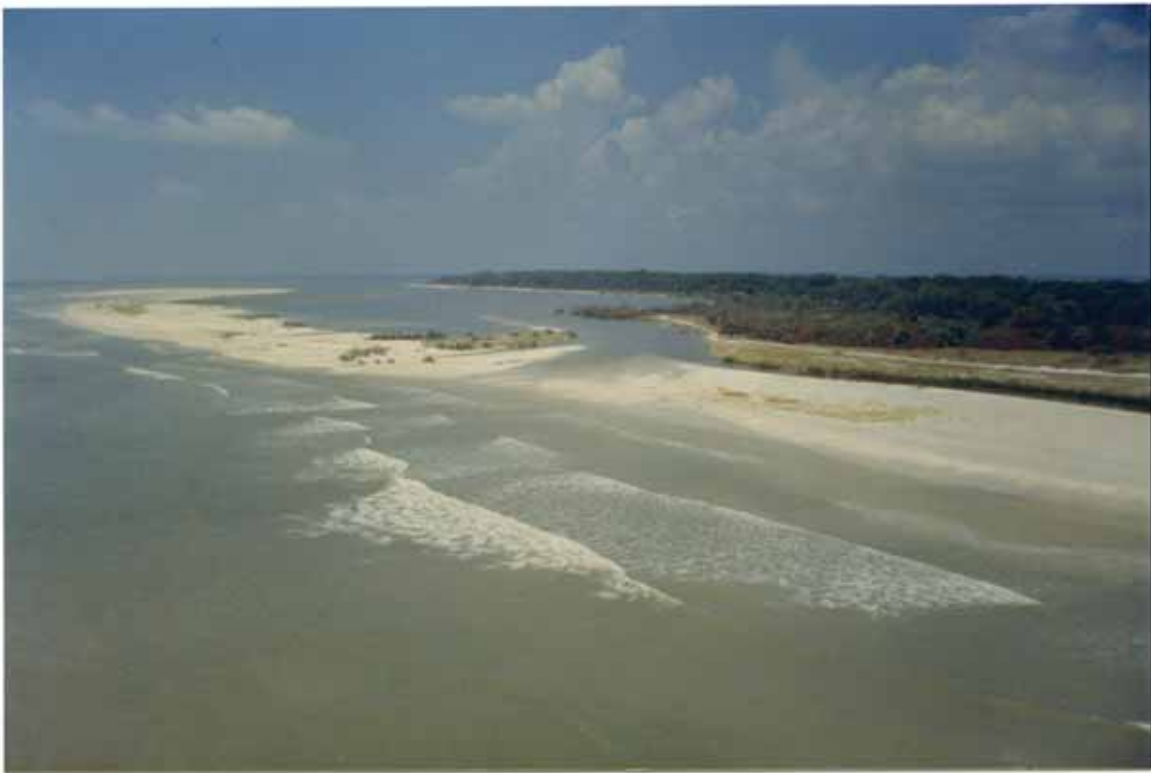
FIGURE 48. Inlet breach on Honeymoon Island

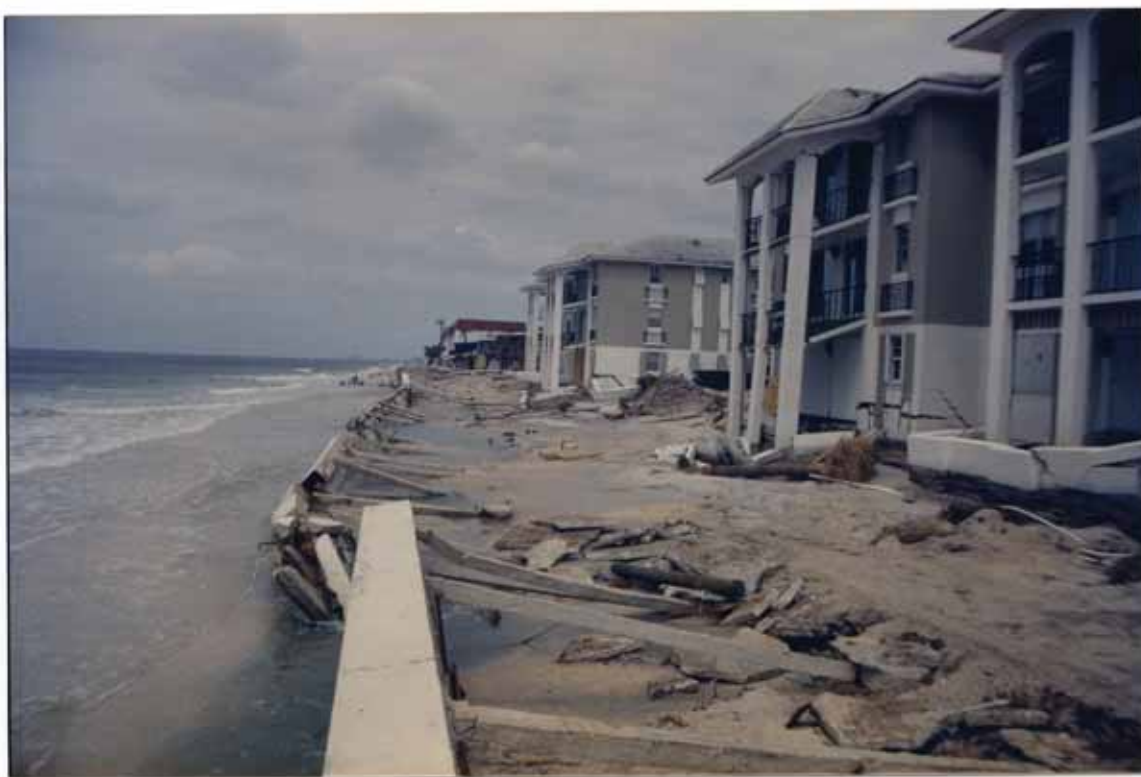
FIGURE 58. Tortugas Condominium bulkhead destroyed and buildings damaged

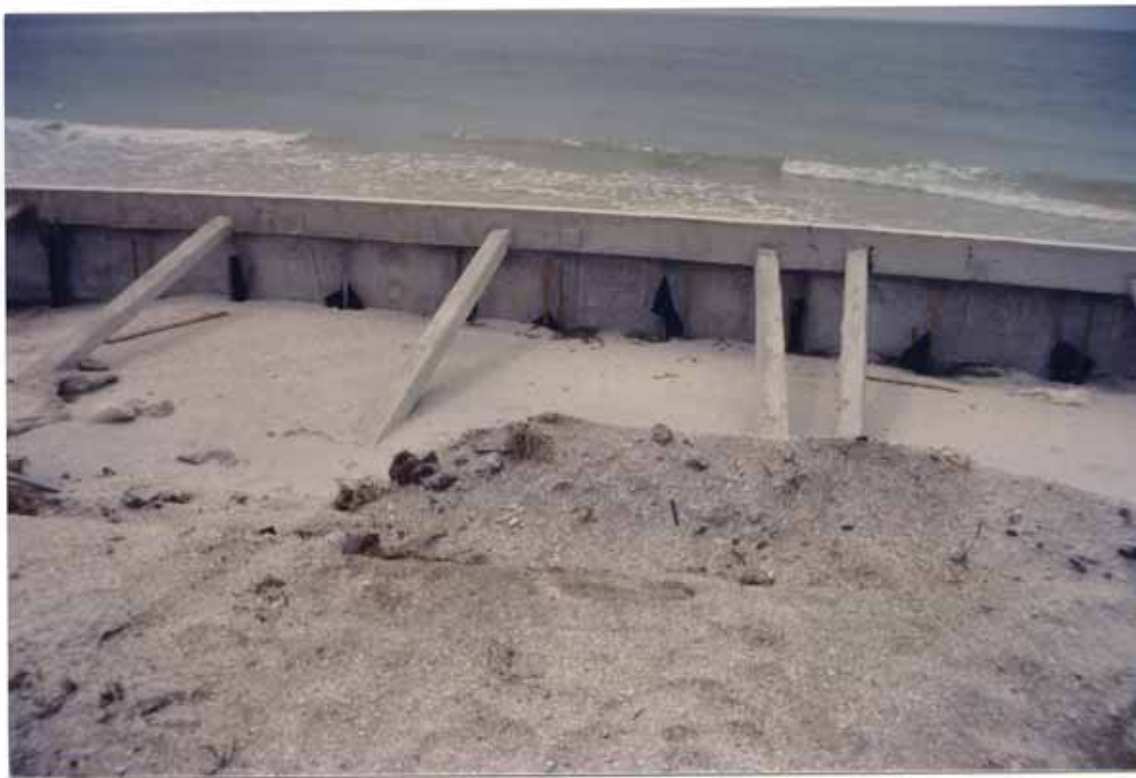
FIGURE 59. Inadequate fill containment with strips of filter fabric

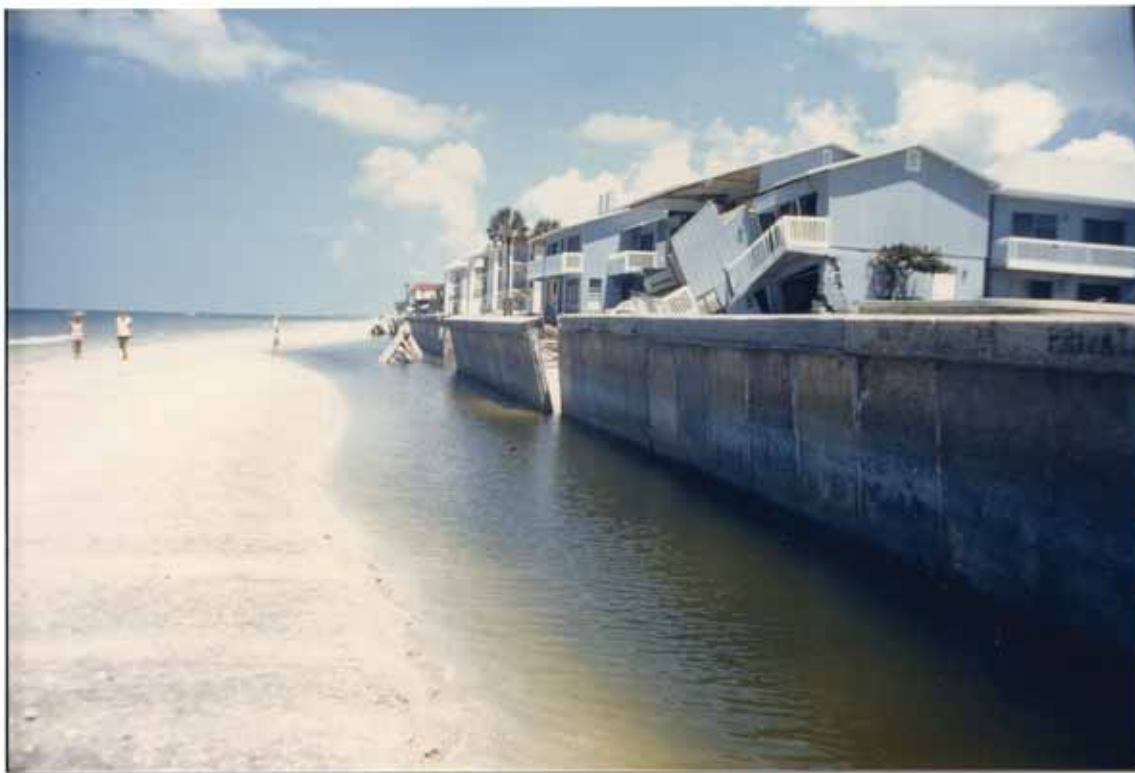
FIGURE 60. Bulkhead damage, La Casa de los Caracoles, Belleair Beach

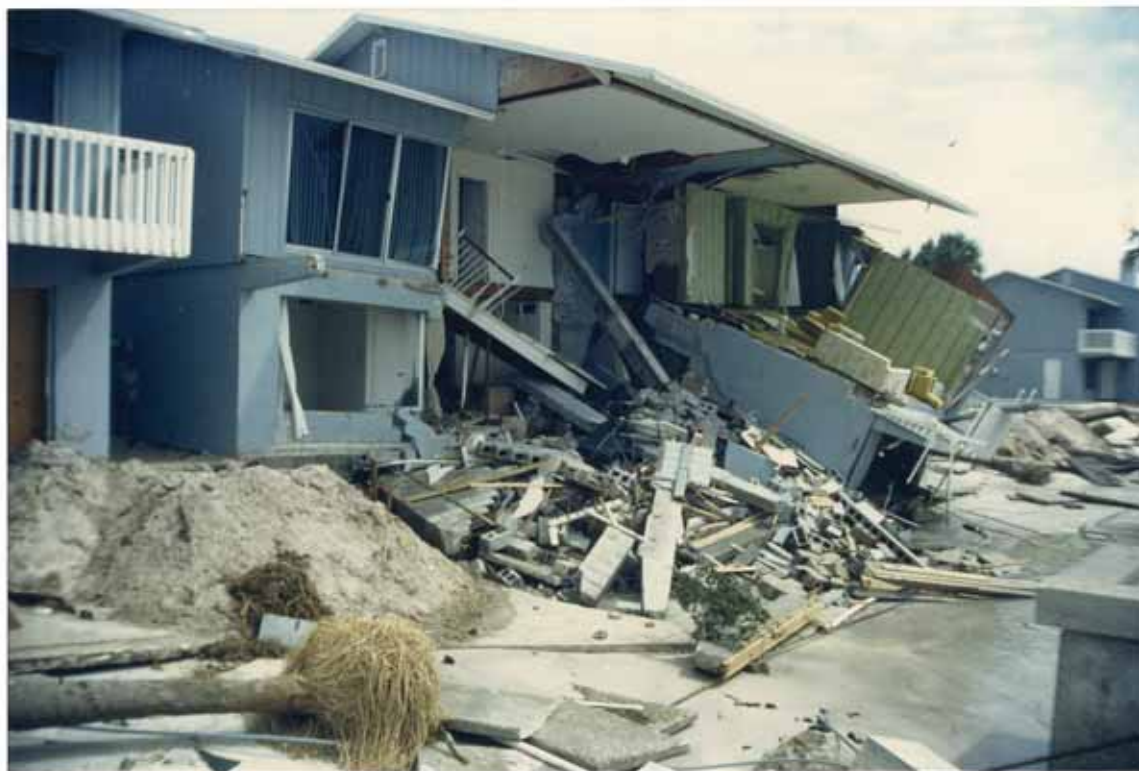
FIGURE 61. Two-unit building destroyed by Elena's waves

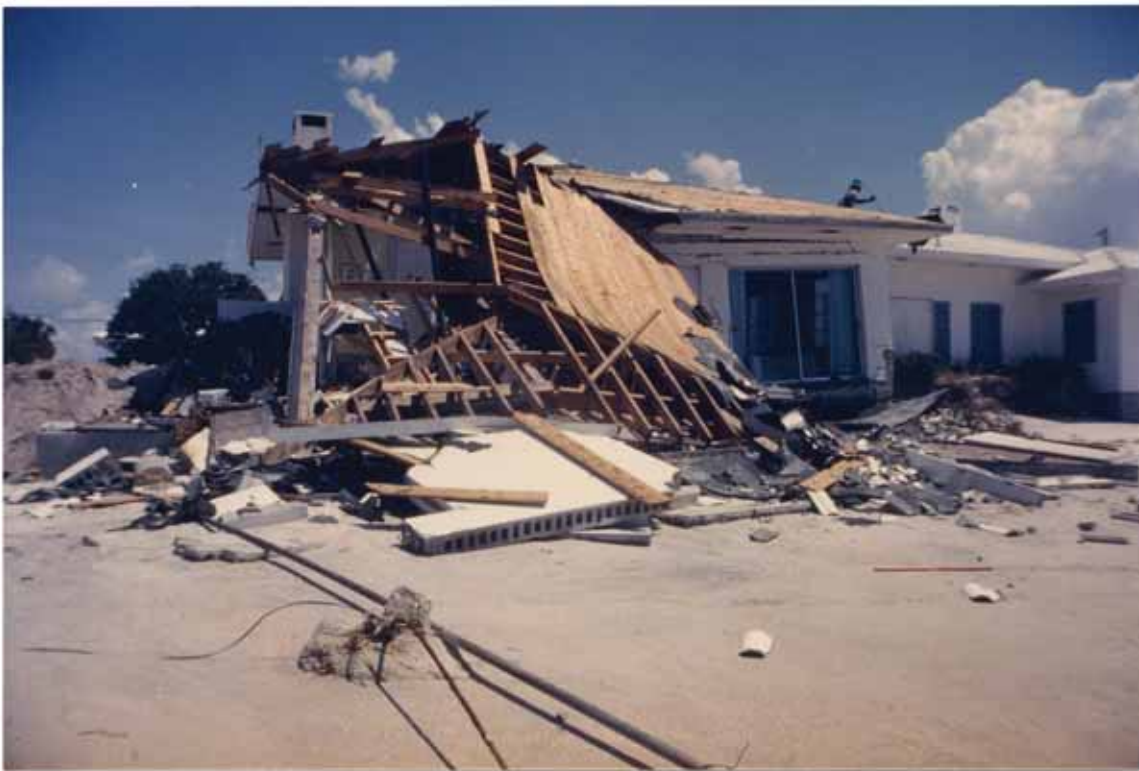
FIGURE 63. Belleair Shore dwelling damaged

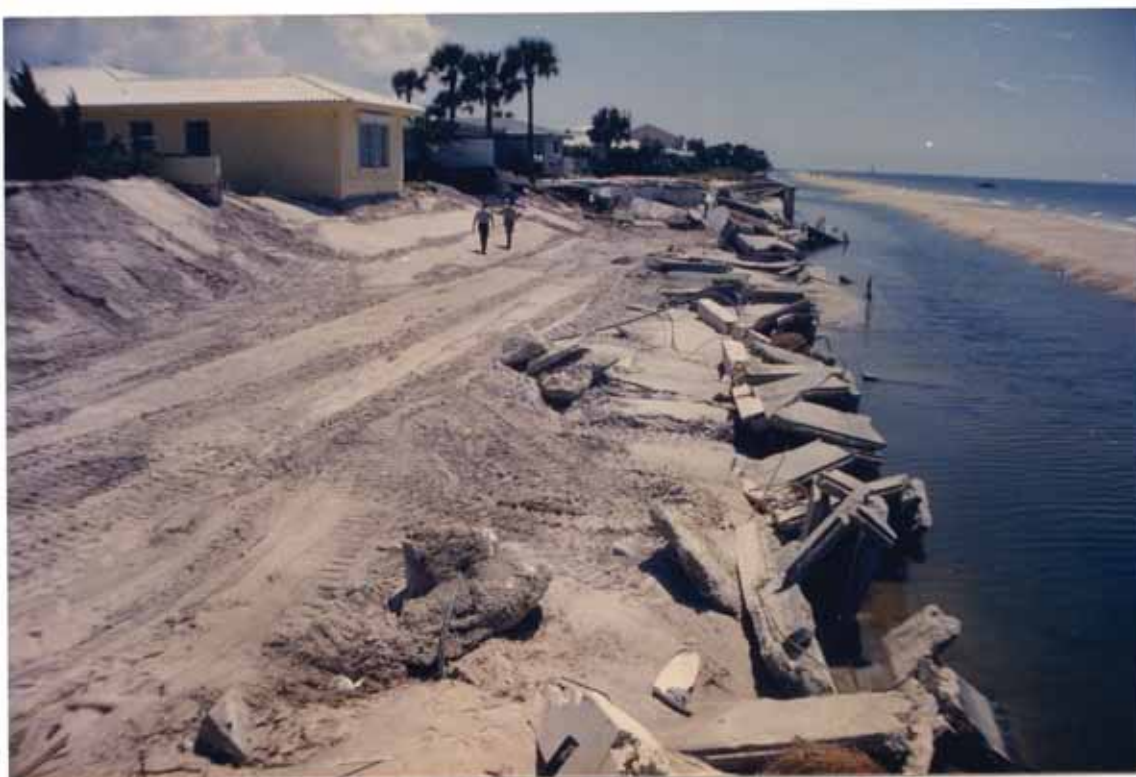
FIGURE 64. Concrete bulkhead destroyed, 650 feet

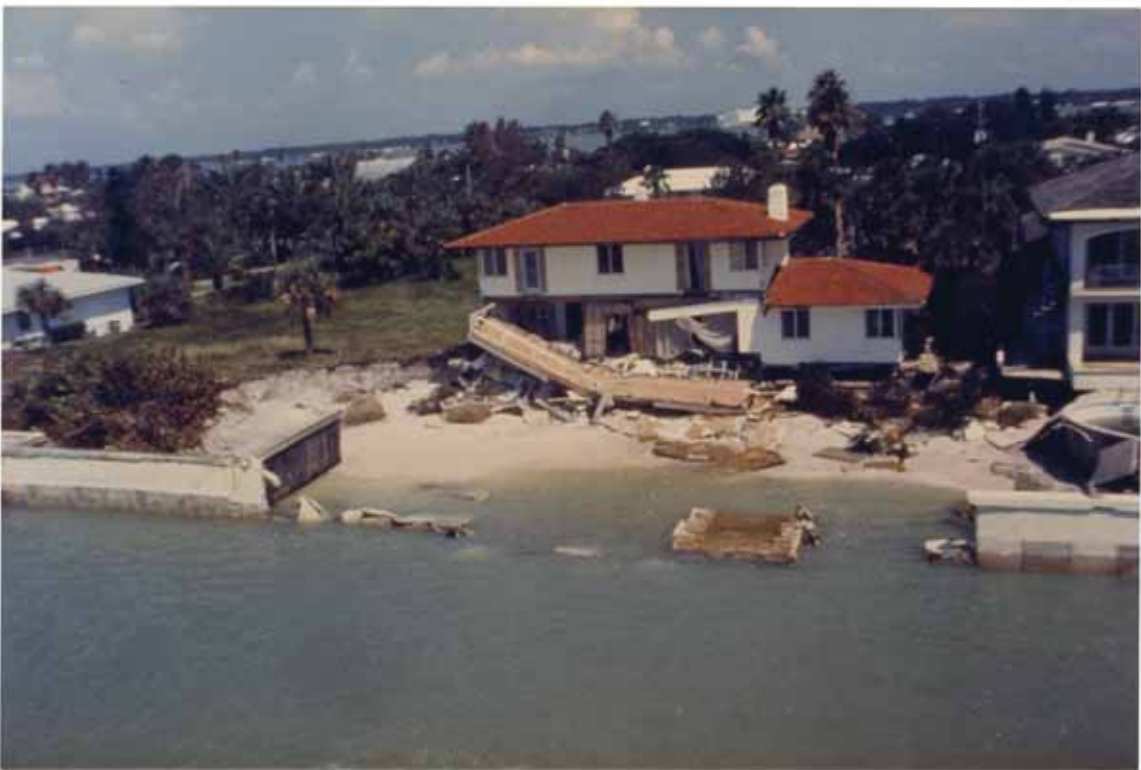
North of 18th Street a 150 foot segment of wall was completely destroyed and two residences were damaged (Figure 62). Between 18th Street and 17th Street the seaward end of a large residence was destroyed (Figure 63). South of 18th Street, with the exception of a damaged 100 foot segment still standing, a 650 foot stretch of wall was destroyed (Figure 64). With the lowering of the profile seaward of the walls and the loss of material from behind the walls, the structures could not withstand the direct wave impact loads. South of 16th Street a swimming pool structure also was destroyed by direct wave impact loads (Figure 65). A 160 foot segment of wall was completely destroyed south of 15th Street and another 160 foot segment was destroyed south of the 12th Street beach access (Figure 66). An 80 foot wall and seaward portion of a house was substantially destroyed adjacent to the Belleair Causeway and a 140 foot segment of wall was destroyed/damaged, a pool damaged, and the seaward portion of a house destroyed between the Belleair Causeway and 9th Street (Figure 67).

FIGURE 67. Wall destroyed and dwelling damaged
