# THE IMPACT OF HURRICANE ELENA AND TROPICAL STORM JUAN ON COASTAL CONSTRUCTION IN FLORIDA

Beaches and Shores Post-Storm Report No. 85-3

March, 1986

Bureau of Coastal Engineering and Regulation  
Division of Beaches and Shores  
FLORIDA DEPARTMENT OF NATURAL RESOURCES

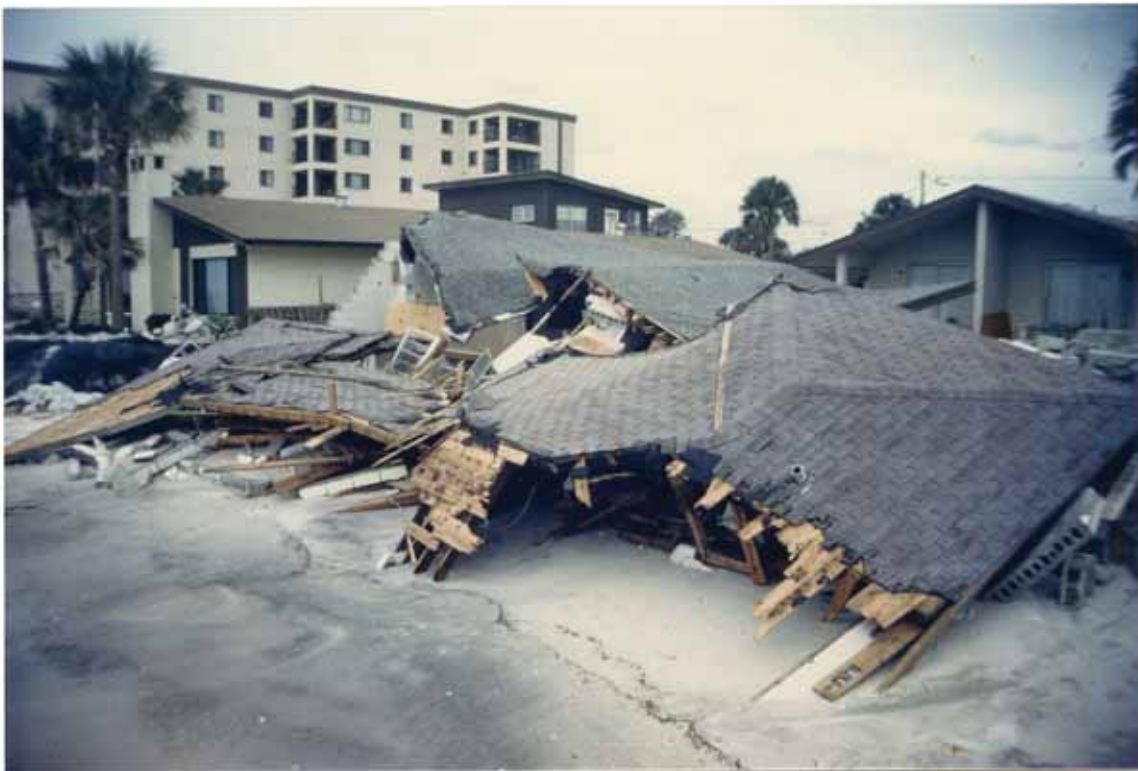
FIGURE 71. Dwelling destroyed by Juan

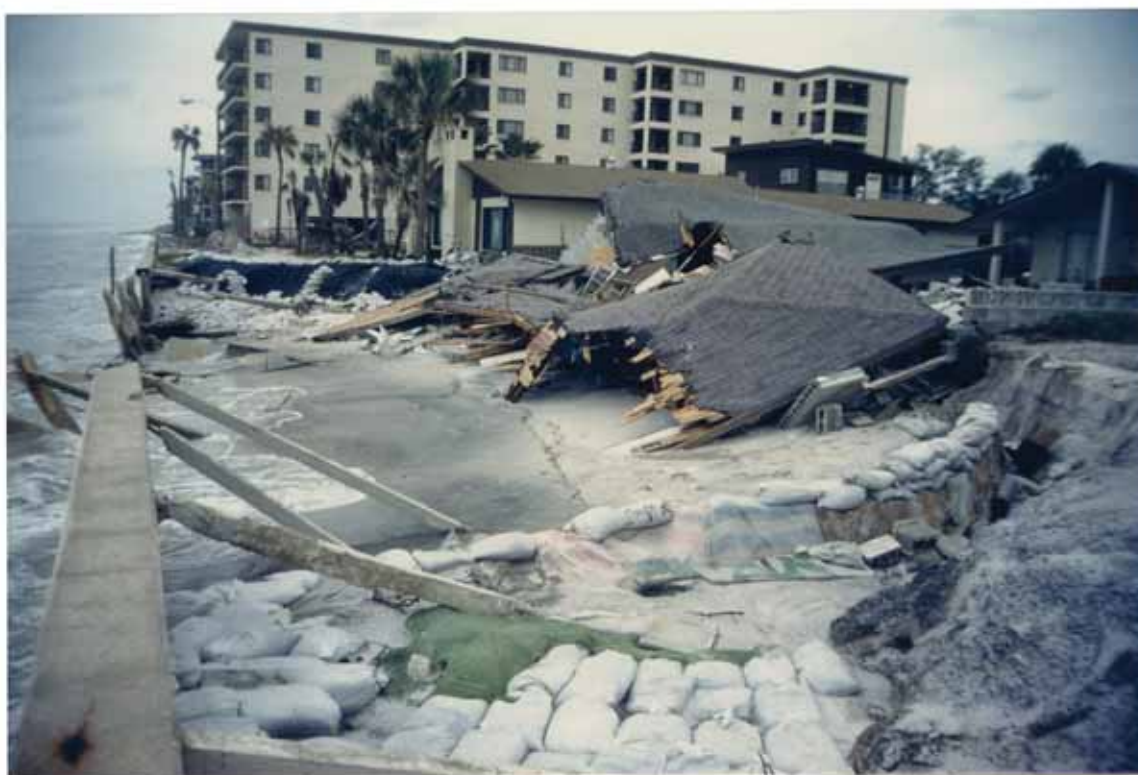
FIGURE 73. Same dwelling destroyed by Juan

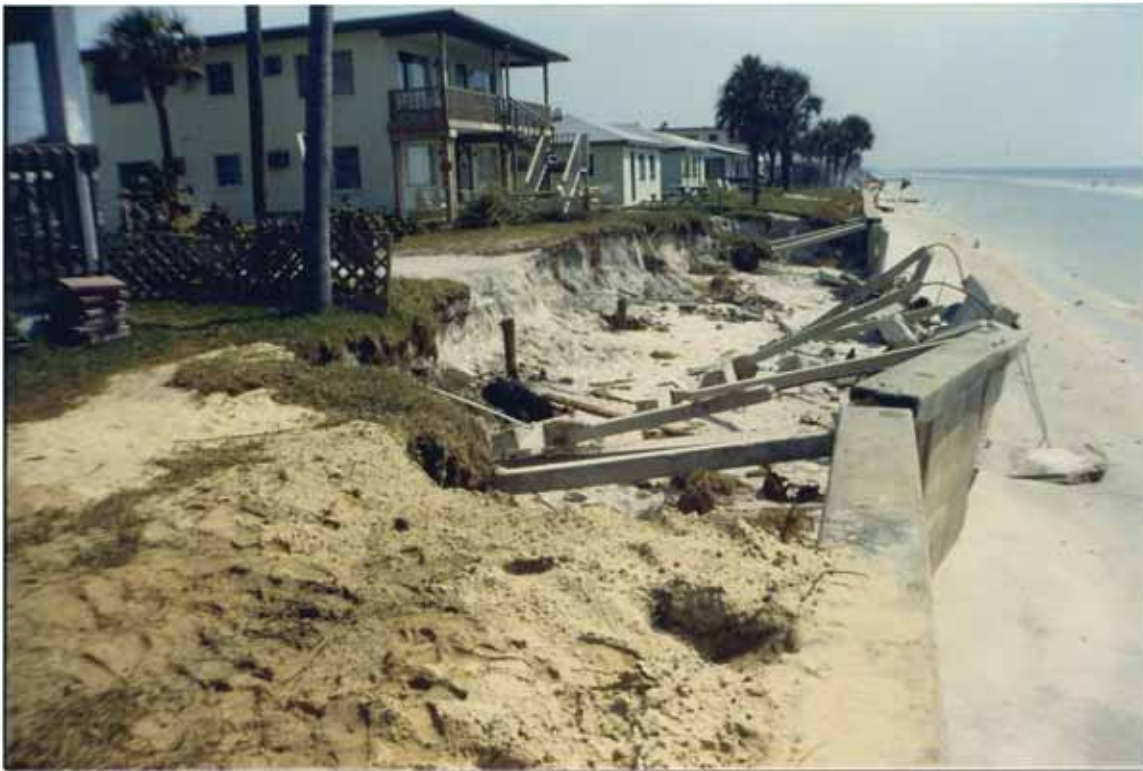
FIGURE 74. Elena damaged 23rd Avenue

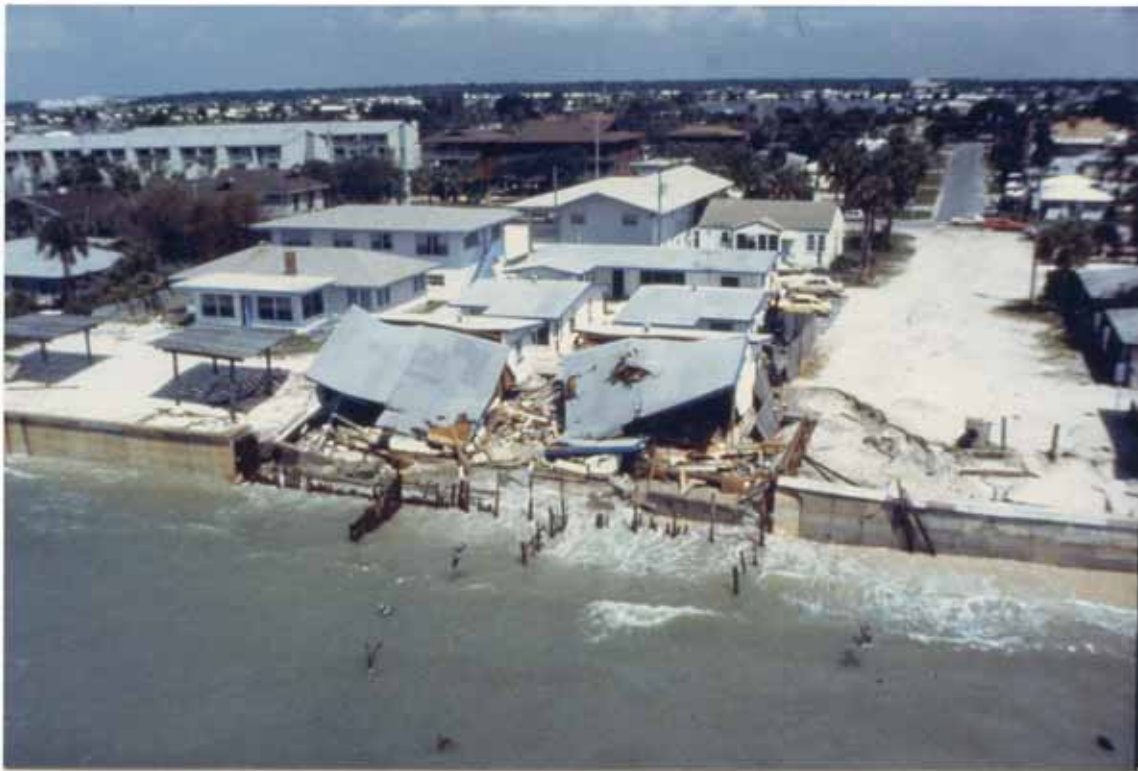
FIGURE 80. Wall and dwellings destroyed by Elena

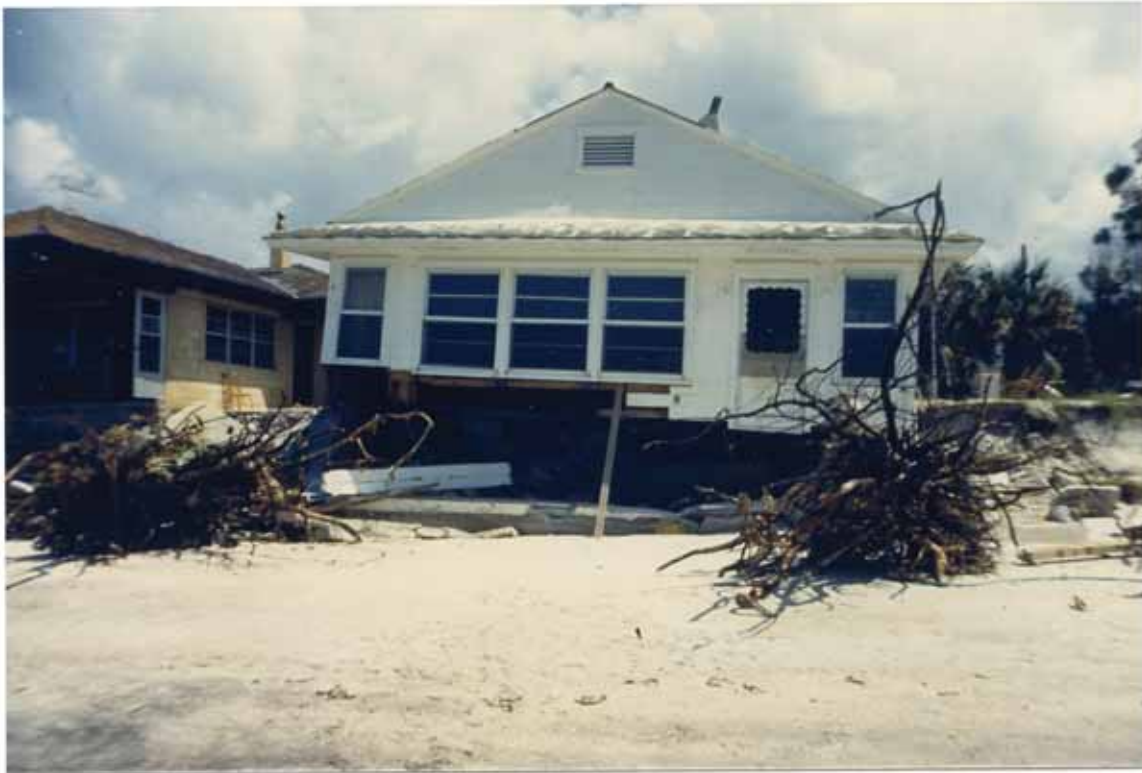
FIGURE 86. Dwelling damaged by Elena

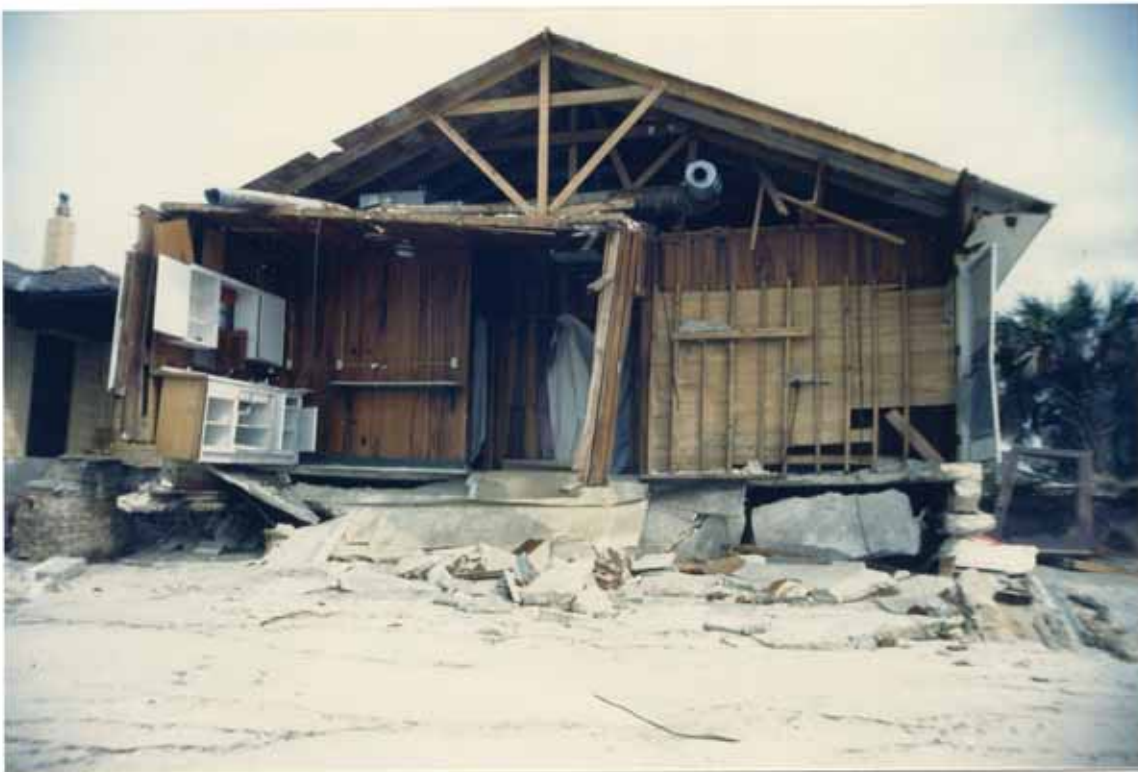
FIGURE 87. Same dwelling damaged by Juan

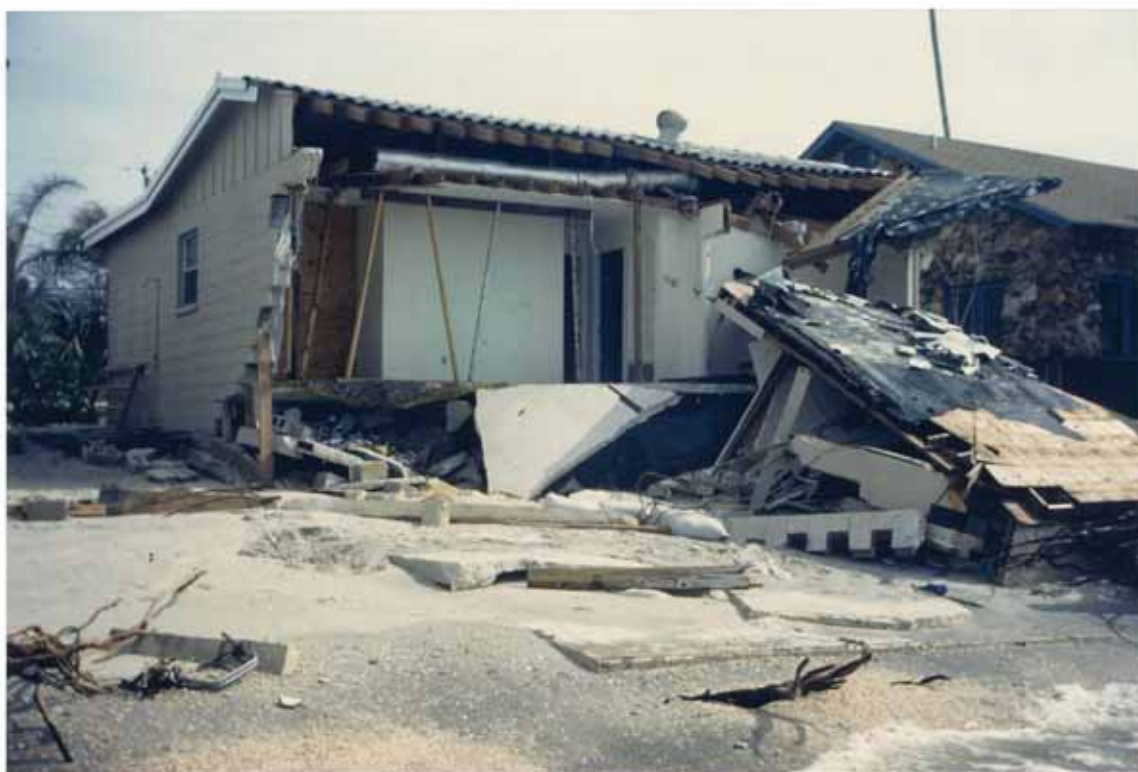
FIGURE 93. Dwelling damage by Juan

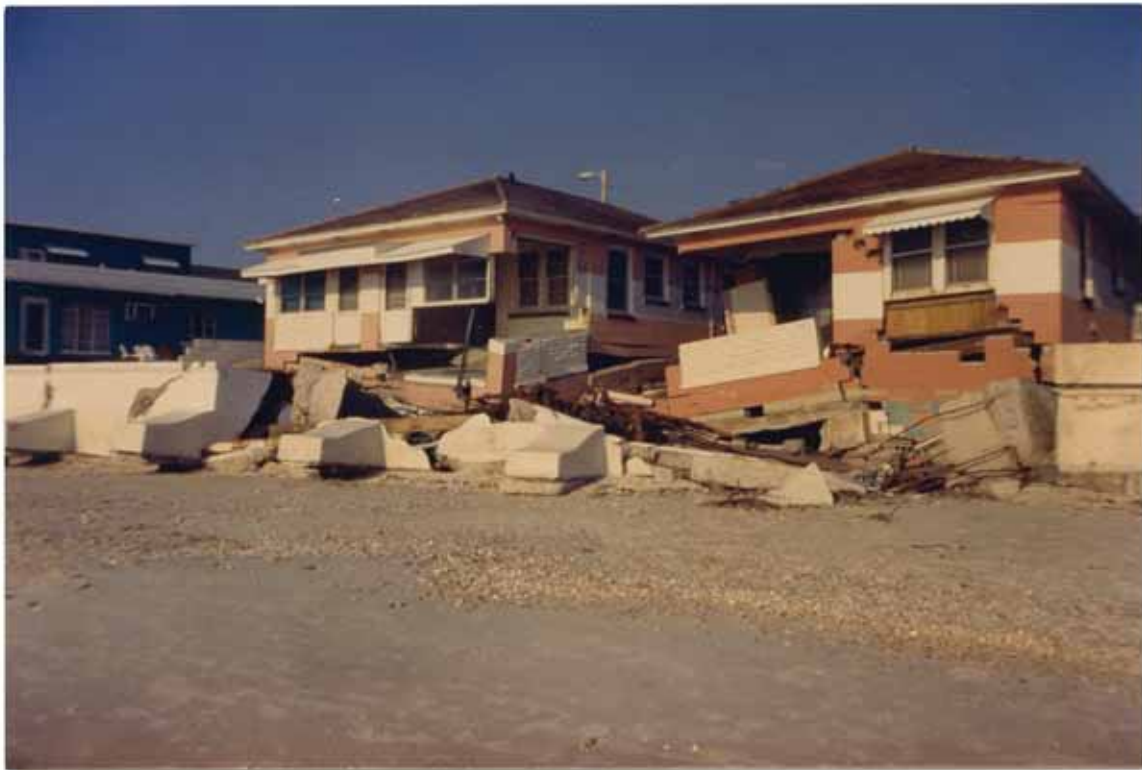
FIGURE 107. Wall destroyed and dwellings damaged

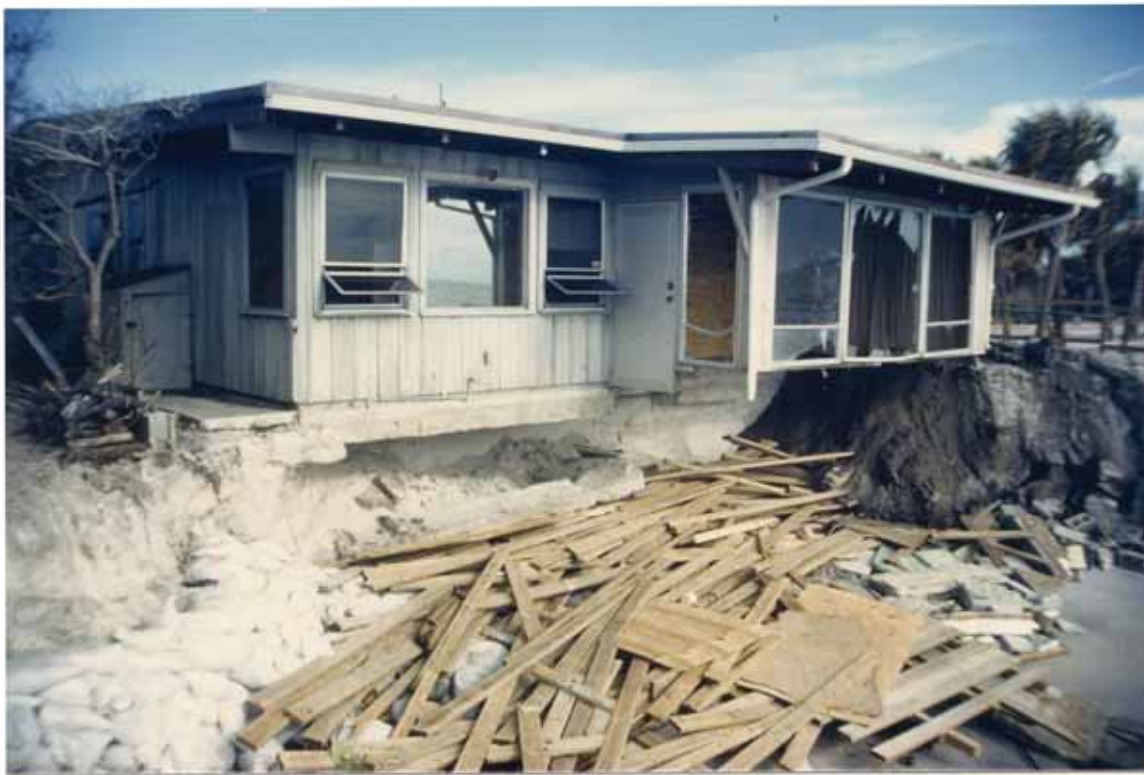
FIGURE 117. Redington Shores dwelling damaged by Juan

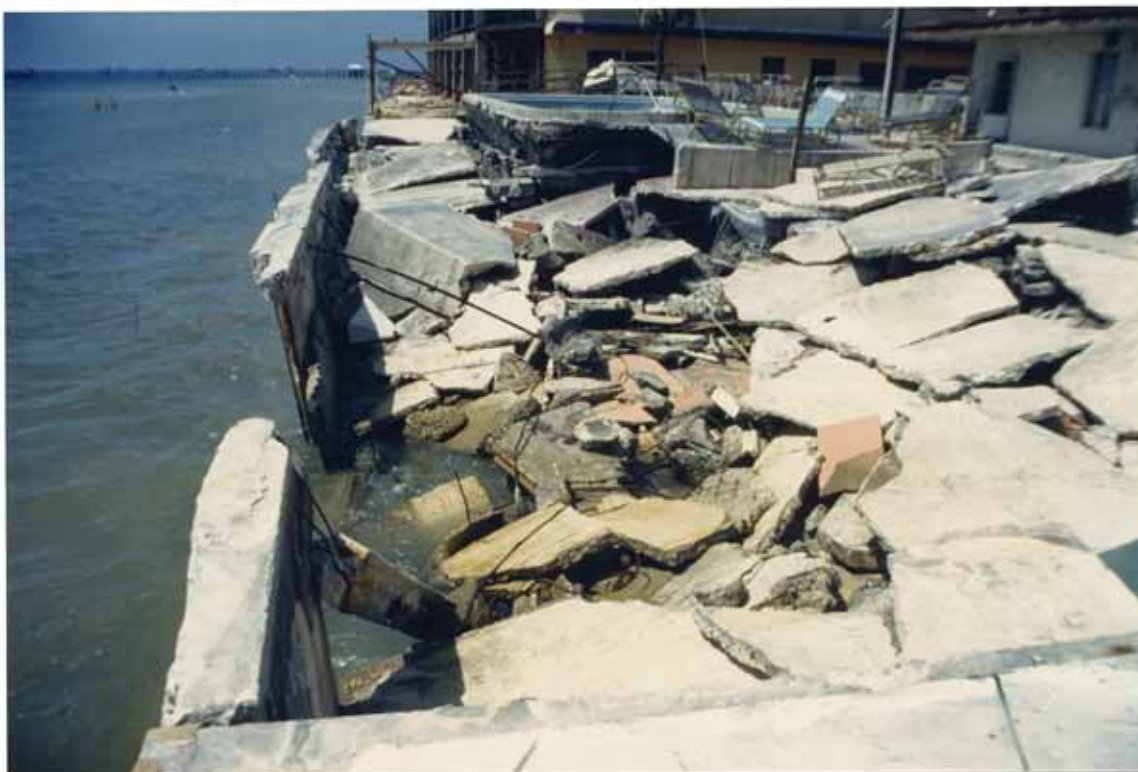
FIGURE 119. Flagship property damage after Elena

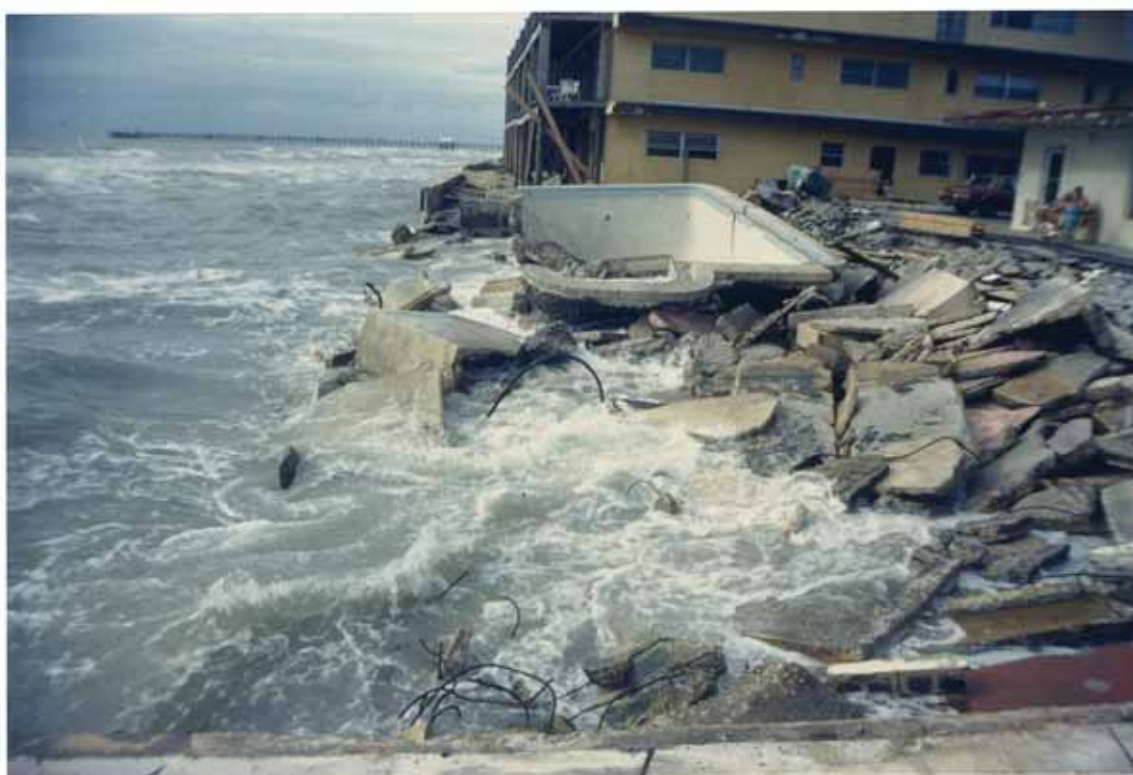
FIGURE 120. Additional damage and pool destroyed by Juan

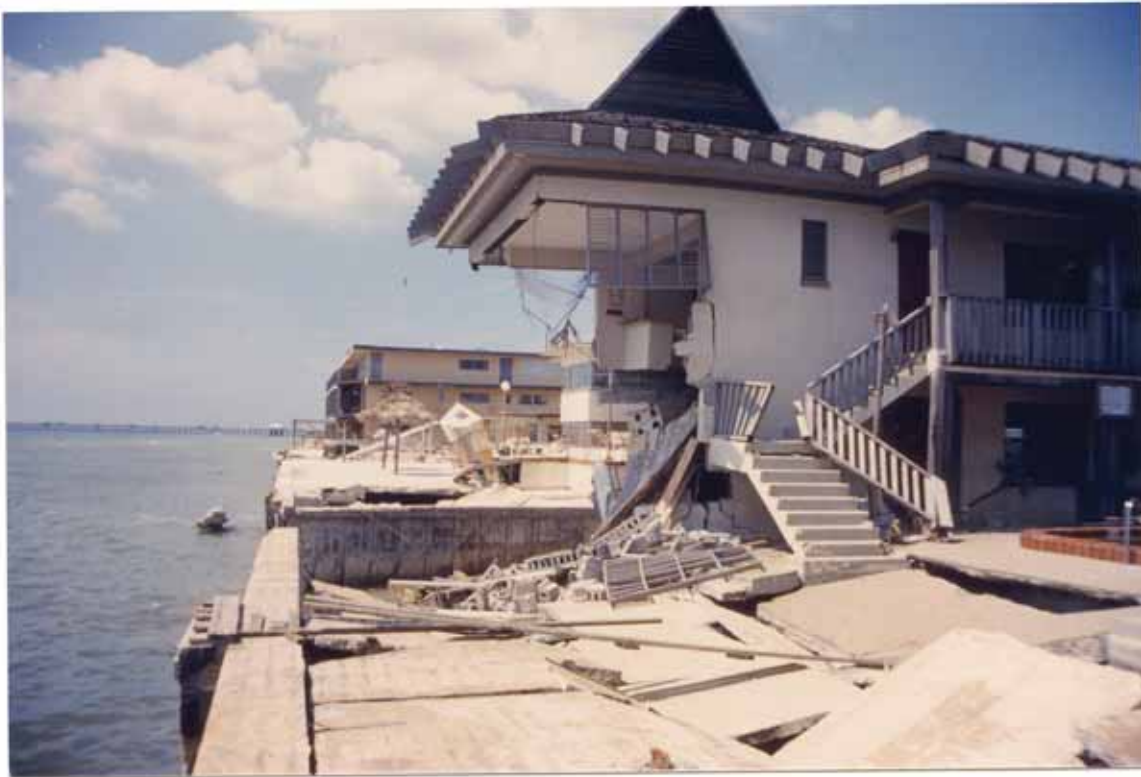
FIGURE 121. The Islander after Elena's damage

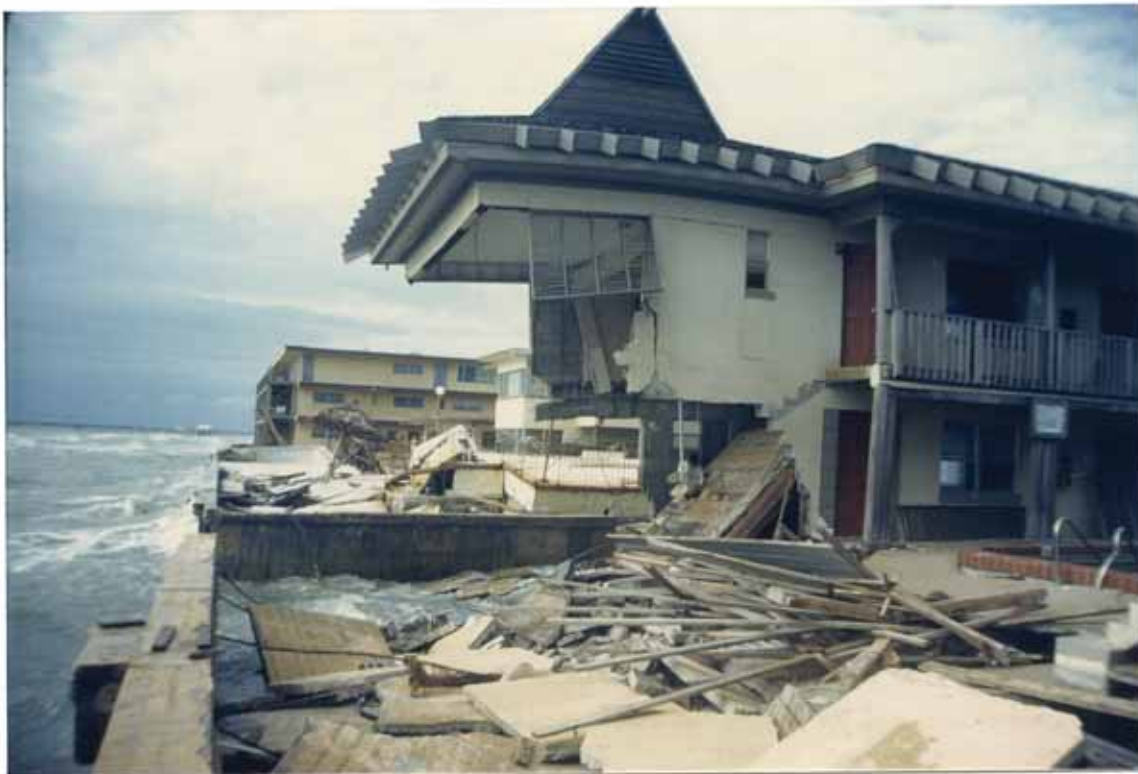
FIGURE 122. The Islander after Juan's additional damage

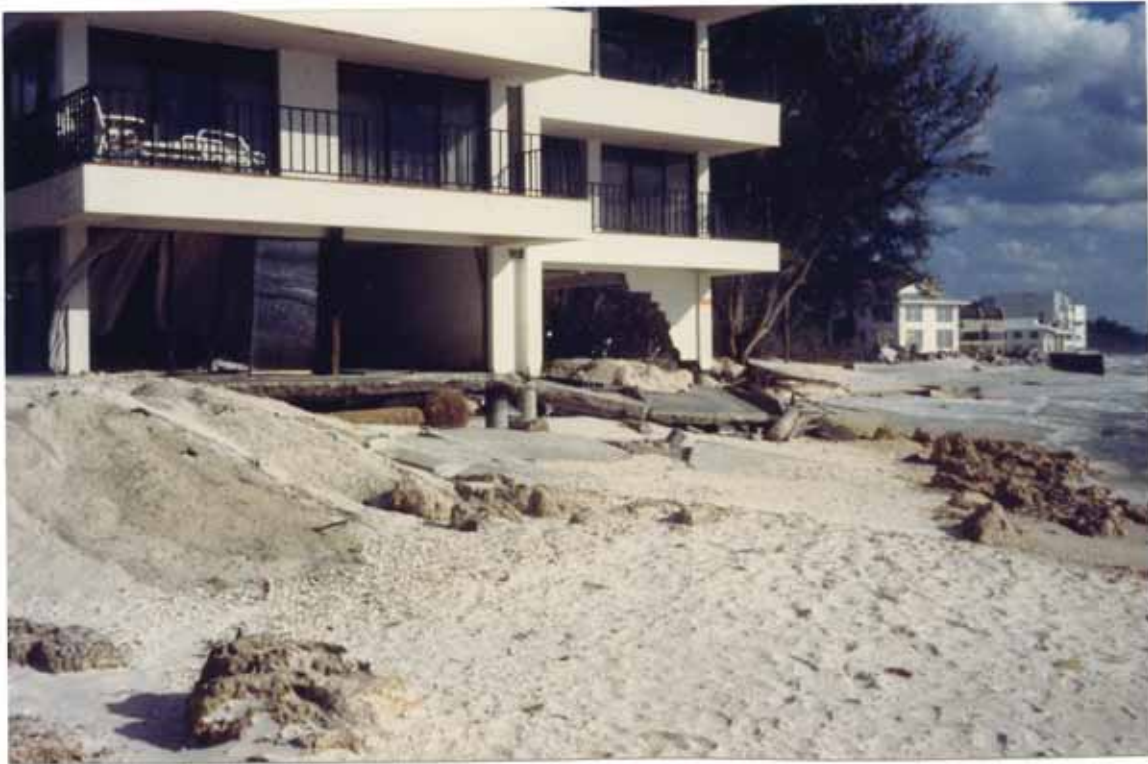
FIGURE 125. Waters Edge Condominium damaged by Elena (S. West)

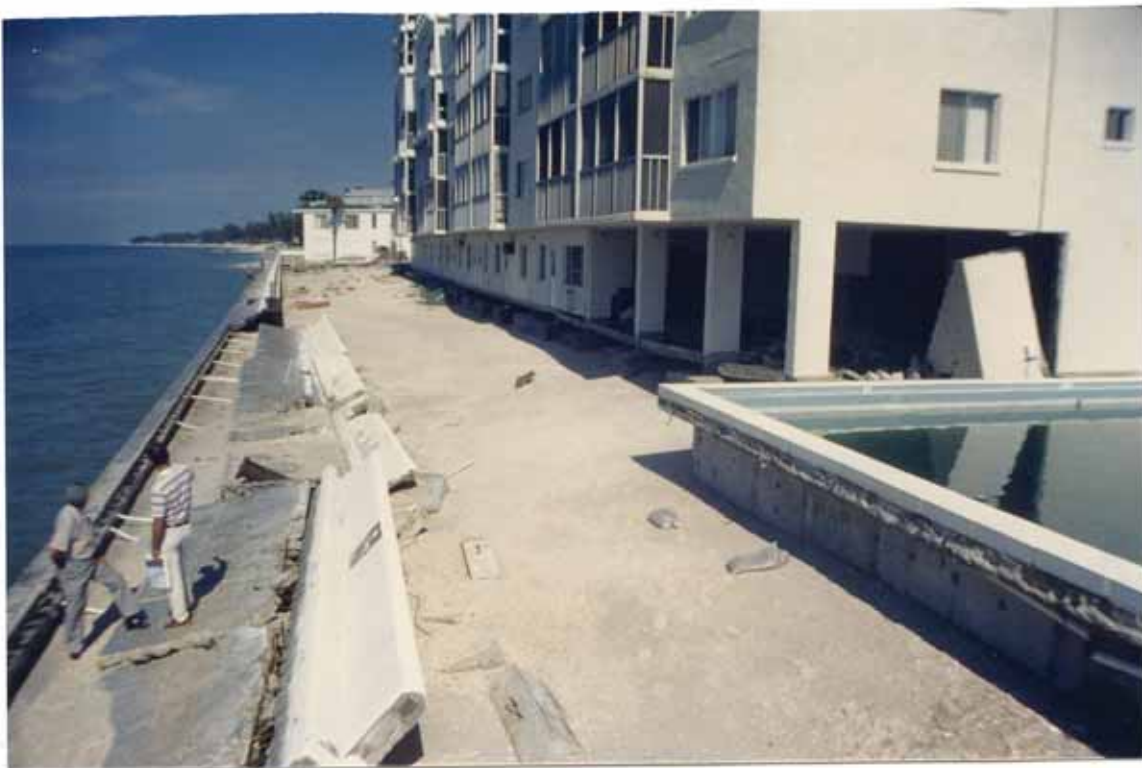
FIGURE 126. Juan destroyed sloping wall at Martinique Condominium

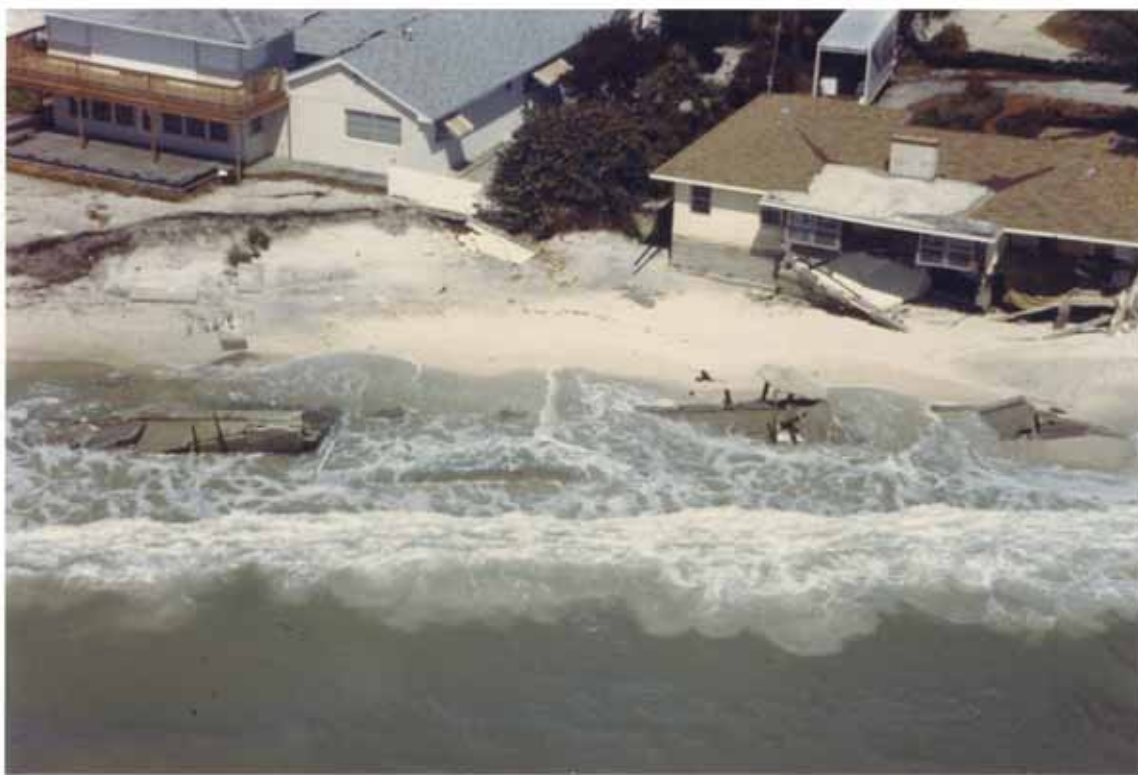
FIGURE 128. Dwelling damaged by Elena

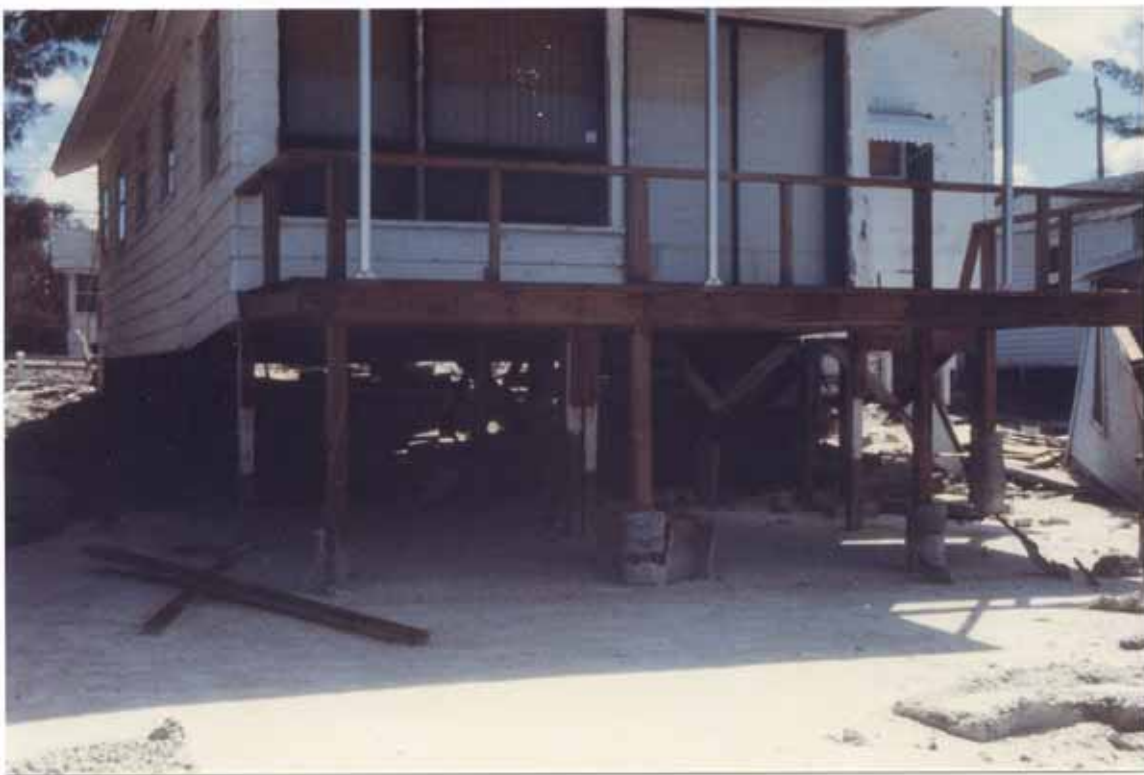
FIGURE 137. Bradenton Beach dwelling damaged by Elena (S. West)

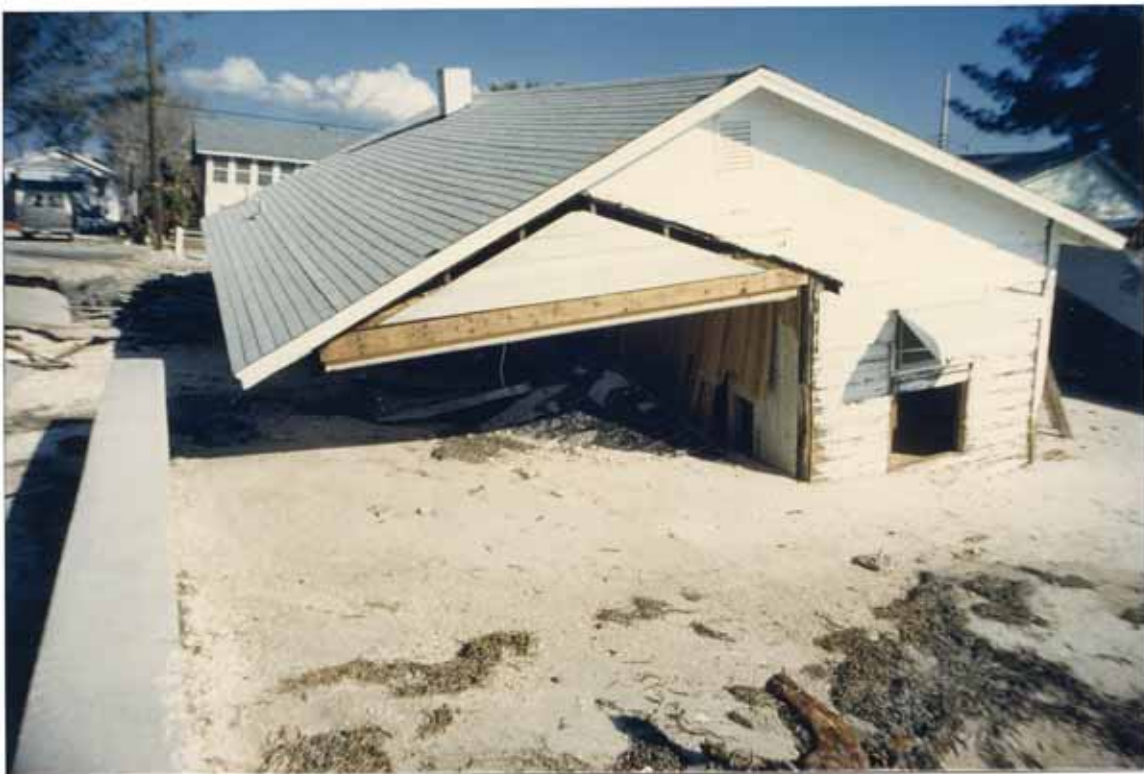
FIGURE 138. Same dwelling destroyed by Juan

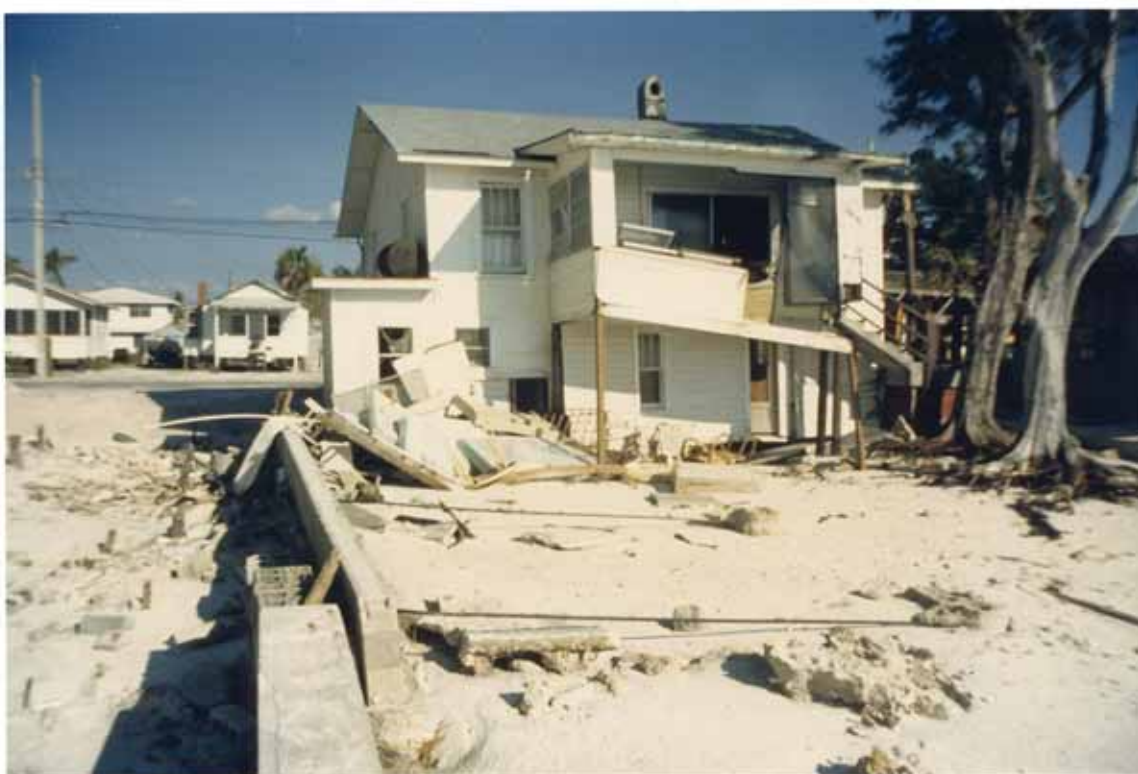
FIGURE 140. Dwelling damaged and settled

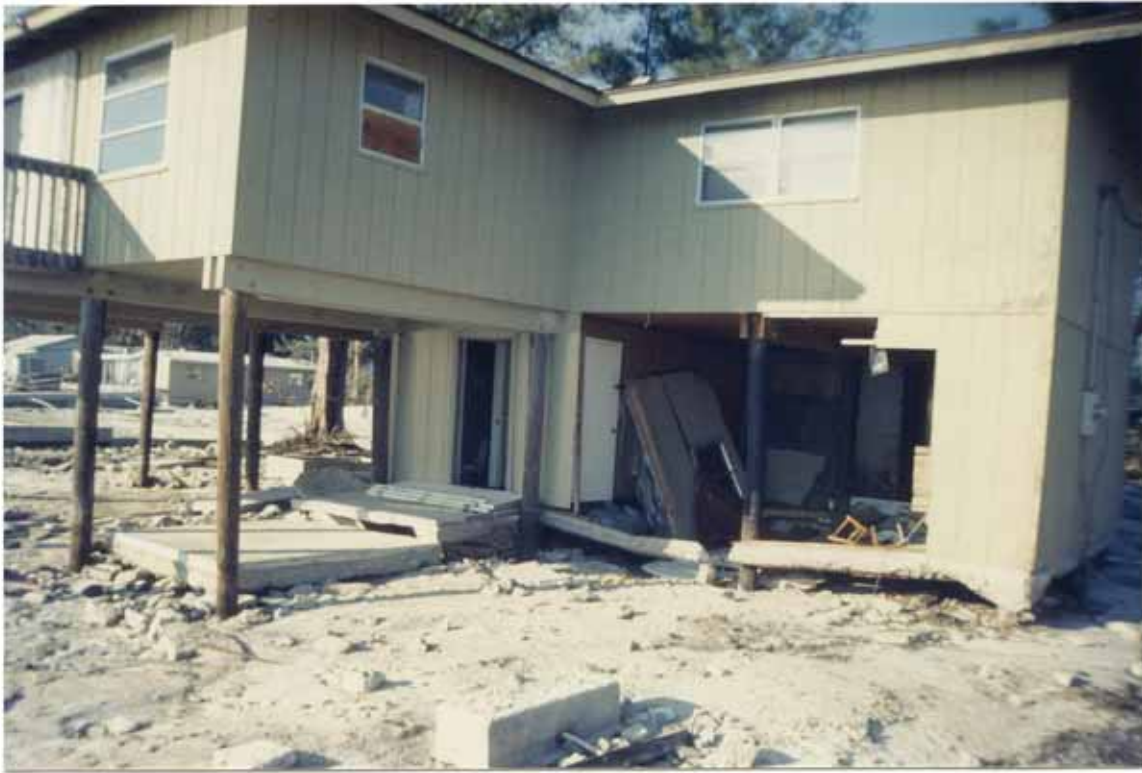
FIGURE 141. Subfloor damage to Longboat Key dwelling

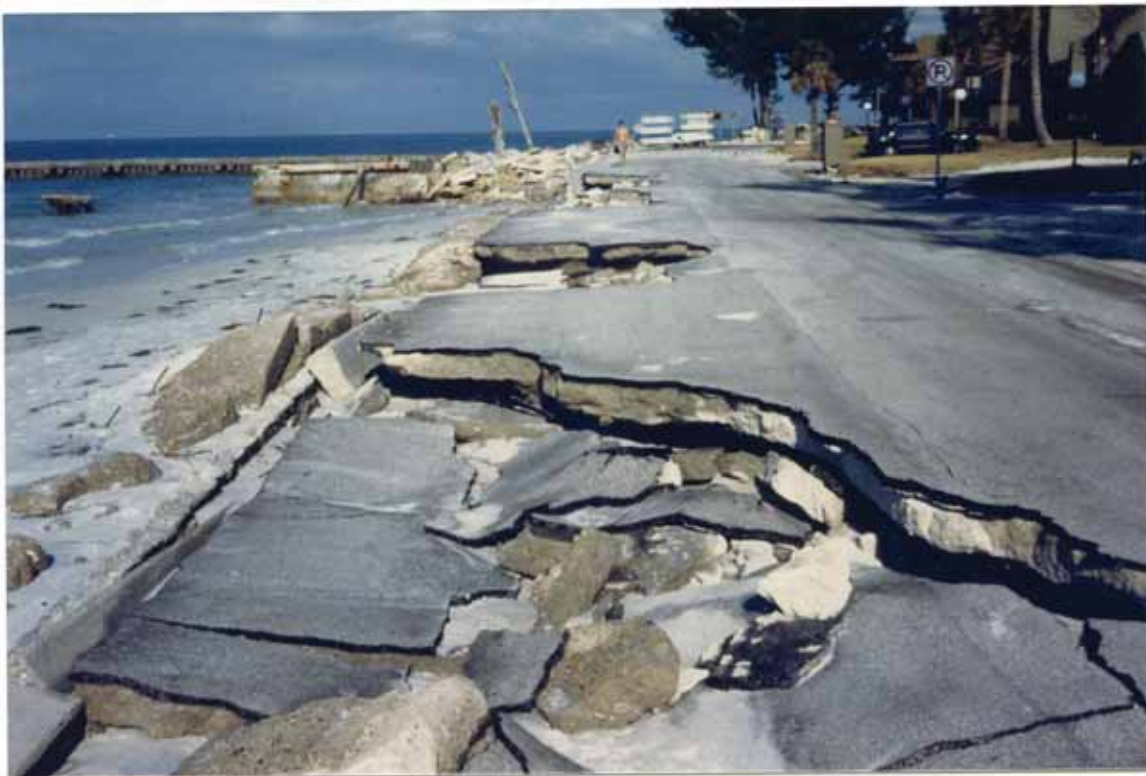
FIGURE 151. Beach Road damaged on Siesta Key (S. West)

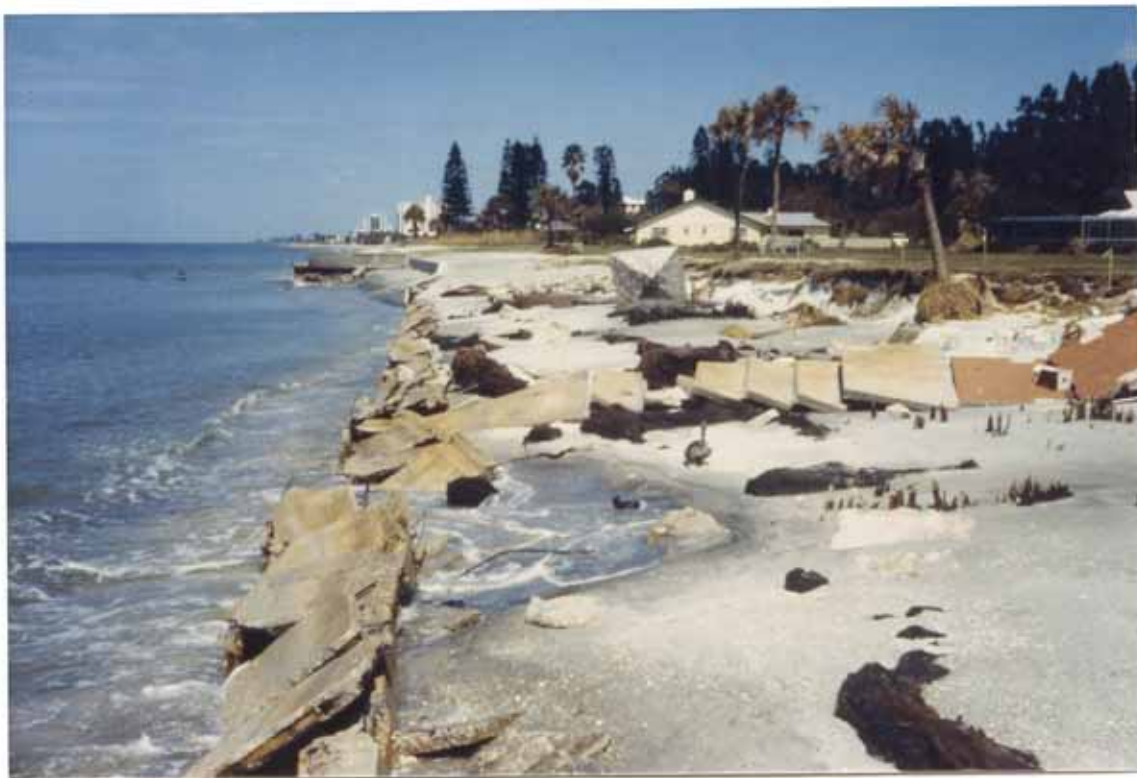
FIGURE 154. Elena destroyed Venice bulkhead (S. West)
