January 28, 2011

**Re: Phase I Hot Spot Issue Response Plan – Phase II
Landfill Gas Header Damage and Repairs
Sarasota County Central County Solid Waste Disposal Facility
FDEP Permit No.: 130542-007-SO/01**

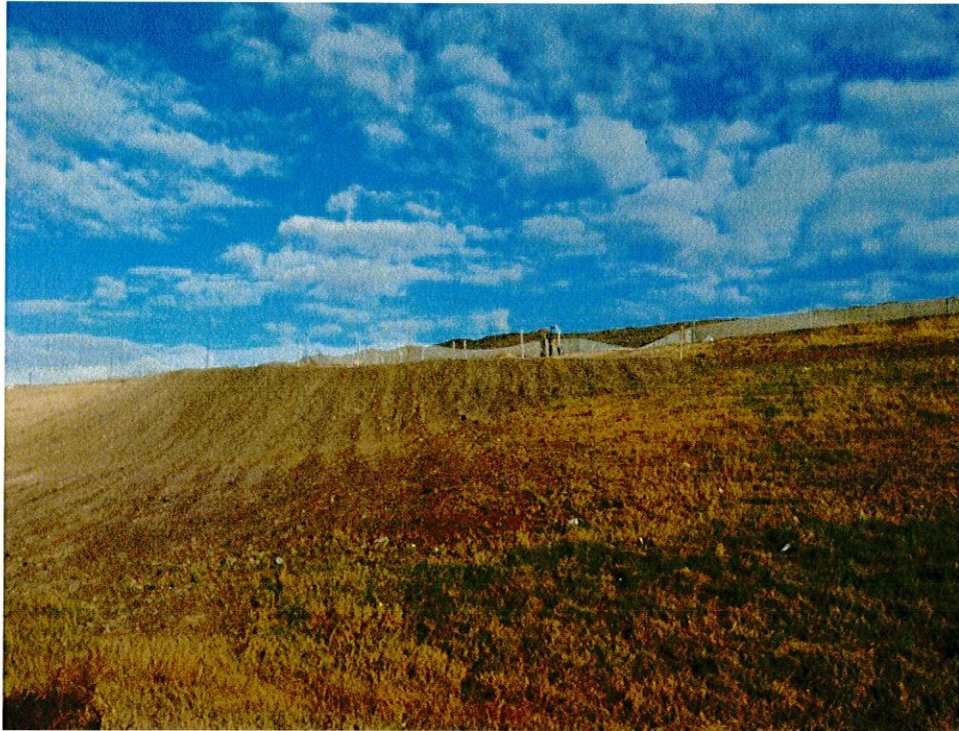
January 24, 2011 – Hot spot area prepared with soil berm.

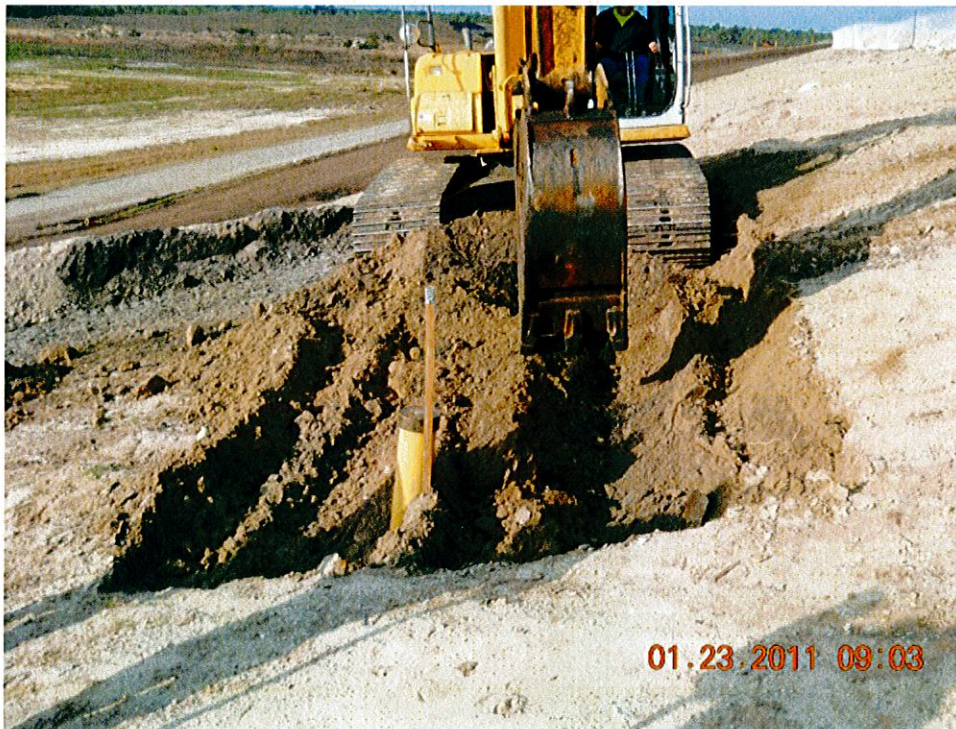
January 24, 2011 – Begin excavation of header pipe at marker pipe.

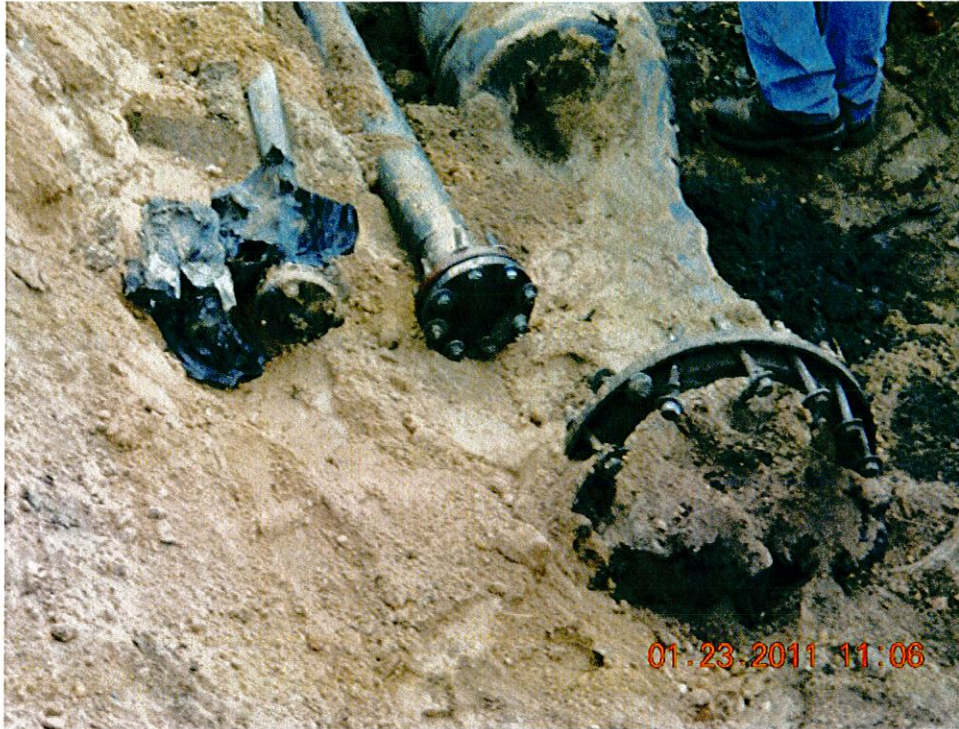
SCS began excavation at the stand pipe which marked the end of the LFGCCS header on the south slope of Phase I. As shown in the photos provided in Attachment A, upon uncovering the 18-inch LFGCCS header line, it was found that the end of the line from the blind flange to about 6 feet down the pipe appeared to have been melted and burned. The 2-inch air line had some burn damage to the blind flange, while the 4-inch force main line appeared to have minor damage. The area around the landfill gas piping appeared to have ash and other remains which indicated that material had been smoldering and/or burned in this area; however, there was no indication of the elevated temperature during the excavation. It appeared that the potential smoldering or hot spot was no longer present.

SCS continued excavation of the header pipe to approximately 25 feet from the end of the header. It was determined through visual inspection of the pipe exterior and interior using a camera that the pipe was not circular, which was most likely due to softening of the pipe when the temperatures were elevated, causing the pipe to become elliptical. It was determined from the exterior and interior inspections that approximately 40 feet from the end of the pipe (blind flange), the pipe returned to a circular shape. Therefore it was determined that this section of piping including the 18-inch header, 4-inch force main, and 2-inch air supply line, should be removed and replaced with new piping. In addition, the 4-inch gas lateral, 4-inch condensate force main, and 2-inch air supply line, from the main header lines to GW-26 should also be replaced due to their proximity to the hot spot.

January 24, 2011 – Uncovered end of header piping, note damage to 18" header end.

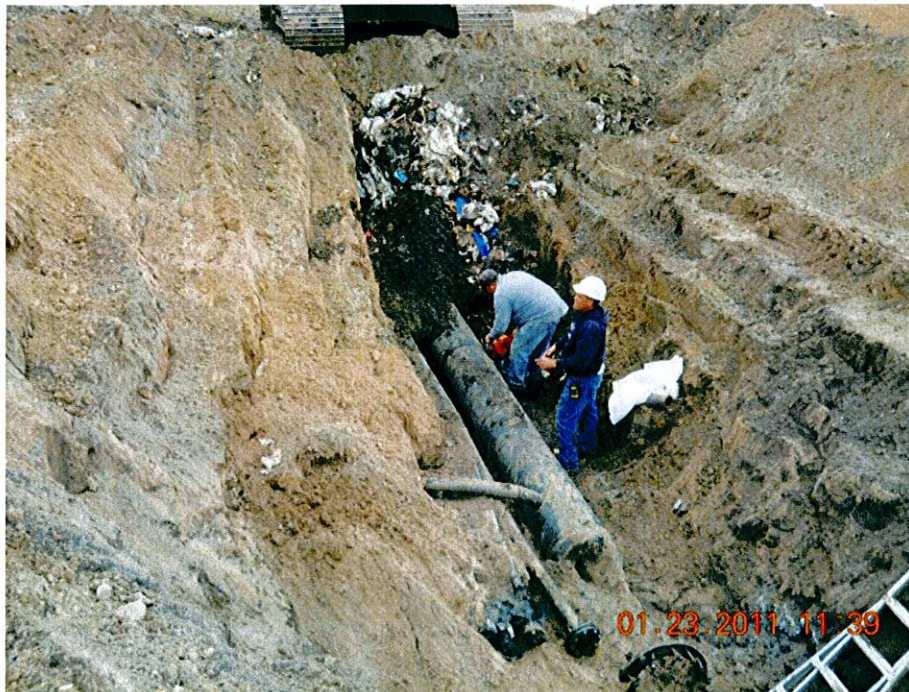
January 24, 2011 – Removing damaged LFGCCS piping.

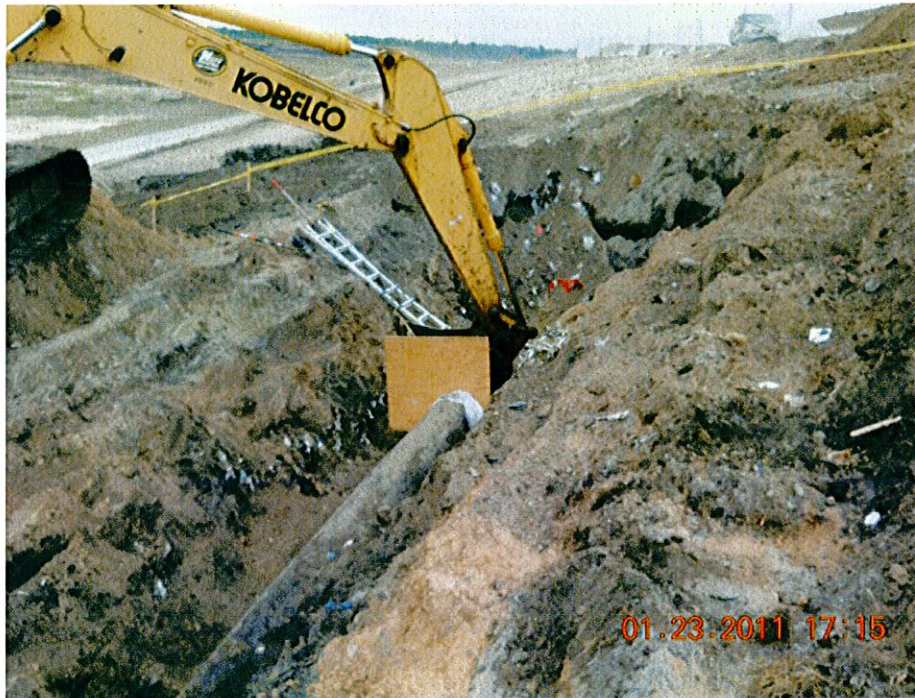
January 24, 2011 – Remove damaged header end, seal end of pipe and secure at end of day.

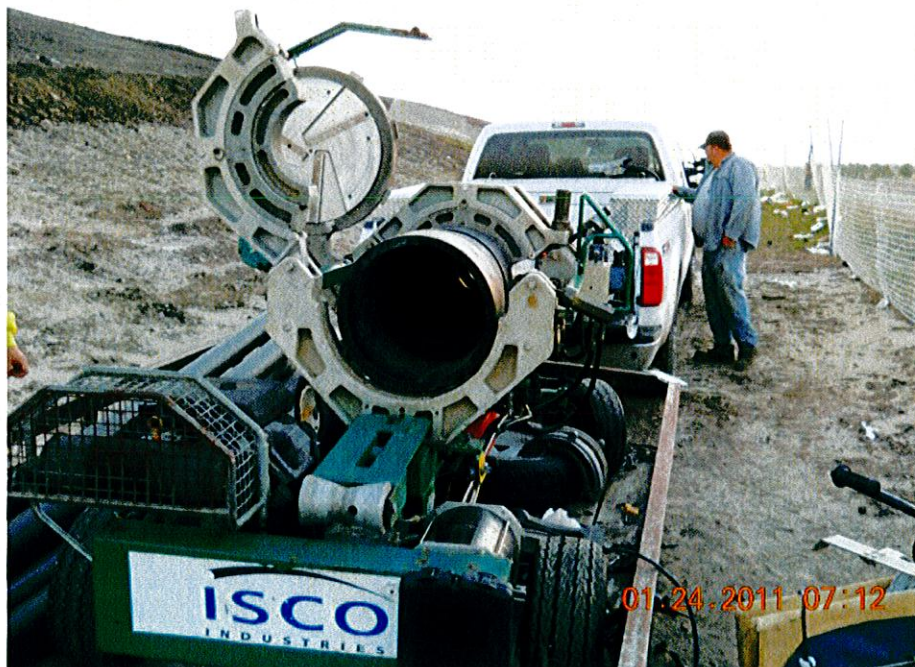
January 25, 2011 – Welding 18" Pipe and Fittings.

On January 25, 2011, SCS procured the required materials, pipe, fittings, and welding equipment to complete the pipe repairs. The 18-inch header pipe, tee and reducing fittings were welded onsite and placed in the trench to weld to the existing piping which was cut at

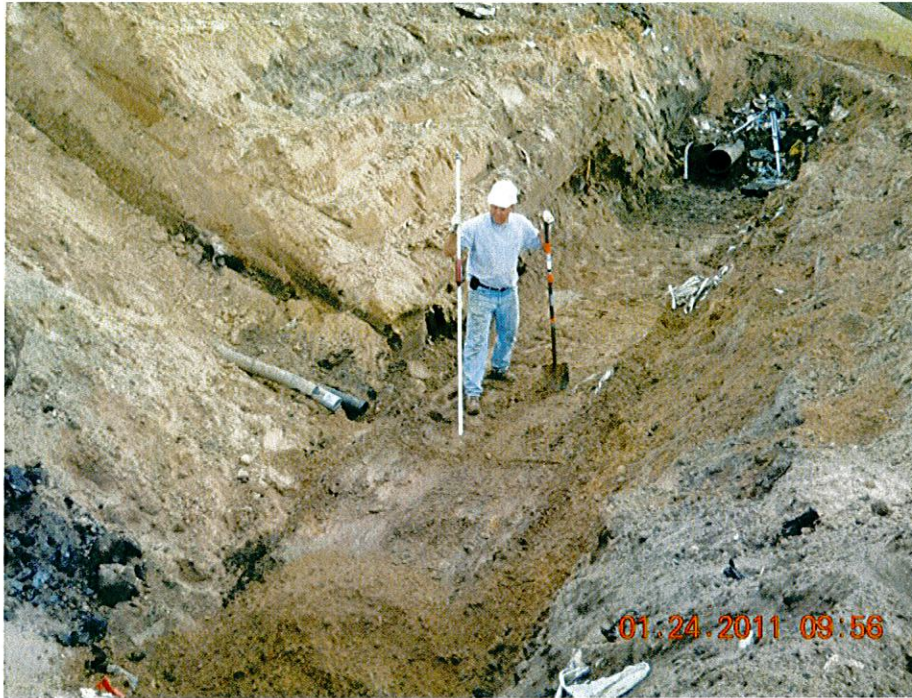
January 25, 2011 – Prepare bedding for piping at 5% grade using laser level.

approximately 40 feet from the original end of the header line. The 18-inch pipe, 4-inch force main, and 2-inch air supply line in the header were replaced; the blind flanged ends wrapped, and the pipe backfilled. SCS field services prepared the bottom of the trench at 5% grade using a laser level and the piping was installed along the same line as the previous piping, therefore revisions to the LFGCCS as-built drawings are not required. The existing lateral lines to GW-26 from the header trench were removed and replaced with new lines and also backfilled. When completed, the area was backfilled by dozer and graded to match existing slope in the surrounding area.

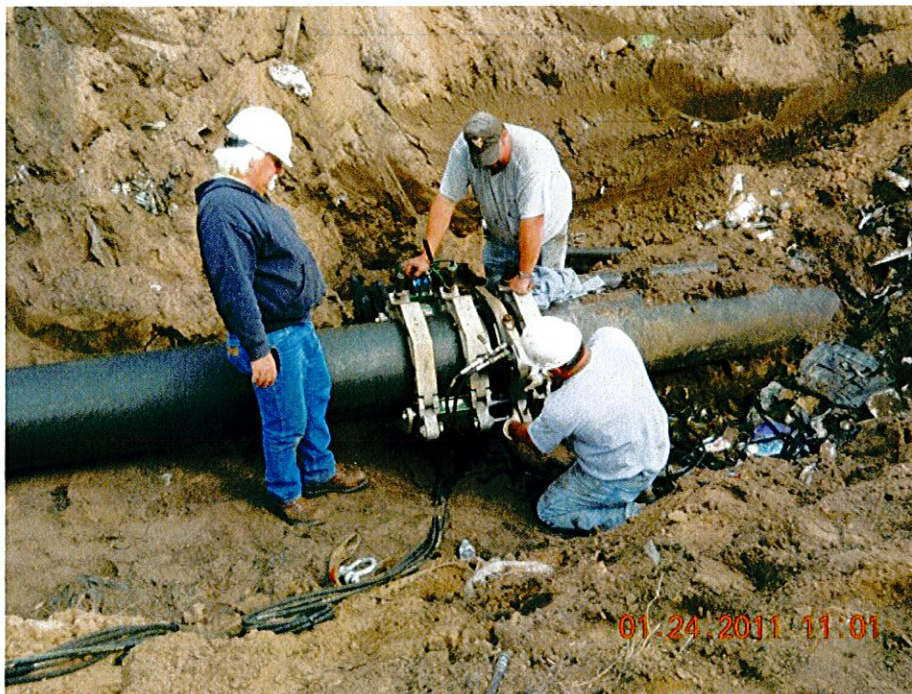
January 25, 2011 – In-trench welding of 18" header piping.

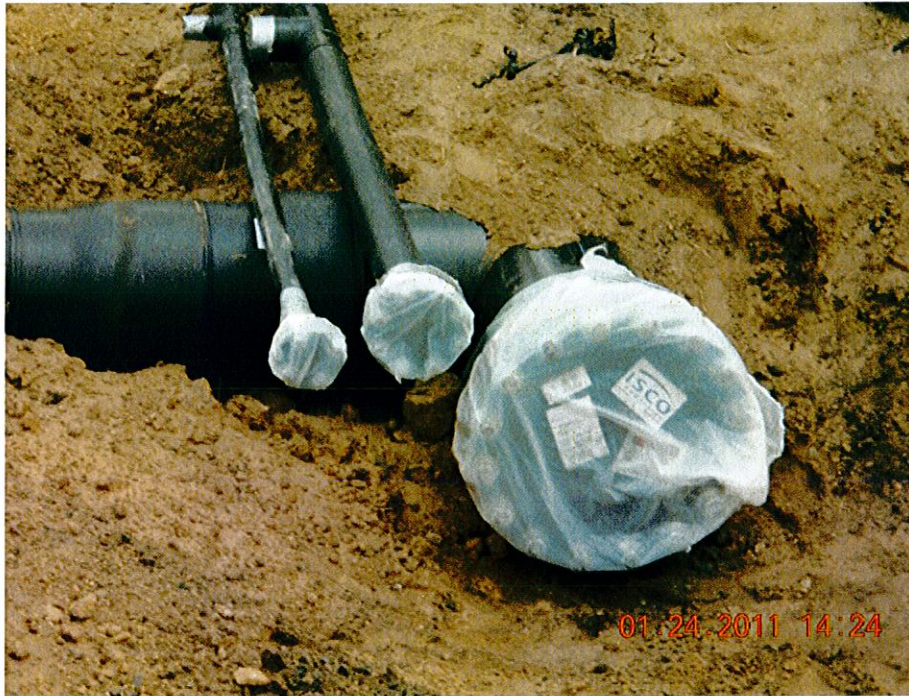
January 25, 2011 – Completed ends of header piping.

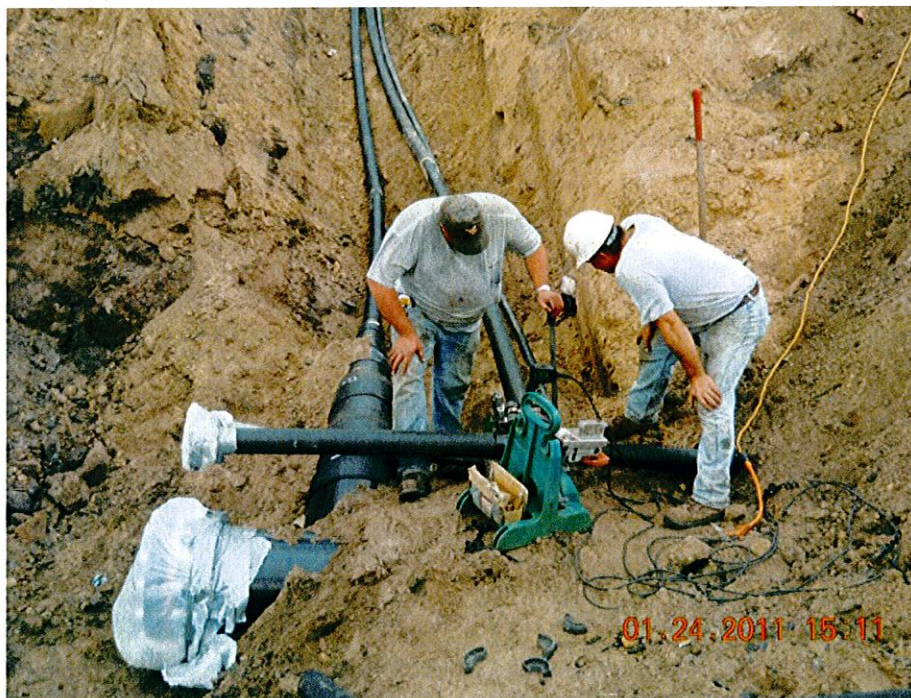
January 25, 2011 – Welding lateral piping to GW-26.

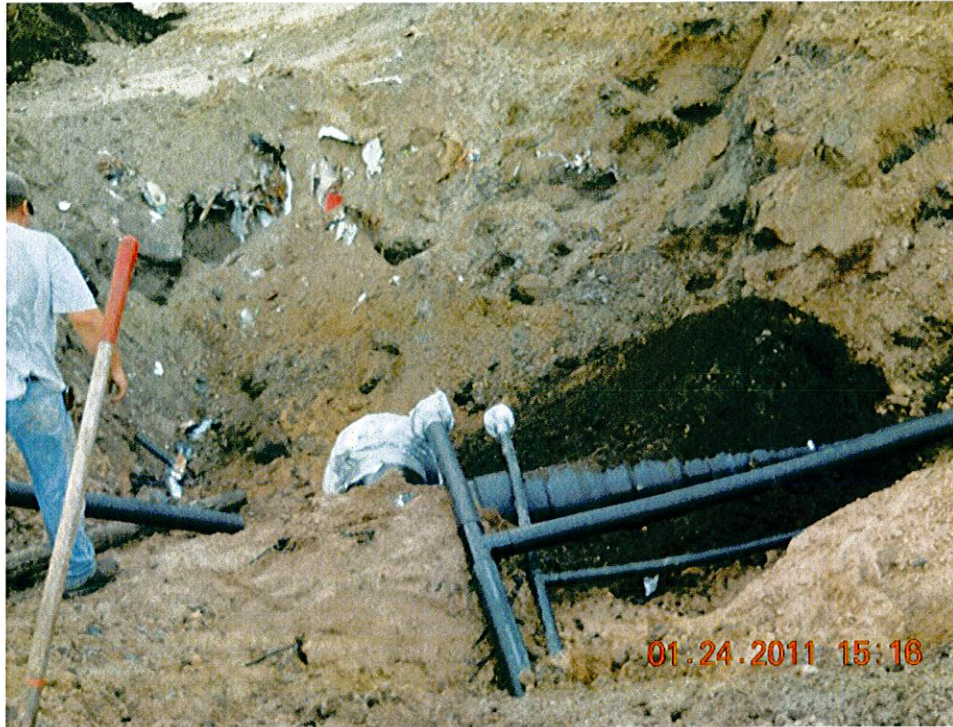
January 25, 2011 – Completed lateral piping to GW-26 and tie-in to header lines.

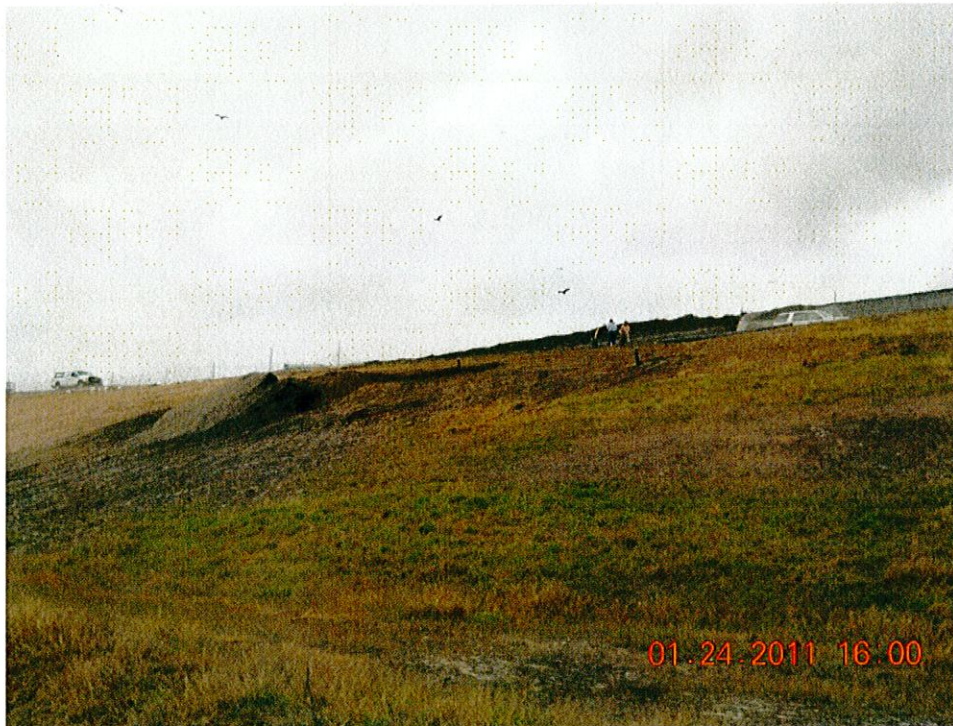
January 25, 2011 – Excavation backfilled and graded to match slope.
