**CITRUS COUNTY CENTRAL LANDFILL  
PHASE 1/1A LEACHATE COLLECTION SYSTEM  
ISSUES**

**230 W. GULF TO LAKE HIGHWAY  
LECANTO, FLORIDA**

**DEPARTMENT OF PUBLIC WORKS  
DIVISION OF SOLID WASTE MANAGEMENT**

# **CITRUS COUNTY LANDFILL PHASE 1/1A LEACHATE COLLECTION SYSTEM ISSUES**

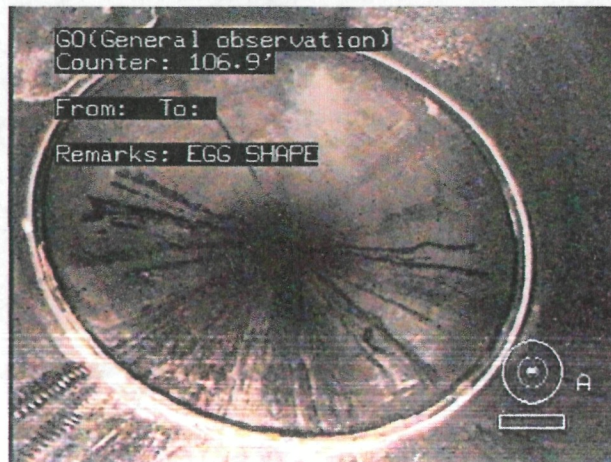
Distance: 106.9 Ft

Obs: General observation

Comments:  
EGG SHAPE

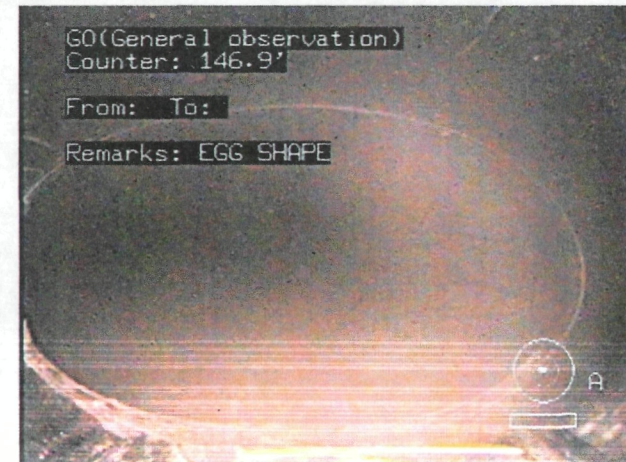
Distance: 146.9 Ft

Obs: General observation

Comments:  
EGG SHAPE

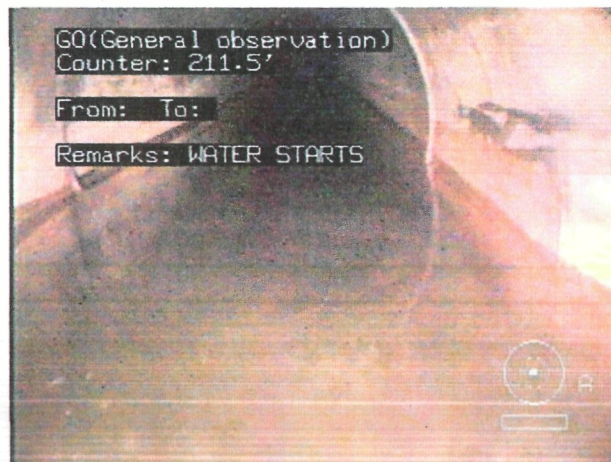
Distance: 211.5 Ft

Obs: General observation

Comments:  
WATER STARTS

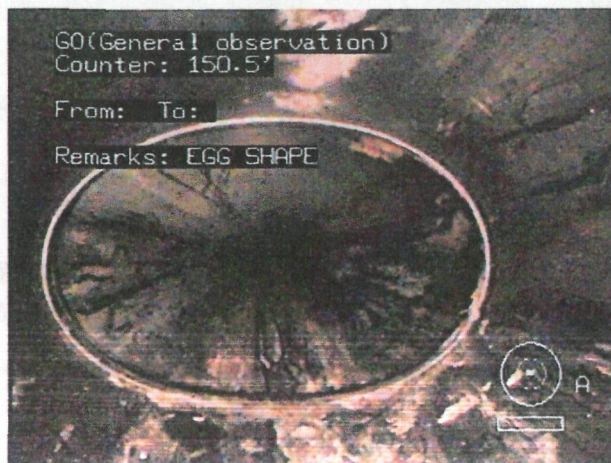
Date: 12/10/2007  
Distance: 150.5 Ft  
Obs: General observation

Comments:  
EGG SHAPE

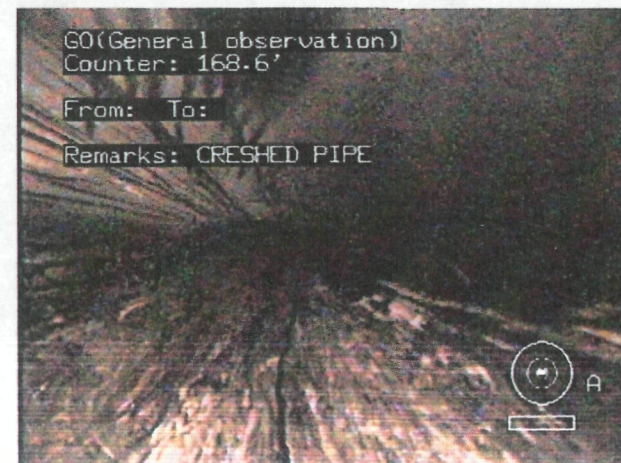
Date: 12/10/2007  
Distance: 168.6 Ft  
Obs: General observation

Comments:  
CRISHED PIPE

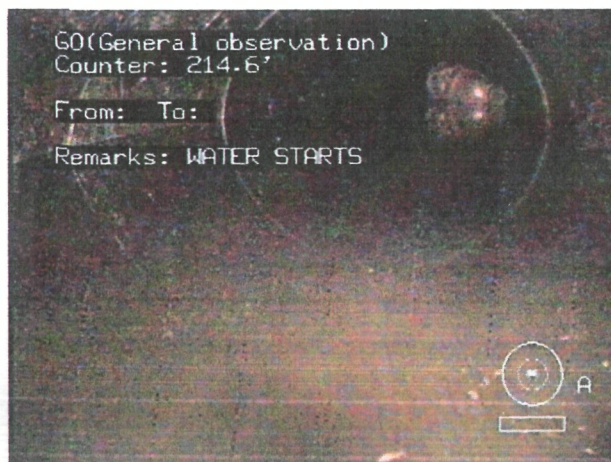
Date: 12/10/2007  
Distance: 214.6 Ft  
Obs: General observation

Comments:  
WATER STARTS

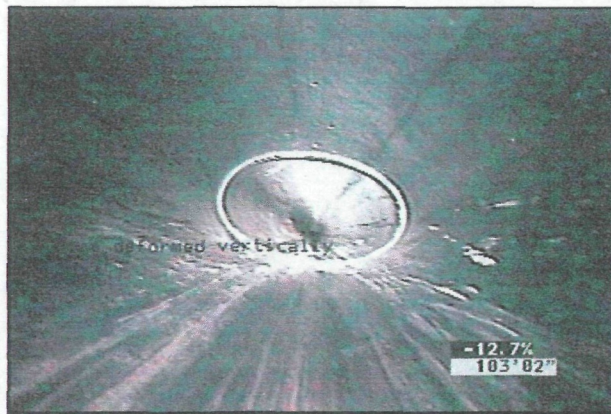
Photo: S\_StartNode\_S\_EndNode\_091108\_094235\_A.JPG,  
VCR #: 1  
103.15FT, pipe deformed vertically

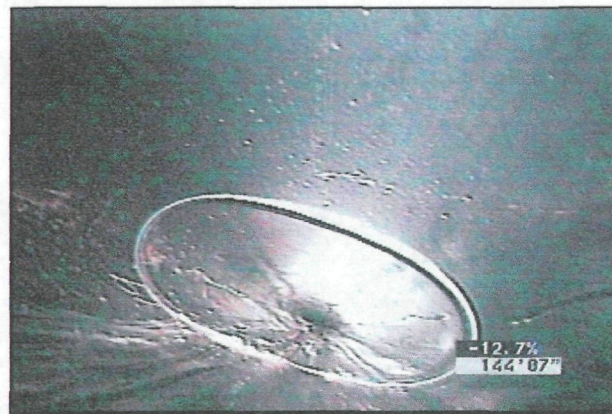
Photo: S\_StartNode\_S\_EndNode\_091108\_094408\_A.JPG,  
VCR #: 1  
144.5FT, pipe deformed vertically

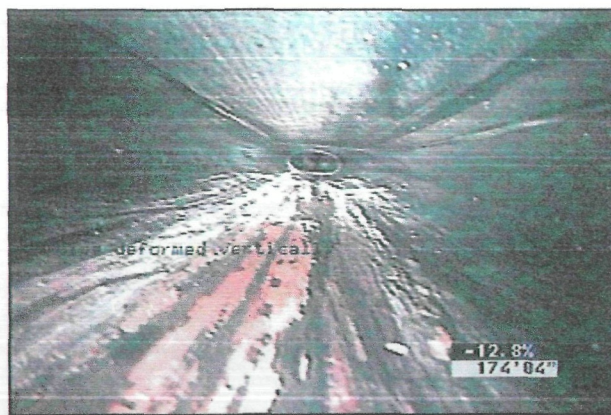
Photo: S\_StartNode\_S\_EndNode\_091108\_094536\_A.JPG,  
VCR #: 1  
174.3FT, pipe deformed vertically

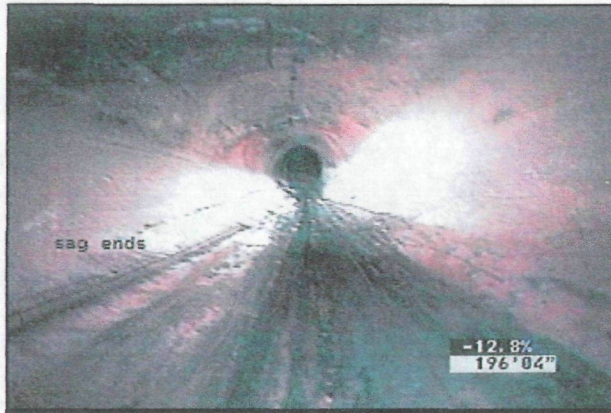
Photo: S\_StartNode\_S\_EndNode\_091108\_095918\_A.JPG,  
VCR #: 1  
196.3FT, sag ends

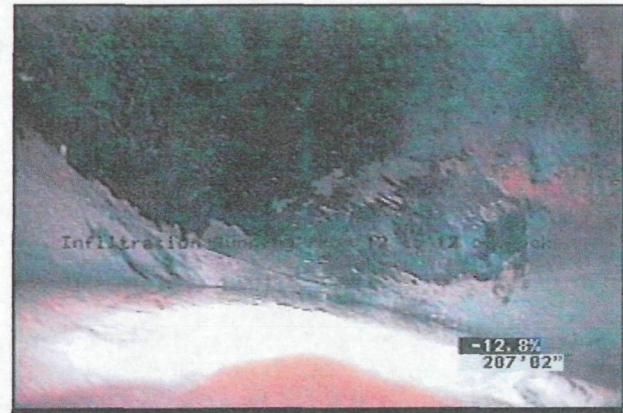
Photo: S\_StartNode\_S\_EndNode\_091108\_100027\_A.JPG,  
VCR #: 1  
207.2FT, Infiltration Running from 12 to 12 o'clock

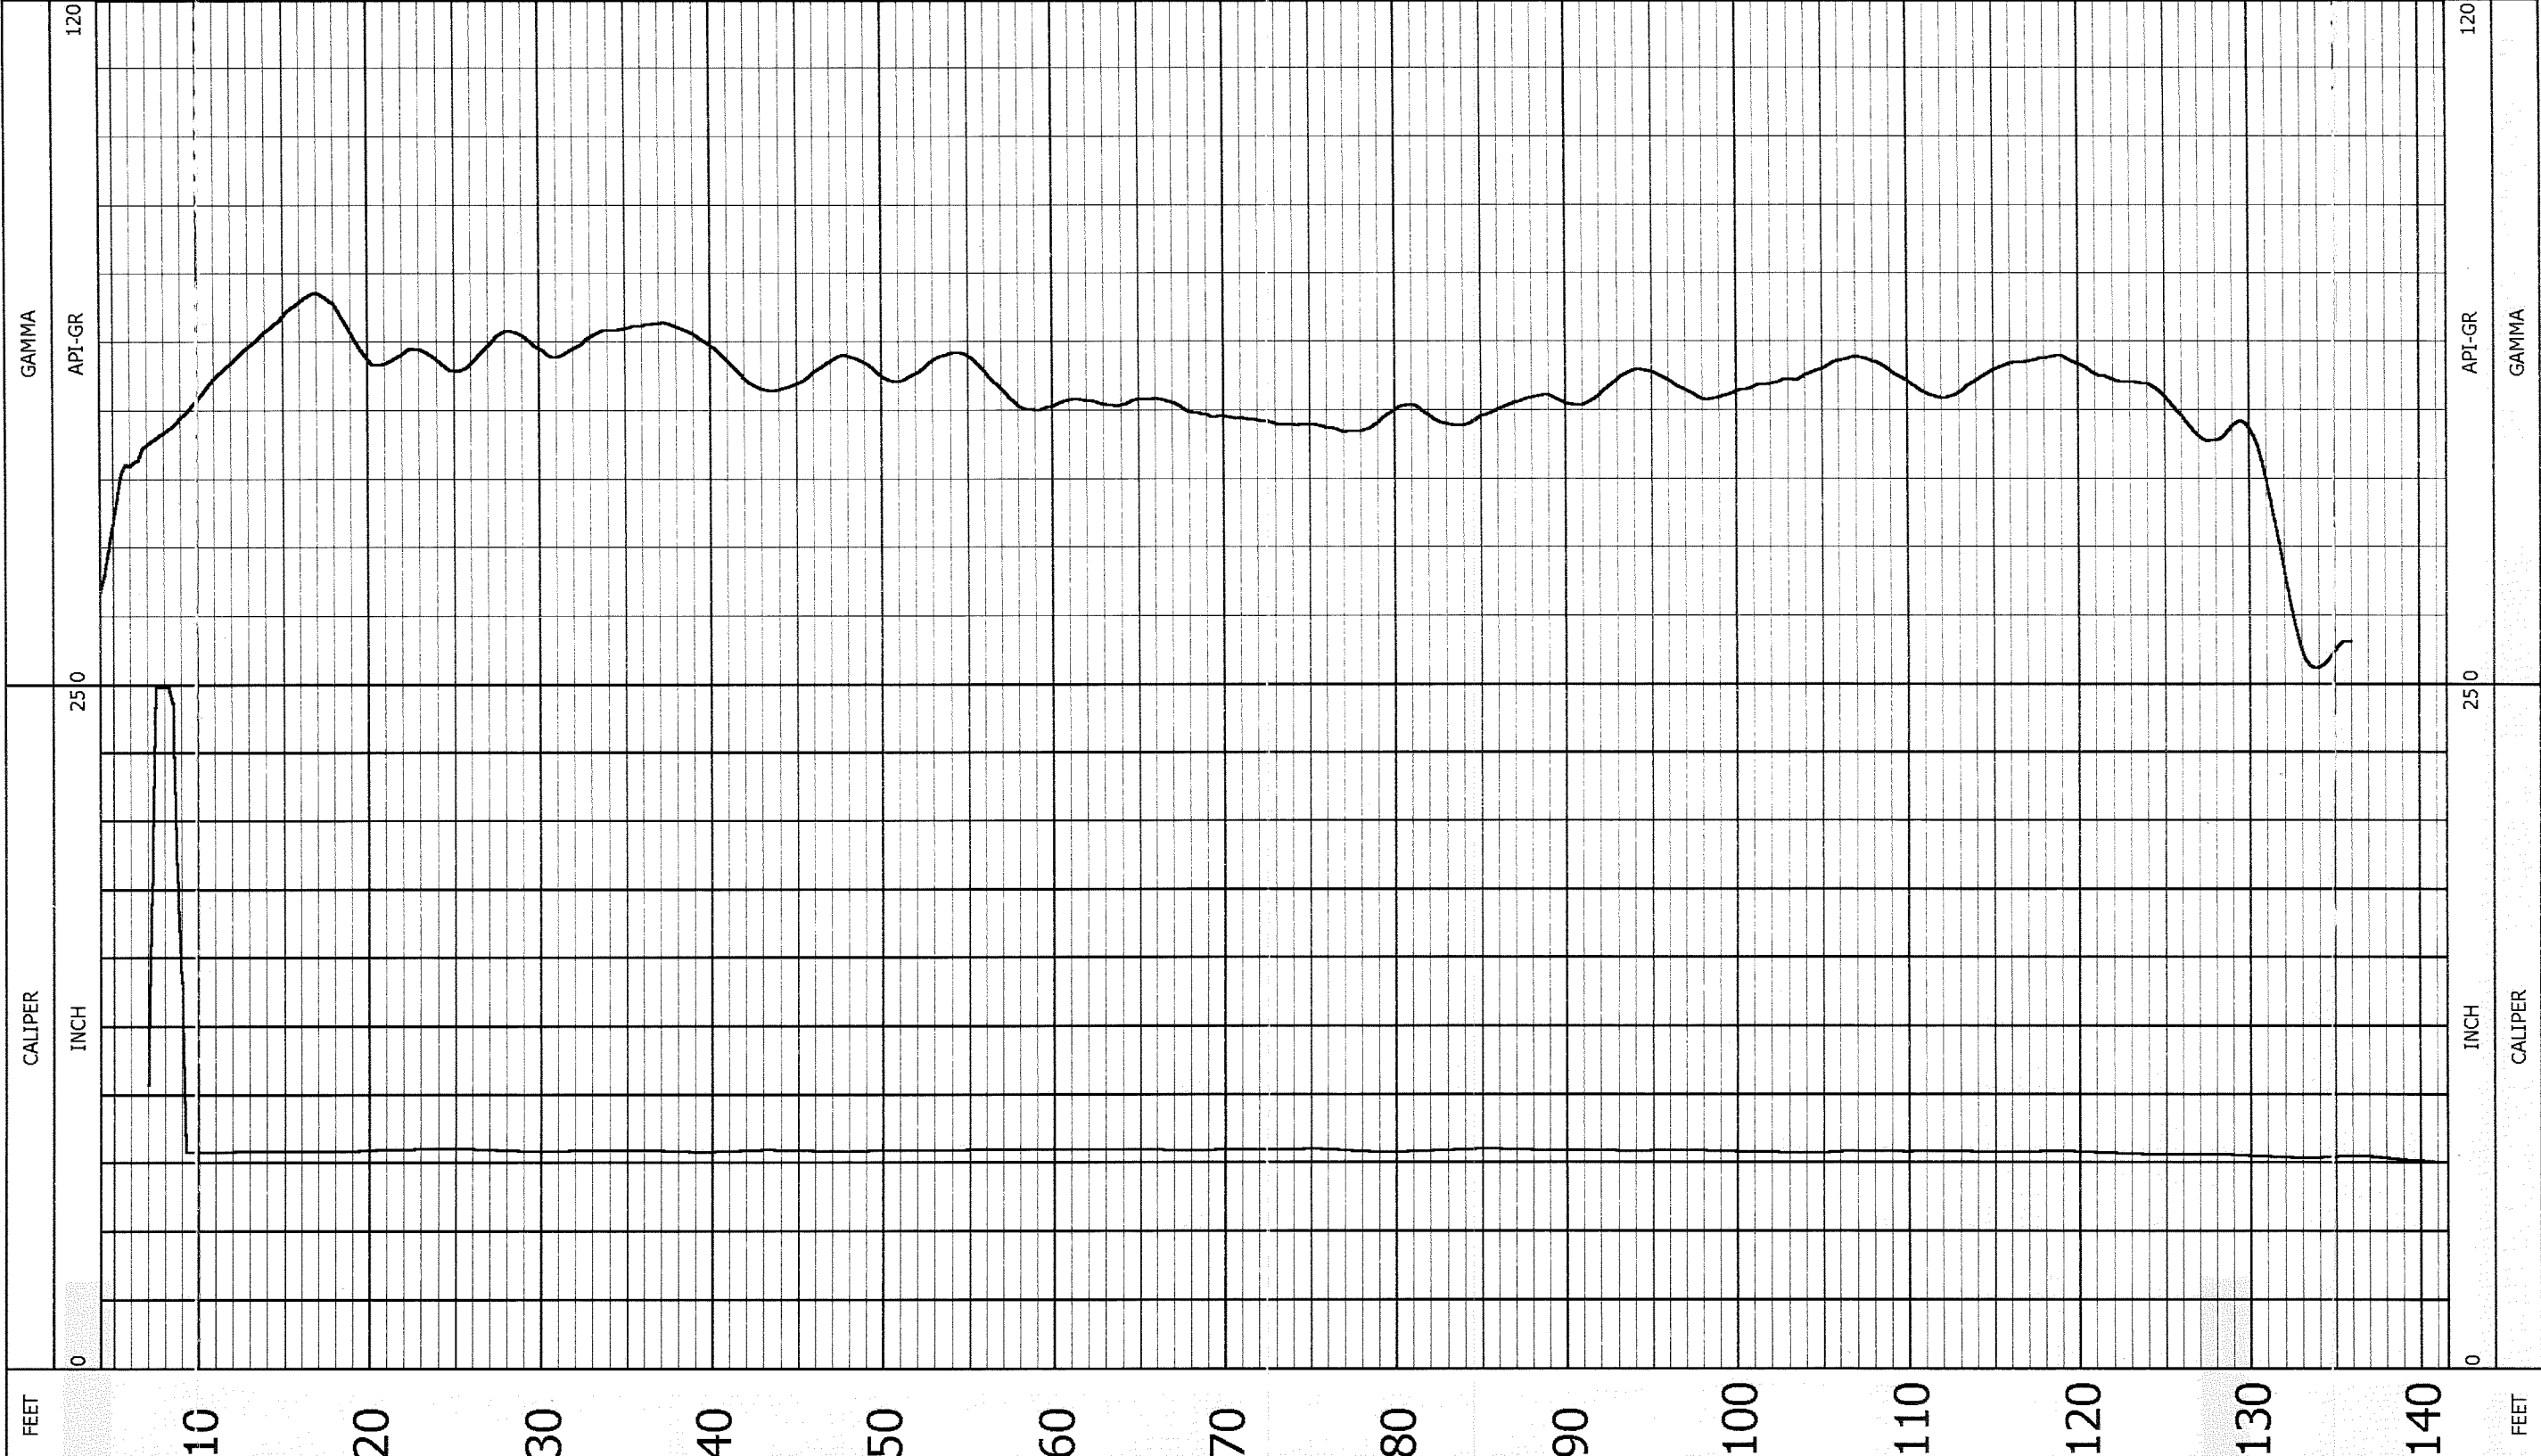
**ATTACHMENT E**  
**CITRUS COUNTY FEBRUARY 26, 2009**  
**CALIPER / GAMMA LOG OF**  
**PHASE 1A LEACHATE COLLECTION CLEAN LINE**

The caliper log of the 8-inch diameter Phase 1A leachate collection/cleanout pipe shows that the diameter is consistently 7.5 inches from the top to the 140 foot depth, at which point the tool would not pass, indicating a diameter of less than 5.7 inches. The gamma ray log for that pipe shows a similar pattern with slight variations from the surface to about 130 feet, then dropping dramatically in the last 10 feet.

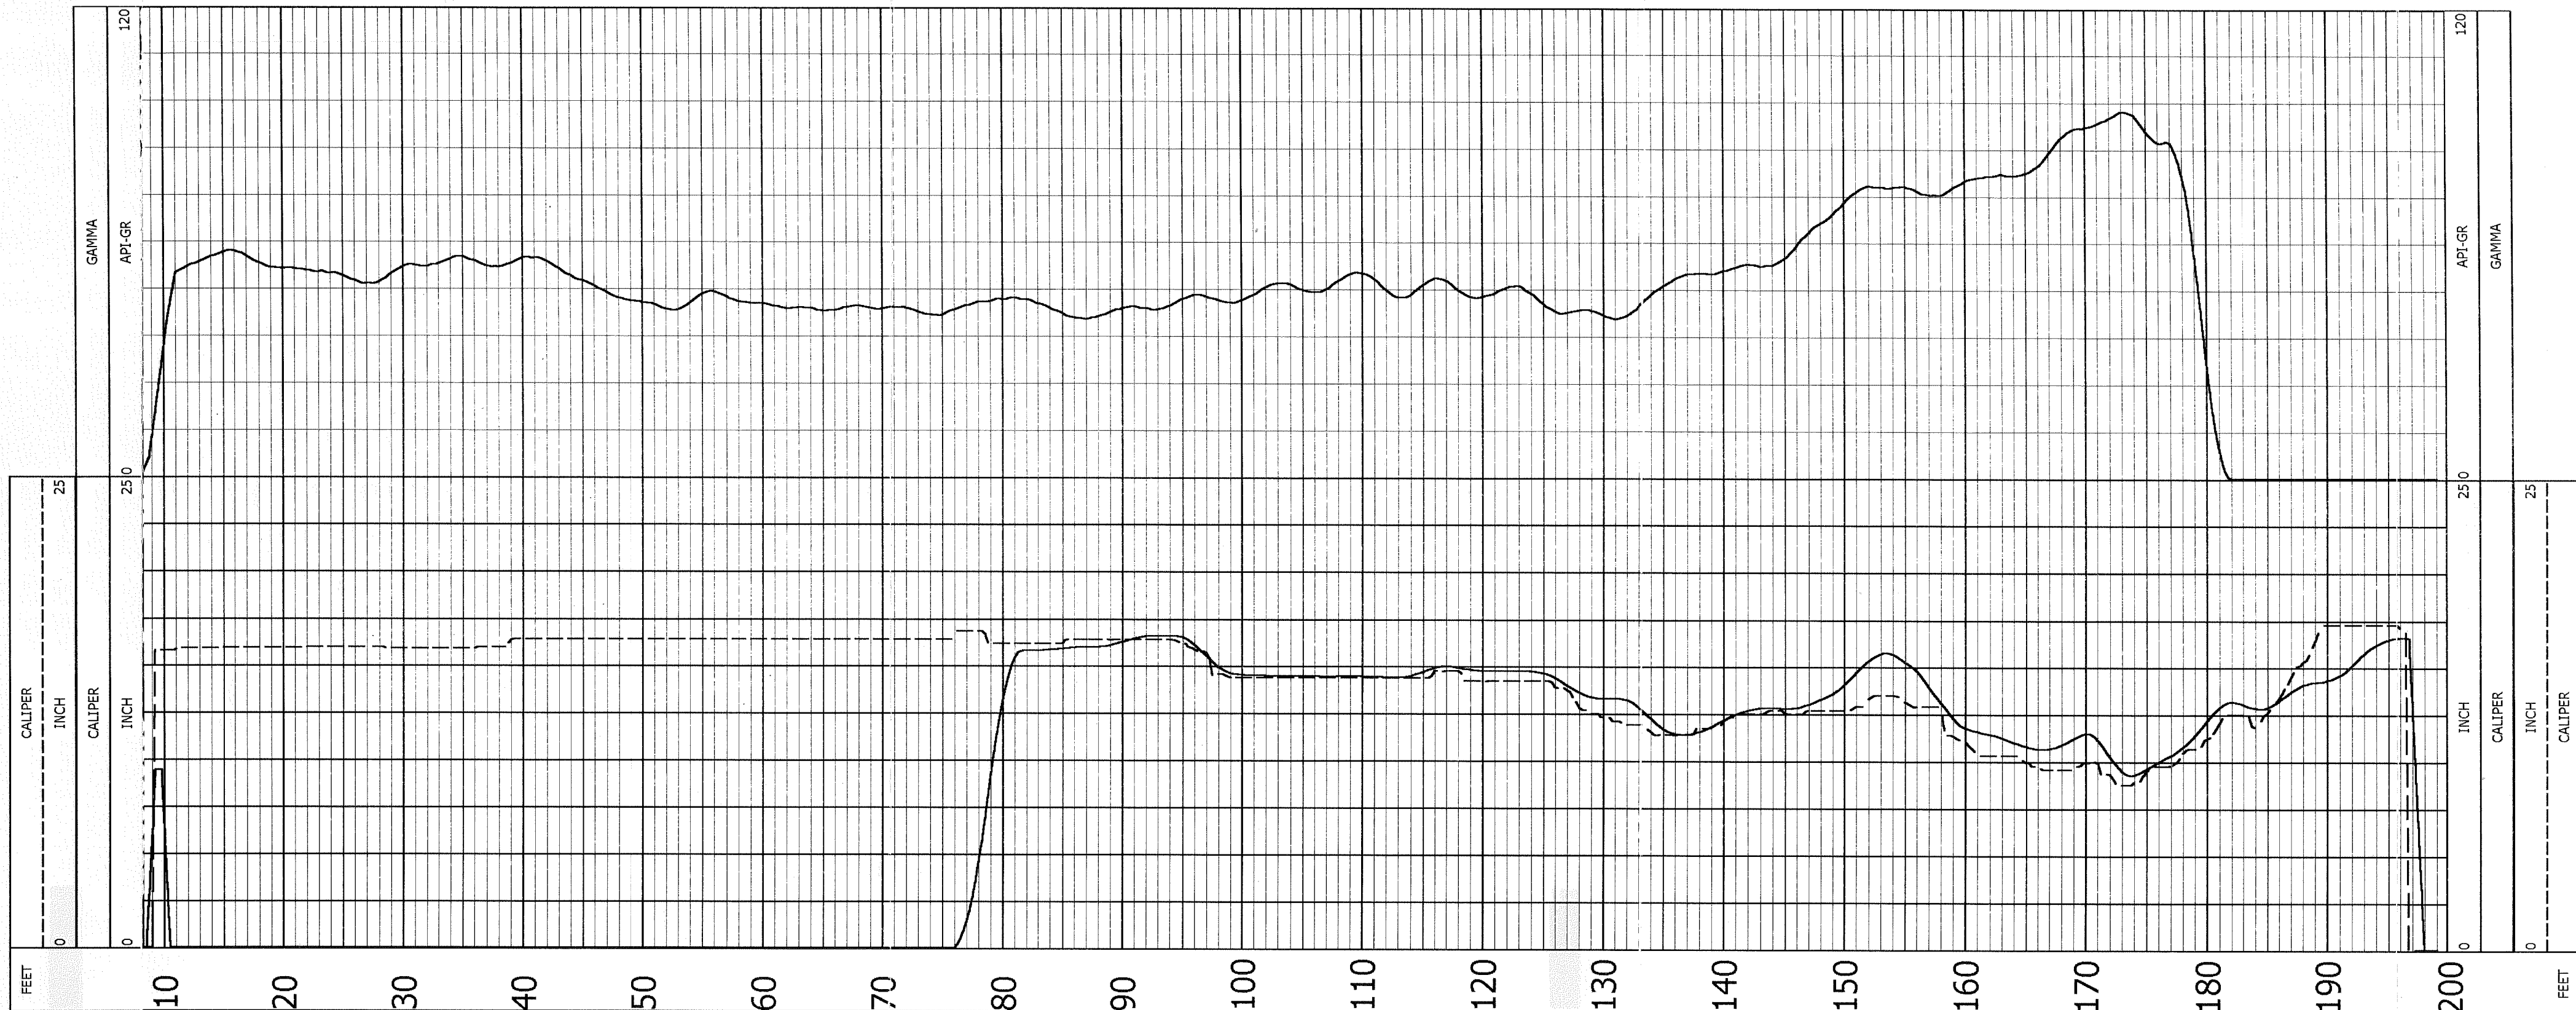
**ATTACHMENT F**  
**CITRUS COUNTY FEBRUARY 26, 2009**  
**CALIPER / GAMMA LOG OF**  
**PHASE 1A SECTION #1 PIPE**

The caliper logs show that the #1 secondary pipe has an interior diameter of 15.6 inches to a depth of 95 feet below the top; it shows uneven deformation from that depth to 195 feet, where the instrument would not pass. The minimum measured diameter was 9 inches at a depth of 173 feet. Advanced Borehole Services, the contractor performing this work, indicated that the measurements indicated on the log may not reflect actual dimensions.

The gamma ray log measures radiation from the surrounding soil. Clays generally exhibit higher radiation levels than sand. Also, if the tool is closer to the soil, the radiation levels should increase. The log of #1 secondary shows slight variations from surface to 130 feet deep, gradually increasing to 175 feet then dropping dramatically to zero from 176 feet to 182 feet, remaining at that level to the end of the log.

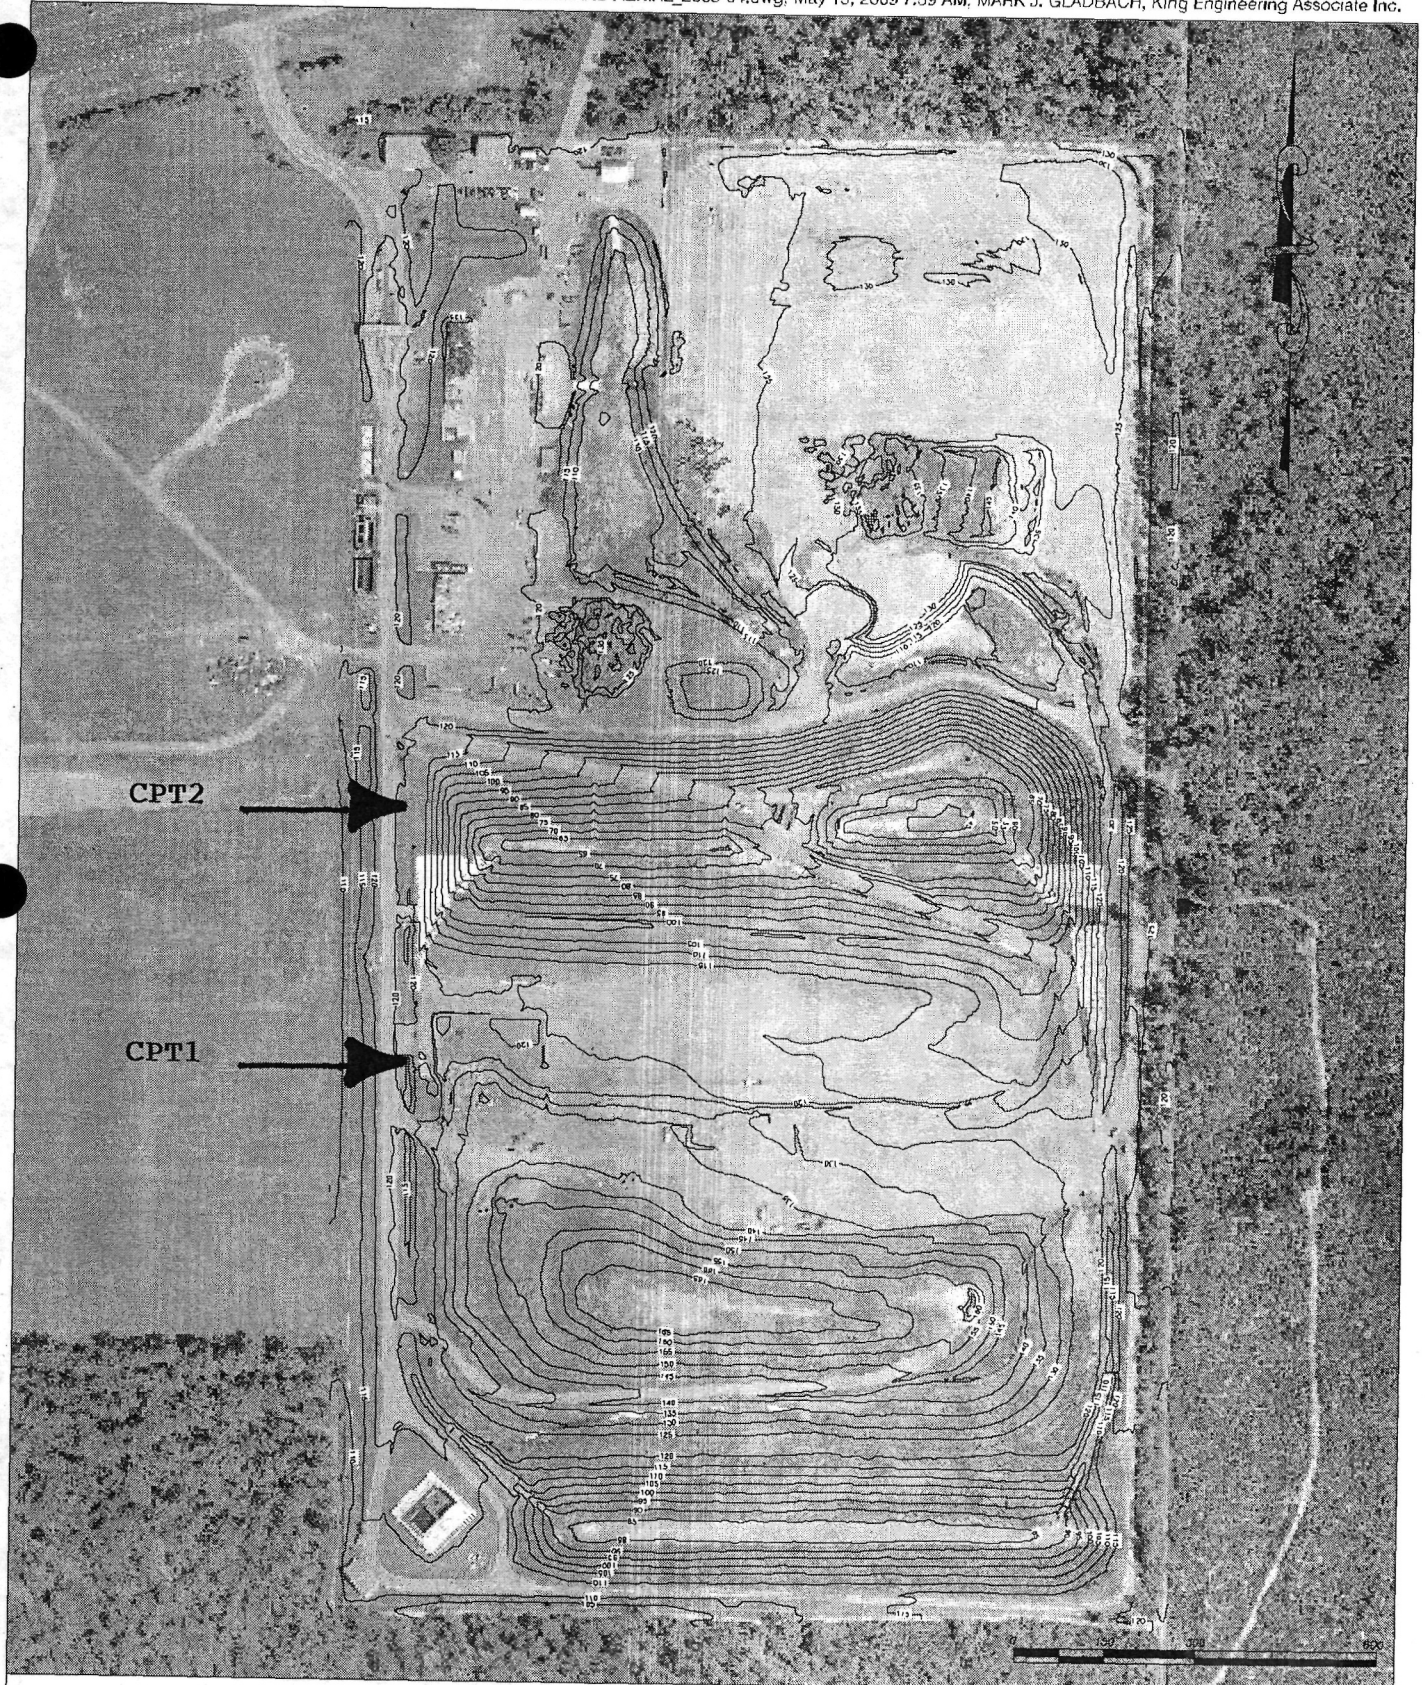
FIGURE 3. LOCATION OF CONE PENETROMETER TESTS

Cone penetrometer tests were conducted on May 1, 2009. The locations of the two borings are shown on Figure 3, with Attachments G and H. presenting the log of each

boring. These investigations suggest that there is no loose soil or evidence of karst activity beneath the outside edge of the liner in the vicinity of the Phase 1/1A leachate pipes or in a similar position related to the proposed Phase 3 liner.
