**Re: Southeast County Landfill
Phases I-VI Leachate Collection System
Water Jet Cleaning and Video Inspection Report
FDEP Permit No.: 35435-014-SO/01
WACS Facility ID No.: SWD/29/41193**

Hillsborough County Solid Waste Southeast County Landfill High-pressure Water-jetting & Explosion-proof Video-inspection

DATE : 3/24/2011
TO : Walter Gray, Larry Ruiz – Hillsborough County Solid Waste
FROM : Ralph Calistri (floridajetclean@yahoo.com)
SUBJECT : Hillsborough County Southeast Landfill – LCS Maintenance

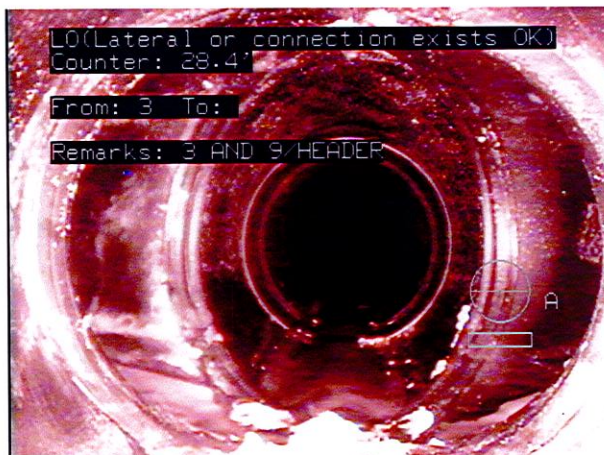
Pipe Graphic Report of PLR 5-3

- In Cleanout Pipe 5-3 at approximately 390 feet, the camera encountered an apparent offset in the pipe. After review of the Phases V and VI Construction Quality Assurance Report prepared in 1992, the LCRS piping was joined using fusion, flange and electro-fusion couplings. After reviewing the video of this location, it appears that the offset may be an electro-fusion coupling. Drainage rock and debris does not appear to be falling into the space between the pipe and the reflection in the video indicates a solid material behind the pipe, which may be the wall of an electro-fusion couple. Since the camera was able to navigate past this location and the pipe was jet cleaned the entire length, it appears that the pipe is functioning normally, therefore HDR does not believe any actions are required at this location based on the above observations.

Also, at this location, the camera stopped at approximately 420 feet. The reason for the stoppage could not be determined since the picture was dark, however, since the pipe was jet cleaned the entire length, a blockage or obstruction is not present. The camera stoppage was mostly likely due to loss of traction or from pipe welds that could not be navigated. HDR does not recommend any action for this location based on the above observations.

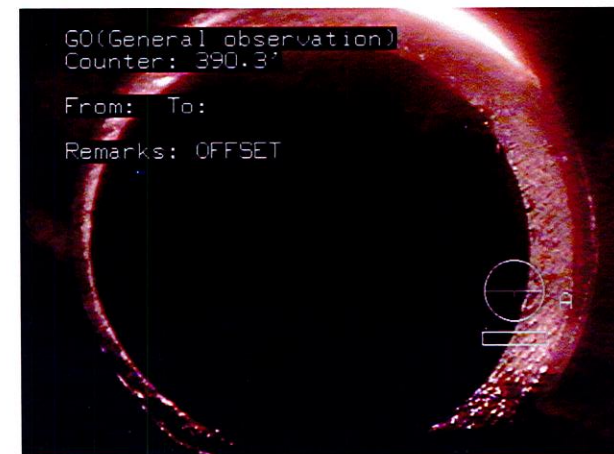
Distance: 390.3 Ft

Obs: General observation

OFFSET

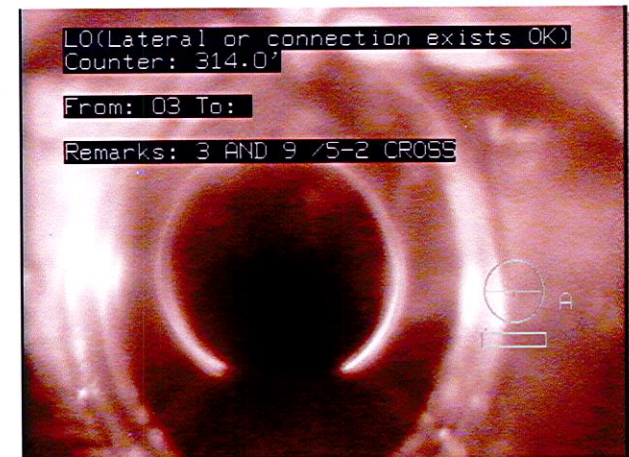
Distance: 314.0 Ft

Obs: Lateral or connection
exists OK

3 AND 9 /5-2 CROSS

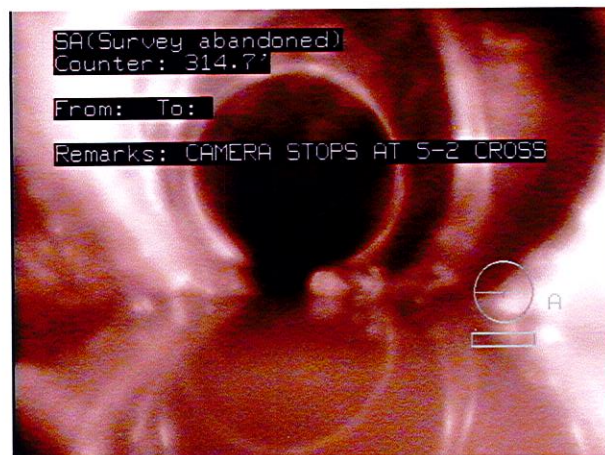
Distance: 314.7 Ft

Obs: Survey abandoned

CAMERA STOPS AT 5-2
CROSS

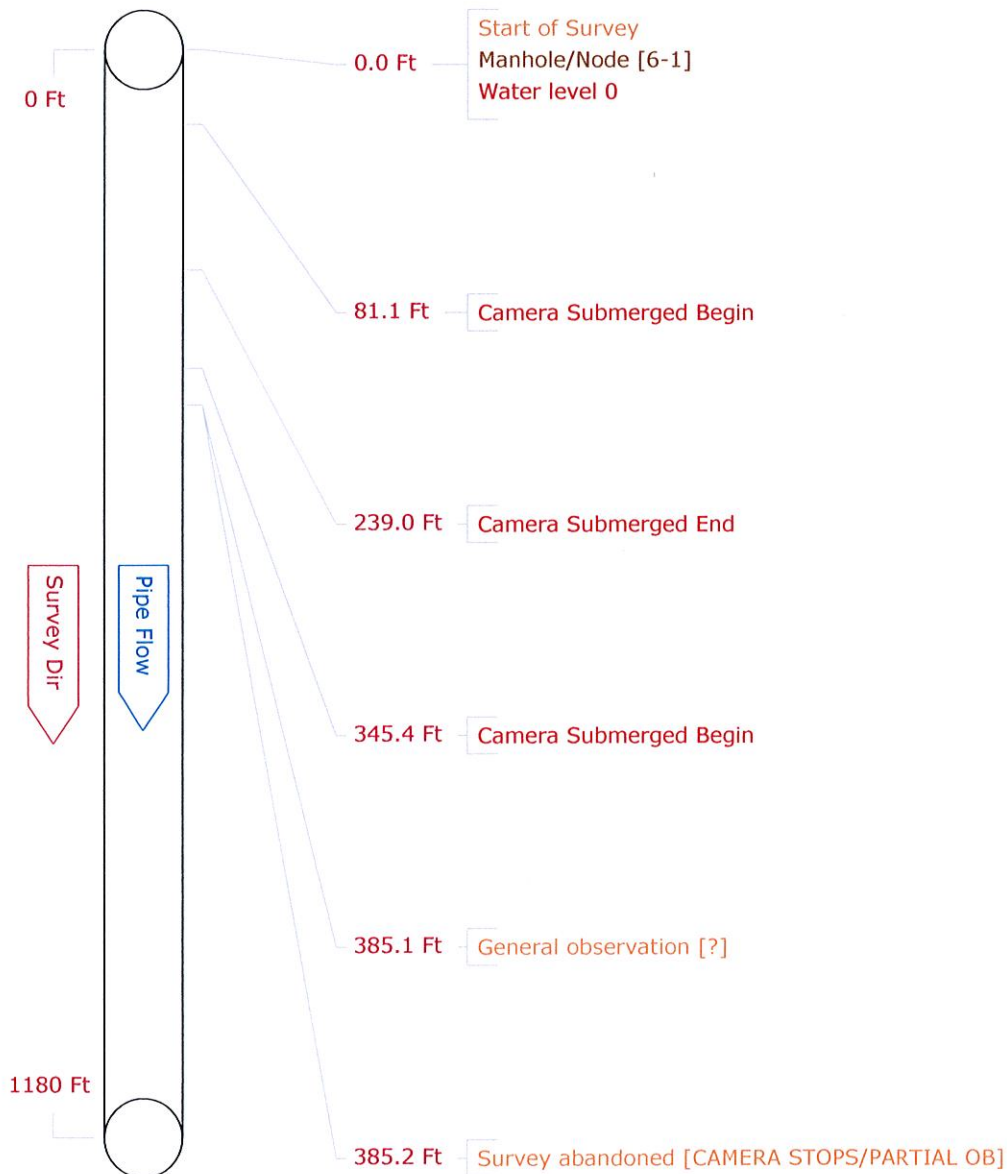
Pipe Graphic Report of PLR 6-1 E for SWA

- In Cleanout Pipe 6-1 an obstruction was noted that prevented the camera from proceeding forward. The obstruction could not be identified, but it is clear from the video that the obstruction is not blocking flow in the pipe and appears to be small points in the side wall of the pipe, possibly weld beads. Again, Cleanout Pipe 6-1 was water jet cleaned the entire length of the pipe with no noted problems and the pipe appears to be operating normally. HDR does not recommend any action in
