Re: Liner Repairs to Hillsborough County Southeast Landfill Effluent Pond A
FDEP Permit No. 35435-014-SO/01
Jones Edmunds Project No. 08449-030-04

**RE: Report on Liner Repairs – Pond A
Southeast County Landfill
Permit No. 35435-014-SO/01
Tampa, Florida**

Civil Design Services, Inc. (CDS) is submitting this report to document the repairs and quality assurance observations made during the repairs by our firm to the geomembrane HDPE liner system in Effluent Pond A at the Southeast County Landfill. This Report was prepared to fulfill the requirements of Specific Condition Part C-6.d of the above referenced FDEP Solid Waste Operations Permit.

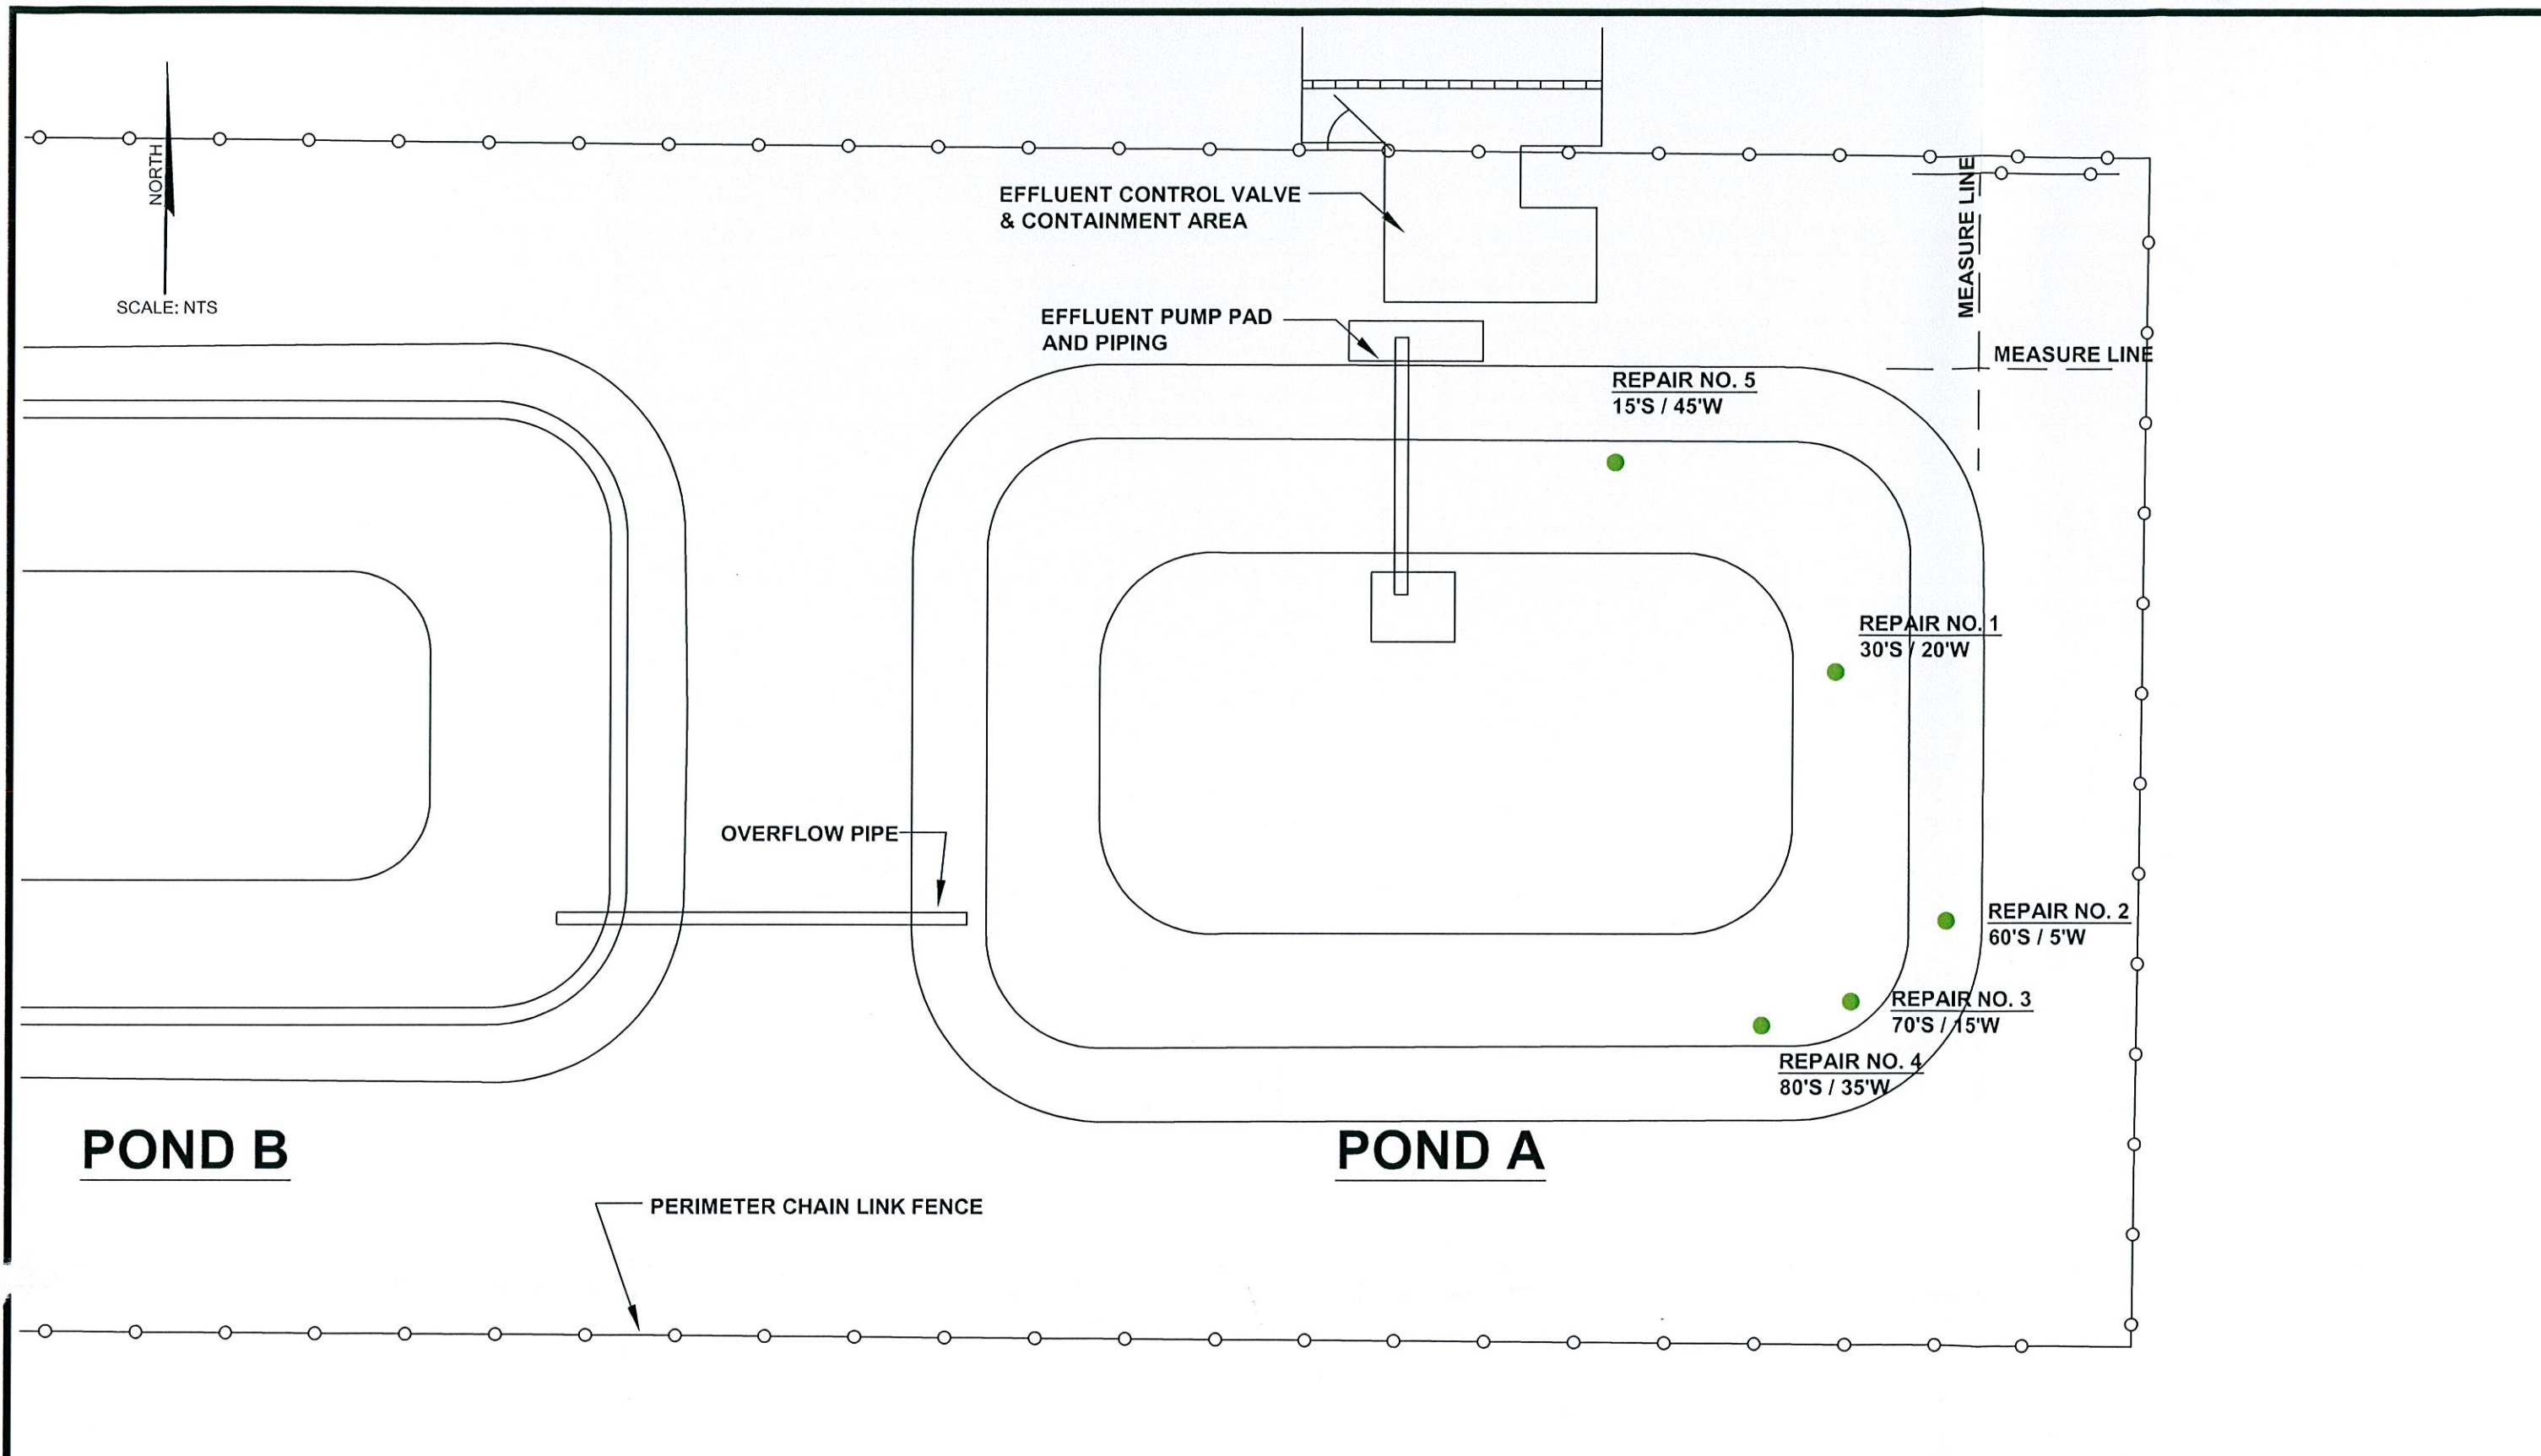
FIGURE NO. 1

REPAIR LOCATION MAP - POND A

- 11:45 am – All repairs and testing completed. CDS onsite to complete Repair Location Map.
- The Repair Location Map prepared by CDS is contained in Attachment A.
- Comanco's Pre-Weld Start-up and Non-Destructive Logs are contained in Attachment B.
- Photographs of the damaged areas and the repairs are contained in Attachment C.

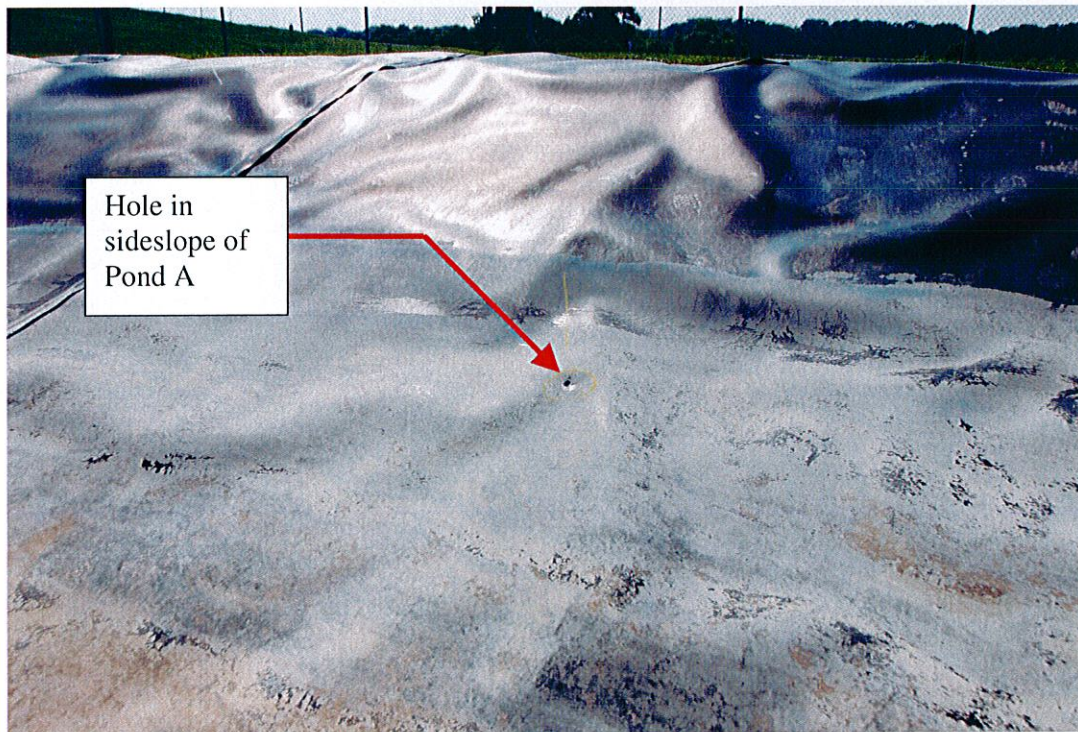
Photograph No. 1 – Holes found in the sideslope of Pond A (Refer to Repair No.1).

- 10:35 am to 11:20 am – CDS cut the primary liner in Repair Area No. 1 in the bottom of Pond A to inspect the subgrade. No rocks or debris were found under the liner. A patch was placed over the hole (Refer to Comanco Log Repair No.1). During the inspection of Pond A, several other small liner scrapes or abrasions were identified (Refer to Comanco Log Repair No. 2 – 5). These scrapes or abrasions were not through the liner; however, these areas could lead to stress concentrations and may have potentially lead to further liner damage. So to reinforce (repair) these areas, the surface of the liner was roughen by grinding and then the area was reinforced (repaired) by placing an extrusion bead across the scrape or abrasion. To ensure the grinding or extrusion welding activities did not comprise the integrity of the liner, Comanco vacuum boxed all the repairs.

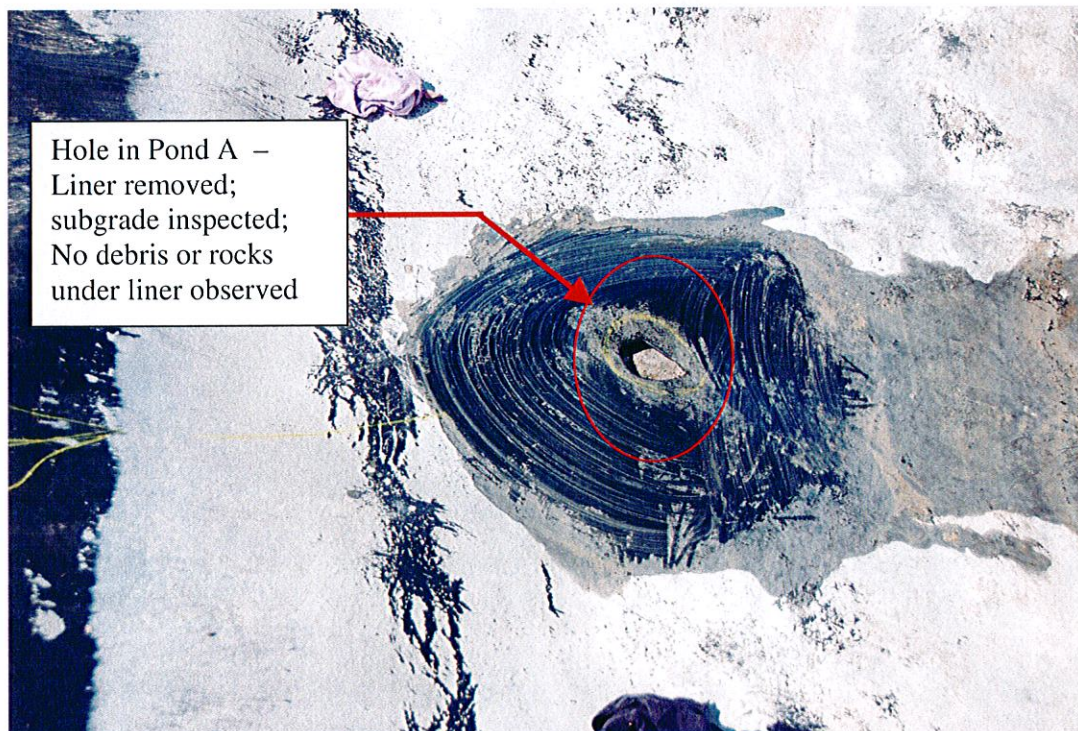
Photograph No. 2 – Pond A (Repair No.1) subgrade inspected.
