FLORIDA TIRE RECYCLING, INC WASTE TIRE SITE:

SITE CONDITIONS AS OF APRIL 29, 1994

The Florida Department of Environmental Protection

TAG Resource Recovery

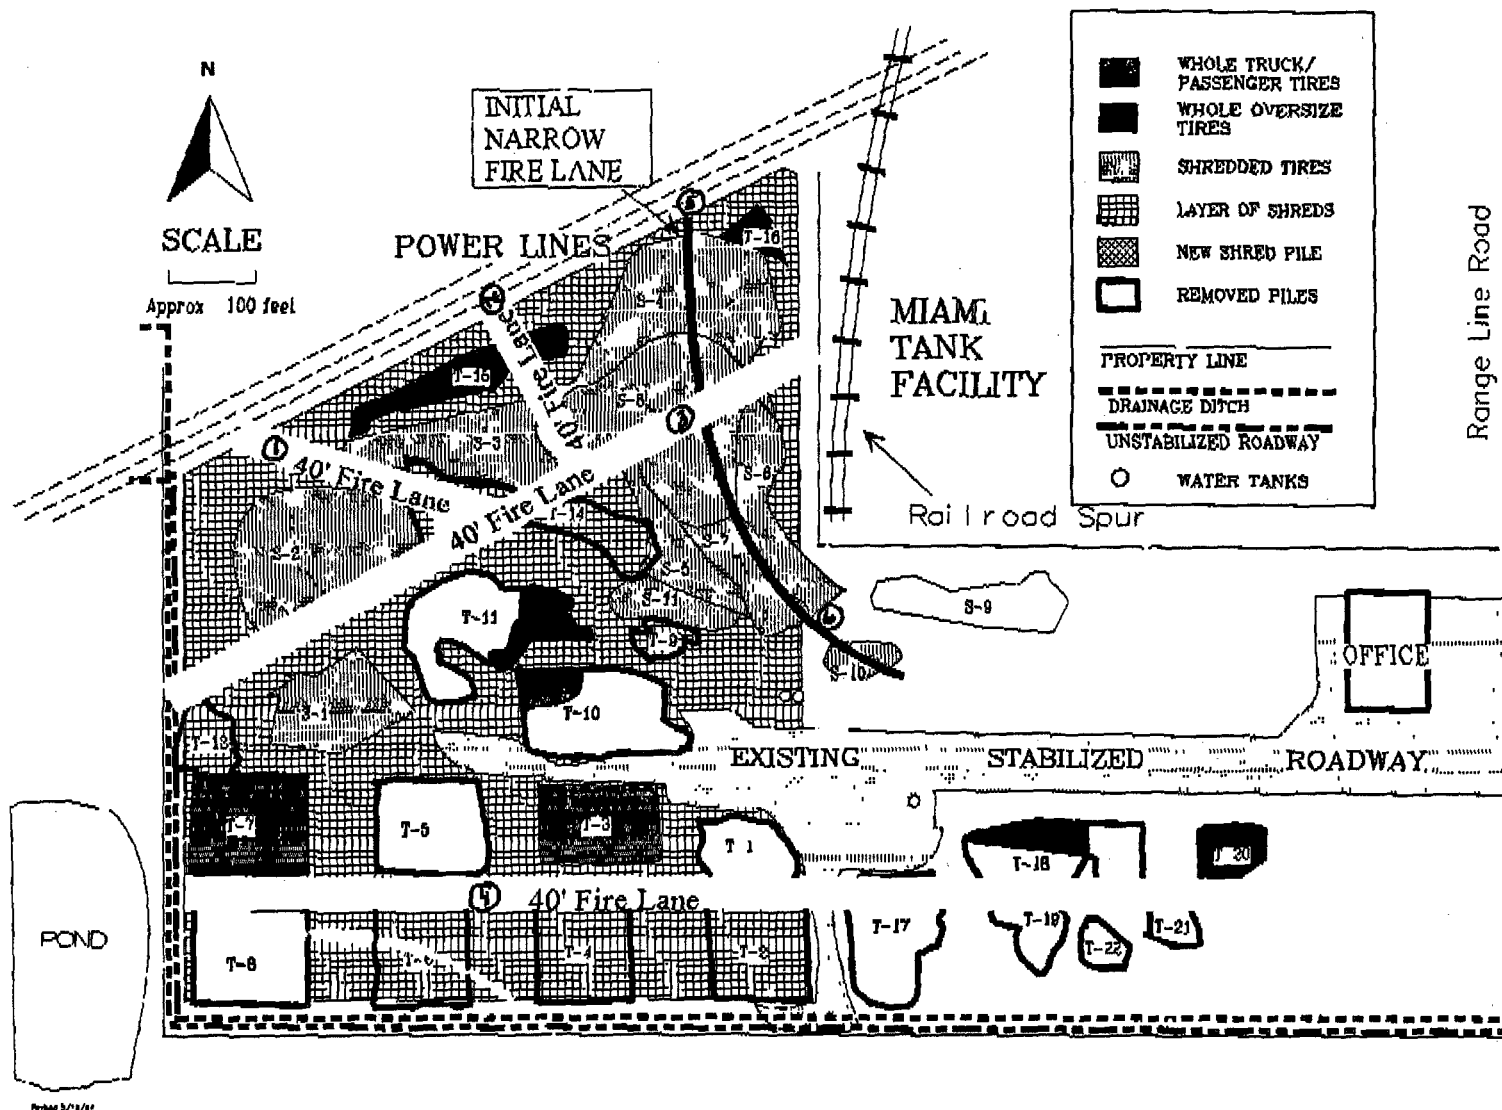
APPENDIX A - FLORIDA TIRE RECYCLING, INC. - SITE SCHEMATIC
KEY

A schematic representation of site conditions as of April 29, 1994 is provided in Appendix A. The schematic illustrates the following changes in site conditions between January 25, 1994 and April 29, 1994:
