FLORIDA TIRE RECYCLING, INC WASTE TIRE SITE:

SITE CONDITIONS AS OF JANUARY 25, 1994

**Prepared for
The Florida Department of Environmental Protection**

**by
Terry A. Gray and Andrew E. Ronchak,
TAG Resource Recovery**

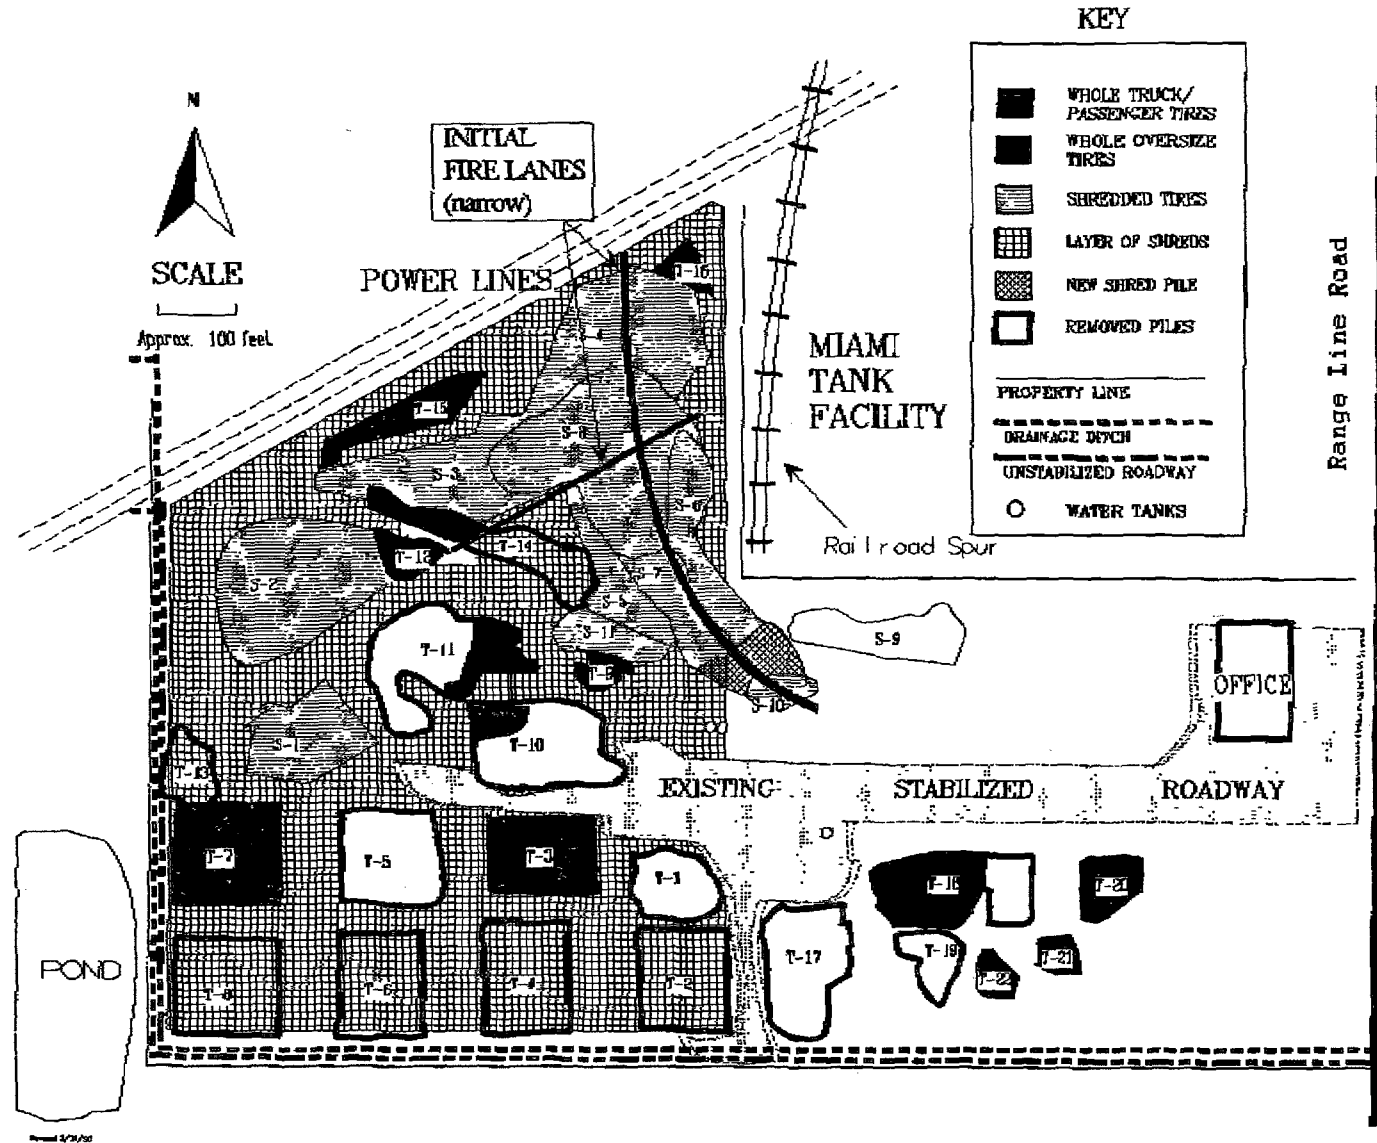
APPENDIX A - FLORIDA TIRE RECYCLING, INC. - SITE SCHEMATIC

A schematic representation of site conditions as of January 25, 1994 is provided in Appendix A. The schematic illustrates the following changes in site conditions between March 11, 1993 and January 25, 1994:

During the second half of 1993 (prior to completion of the court agreement), Florida Tire created narrow fire lanes within the main shred pile as depicted in the site schematic. These fire lanes are only 8 to 10 feet wide with sharp vertical walls, representing a path generated by one pass of their large loader through the pile.

The fire lanes had not been broadened since their initial creation in 1993. Shreds were not removed down to ground level within these fire lanes. As a result of their narrow width and remaining ground-level shreds, these fire lanes represent virtually no impediment to transmission of fire between adjacent pile segments.
