FLORIDA TIRE RECYCLING, INC WASTE TIRE SITE:

SITE CONDITIONS AS OF JANUARY 25, 1994

Terry A. Gray and Andrew E. Ronchak,

TAG Resource Recovery

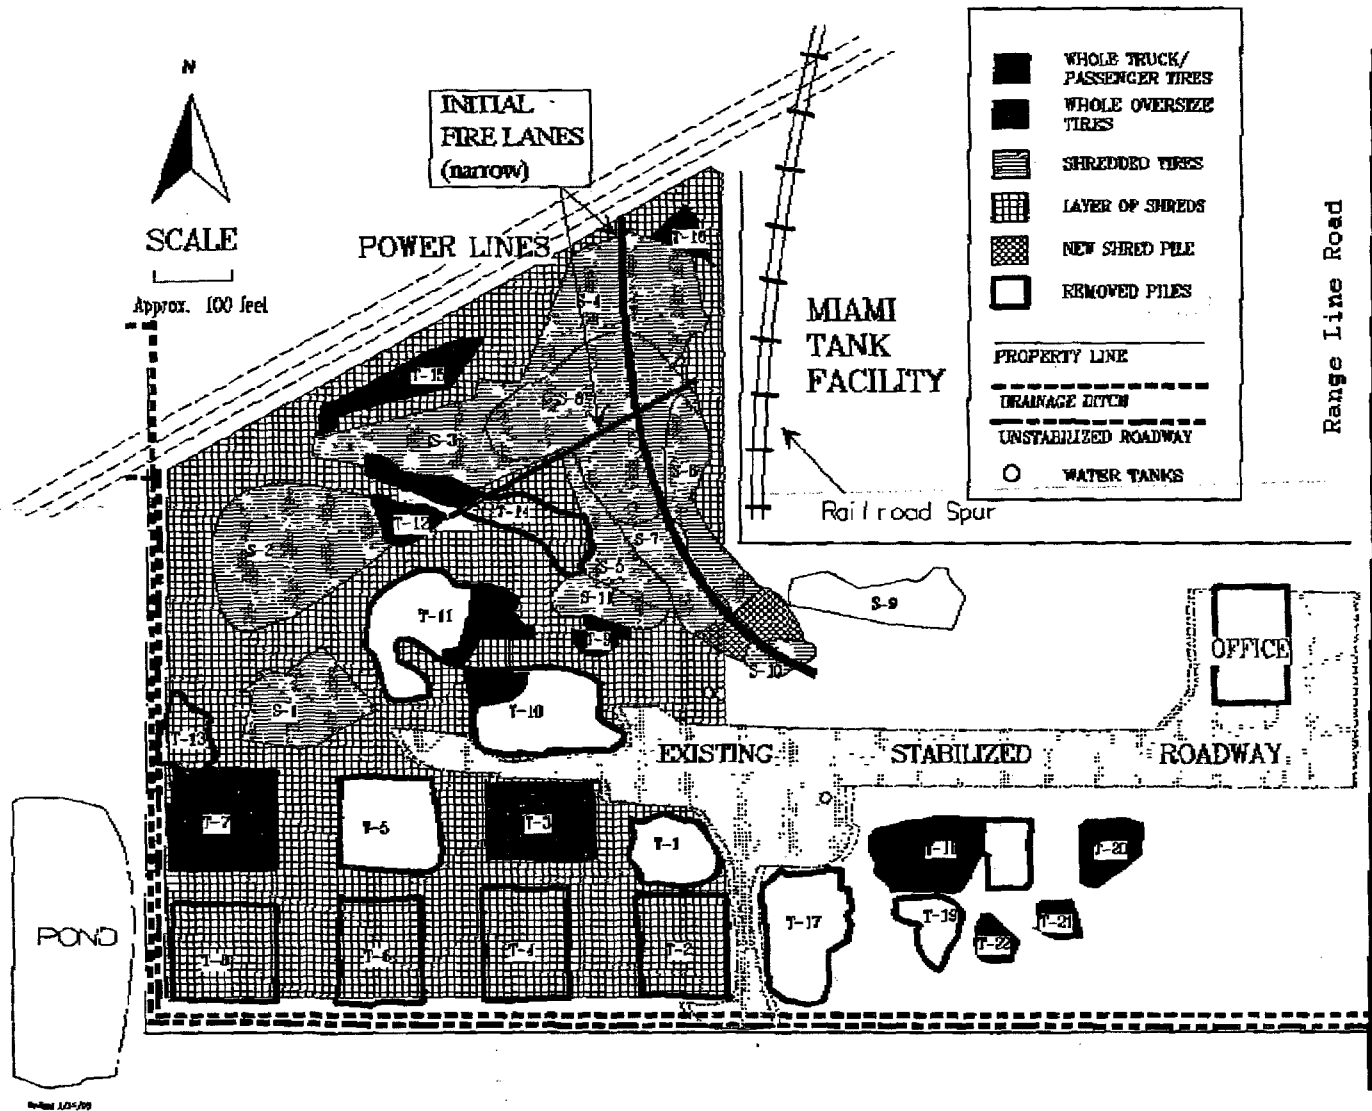
APPENDIX A - FLORIDA TIRE RECYCLING, INC. - SITE SCHEMATIC

A schematic representation of site conditions as of January 25, 1994 is provided in Appendix A. The schematic illustrates the following changes in site conditions between March 23, 1993 and January 25, 1994:

During the second half of 1993 (prior to completion of the court agreement), Florida Tire created narrow fire lanes within the main shred pile as depicted in the site schematic. These fire lanes are only 8 to 10 feet wide with sharp vertical walls, representing a path generated by one pass of their large loader through the pile.

The fire lanes had not been broadened since their initial creation in 1993. Shreds were not removed down to ground level within these fire lanes. As a result of their narrow width and remaining ground-level shreds, these fire lanes represent virtually no impediment to transmission of fire between adjacent pile segments.
