Board of County Commissioners
DEPARTMENT OF PUBLIC WORKS
SOLID WASTE MANAGEMENT DIVISION

Re: Citrus County Central Landfill
Permit No. 21375-008-SO/01 and 126602-002-WT/02
Response to Site Inspection Comments received August 25, 2010

Area: Closed 60 Acre Landfill

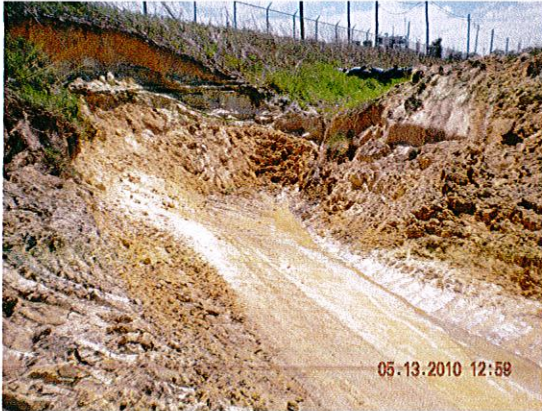
Explanation: Department Staff observed a 10-15 ft. wide surface depression on the South-East back of DRA #4.

Response: The facility determined that the feature in question was the result of run-off collecting in the adjacent swale and moving at too great a velocity thereby causing erosion. Repairs were made immediately following the inspections by the Department and FGS. Unstable wet soils were removed and remaining soils dewatered when overburdened was released, the area was back filled in 12" lifts, hand compacted and brought up to final grade using sand bags. The sand bags were used to maintain a stabilized surface while vegetation re-established itself. Mulch was spread to stabilize the remainder of the disturbed area. Two sand bag dams were installed in the swale to decrease the velocity of the water

Wet Soils removed

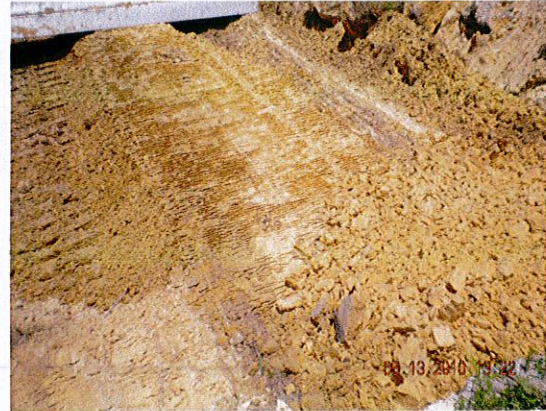
Soils replaced in 12" lifts

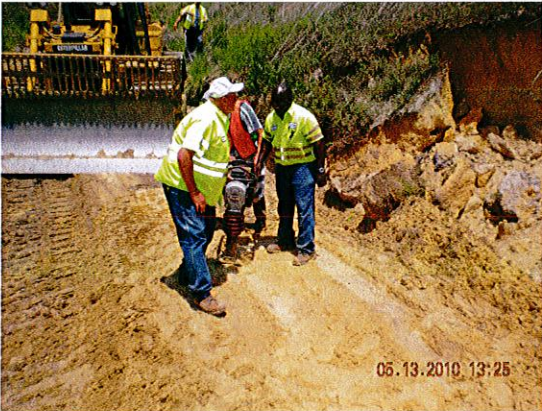
Soils compacted

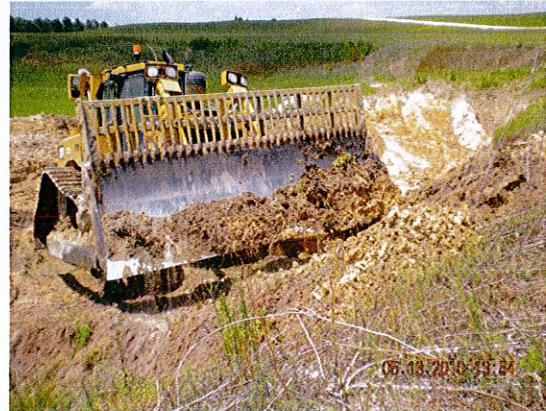
Dozer repairing slope

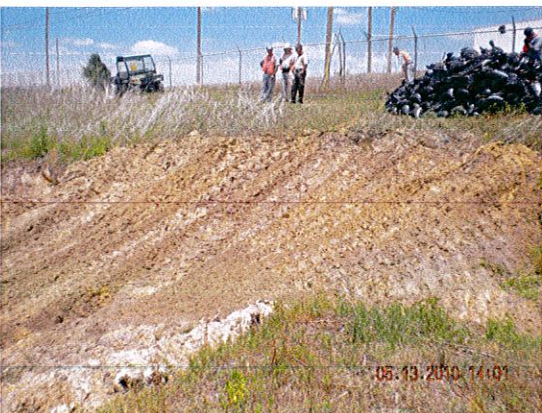
Slope repaired, sand bags staged

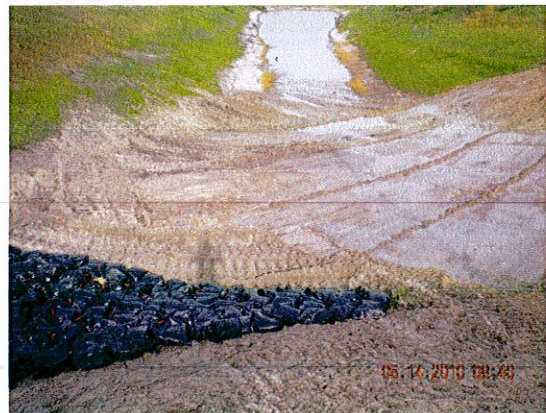
Sand bags placed

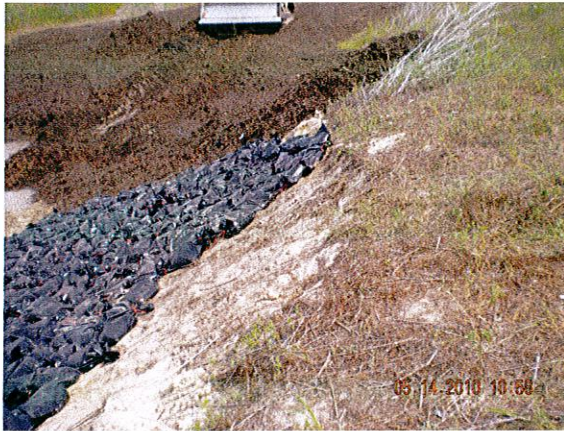
Mulch placed to enhance stabilization

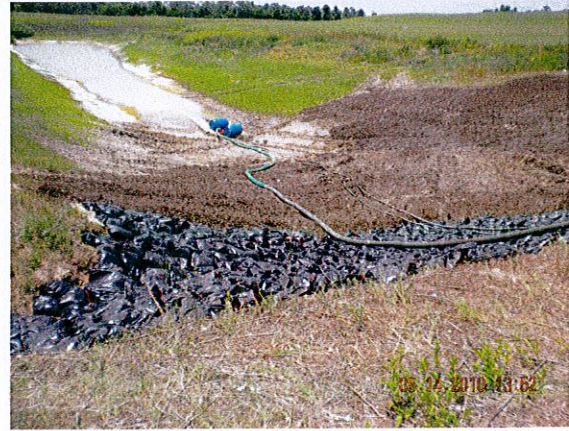
Repair completed

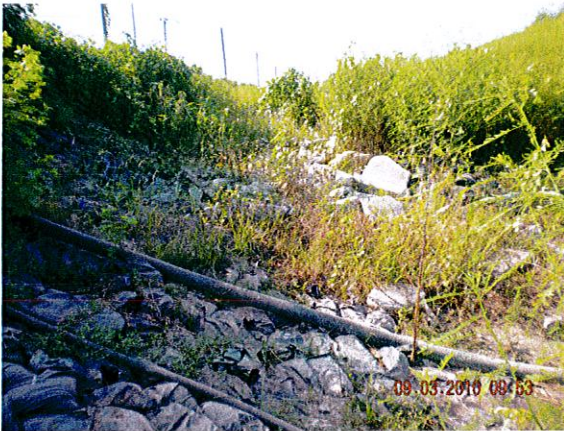
Current condition, vegetation re-established

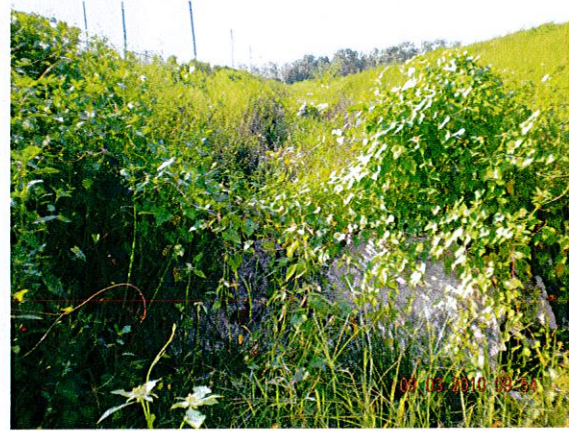
Rock check dam, foreground and mid photo

in the swale leading to the DRA #4, these proved ineffectual and were replaced by rock check dams constructed of crushed concrete. This process has corrected the erosion noted in the inspection. Staff has been advised to check this during the daily inspections.
