**Re: Southeast County Landfill
Landfill Gas Header Damage and Repairs
FDEP Permit No.: 35435-014-SO/01**

**HILLSBOROUGH COUNTY
SOUTHEAST COUNTY LANDFILL
SECTION 8 GCCS**

PIPE REPAIR FIGURE

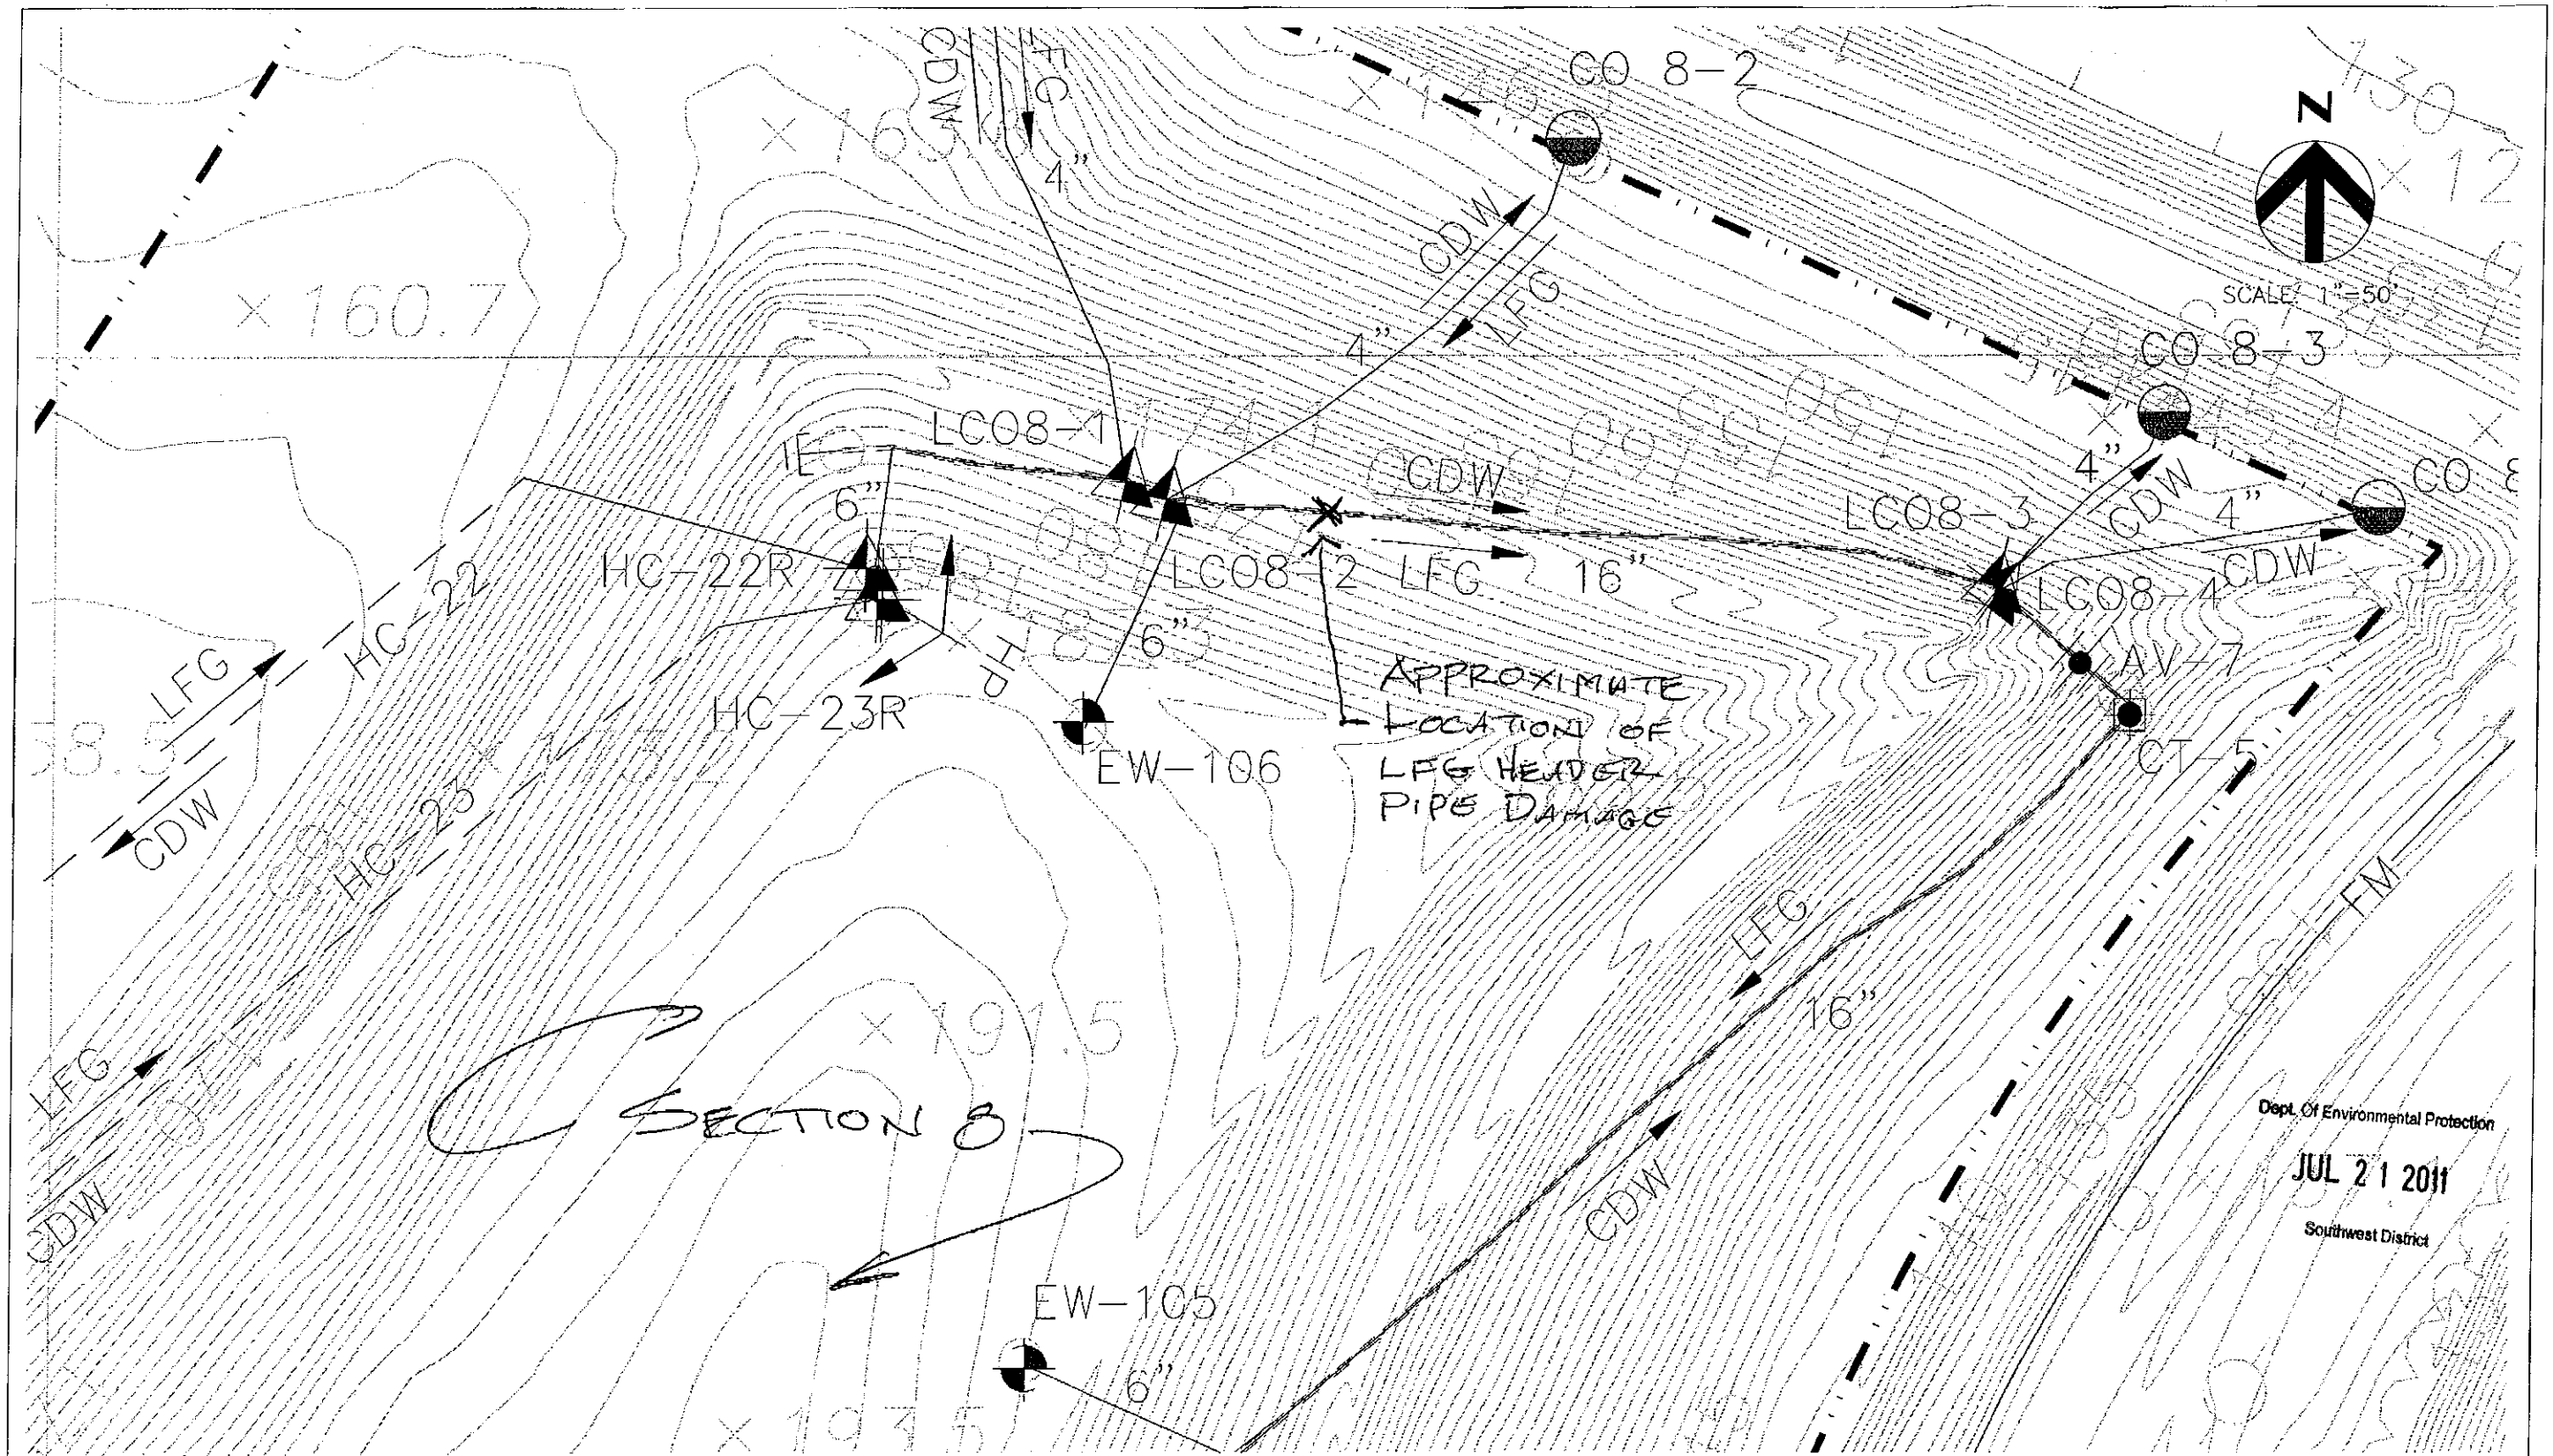
1

During the morning of July 14, 2011, the SWMG's landfill operator damaged a portion of the landfill gas collection and control system's (LFGCCS) header piping, air supply piping, and condensate piping located along the north side of Section 8 approximately 20 feet east of the header pipes for LCO8-2 as shown on the drawing provided in Attachment 1. The damage occurred as a result of re-grading in the area along the north side slope of Section 8. For a short duration, the landfill operator shut down the LFGCCS to assess the damage. This shut down was recorded in accordance with the SSM plan for system shut-down and startup.

The permanent repair for the damaged header was performed on Friday, July 15, 2011. The landfill operator and a welding technician from ISCO Industries, Inc. (ISCO) used two electro fusion couplings and a section of 16-inch Dia. SDR 17 HDPE pipe to repair the damaged section. The repair work was observed by representatives of both HDR and the SWMG. The repairs were documented in detail using the field work daily log provided in Attachment 1. Representative photos of the repair work are provided in Attachment 2. The Section 7 and 8 portion of the GCCS was isolated from the blower/flare station using GCCS Valve V-8 from 10:00AM to 4:30PM, however, the GCCS system, including blowers and the flare, was never shutdown during the repairs. Following the repair of the header pipe and the recommended weld cooling period, Valve V-8 was reopened and the seams at the electrofusion coupling checked for leaks. No leaks were identified. All wells on Section 7 and 8 were reopened for normal operation.

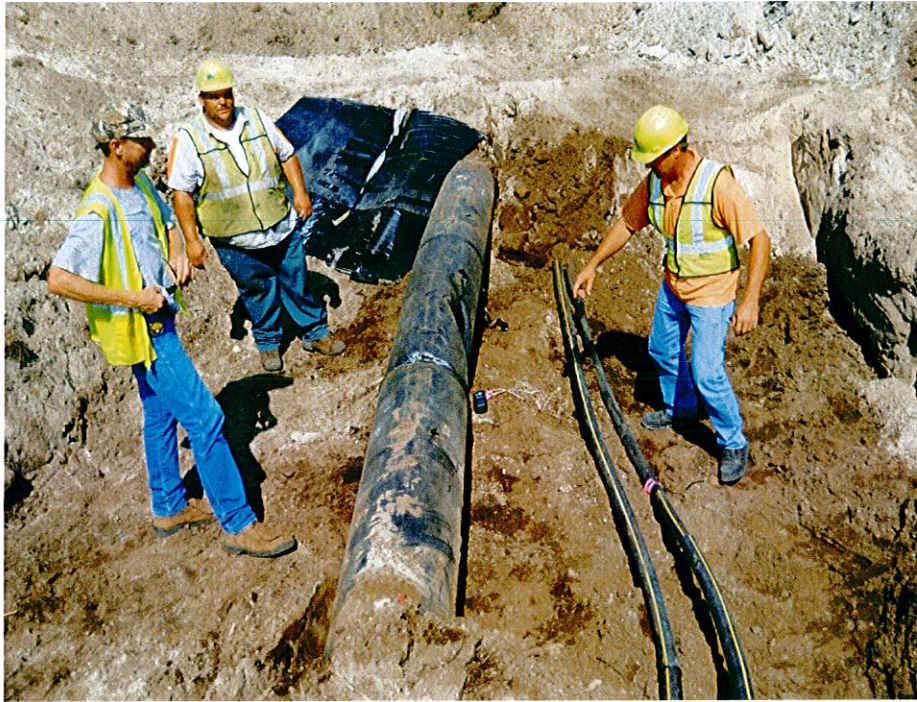
July 15, 2011 – Damaged GCCS Header Pipe on Section 8 north slope.

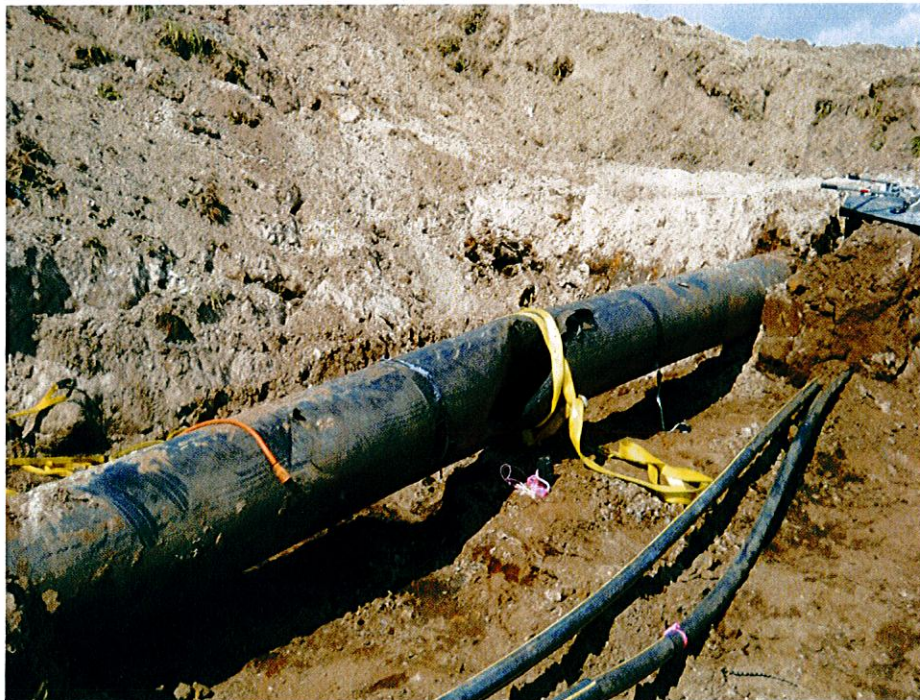
July 15, 2011 – Damaged GCCS Header Pipe on Section 8 north slope.

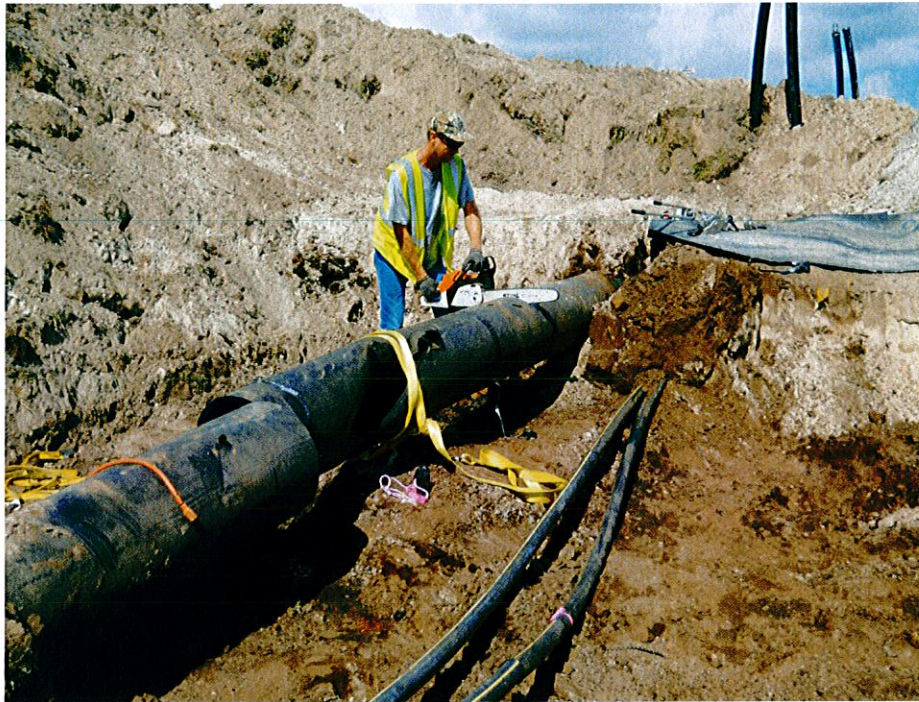
July 15, 2011 – Removing section of damaged pipe.

- 10:30 AM – ISCO cuts out damaged section of 16" header line (approximately 7.5 feet). Pipe ends and surrounding checked for gases. Gases present at west end of cut pipe. WMI uncapped LCO heads 8-1 and 8-2 to vent. Gases dissipated at pipe end, area checked OK, no gases, 20% oxygen.

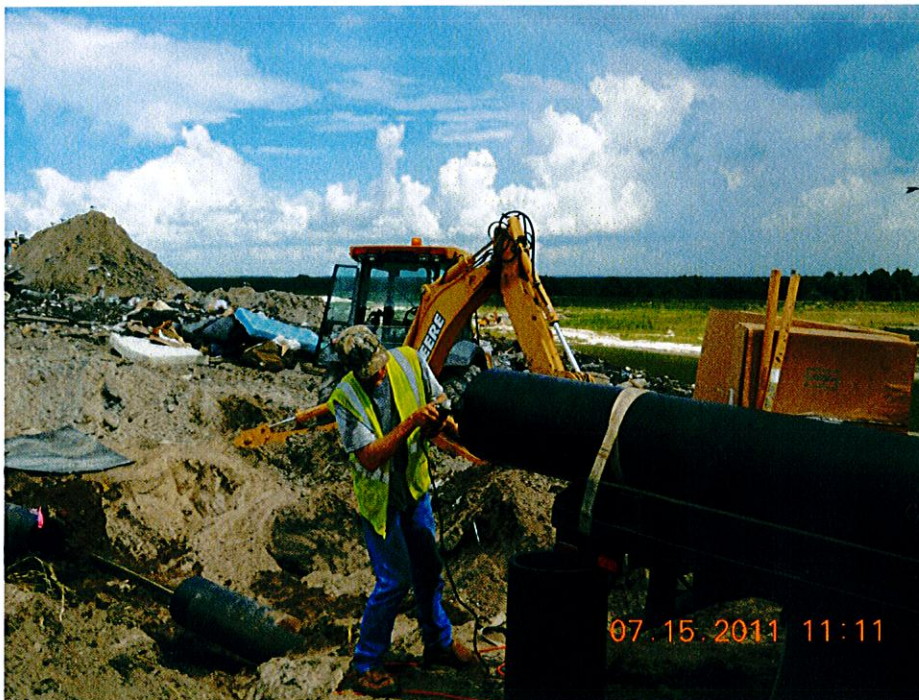
July 15, 2011 – Preparing ends of pipe for electrofusion couplings.

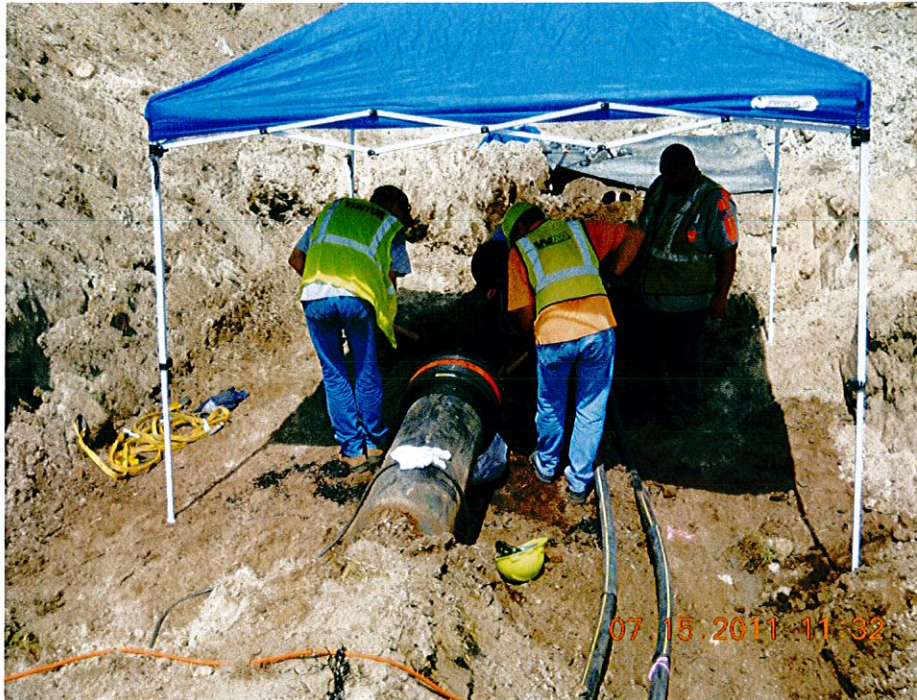
July 15, 2011 – Installing electrofusion couplings.

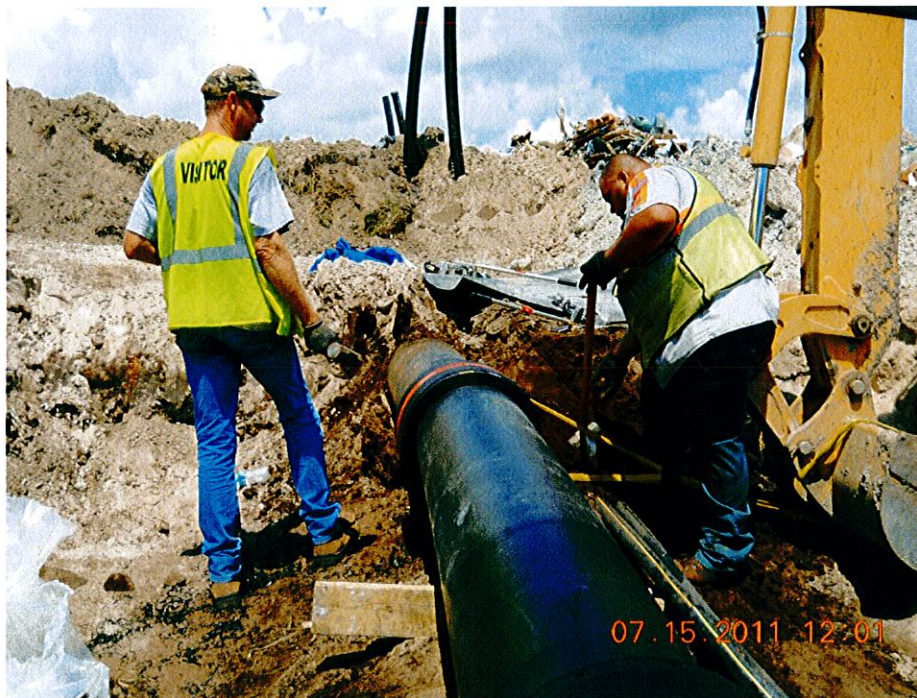
July 15, 2011 – Installing electrofusion couplings and aligning pipe

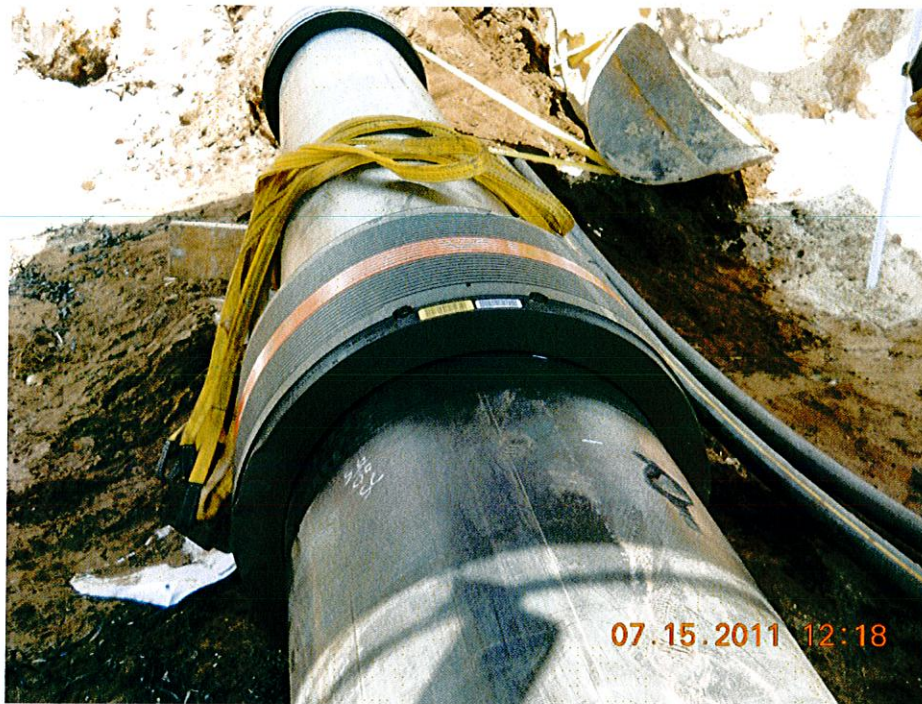
July 15, 2011 – Electrofusion coupling installed.

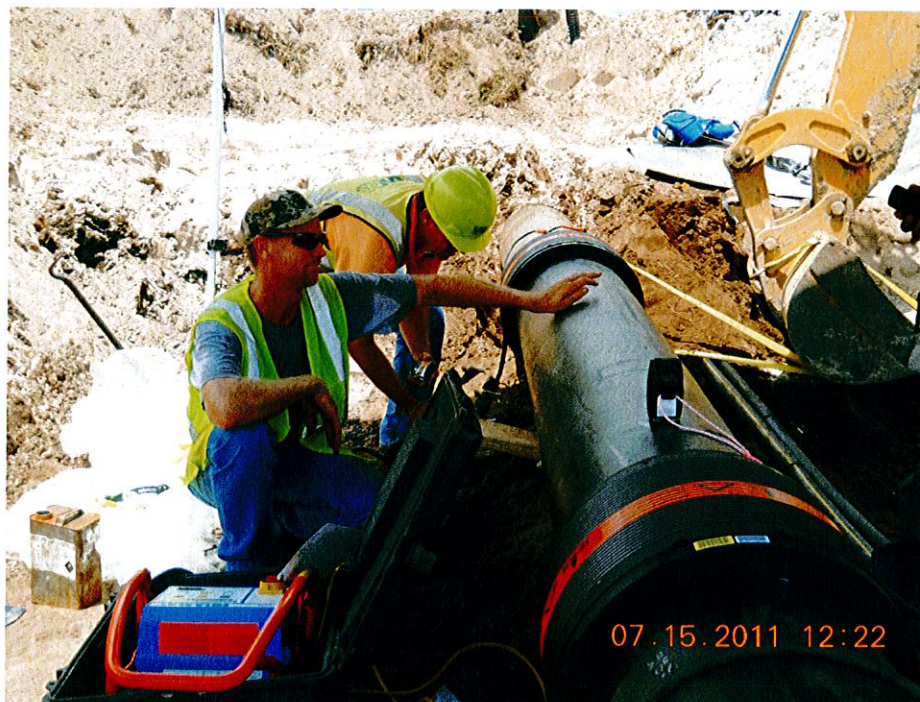
July 15, 2011 – Preheat and welding cycles for electrofusion welds.

- 12:15 PM – ISCO begin preheat cycles for each of the electrofusion ends - 2 for each couple (4 total at ~800 seconds per cycle).
- 1:30 PM – ISCO completes preheating for each end of coupling and begin welding cycling for each couple end – 2 for each couple (4 total at ~660 seconds per cycle). Weld #1 completed at 1:38PM, Weld #2 completed at 1:50PM, Weld #3 completed at 2:03PM, Weld #4 completed at 2:15PM – Allow 2 hour cool cycle, therefore pipe will not be pressurized until 4:30PM.

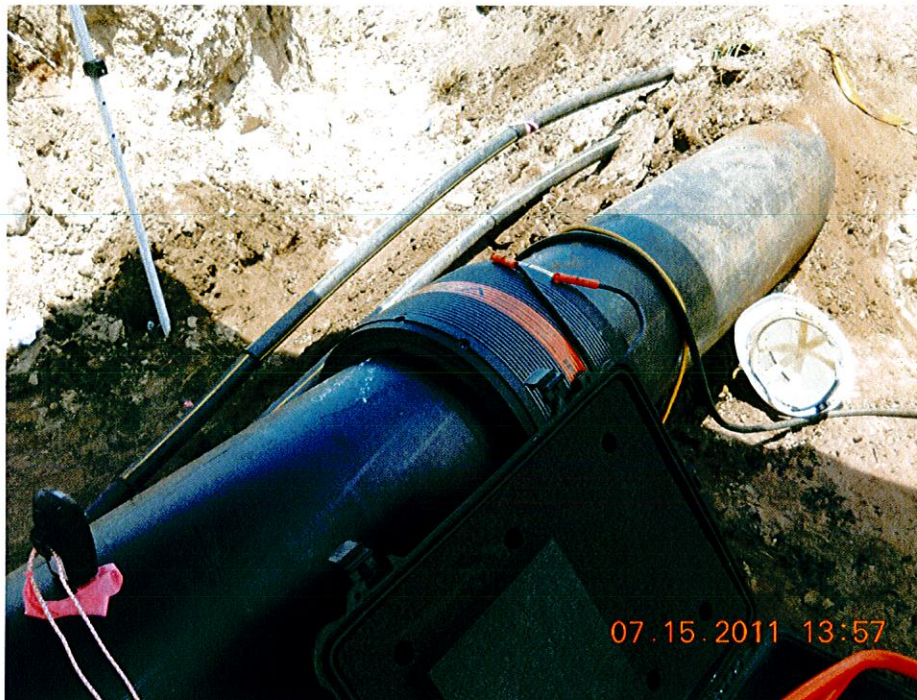
July 15, 2011 – Final welding cycle.

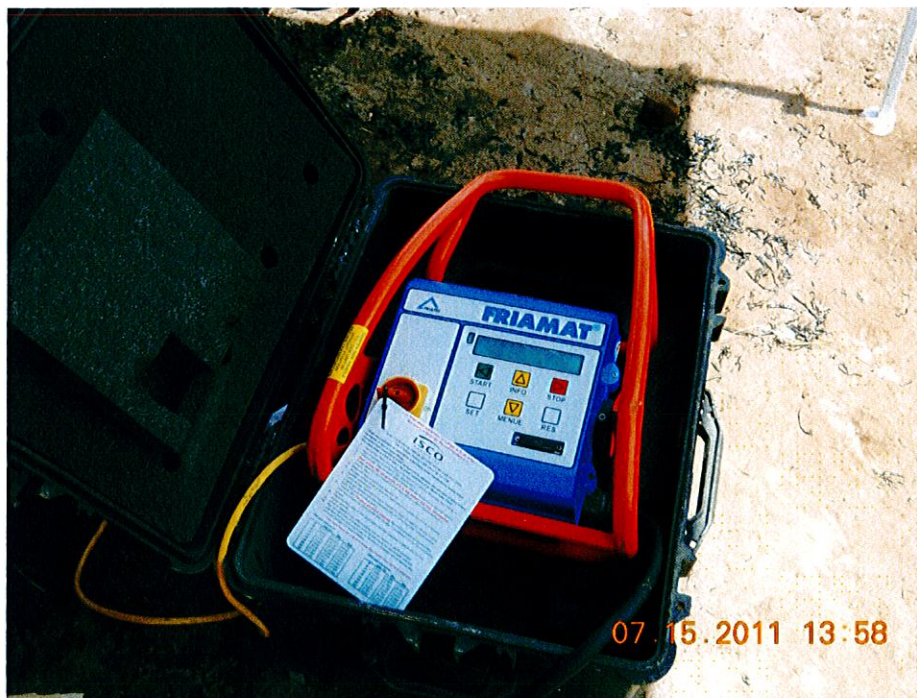
July 15, 2011 – Friatec Electrofusion Processor

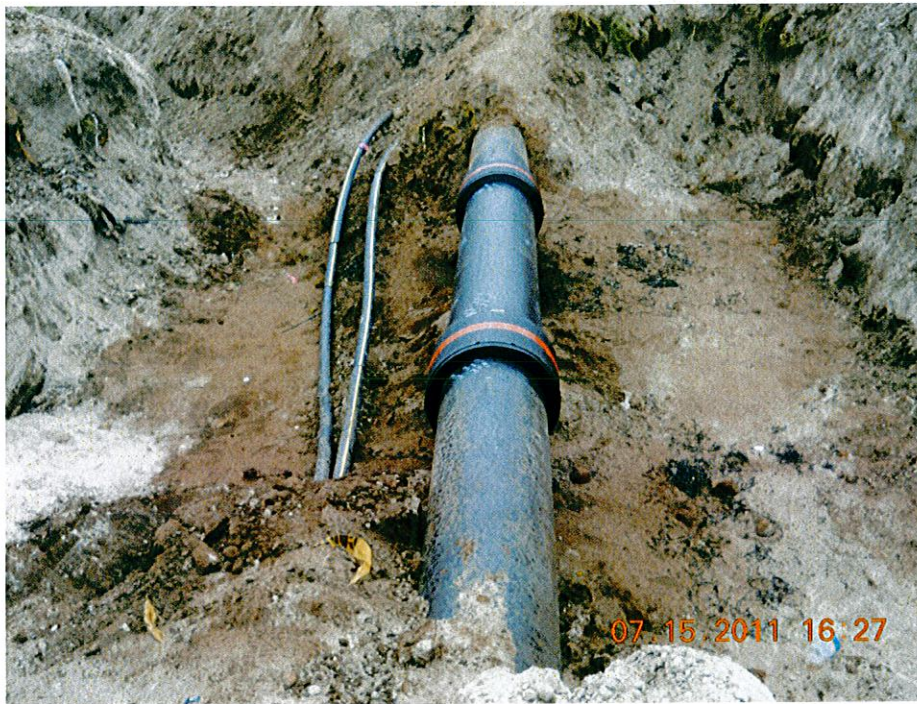
July 15, 2011 – Complete pipe repair installation. No leaks detected.

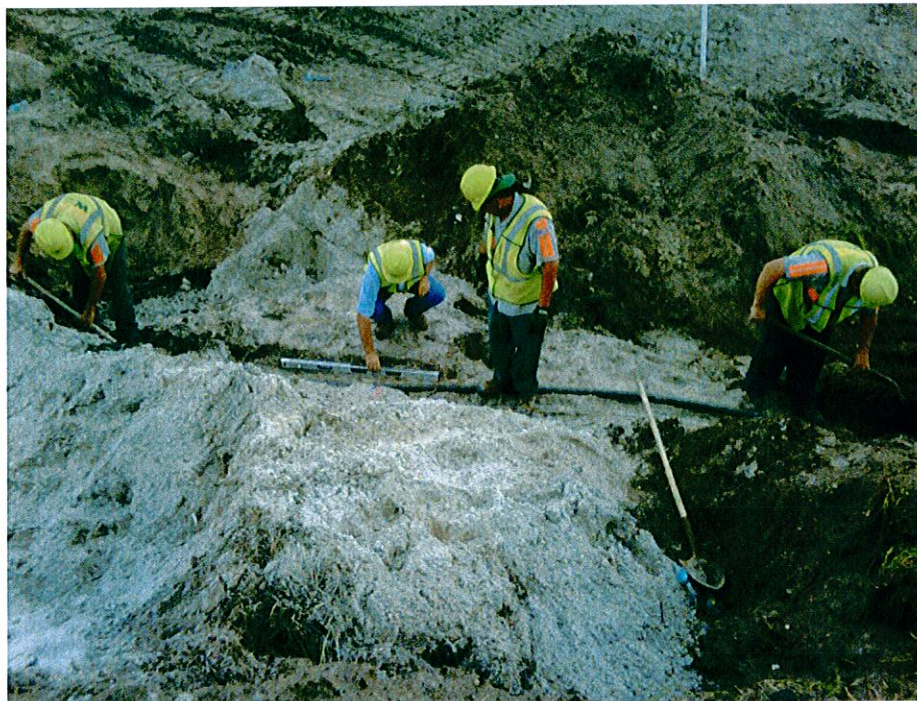
July 18, 2011 – Repair and placement of 2-inch air header line.

The 2-inch air supply piping was repaired by the landfill operator on July 14, 2011 and the 2-inch condensate piping was repaired by the landfill operator on July 18, 2011. Following repair of the 2-inch condensate line, the GCCS piping in the area of the damage was backfilled and brought to existing grades.
