## SCS ENGINEERS

August 12, 2011  
File No. 09207049.04

Subject: Response to RAI No. 2  
Citrus County Central Class I Landfill  
7-Acre Re-Closure Construction Certification  
Permit No. 21375-014-SF/01, Citrus County  
WACS No.: SWD/09/39859

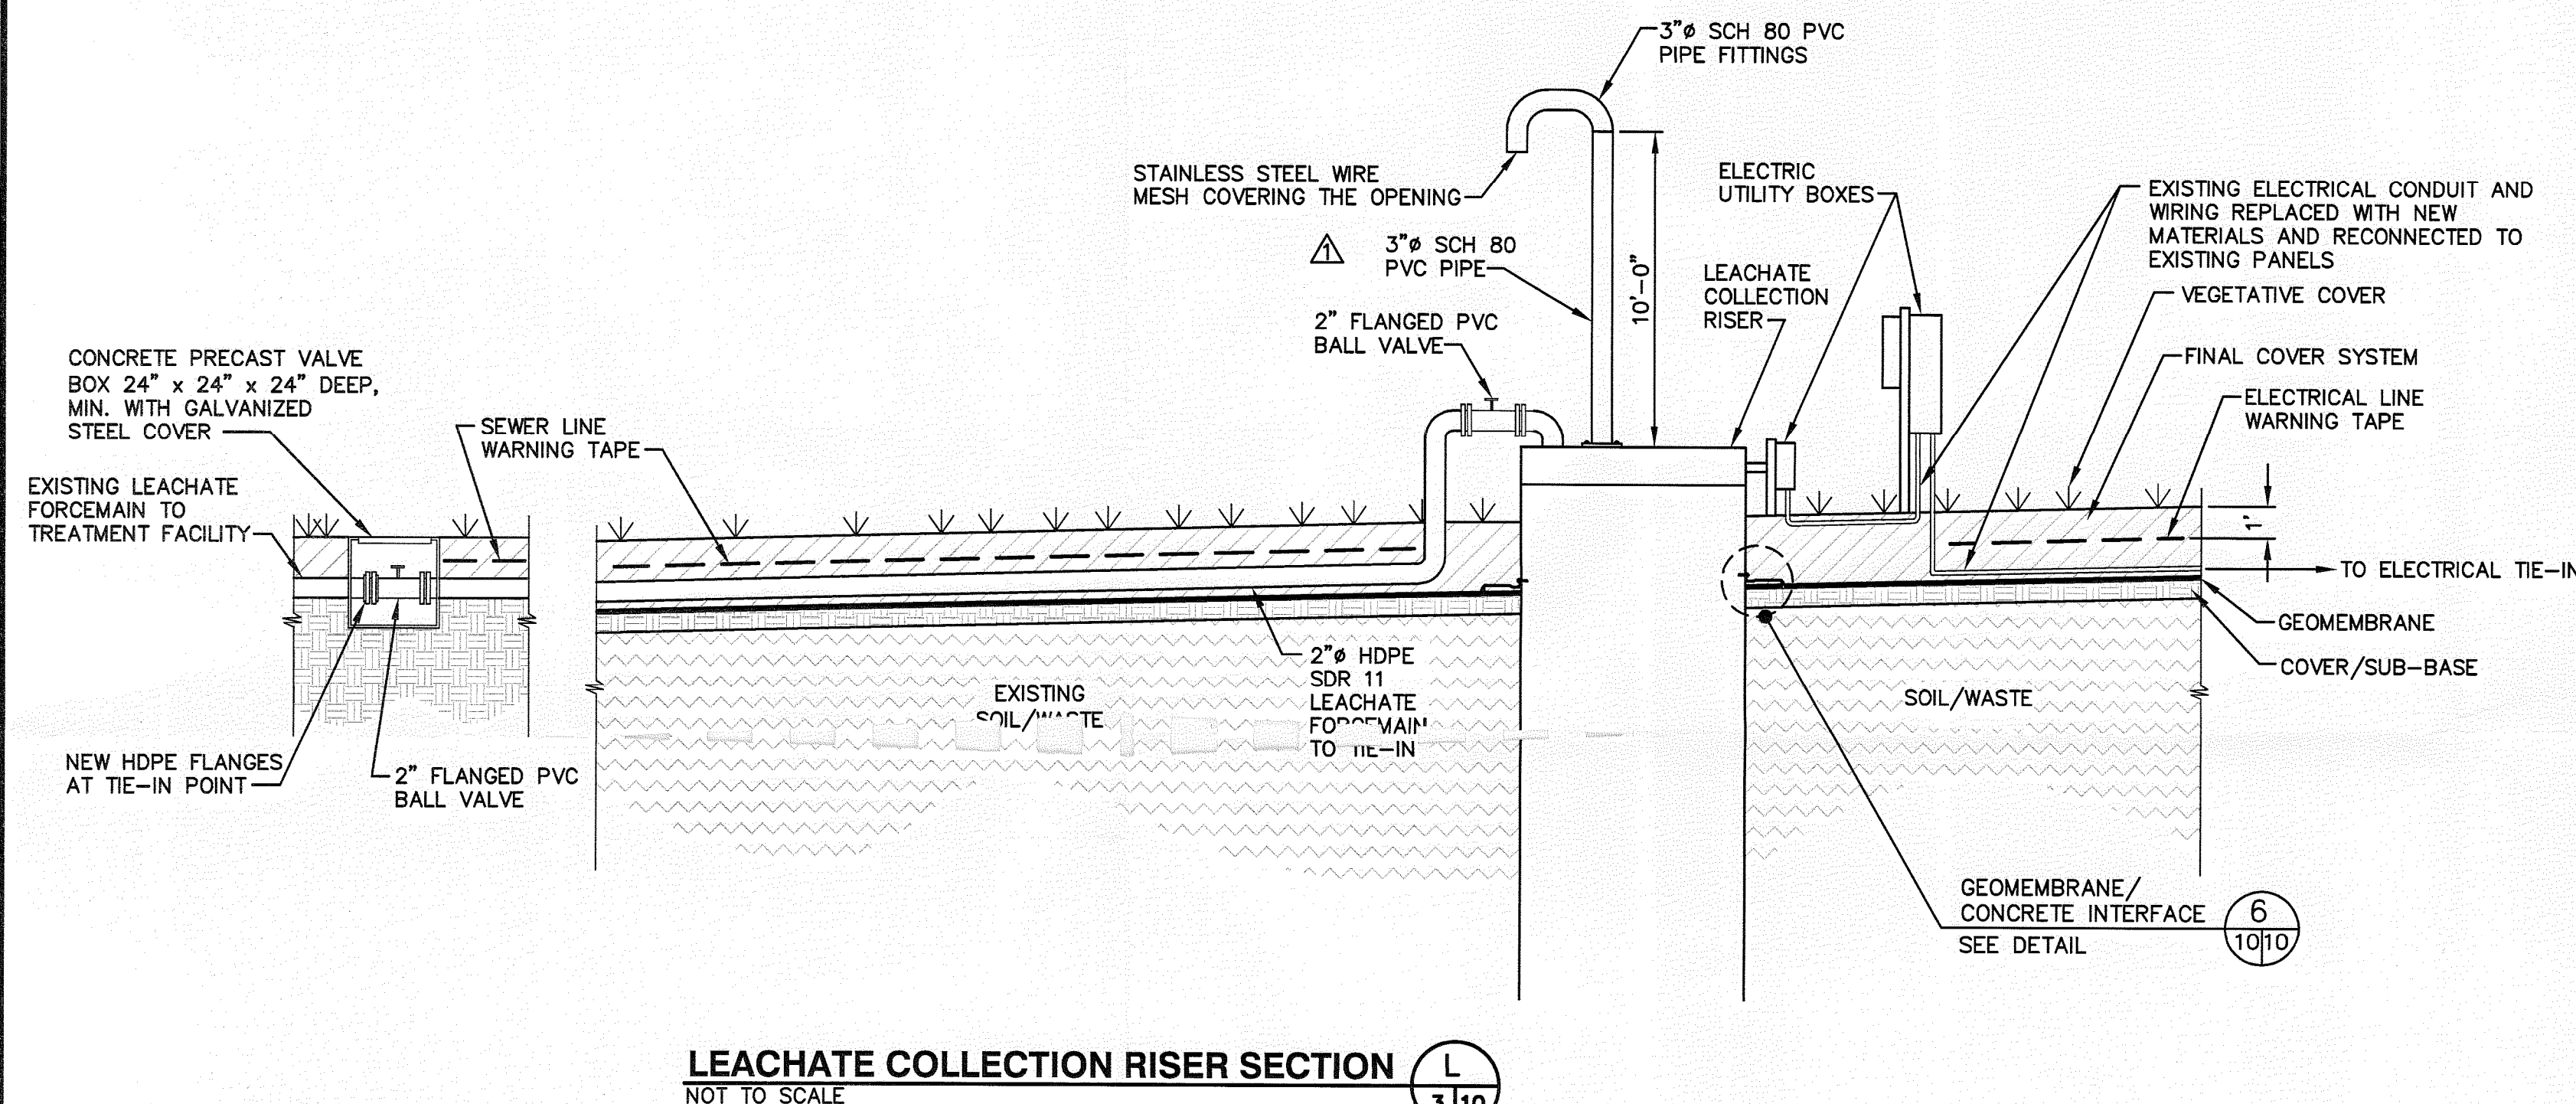
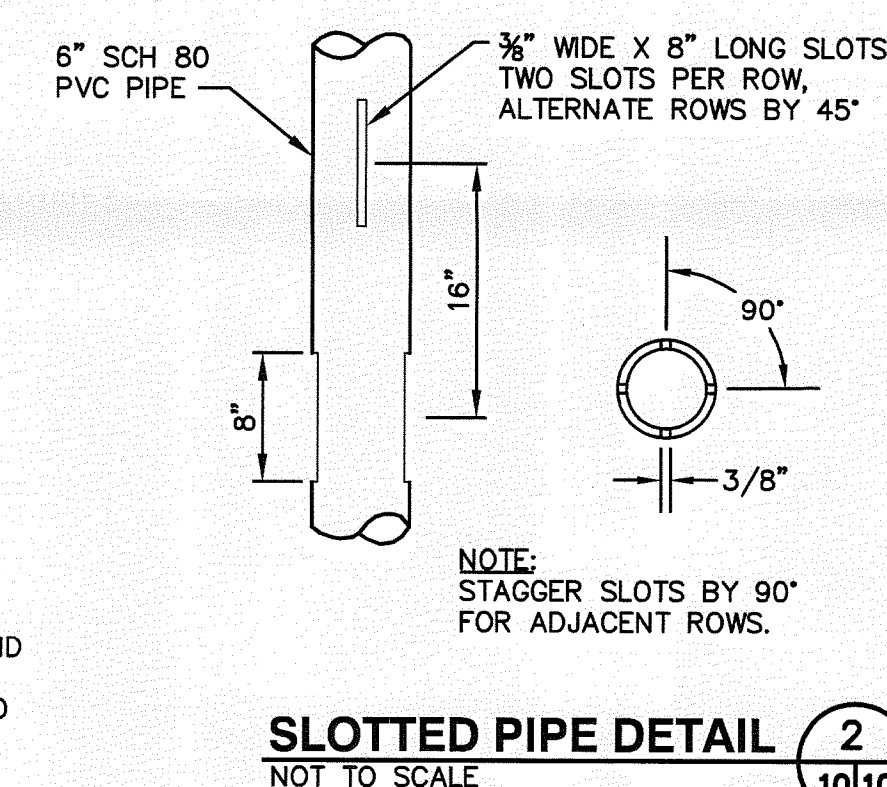
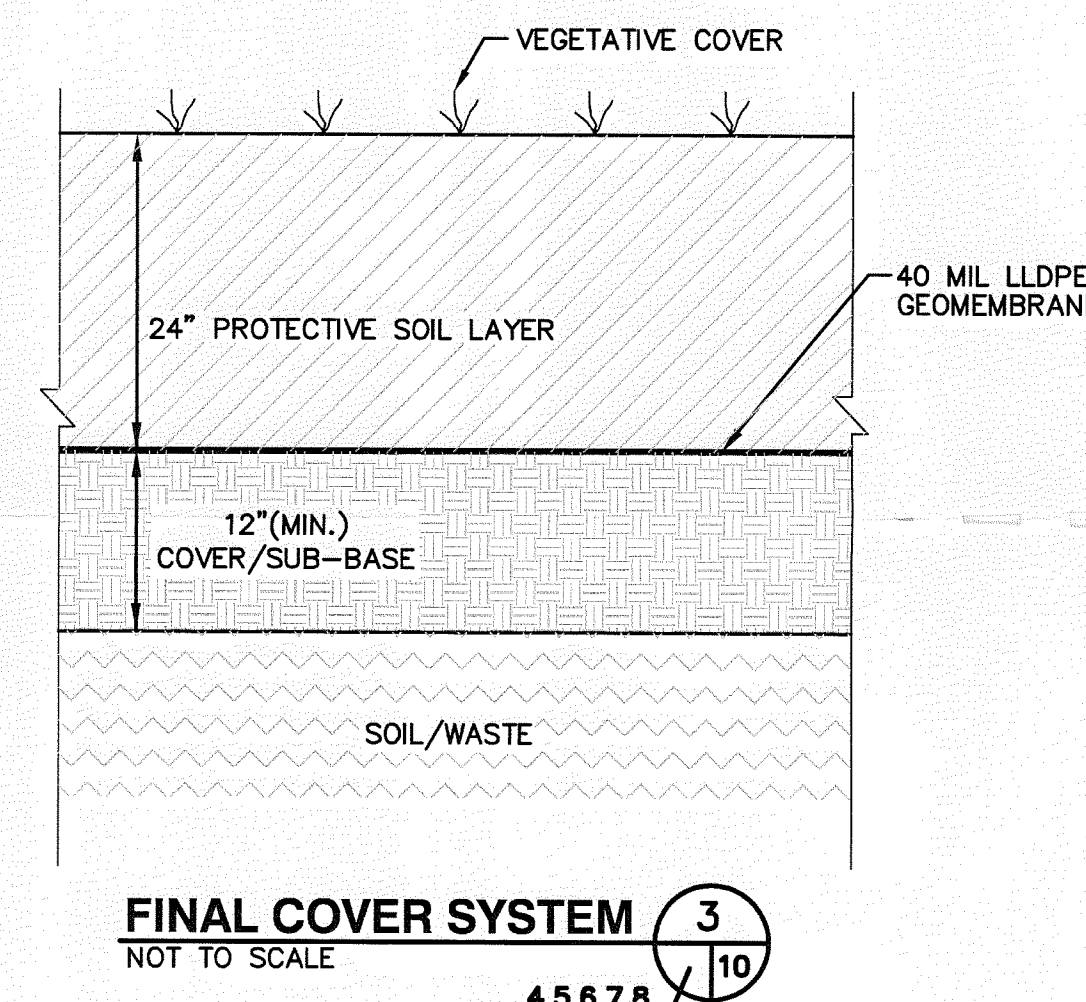
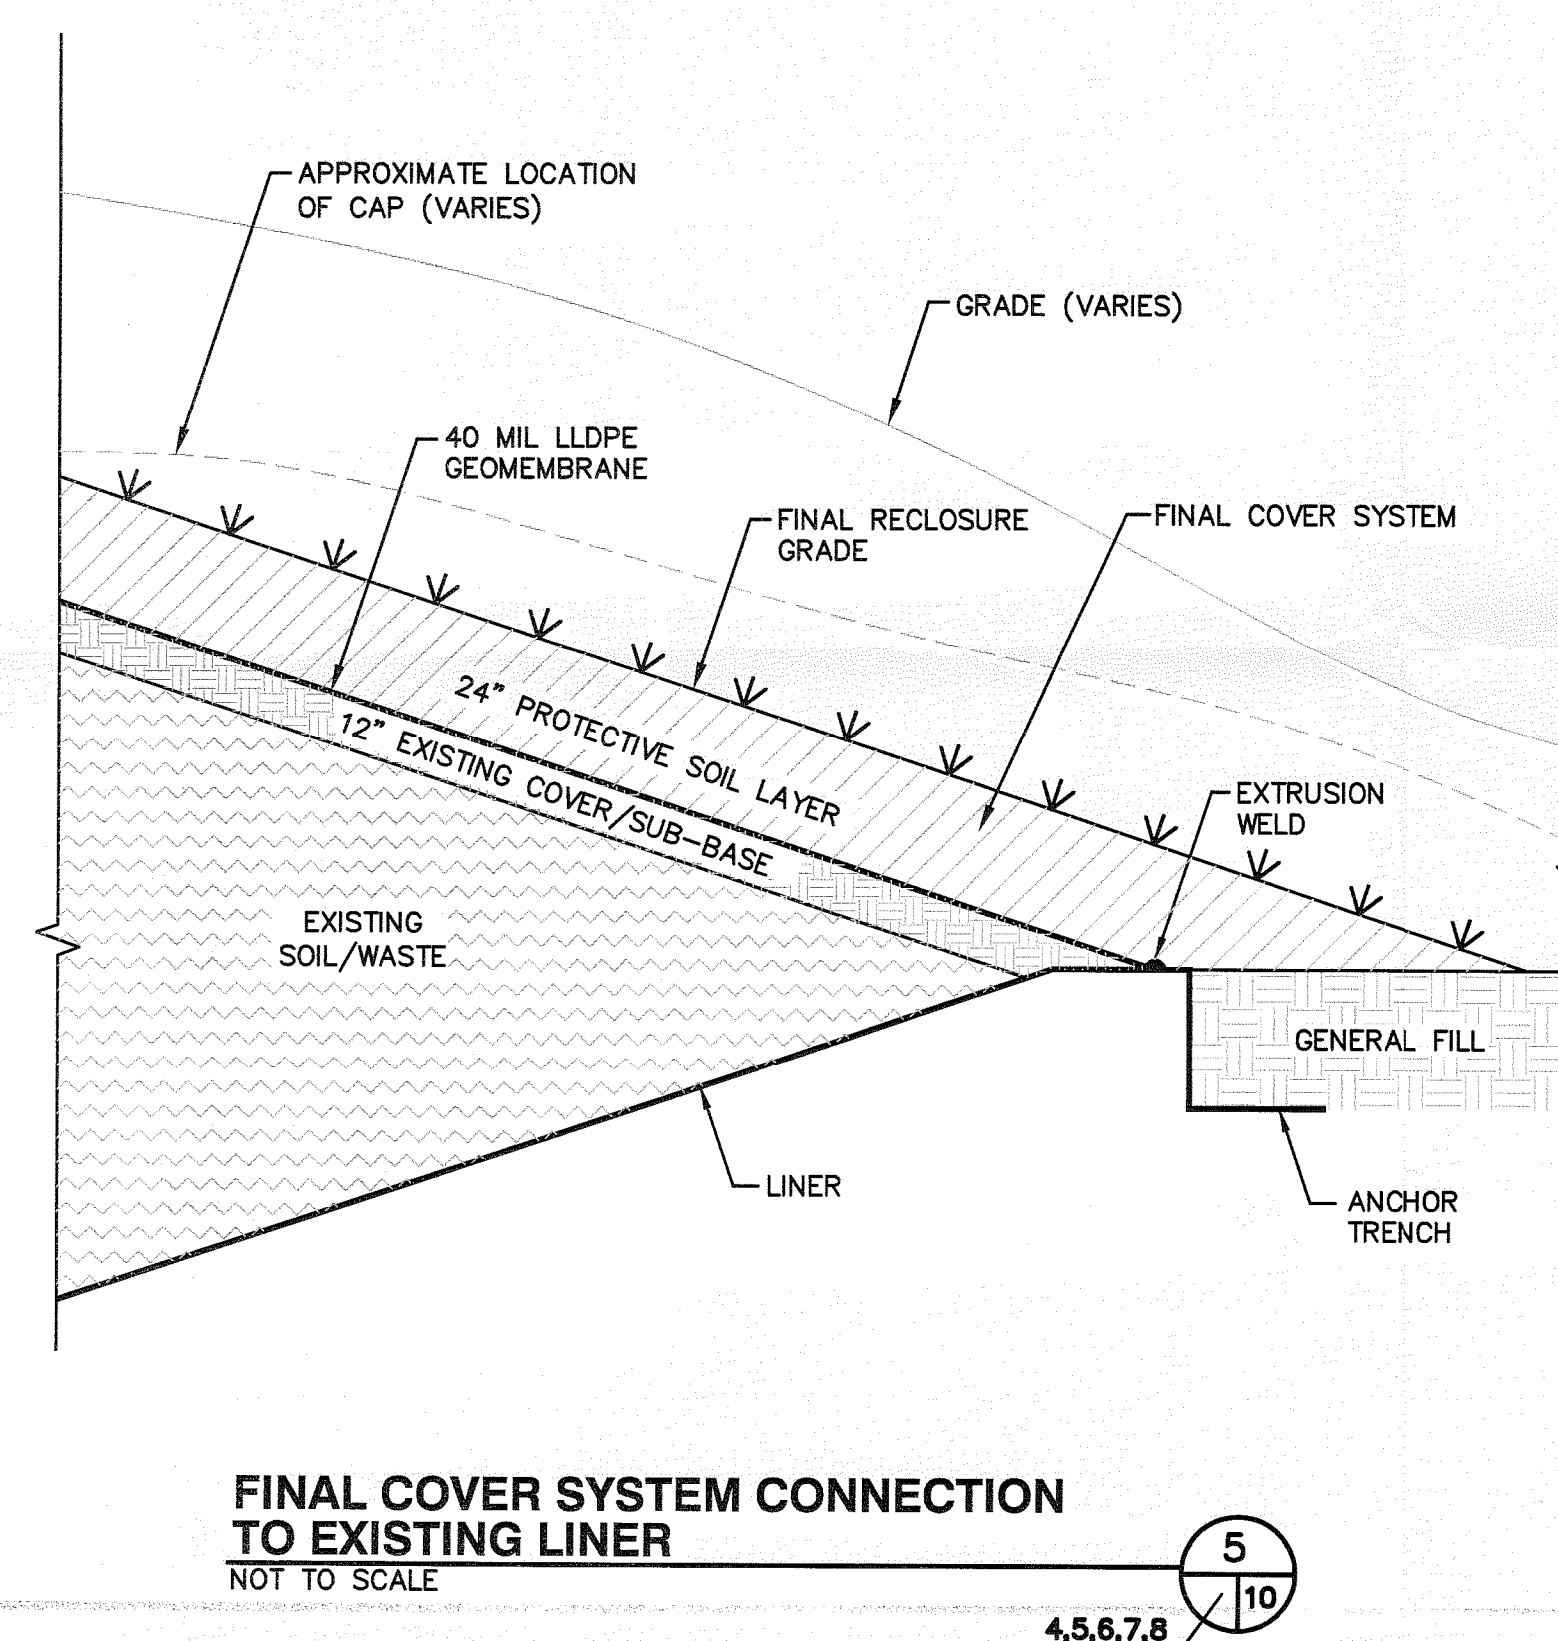
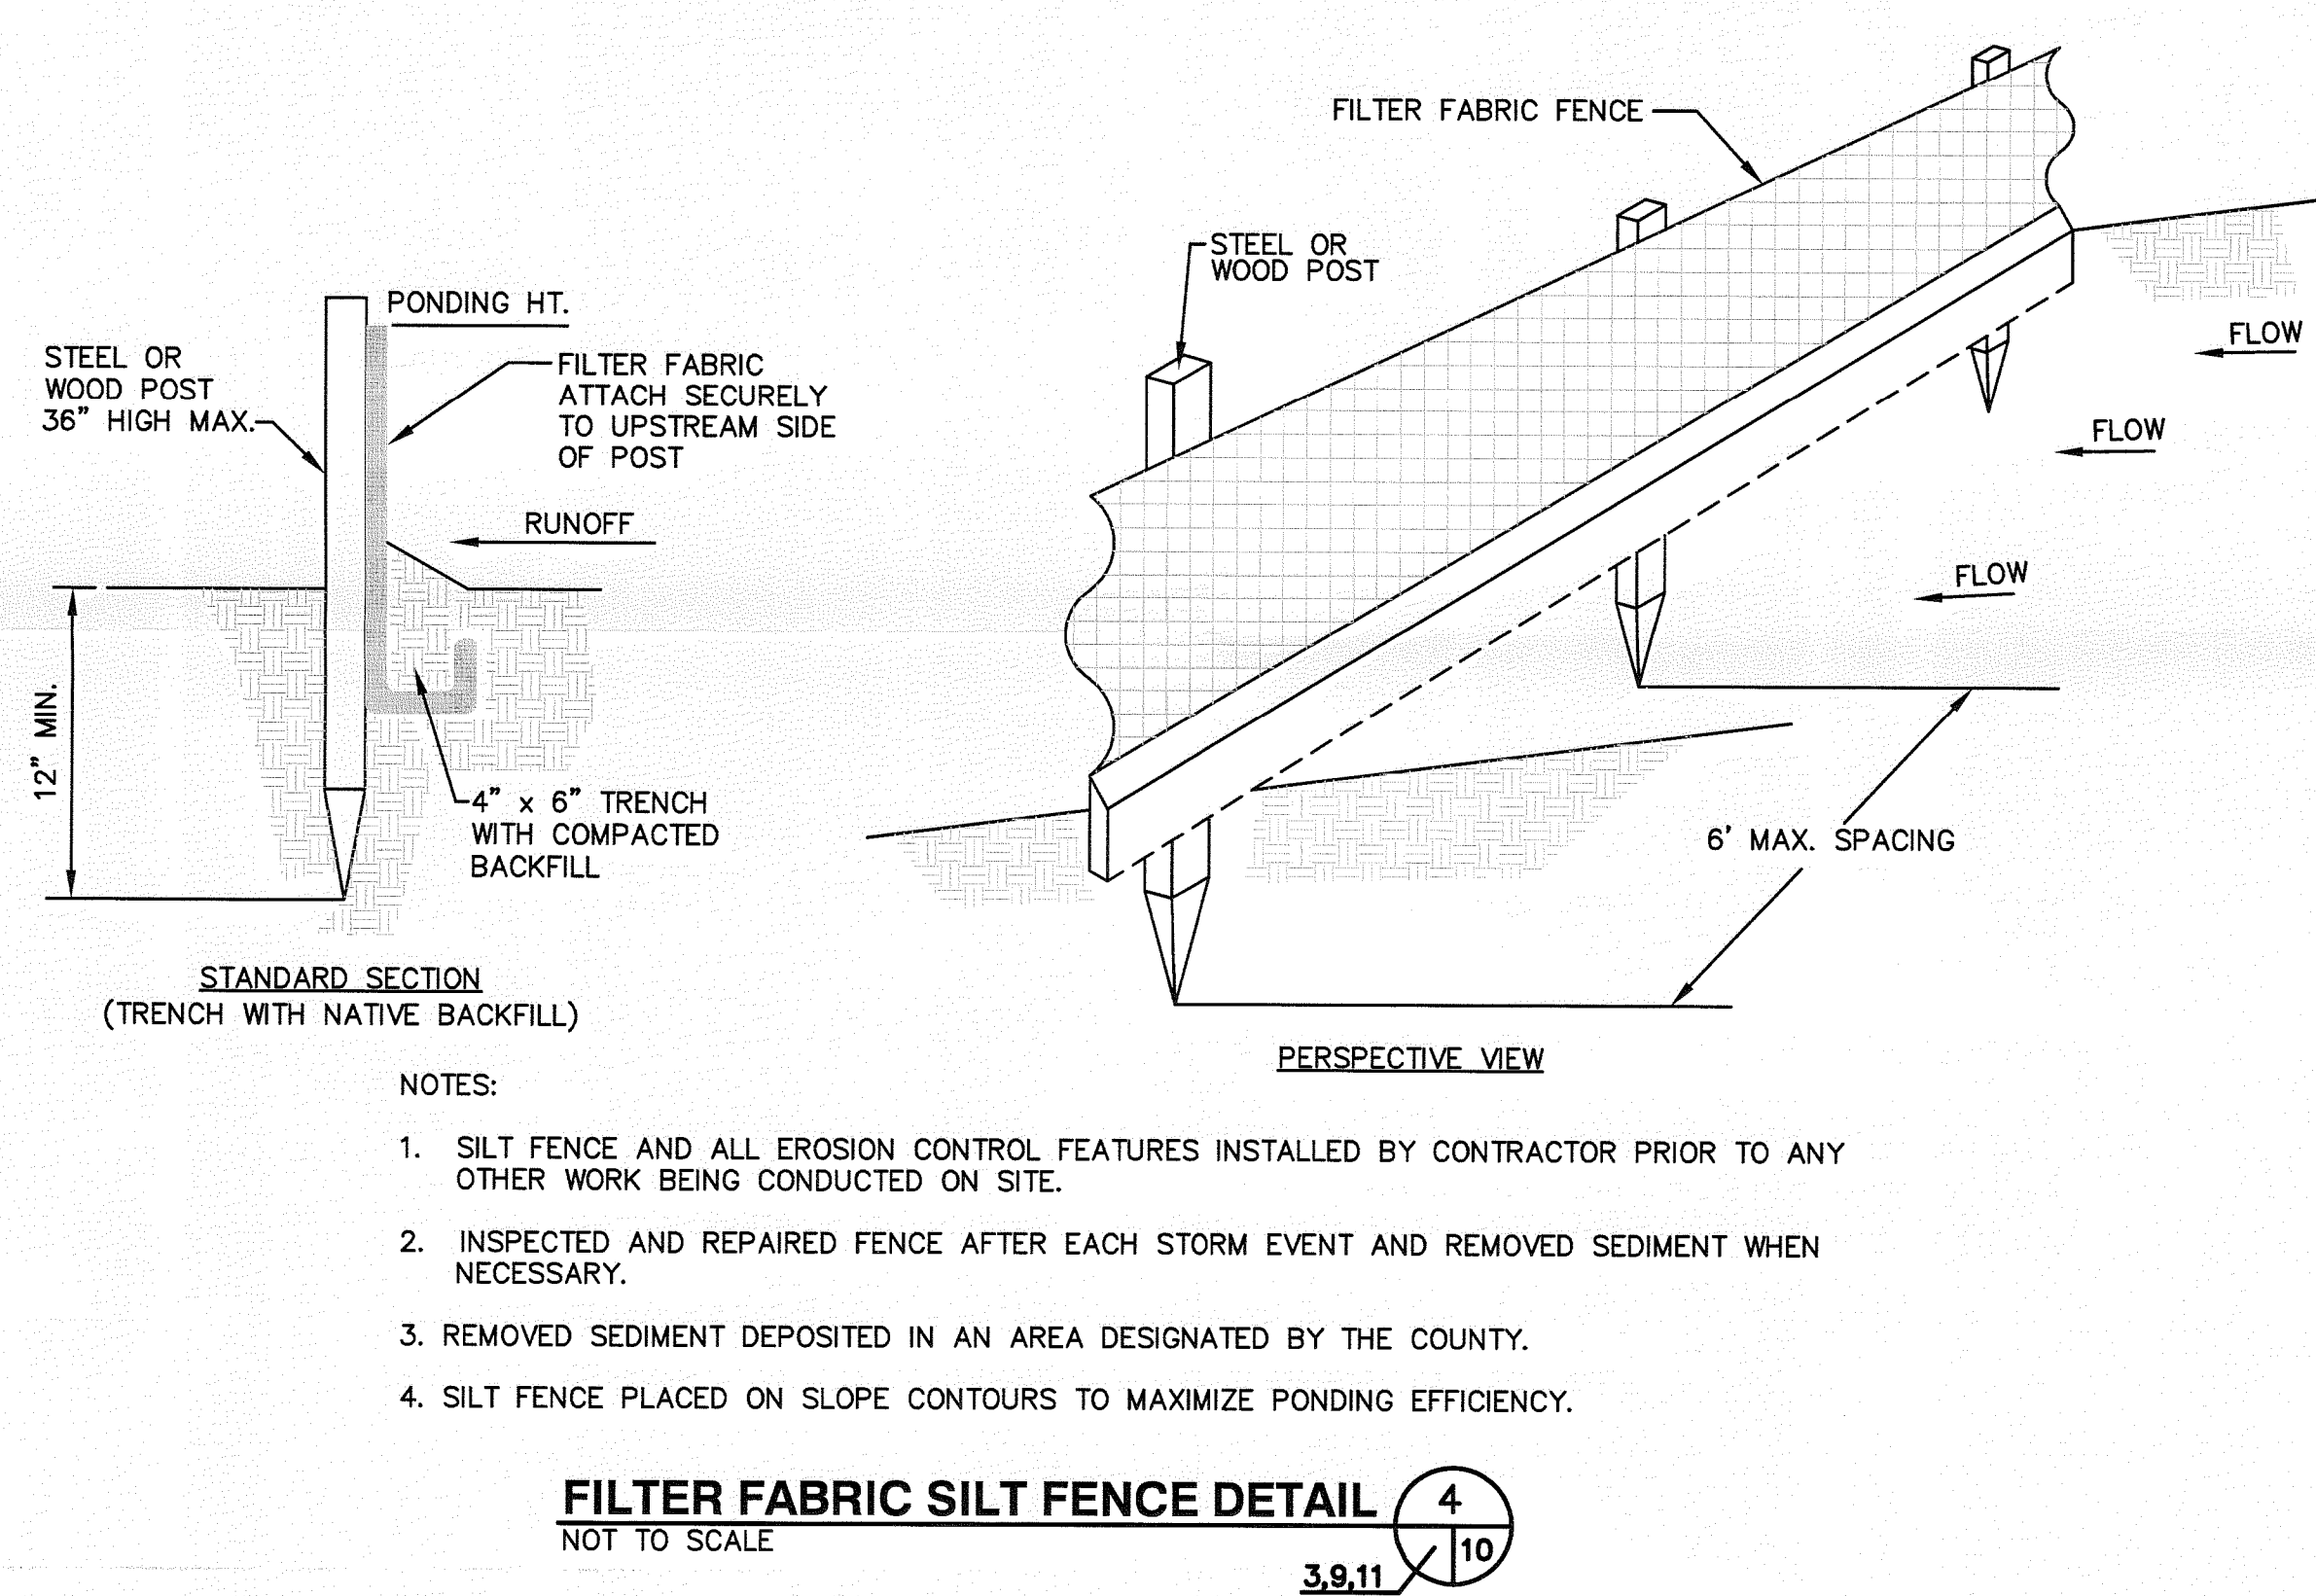
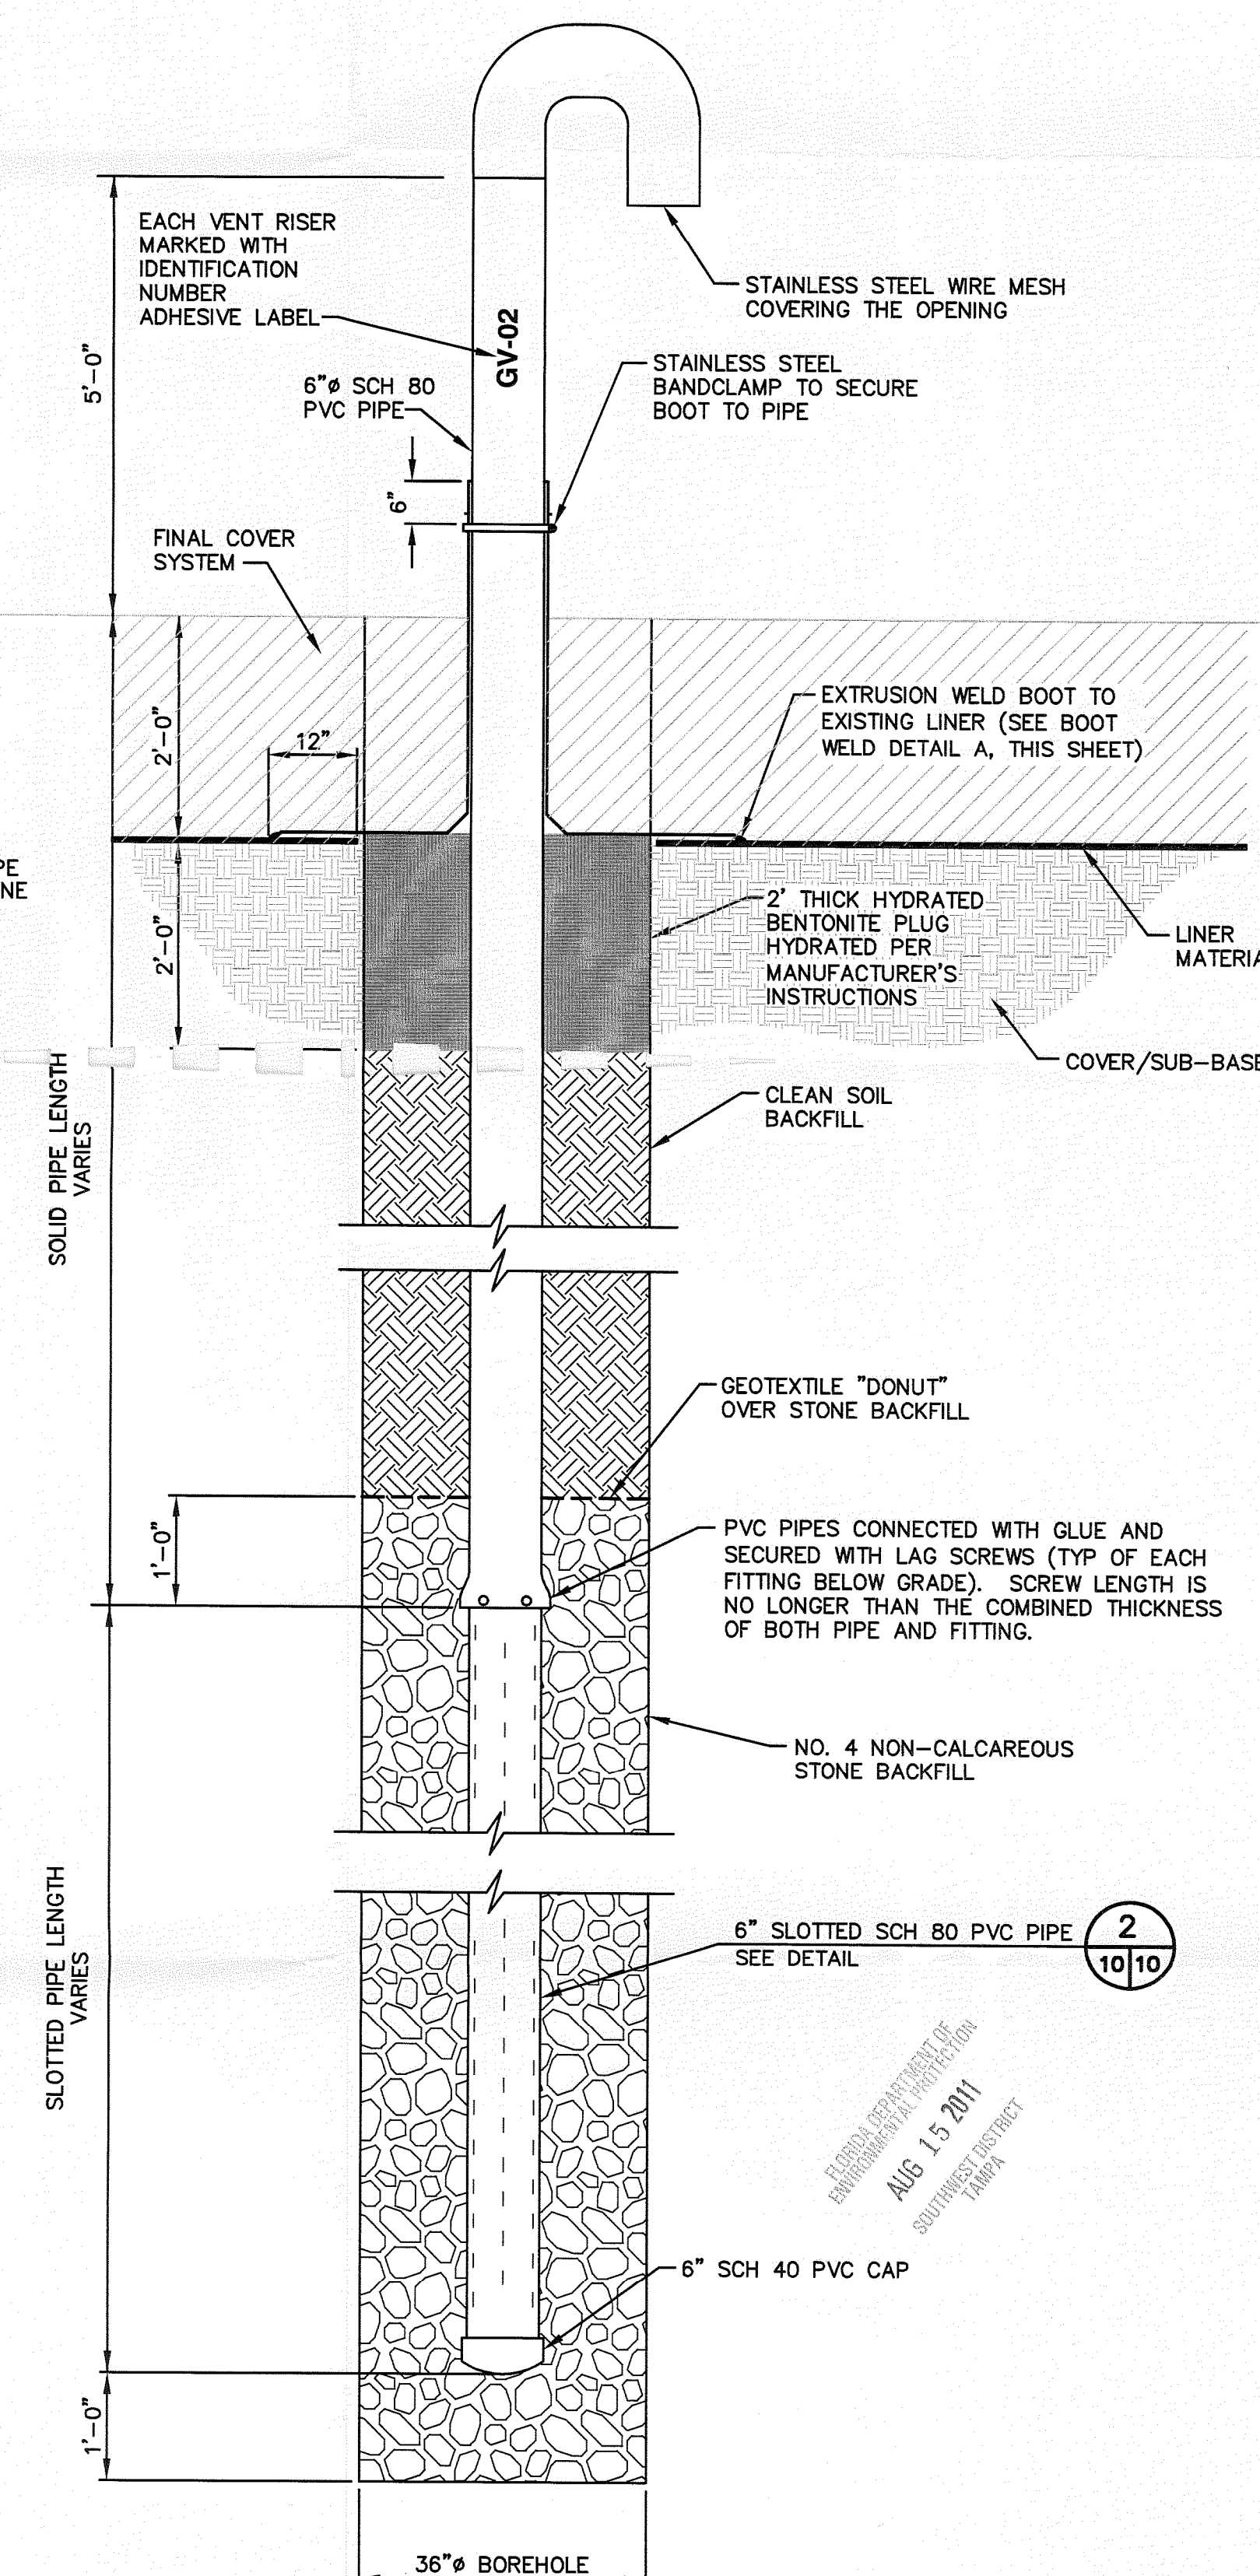
REVISED RECORD DRAWINGS SHEET 10 OF 27

**Vertical Gas Vents: Rule 62-701.530(1) (a)3., F.A.C. specifies that "Collection pipes, pathways, or vents shall (be designed to) collect gas from the upper two-thirds of the filled waste or where the most anaerobic conditions exist". Based on a review of the gas vent depths reported on the Vent Schedule on Sheet 10 of 27 of the Record Drawings, gas vents GV-2, GV-3, and GV-6 do not appear to meet this criterion.**

a. The February 9, 2011 response letter refers to the shortening of the three gas vents (GV-2, GV-3, and GV-6) "by approximately 7 ft each". The Vent Schedule indicates that these vents were shortened by 14 ft, 14 ft, and 19 ft respectively. Please verify and explain this discrepancy.

Response: Gas vents GV-2 and GV-3 and GV-6 were all drilled to 35 feet as indicated on the well logs submitted with the original Report of Construction dated August 31, 2010. All the gas vents were originally designed to be 50 feet deep with 49 feet of perforated and solid pipe below grade. Of the pipe below grade 19 feet was

designed to be solid and 30 feet to be perforated.

Once construction commenced the actual ground elevations at the vent locations were surveyed and elevations were lower than expected. i.e. Vent GV-1 design ground elevation = 129 feet, actual ground elevation = 125 feet. It was also decided during construction to drill the wells 15 feet less than the estimated depth of waste instead of the originally designed 10 feet to assure no encounters with the bottom liner system since the settlement had been so significant and the bottom liner elevation data was very old. This resulted in new design boring depths for all of the wells. The wells in question had new design depths of 42 feet for GV-2, 41 feet for GV-3 and 43 feet for GV-6. The statement made in the February 9, 2011 response was stating that the 35 feet drill depth achieved was approximately 7 feet less than the new design depths determined during construction. Actually 7 ft, 6 ft and 7 ft for vents GV-2, GV-3 and GV-6 respectively. The vent schedule with that submittal on sheet 10 of 27 indicated the actual depth of refuse and actual boring depths, however this drawings did have three inaccurate values, which were the boring depth of GV-3, which should be 35 feet instead of 41 feet, the slotted pipe length of GV-6, which should be 15 feet instead of 11 feet and the slotted pipe length of GV-2, which should be 15 feet instead of 16 feet. Attachment 1 contains a new Sheet 10 with the corrections noted. And Attachment 2 contains corrected drilling logs for vents GV-2 and GV-6.

**Response:** Attachment 1 contains a new Sheet 10 in which the correct well depths, solid and slotted pipe lengths are given and noted. Attachment 3 contains a revised boring log for GV-6 in which the 11 feet of slotted pipe has been increased to 15 to indicate the appropriate amount of installed pipe.

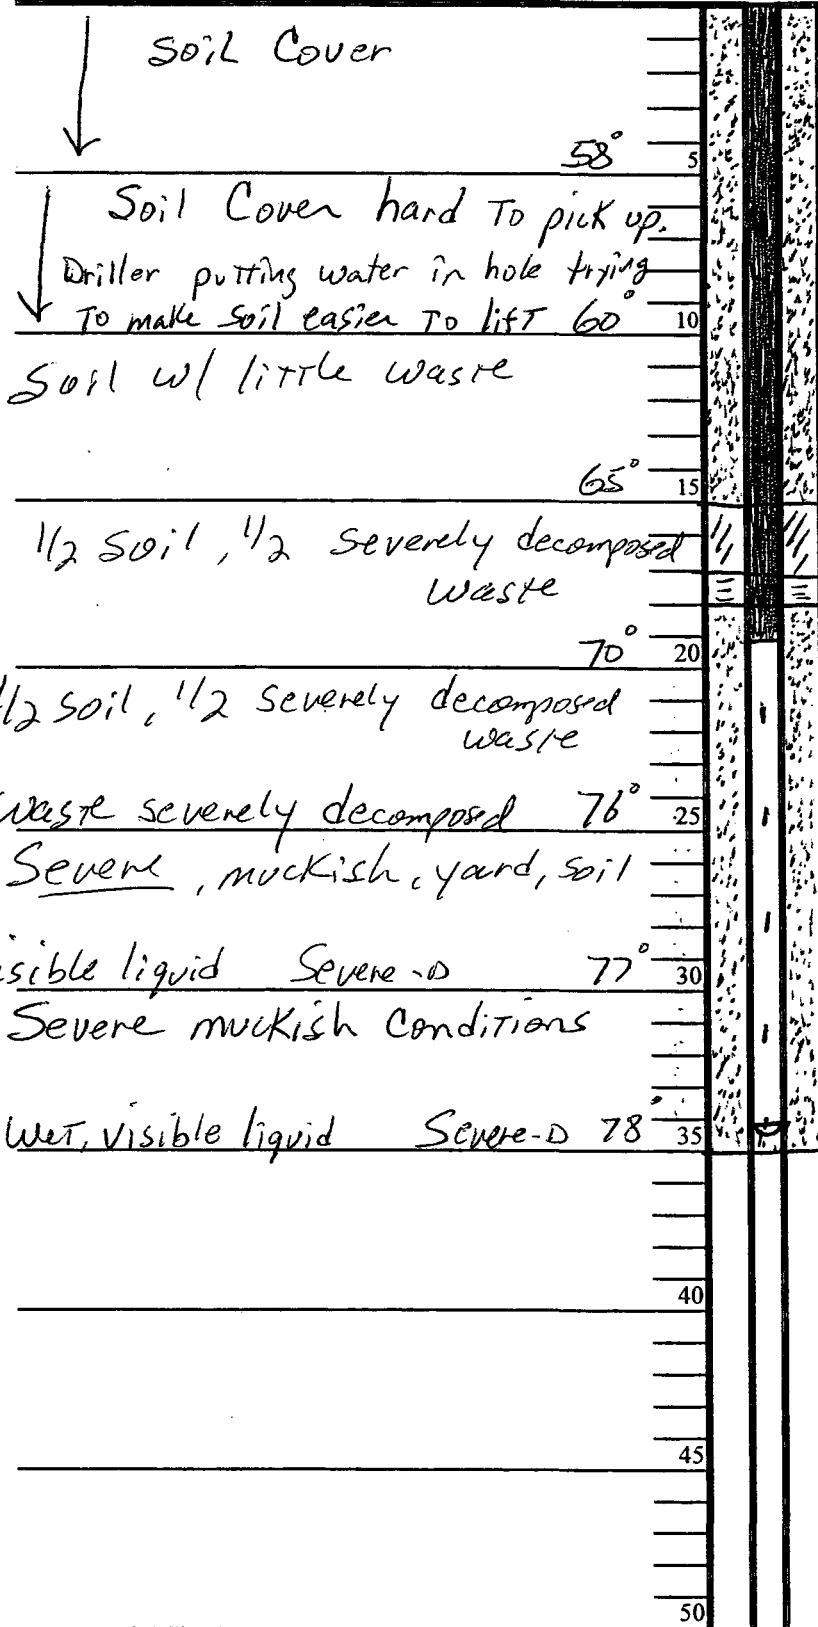
Site Name: \_\_\_\_\_ Well Number: **GV-06**  
 Project #: \_\_\_\_\_ Coordinates: \_\_\_\_\_  
 Start Date: \_\_\_\_\_ Surface Elevation: **126.00**  
 Completed: \_\_\_\_\_ Top of Casing Elevation: **133.00**

COMPLETION LOG	
RISER STICK UP	7'
RISER BELOW	19'
SLOTTED PIPE	16' 15'
BACKFILL	15'
HYDRATE	✓
BENTONITE #1	2'
BACKFILL	1'
DONUT	✓
GRAVEL PACK	18'
Stone	
Structural fill	
Bentonite fill	
MATERIALS LIST	
TOP CAP	✓
SOLID PIPE	7' + 19'
SLOTTED PIPE	16' 15'
BOTTOM CAP	✓
BENTONITE	12 bags
BACKFILL	15' + 1'
STONE	18'

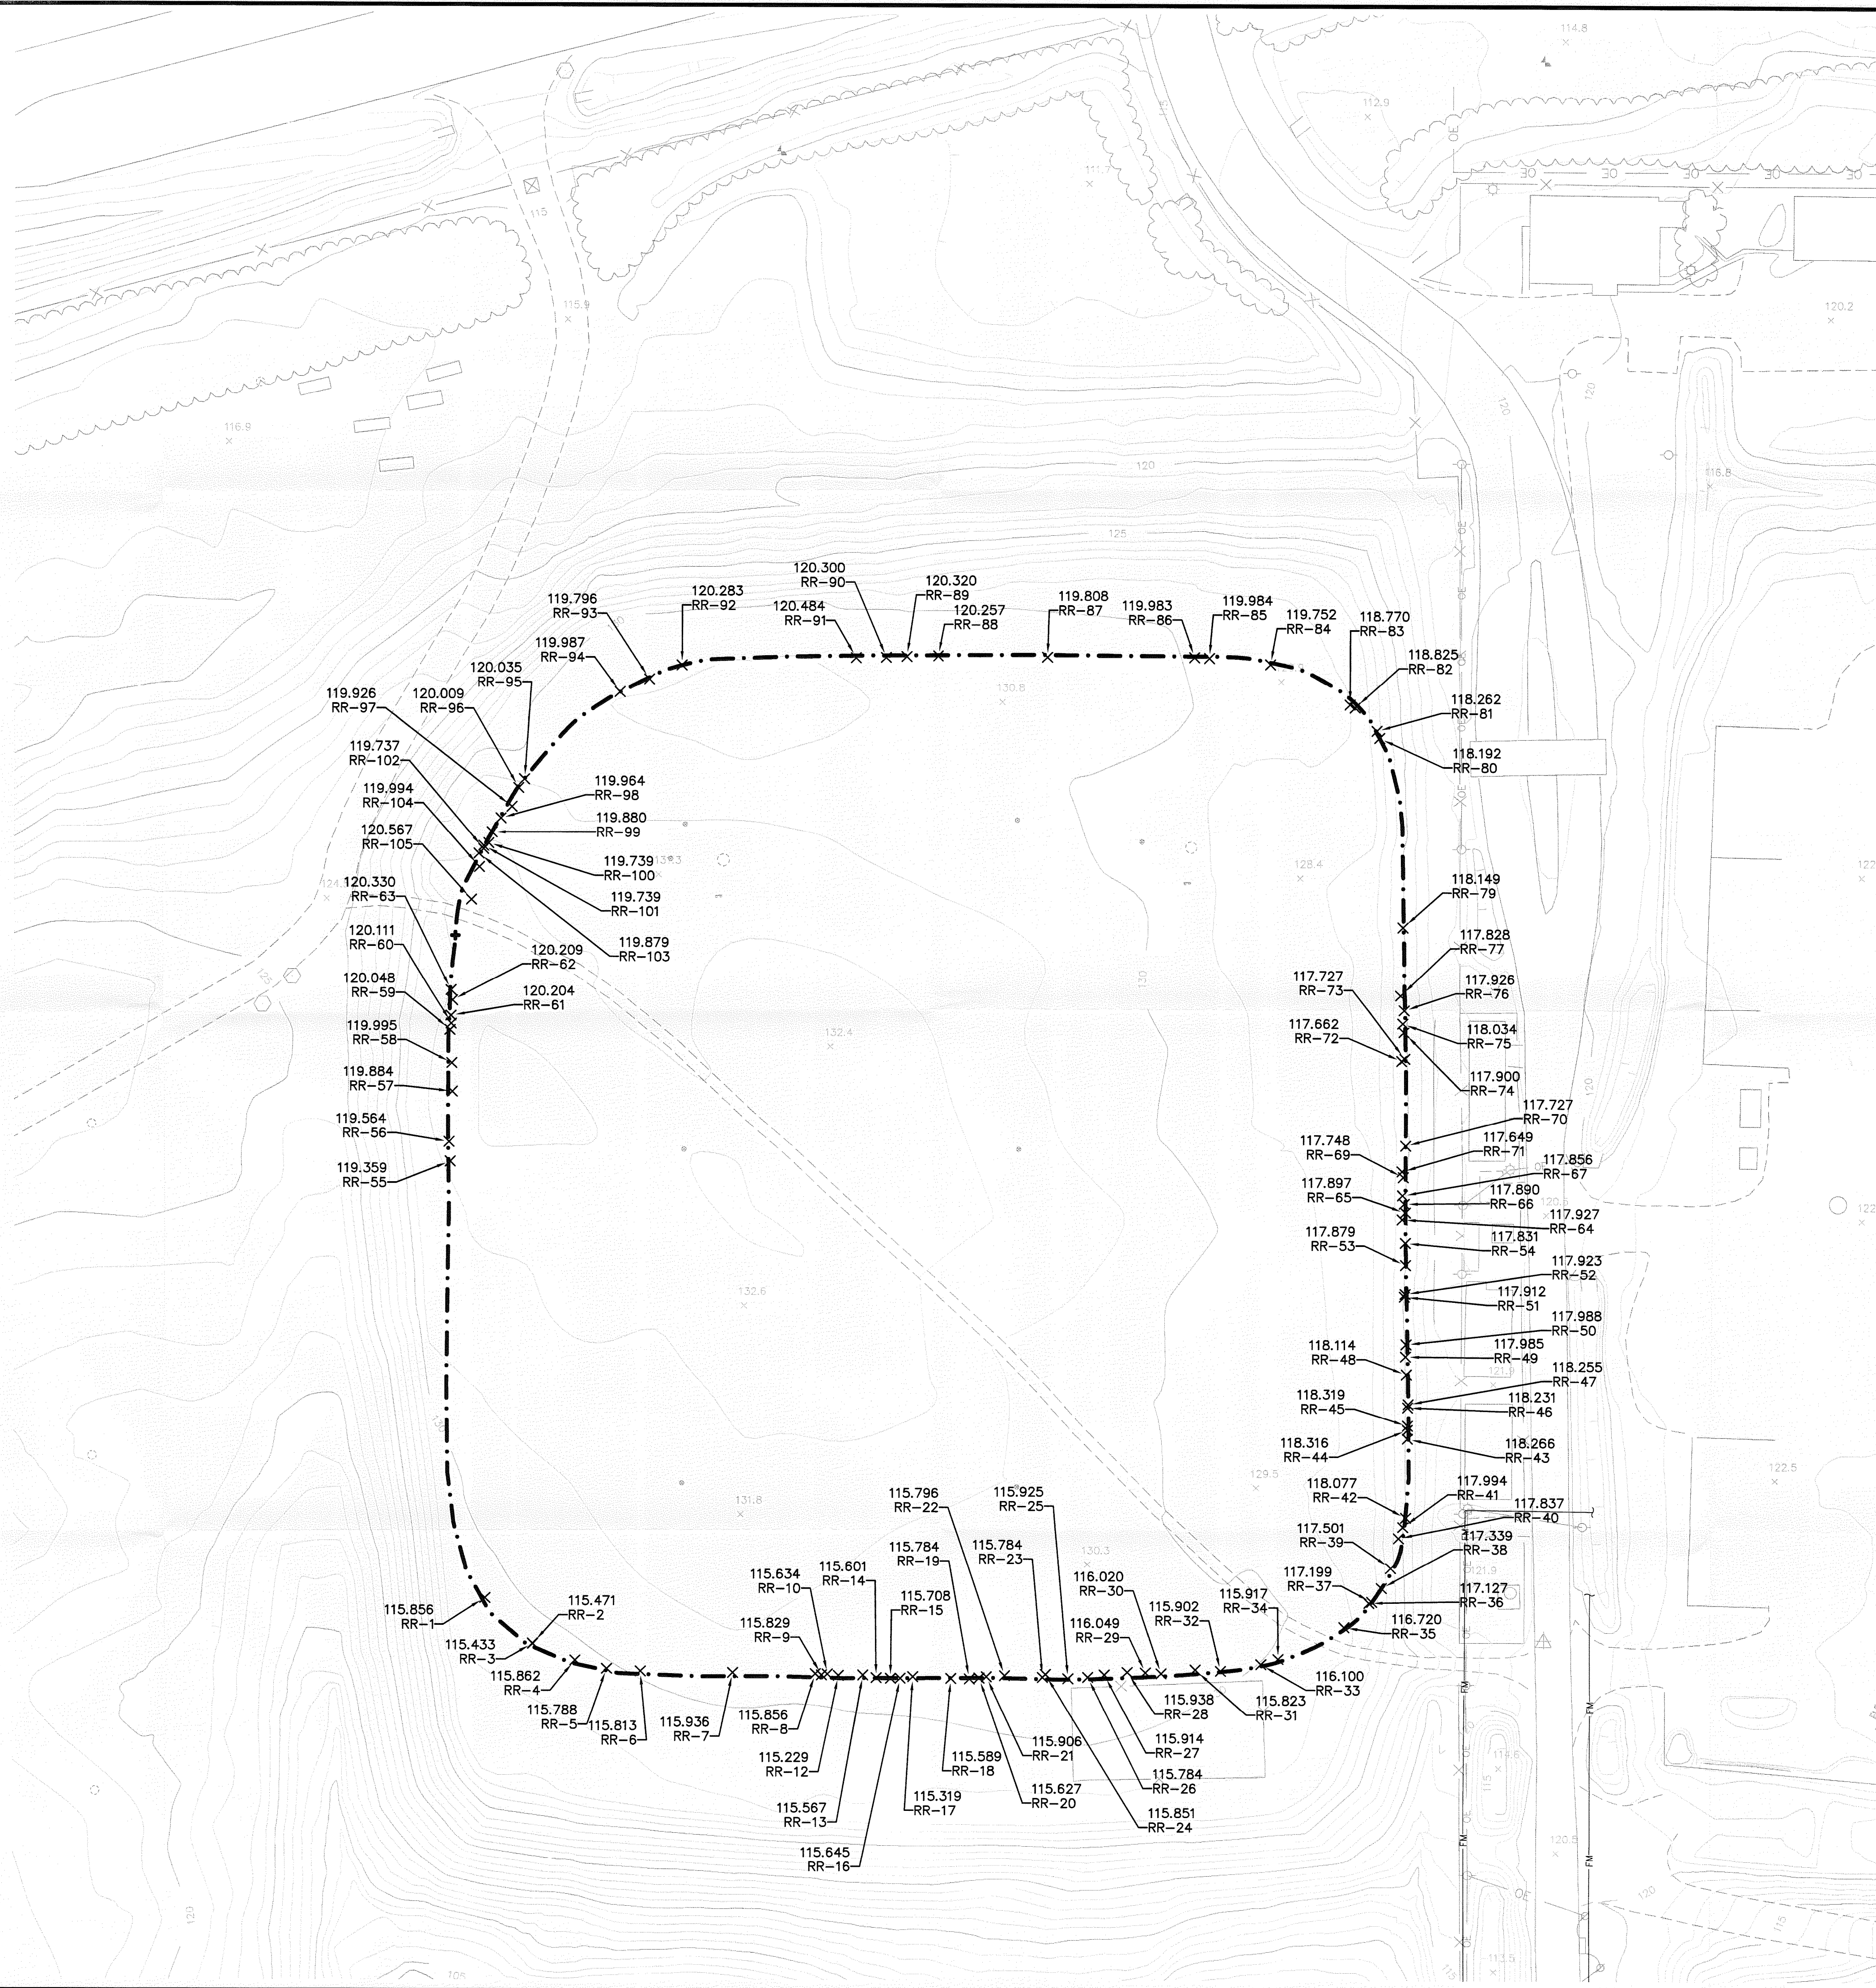
7. The existing liner Repair Numbers and locations on the figure provided in Attachment 3A are not legible. Please provide a revised figure of sufficient size and scale to allow identification of the repair designations on the figure.

8. Repair RR-1 and RR-2 are shown on the bottom liner in the interior of the landfill (i.e., beneath the existing waste). Please verify the location of these repairs reported in the log and revise the figure and/or the location of the repairs reported in the repair log, as appropriate.

**Response:** Attachment 6 Contains a revised Existing liner repair drawing more clearly indicating the location of the Repairs. The Existing repair log submitted as Attachment A-3 of the February 9, response does correctly indicate the northing and easting of the repairs as well.

**Response:** The points RRR-1 and RRR-2 indicated on the interior of the liner are not repair locations and have been deleted from the drawing in Attachment 6. They were reference points used for internal purposes only.
