GeoSYNTEC
CONSULTANTS
Boynton Beach, Florida

REV.	DATE	DESCRIPTION	DRN BY	APP BY
		PROJECT NO. FQ20:0	SCALE: 1"=50'	
DATE:	5-9-92	PROJECT: TRAIL RIDGE LANDFILL		
DES BY	-	PHASE: IA AND IB		
DRN BY	SLB	DATE: 5-5-92		
CHK BY	HMT	5-8-92		
REV BY	DAS	5-9-92		
APP BY	AK	5-9-92

SHEET TITLE:
SECONDARY GEOMEMBRANE PANEL
LAYOUT AND SEAM REPAIR LOCATION

Trail Ridge Landfill, Inc.

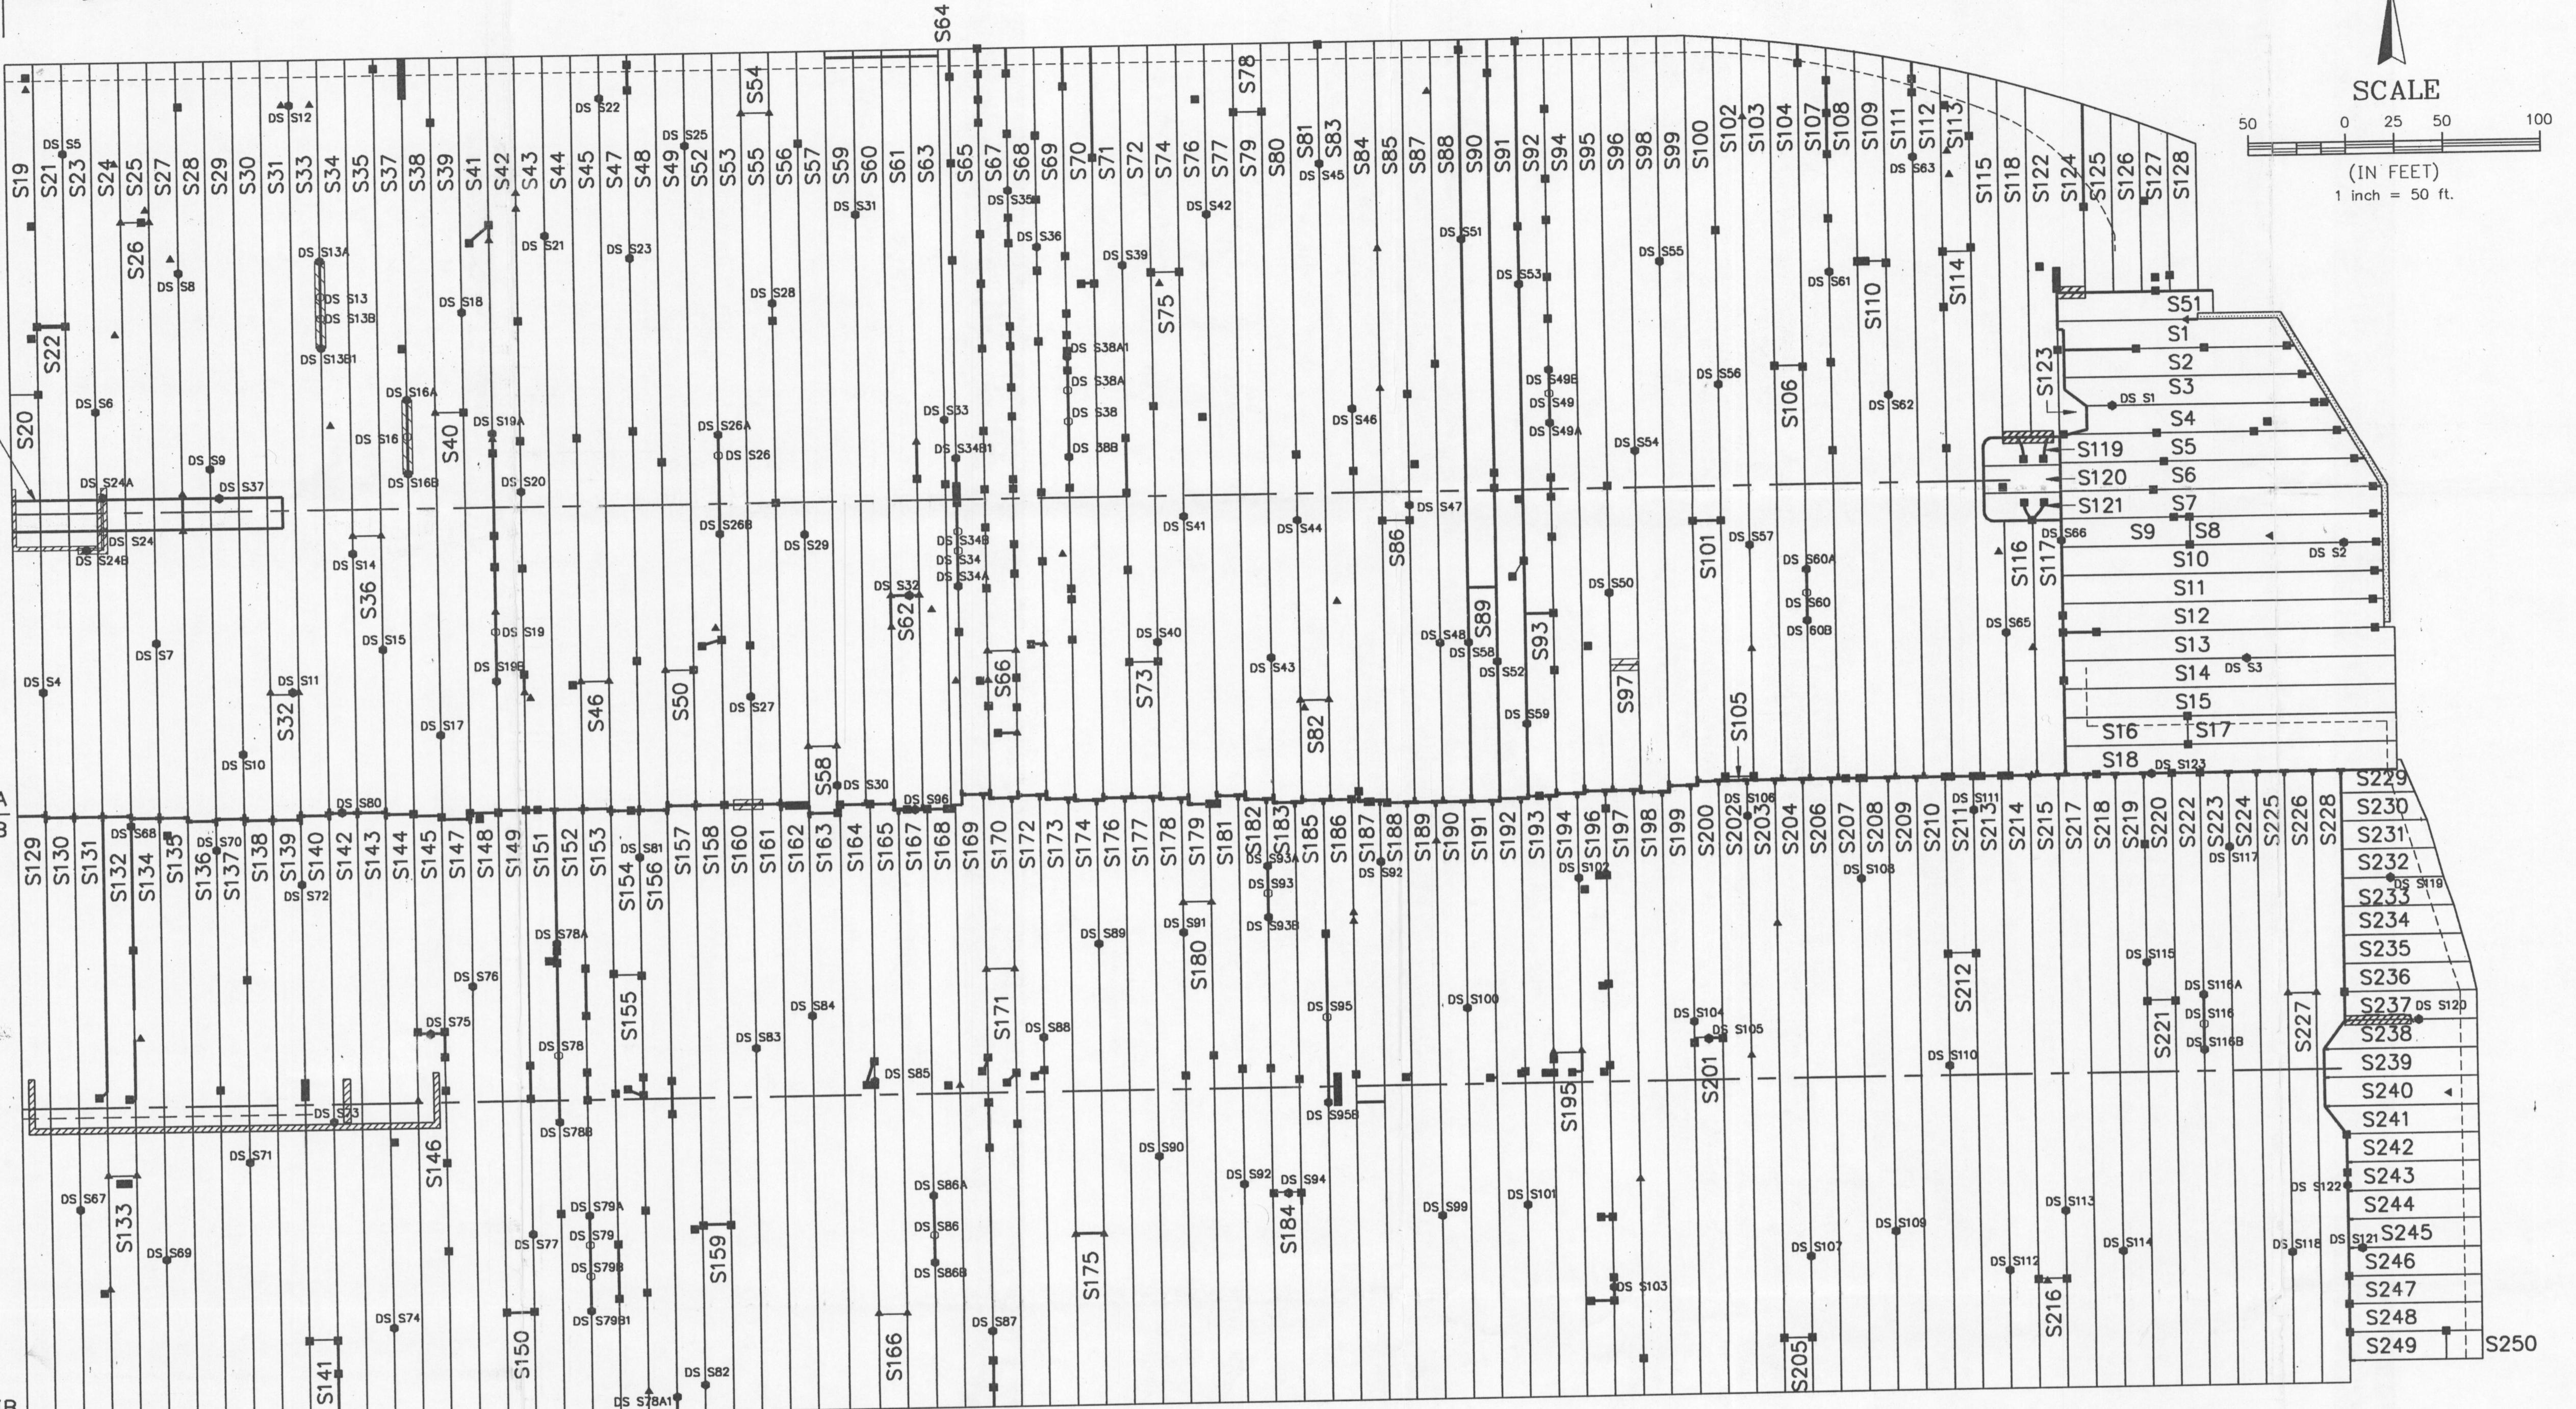
1	OF 3
SHEET 1 OF 3	DRAWING NO.

THIS RECORD DRAWING IS A GRAPHIC REPRESENTATION OF THE SECONDARY HDPE GEOMEMBRANE PANEL PLACEMENT AND DESTRUCTIVE SEAM SAMPLE LOCATIONS. FOR TRUE LENGTH OF THE HDPE GEOMEMBRANE PANELS, SEAMS, AND SAMPLE LOCATIONS, REFER TO APPENDICES OF GEOSYNTEC CONSULTANTS CQA FINAL REPORT DATED MAY 1992.
