Responses to Request for Additional Information No. 1 Hardee County Class I Landfill Wauchula, Florida Phase 1 Closure

Subject: Response to Request for Additional Information No. 1
Certification of Construction - Phase I Closure
Hardee County Class I Landfill
Permit No. 38414-012-SF/01, Hardee County
WACS No. SWD/25/40612

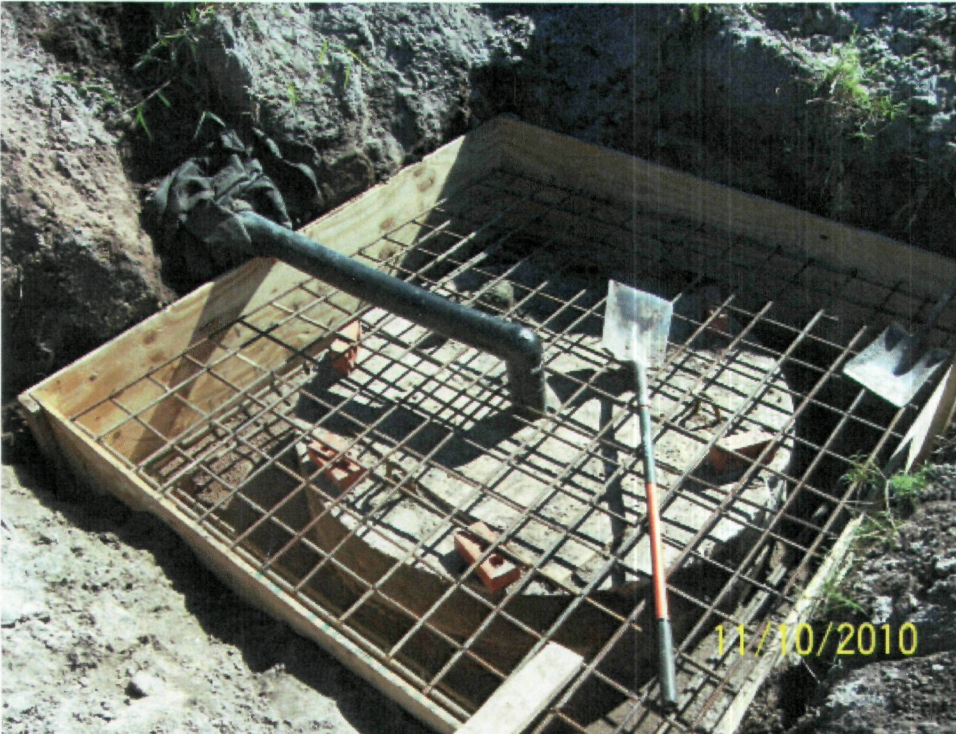
Photo 1

- A - Photos Identifying The LFG Line Tie-In To Existing Manhole MH-5
- B - Revised Hardee County Landfill Phase I Closure Construction Record Drawings (Drawings 1, 17 and 19)
- C - Revised As-Built Panel Layout Drawing
- D - Revised SCS Geomembrane Repair Logs
- E - Revised SCS Destructive Test Logs
- F - Revised TRI 60 mil Destructive Seam Test Results Table
- G - Revised AGRU CQA Test Results 60 mil HDPE Hardee County Class I Landfill Phase I Closure Table
- H - Revised Quality Drilling Service Drilling and Completion Logs and Revised Quality Drilling Service Job Summary Table
- I - Universal Engineering Sciences Test Results of the Protective Cover Soil and In-place Density Tests
