Citrus County Central Landfill

Landfill Gas Remediation System Status Report Jones Edmunds Project No.: 03860-038-01

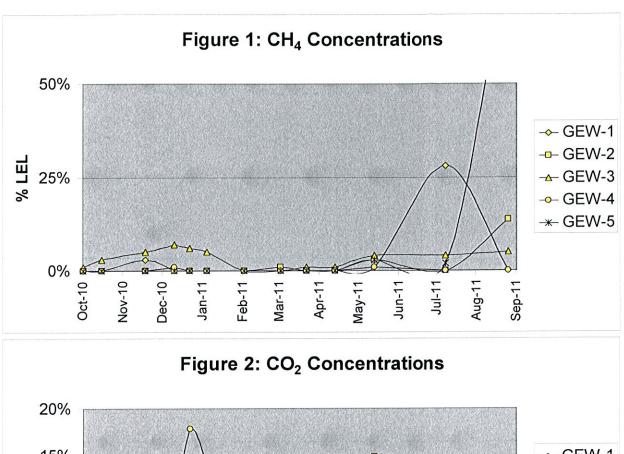
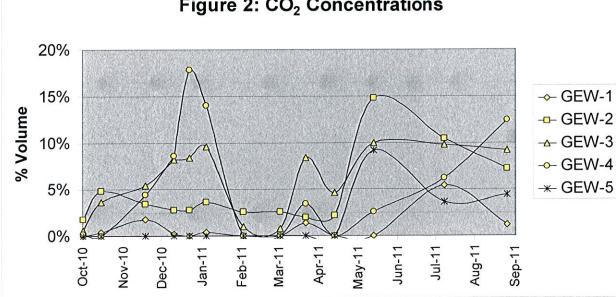
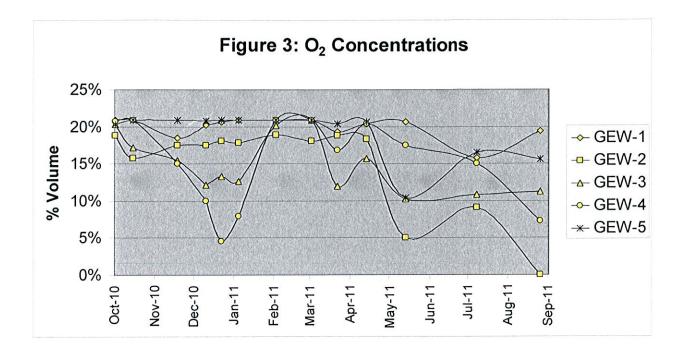
Gas monitoring results are graphed in Figures 1 through 3. Table 1 provides a summary of the monitoring results for each site visit through August 2011. Methane detections in GEW-3 appear to be stable. However, Methane in GEW-1, GEW-2, and GEW-5 appear to be increasing. Carbon Dioxide and Oxygen are showing nearly equal and opposite reactions in all wells; as Carbon Dioxide increases, Oxygen decreases. Also evident in the data are the responses to the system's temporary shut-down from February to March in GEW-3 and GEW-4. This pattern shows that gas is being drawn from the wells as designed.

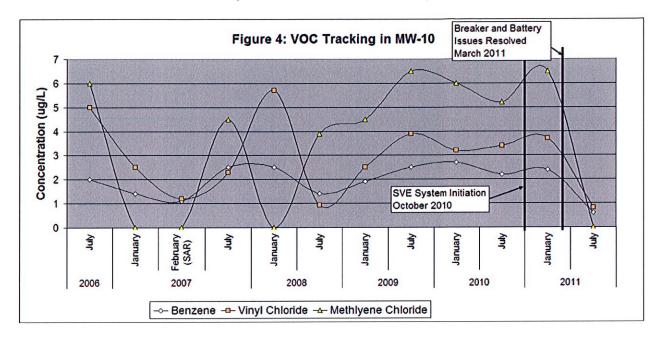
Groundwater data, including all required quality assurance documentation, are submitted with the routine semiannual reports. Figure 4 summarizes the results for selected VOCs from the 2006 second semiannual sampling event to the 2011 second semiannual sampling event including notations on the initiation of the system and on the date when system issues were resolved.

The January 2011 sampling event (confirmed in a February 2011 resampling) show VOCs at about the same concentration as detected before the initiation of the system. However, the system checks between December 10, 2010 and March 2, 2011 showed that the battery was not providing consistent charge causing the system to fail or intermittently operate. In the four months after installing the new battery, the VOCs dropped to concentrations below 1 μ g/L as shown in the July 2011 sampling event.

The first year's data appear to show that the system is working to bring contaminant concentrations below the groundwater standards. However, this is only based on a single sampling event. After another year of operation with systems checks every two months to ensure the system is operating, we will submit a second remedial status report. The report will be submitted to FDEP by December 31, 2012.
