Certification of Construction Completion of a Solid Waste Management Facility

Name of Project: Cell 8 Construction - J.E.D. Solid Waste Management Facility

Name of Owner: Omni Waste of Osceola County, LLC

Type of Project: Construction of Cell 8 Disposal Area

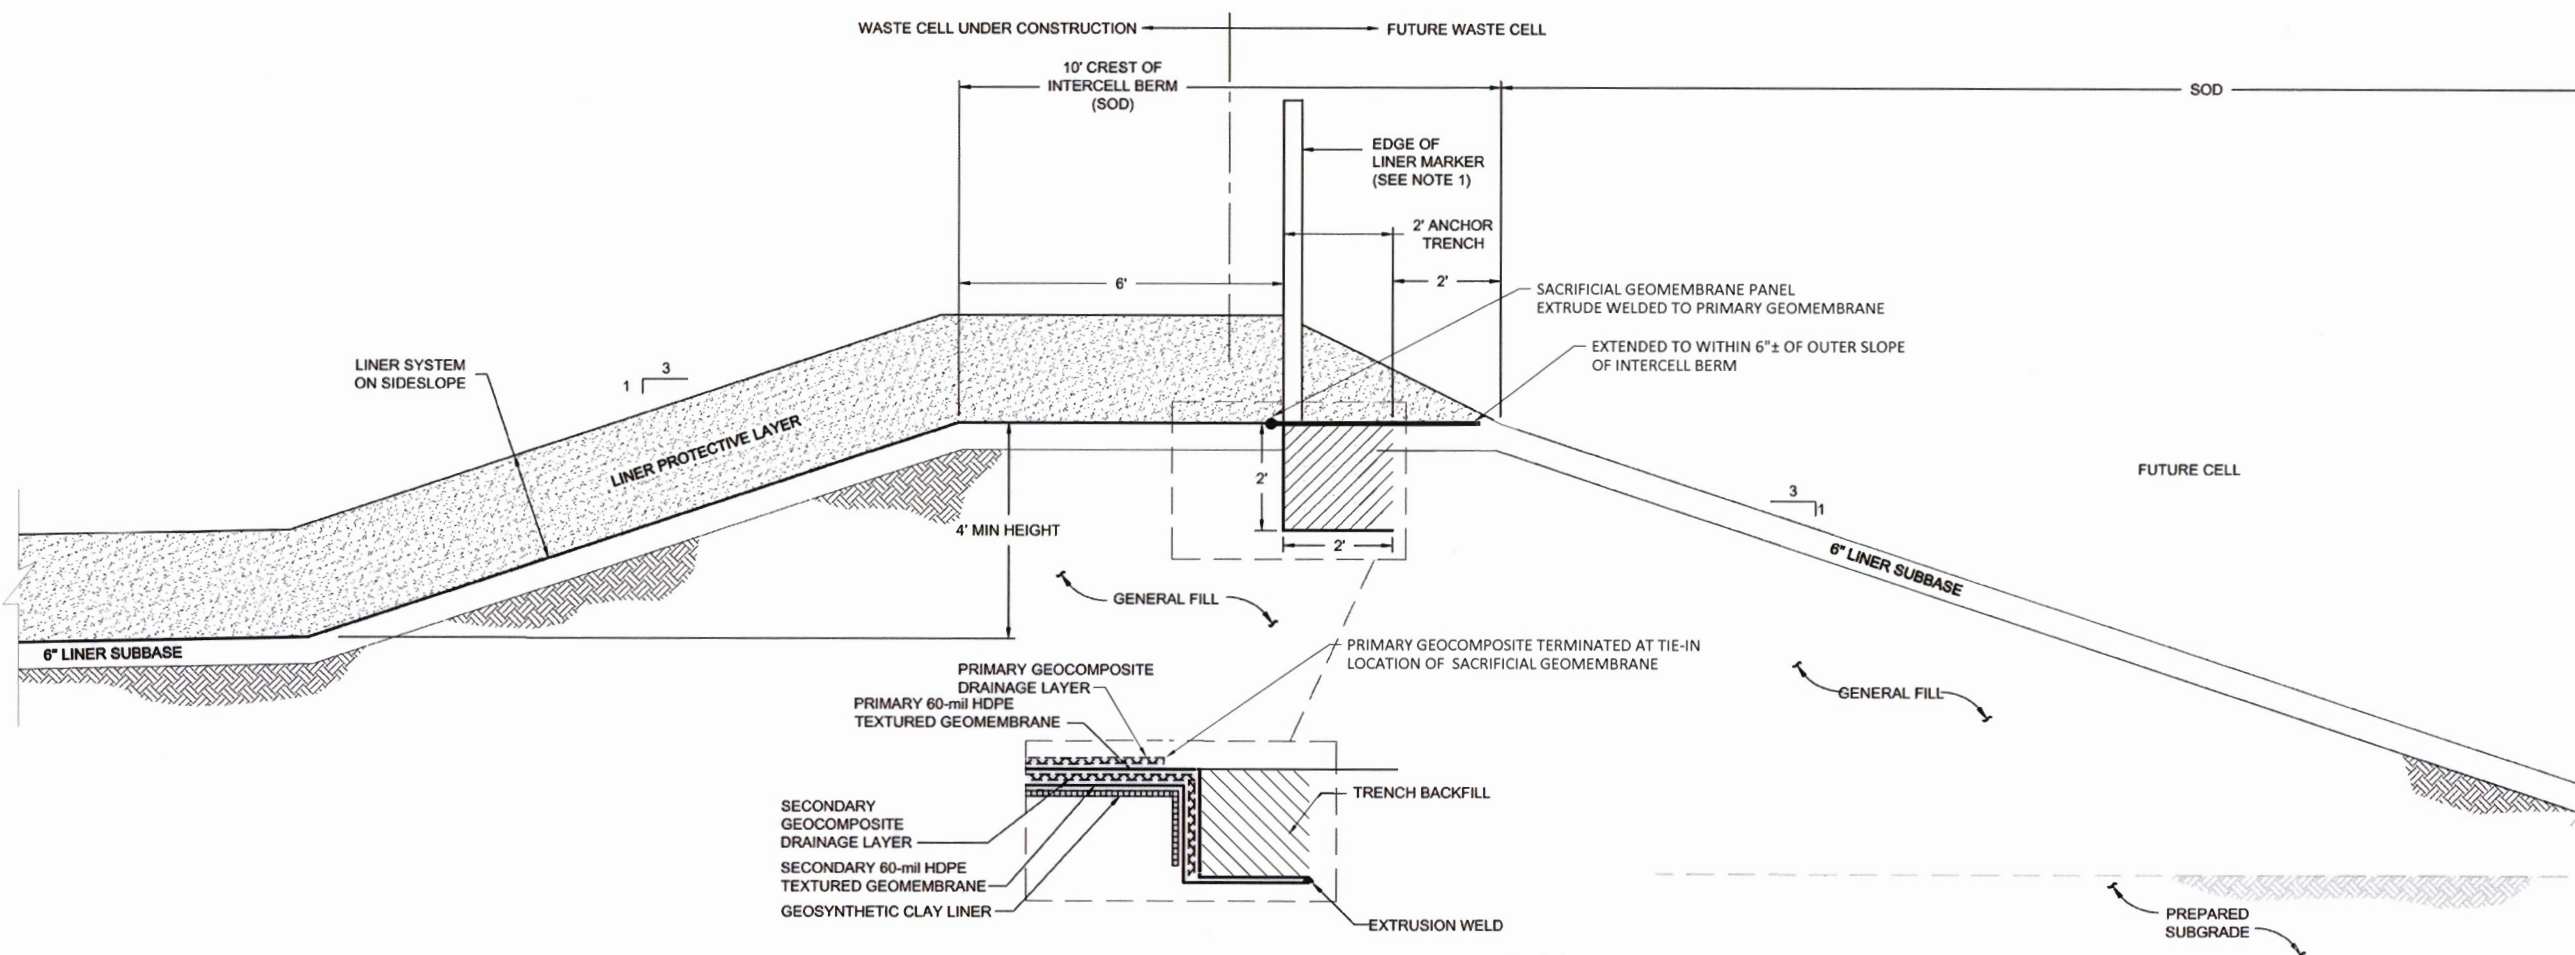
D
3 SECTION (TYPICAL)
LINER SYSTEM TERMINATION AT INTERCELL BERM
SCALE: 1" = 2'

The intercell berm anchor trench design was revised as shown on the enclosed "Liner System

Termination at Intercell Berm" detail drawing.

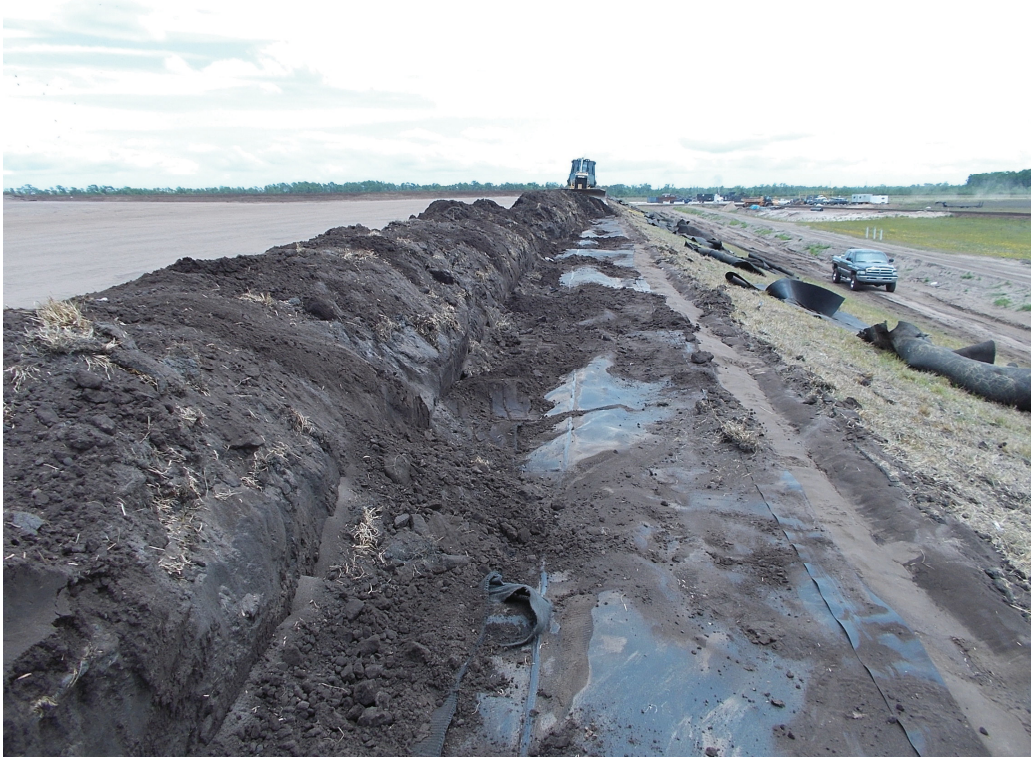
On April 30, 2012, Omni received an e-mail from Ms. Kim Rush of the FDEP notifying Omni that the Air Resources Department would not authorize venting of the geocomposite at the intercell berm. This approach would apparently not meet conditions of the Facility's air construction and operating permits. Omni remobilized the Cell 8 earthwork contractor on May 3rd and began removing the vented section of geocomposite. The geocomposite was removed to the limits shown on the revised as-built detail "Liner System Termination at Intercell Berm" provided with this response package and Appendix A of the Report. Weaver Boos observed removal of the geocomposite, and replacement of the protective cover soils and sod. The work was completed on May 7th. A daily summary and pictures documenting the work are provided with this response package.

Exposure and Removal of Geocomposite in Intercell Berm

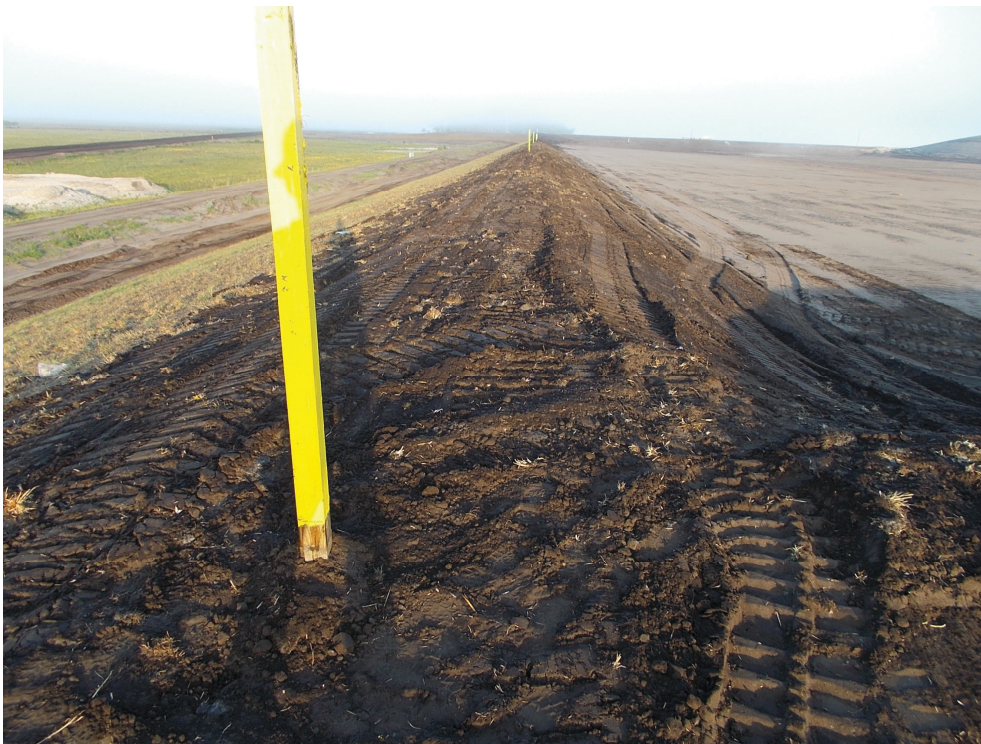
Backfill of Intercell Berm

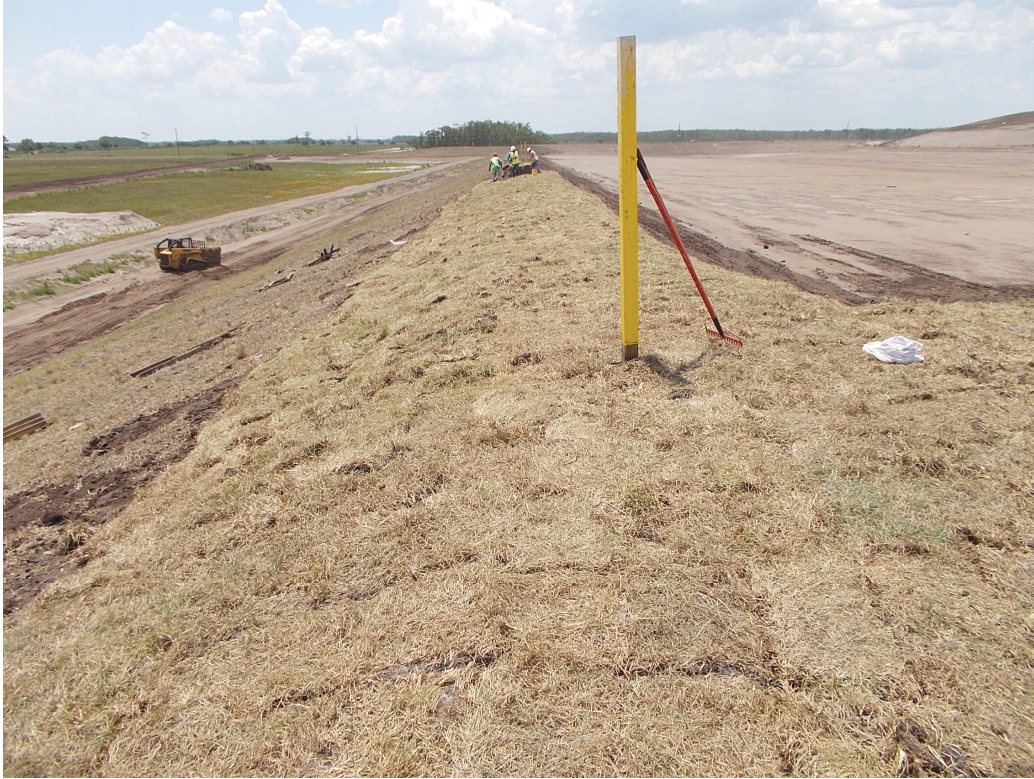
Replacement of Sod on Intercell Berm

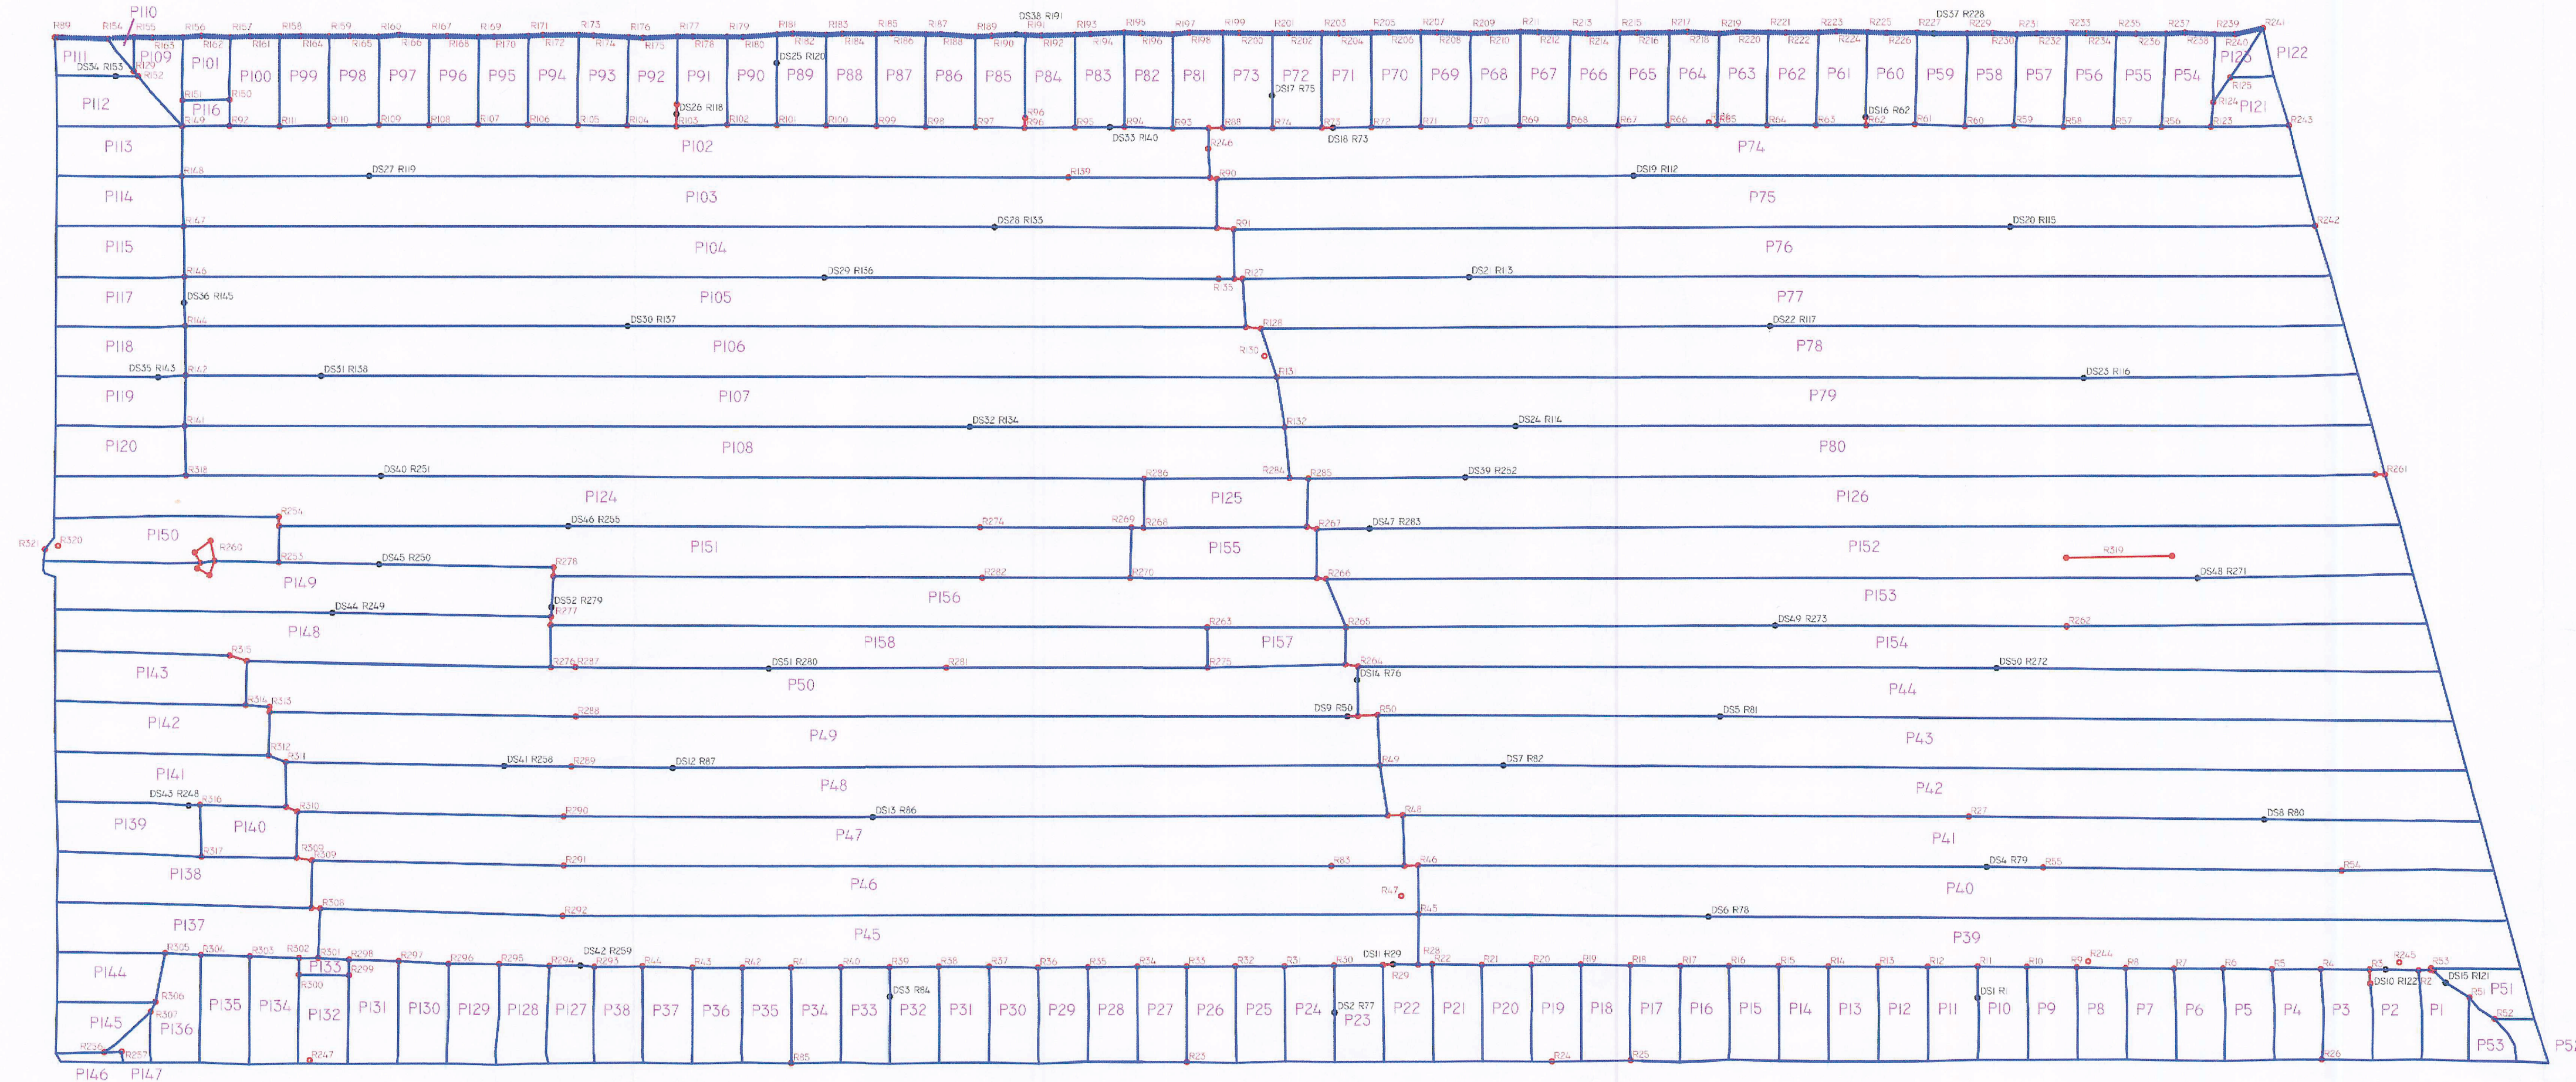
CELL 8 PRIMARY LINER AS BUILT
SCALE: 1"=100'

Repair summary logs prepared by Weaver Boos during CQA activities are included in **Appendix P** of this report. Record Drawings illustrating layout of panels, location of seams, destructive samples, and repairs are included in **Appendix A**.
