Re: Notification of Completion of Repairs – Cell 1 Leachate Sump Manholes
Oak Hammock Disposal Facility (JED Solid Waste Management Facility)
Osceola County, Florida
Permit Nos. SC49-0199726-004 and SO49-0199726-005

Please find enclosed two copies of the CQA Report for Cell 1 Sump Repairs prepared by Globex Engineering and Development. Documented in the report are repairs made to the Cell 1 leachate sump manholes damaged by a lightning strike in July, 2007. The Cell 1 leachate system has been fully repaired and is operating as designed.

Subject: CQA Report for Cell 1 Sump Repairs
The J.E.D. Solid Waste Management Facility
Osceola County, Florida

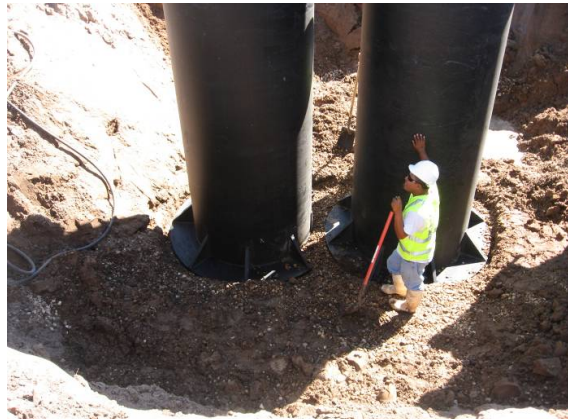
At 9:12am After re-check elevations the 50" Ø HDPE Primary Sump Risers were 2' higher than the Secondary Sump Riser, the 50" Ø HDPE Primary Sump Risers were removed and the 10" bed rock too and G4 dug 12" more and set 4" bed rock leaving 3' sleeve of 48" Ø HDPE inside the two 50" Ø HDPE Primary Sump Risers after being re-installed; elevations were checked and the 50" Ø HDPE Primary Sump Risers were 1' higher than the Secondary Riser as required.

At 11:34 am G4 start setting the first lift of soil around the 50" Ø HDPE Primary Sump Risers

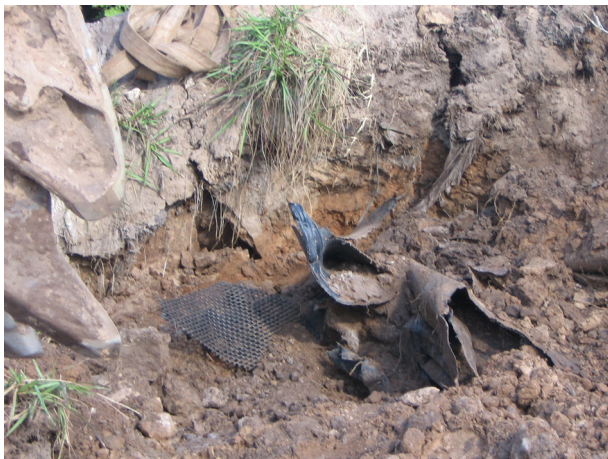
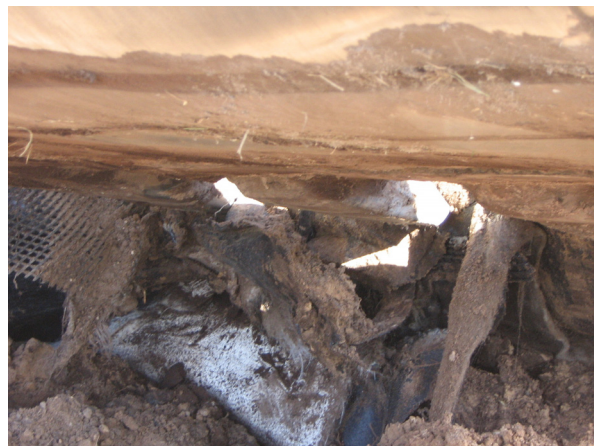
While G4 was cleaning the area around the sump found a repair, a hole was made in the liner going thru the 6 layer in the east corner of the sump.

G4 clean the area to Comanco could repair it to morrow.
