Re: Permit Condition C.8.g (3) Leachate Storage Tank Systems Inspection

**Citrus County, Florida
Leachate Storage and Treatment Tank(s)
Inspection Report**

**Prepared by
T. Casey Stephens
Citrus County Division of Solid Waste Management
P.O. Box 340, Lecanto, FL 34460
Citrus County Central Landfill
230 W. Gulf to Lake Highway, Lecanto, FL 34461**

Technical Memorandum
Landfill Leachate Storage Tank Evaluation

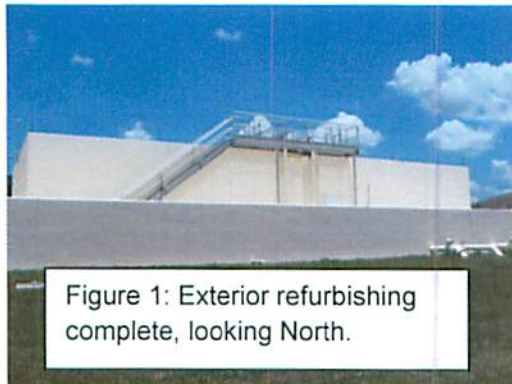
Figure 1: Exterior refurbishing complete, looking North.

Sikaflex 1A from Coastal Construction Products, Inc. and backer material purchased at Lowe's was used to complete the expansion joint replacement. Figures 1 and 2 illustrate completion of the refurbishing.

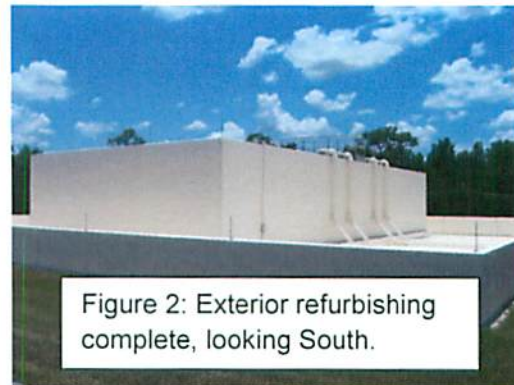
Figure 2: Exterior refurbishing complete, looking South.

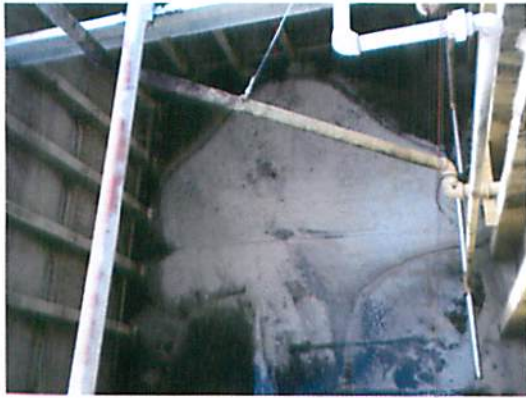
Figure 3: SRB #1 (Digester)
Tank interior post-cleaning.

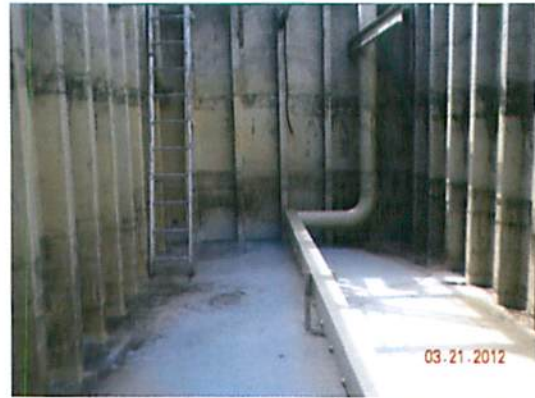
Figure 4: SBR #2 – Tank interior
post-cleaning, prior to diffuser re-
installation.

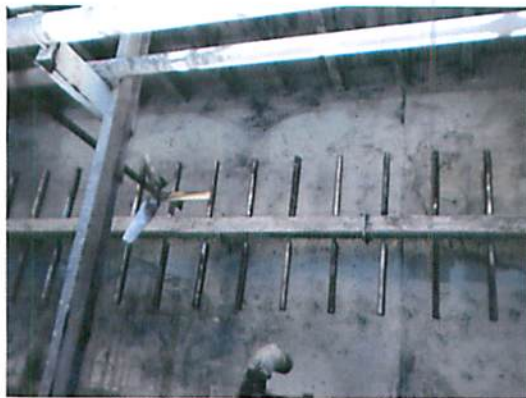
Figure 5: SBR #3 – Tank interior
post-cleaning, diffusers re-installed.

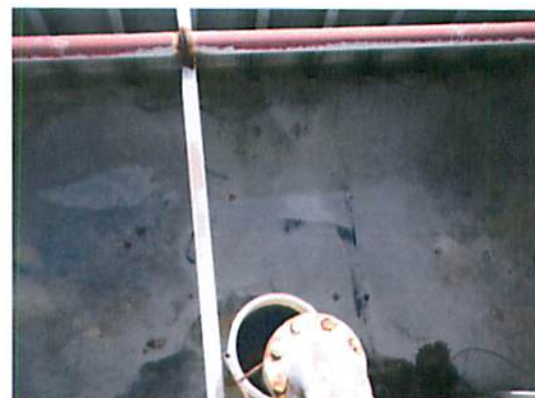
Figure 6: SBR #4 – Tank interior post-
cleaning.

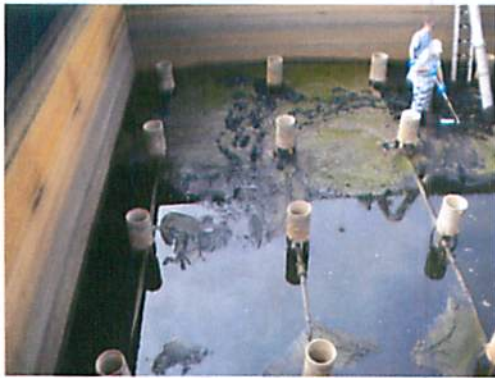
Figure 7: South Tank cleaning process, December, 2012.

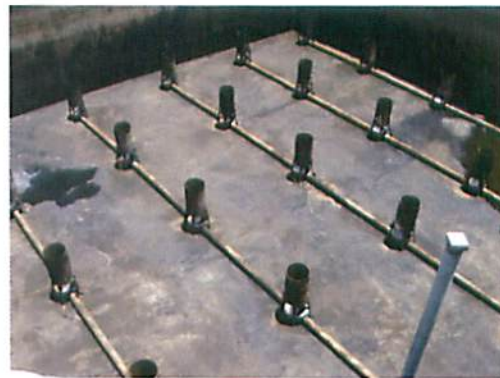
Figure 8: North Tank interior post-cleaning, May, 2012.

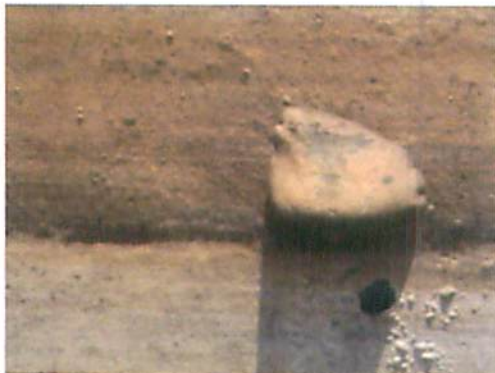
Figure 9: North Tank interior wall with intact air bubble.

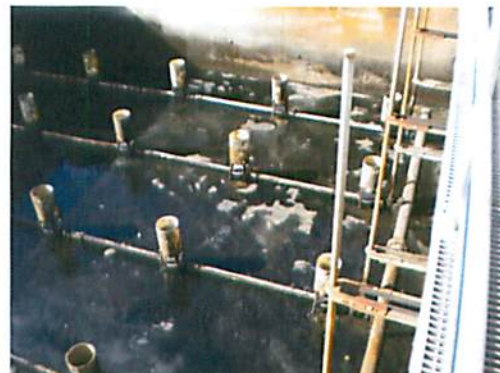
Figure 10: South Tank interior post-cleaning, December 2012.

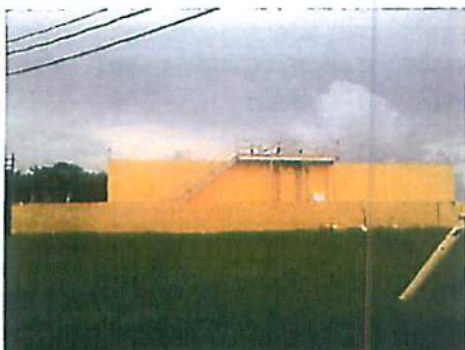
Storage tank and containment structure looking west

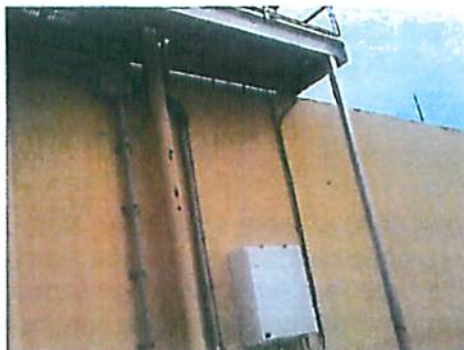
Exterior of storage tank (south end)

The existing concrete tanks and containment structure generally appear to be in good condition. County personnel indicated that leakage from the tank has not been observed to date. Upon inspecting the tanks, several surface cracks were observed around the perimeter of the tank. These cracks appeared to be related to temperature and shrinkage and are likely made more visible due to the coating on the exterior of the tank. Similar cracking patterns were not visible on the interior of the tank due to the existence of an epoxy coating. The coating did appear to have a few locations containing minor blisters but appeared to be in good condition.

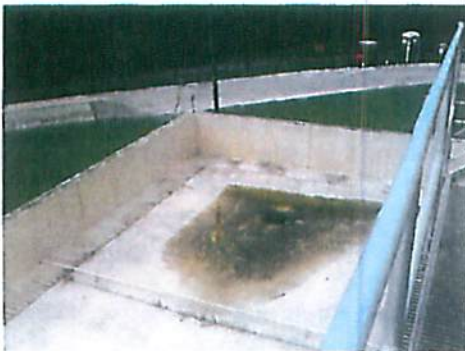
Containment structure viewed from stairs

The masonry perimeter wall and slab-on-grade were previously painted similar to the exterior of the tanks. The expansion joints within the walls and slabs were in poor condition and the County indicated some backer material had been removed in anticipation of rehabilitation work. The containment area had standing water from rainwater present near the existing drains.

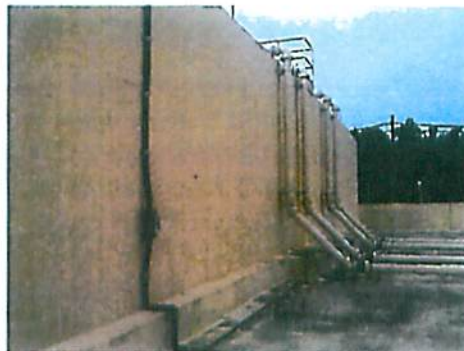
Exterior of storage tank (north end)

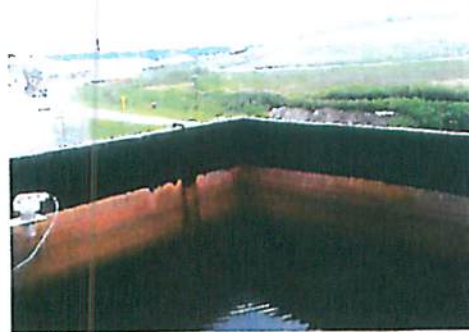
Interior of storage tank viewed from walkway
