Florida Department of
Environmental Protection
Inspection Checklist

Facility Name: CITRUS CENTRAL SLF
On-Site Inspection Start Date: 03/12/2013
On-Site Inspection End Date: 03/12/2013
WACS No.: 39859
Facility Street Address: 3MI E LECANTO, SR44
City: LECANTO
County Name: CITRUS
Zip: 34461

Routine Operation Inspection for Landfill - Class I facility

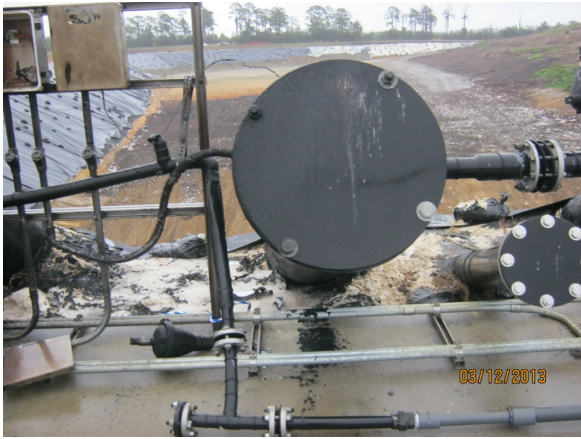
Phase III LCS riser

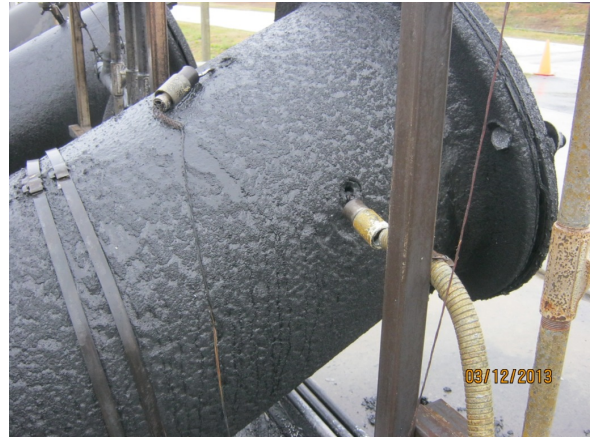
Phase III LCS riser

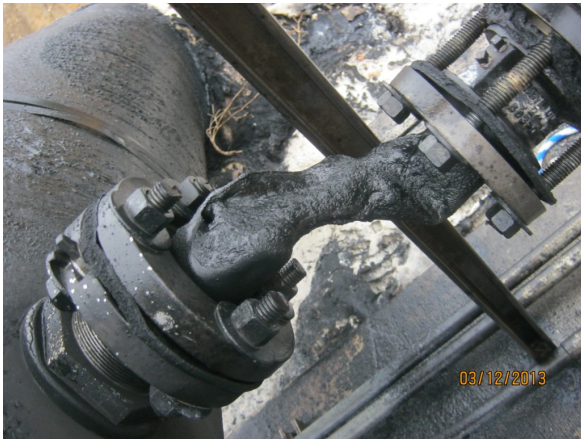
HDPE pipe deformation

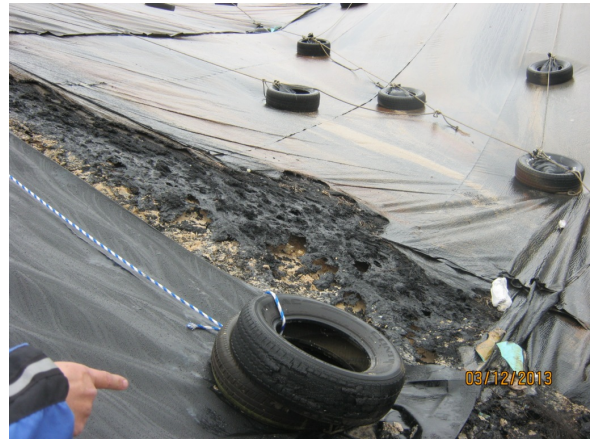
liner system, toe of W slope

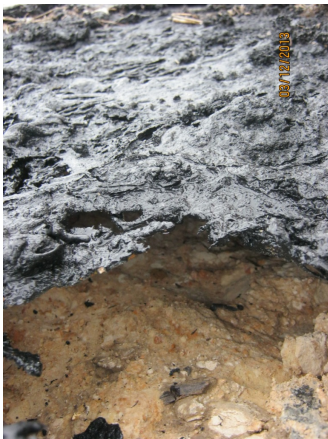
liner damage to subgrade, erosion

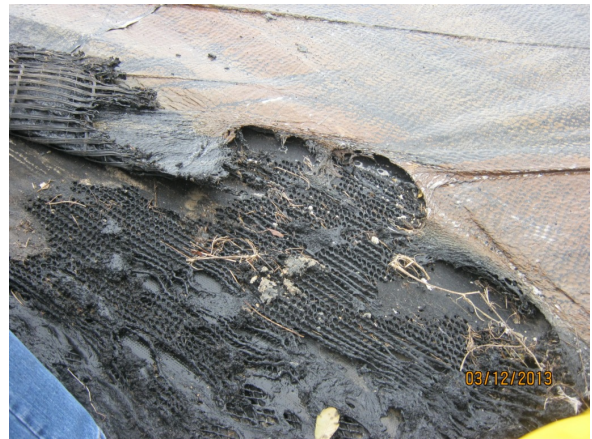
damage to geocomposite

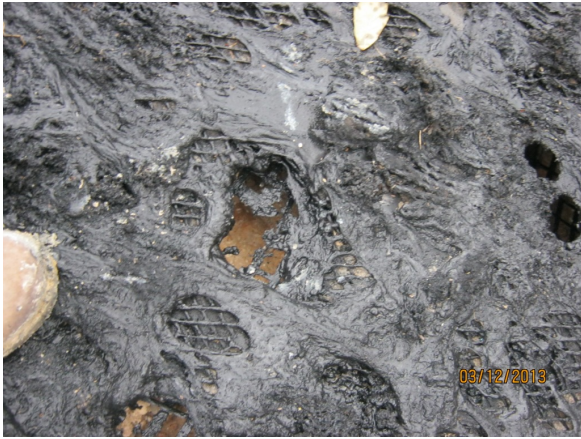
liner damage

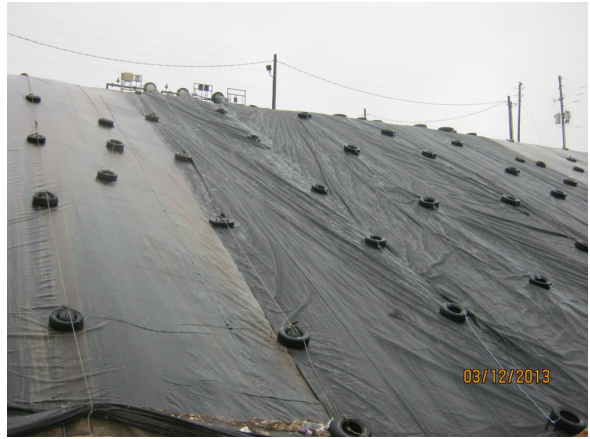
~100'w damaged area (w/temp tarp)
