LOBEX

7 February 2008

Subject: CQA Report for Cell 1 Sump Repairs
The J.E.D. Solid Waste Management Facility
Osceola County, Florida

Globex Engineering & Development, Inc. (Globex) is pleased to submit this letter report for the construction quality assurance (CQA) services provided by Globex during repairs to the vertical risers at the Cell 1 sump at the J.E.D. Solid Waste Management Facility located in Osceola County, Florida. The remainder of this letter report includes a background, parties involved, description of repair activities monitored by Globex, and certification of the completed work.

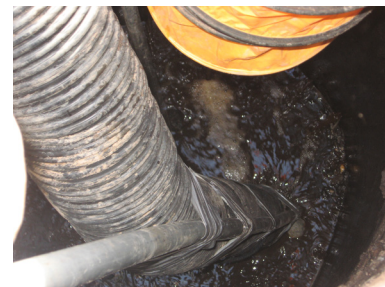
At 10:40 am FECC was done with the clean up of riser #1 and left.

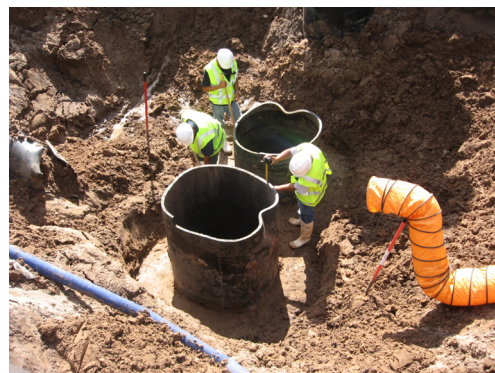
At 1:00pm the 3' were rich.

At 1:30pm the 10" rock bed was in place.

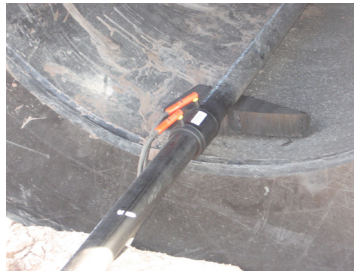
At 1:35pm G4 start welding the 2" inside pipes

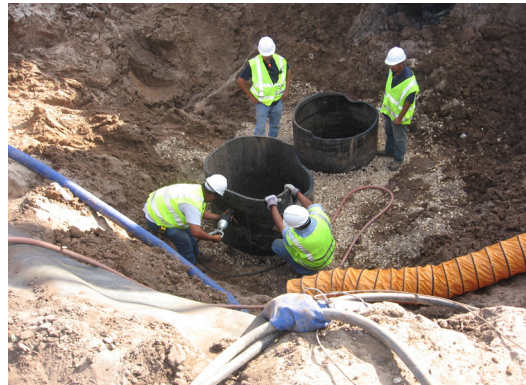
At 3:20pm G4 cut the last portion of the risers that melt getting the two risers at the same level.

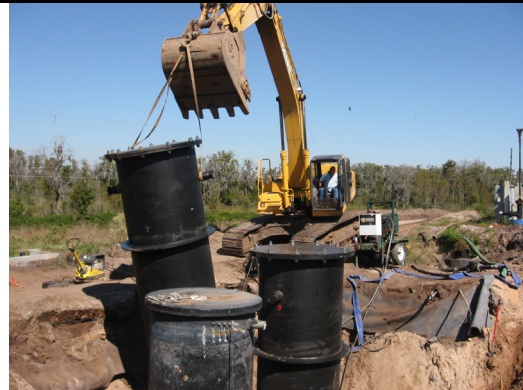
At 8:15am G4 crew start setting the 50" Ø HDPE Primary Sump Risers. 50" Ø HDPE Primary Sump Riser # 2 was set first while the pump was running on Sump Riser #1 to keep leachate level down. After setting 50" Ø HDPE Primary Sump Riser # 2 hydraulic pump was removed from Sump Riser #1 and proceed to set 50" Ø HDPE Primary Sump Riser #1

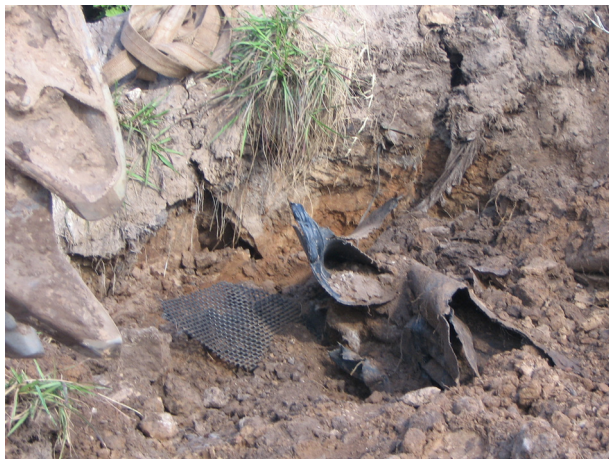
While G4 was cleaning the area around the sump found a repair, a hole was made in the liner going thru the 6 layer in the east corner of the sump.

G4 clean the area to Comanco could repair it to morrow.

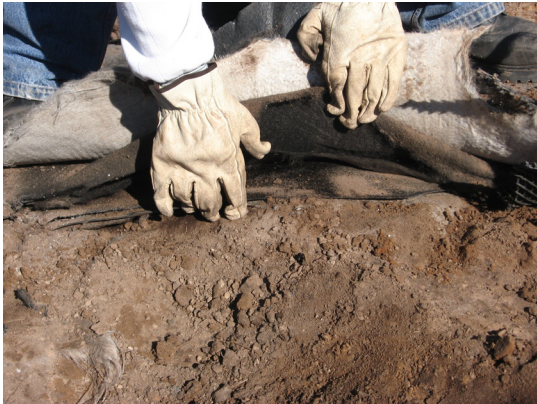
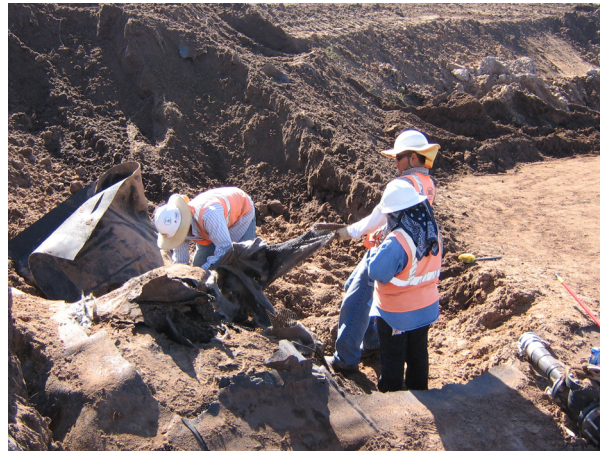
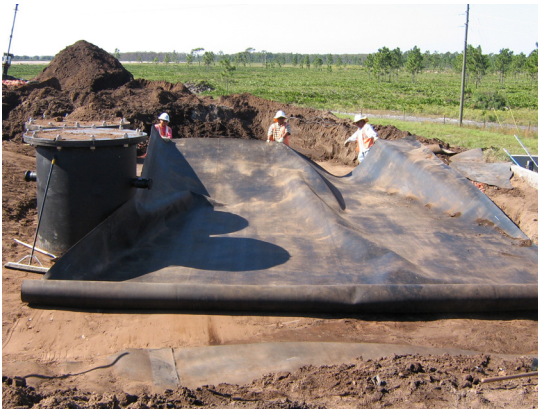
At 8:30 am arrive to job site and Comanco was on site with Comanco trailer and Skytrak 10k forklift.
At 9:30 am Comanco start working on repair of the 6 layer patch and the liner cap of the Sump.

At 3:30 pm Comanco finish repair and G4 complete 10th lift
at 4:00 pm passing compaction test.

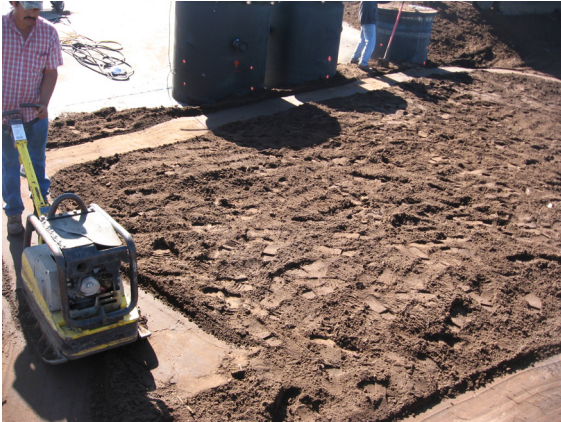
At 8:30 am arrive to job site and Comanco was on site.
At 11:00 am Comanco finish Sump cover liner and start vacuum testing, all good.
At 11:30 am G4 start working on 11th lift, this lift will cover the liner with 1' of dirt.
At 11:45 am Comanco Left the premises.
At 12:00 pm lunch break.
At 1:40 pm G4 complete 11th lift by passing compaction test.

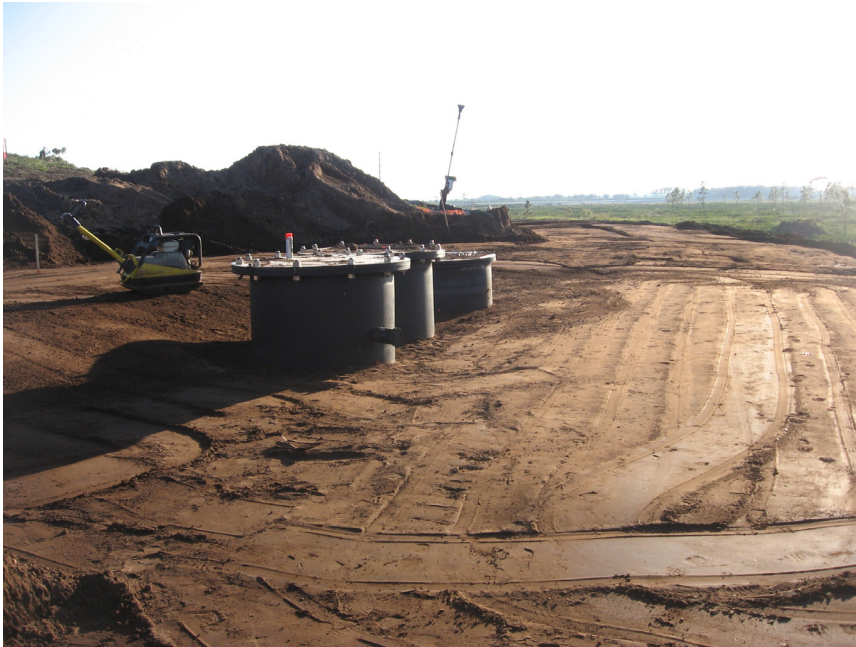
At 3:30 pm G4 complete 12th lift
finish the dirt face and the area is
ready to concrete and electrical
work.

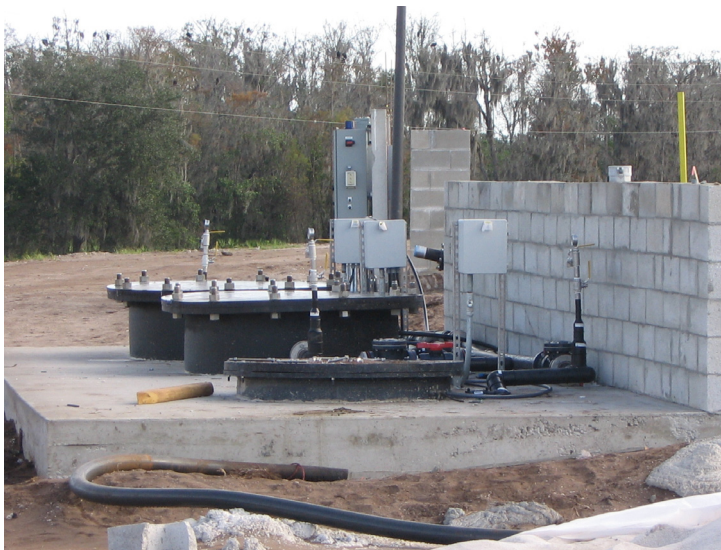
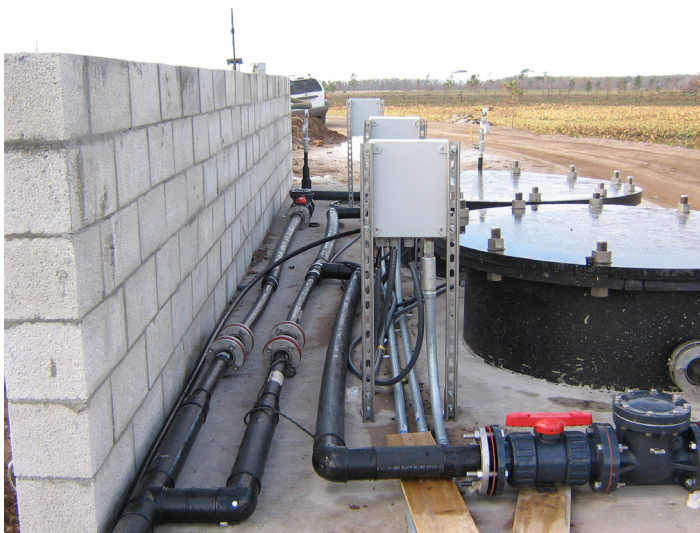
Went to work area and concrete, electrical and pipe connections were done took pictures start pumps to verify they are in operating conditions.
