SOUTHEAST LANDFILL - SOIL TESTING

HILLSBOROUGH COUNTY, FLORIDA

LAW ENGINEERING PROJECT NO. TM-1103A

SUBJECT: Southeast Landfill - Soil Testing  
Hillsborough County, Florida  
Law Engineering Project No. TM-1103A

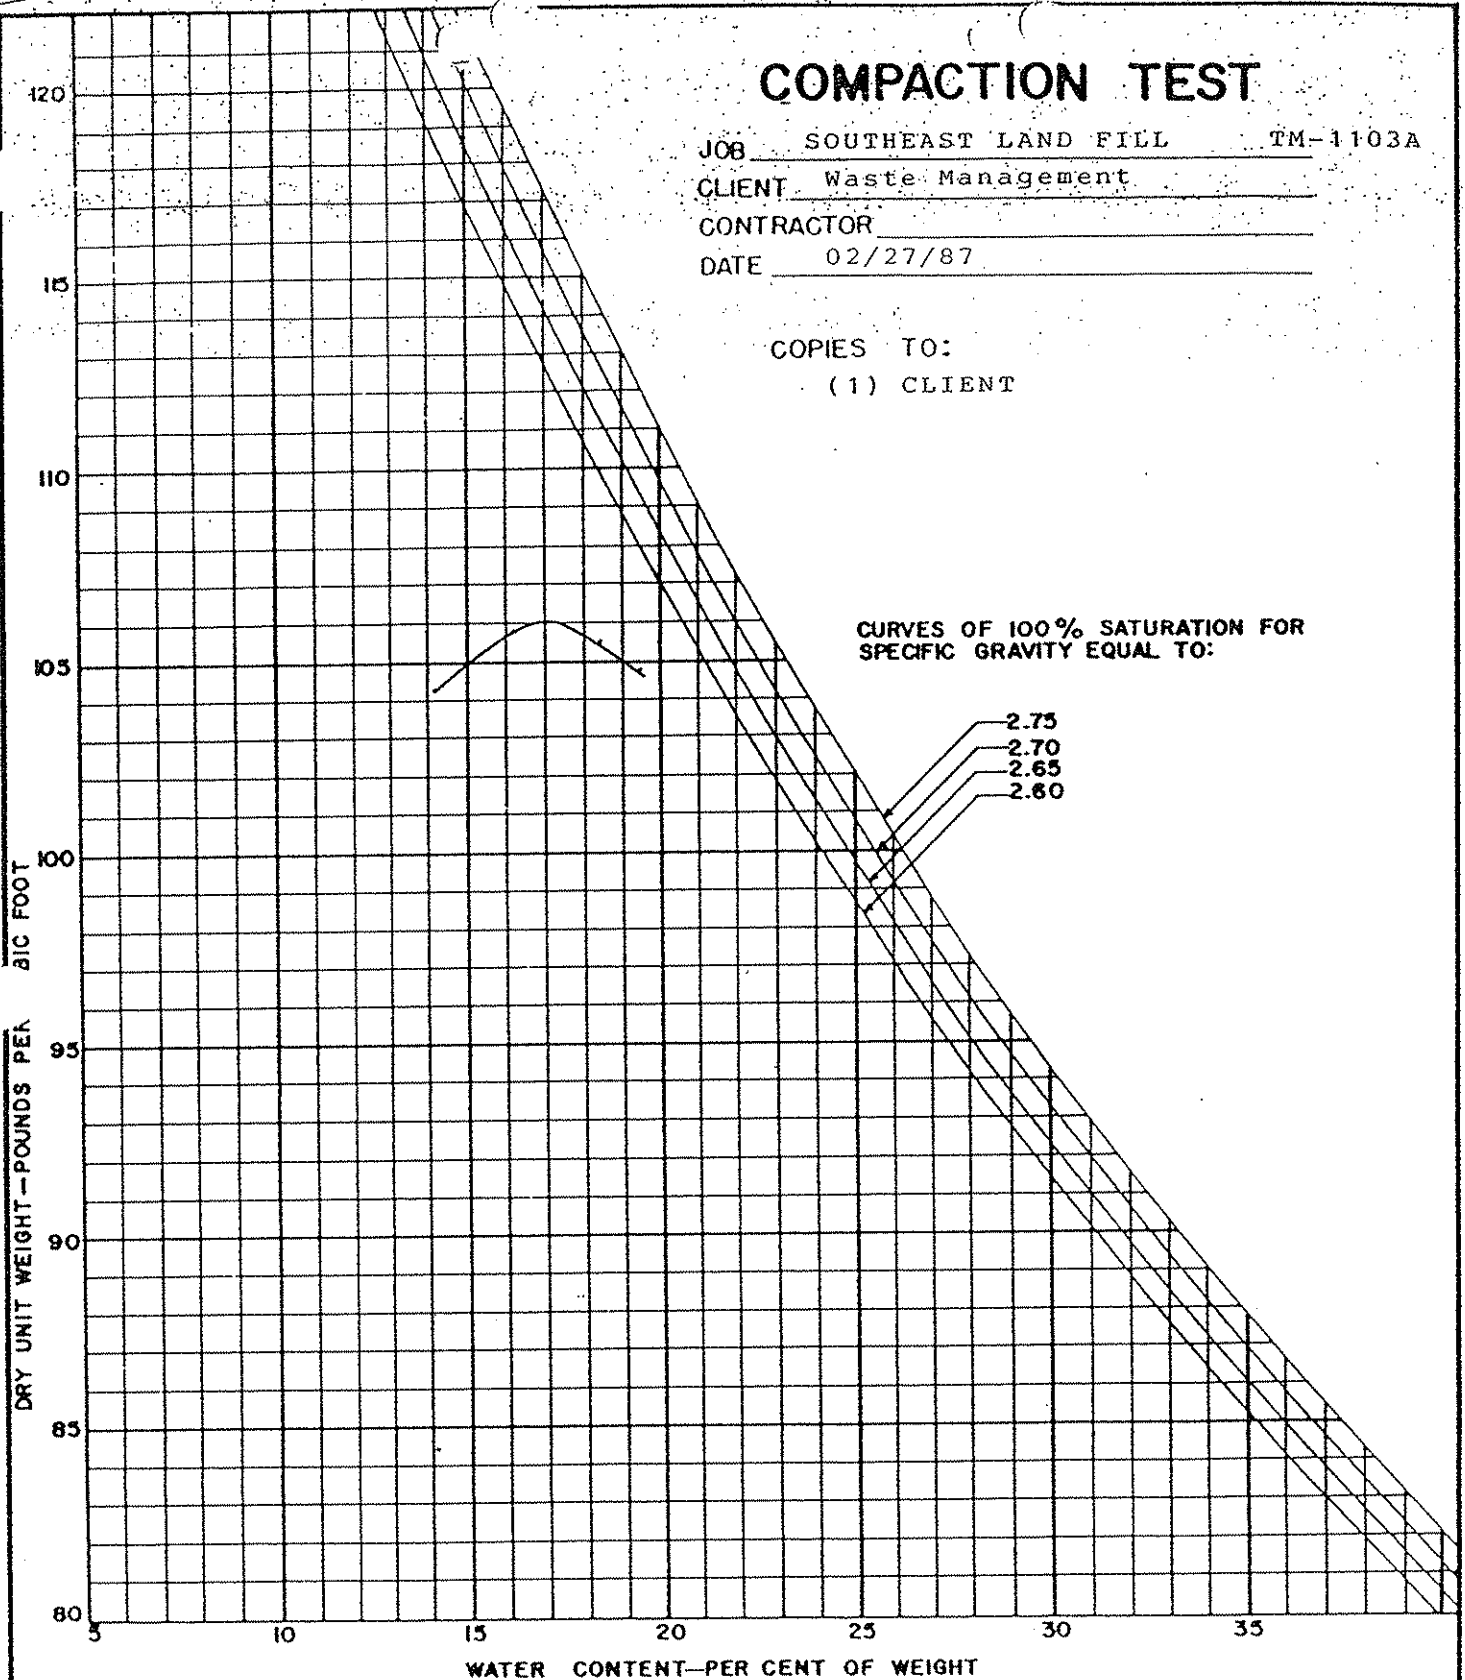
| MOISTURE DENSITY RELATION | METHOD OF TEST | MAX. DRY DENSITY PCF | OPTIMUM MOISTURE CONTENT % | SOIL DESCRIPTION OR CLASSIFICATION AND SAMPLE LOCATION |
|---|---|---|---|---|
| #1 | ASTM D-698 Method A | 106.0 | 17.0 | DESCRIPTION: Tan silty fine SAND with clay<br>LOCATION: South side of slope |

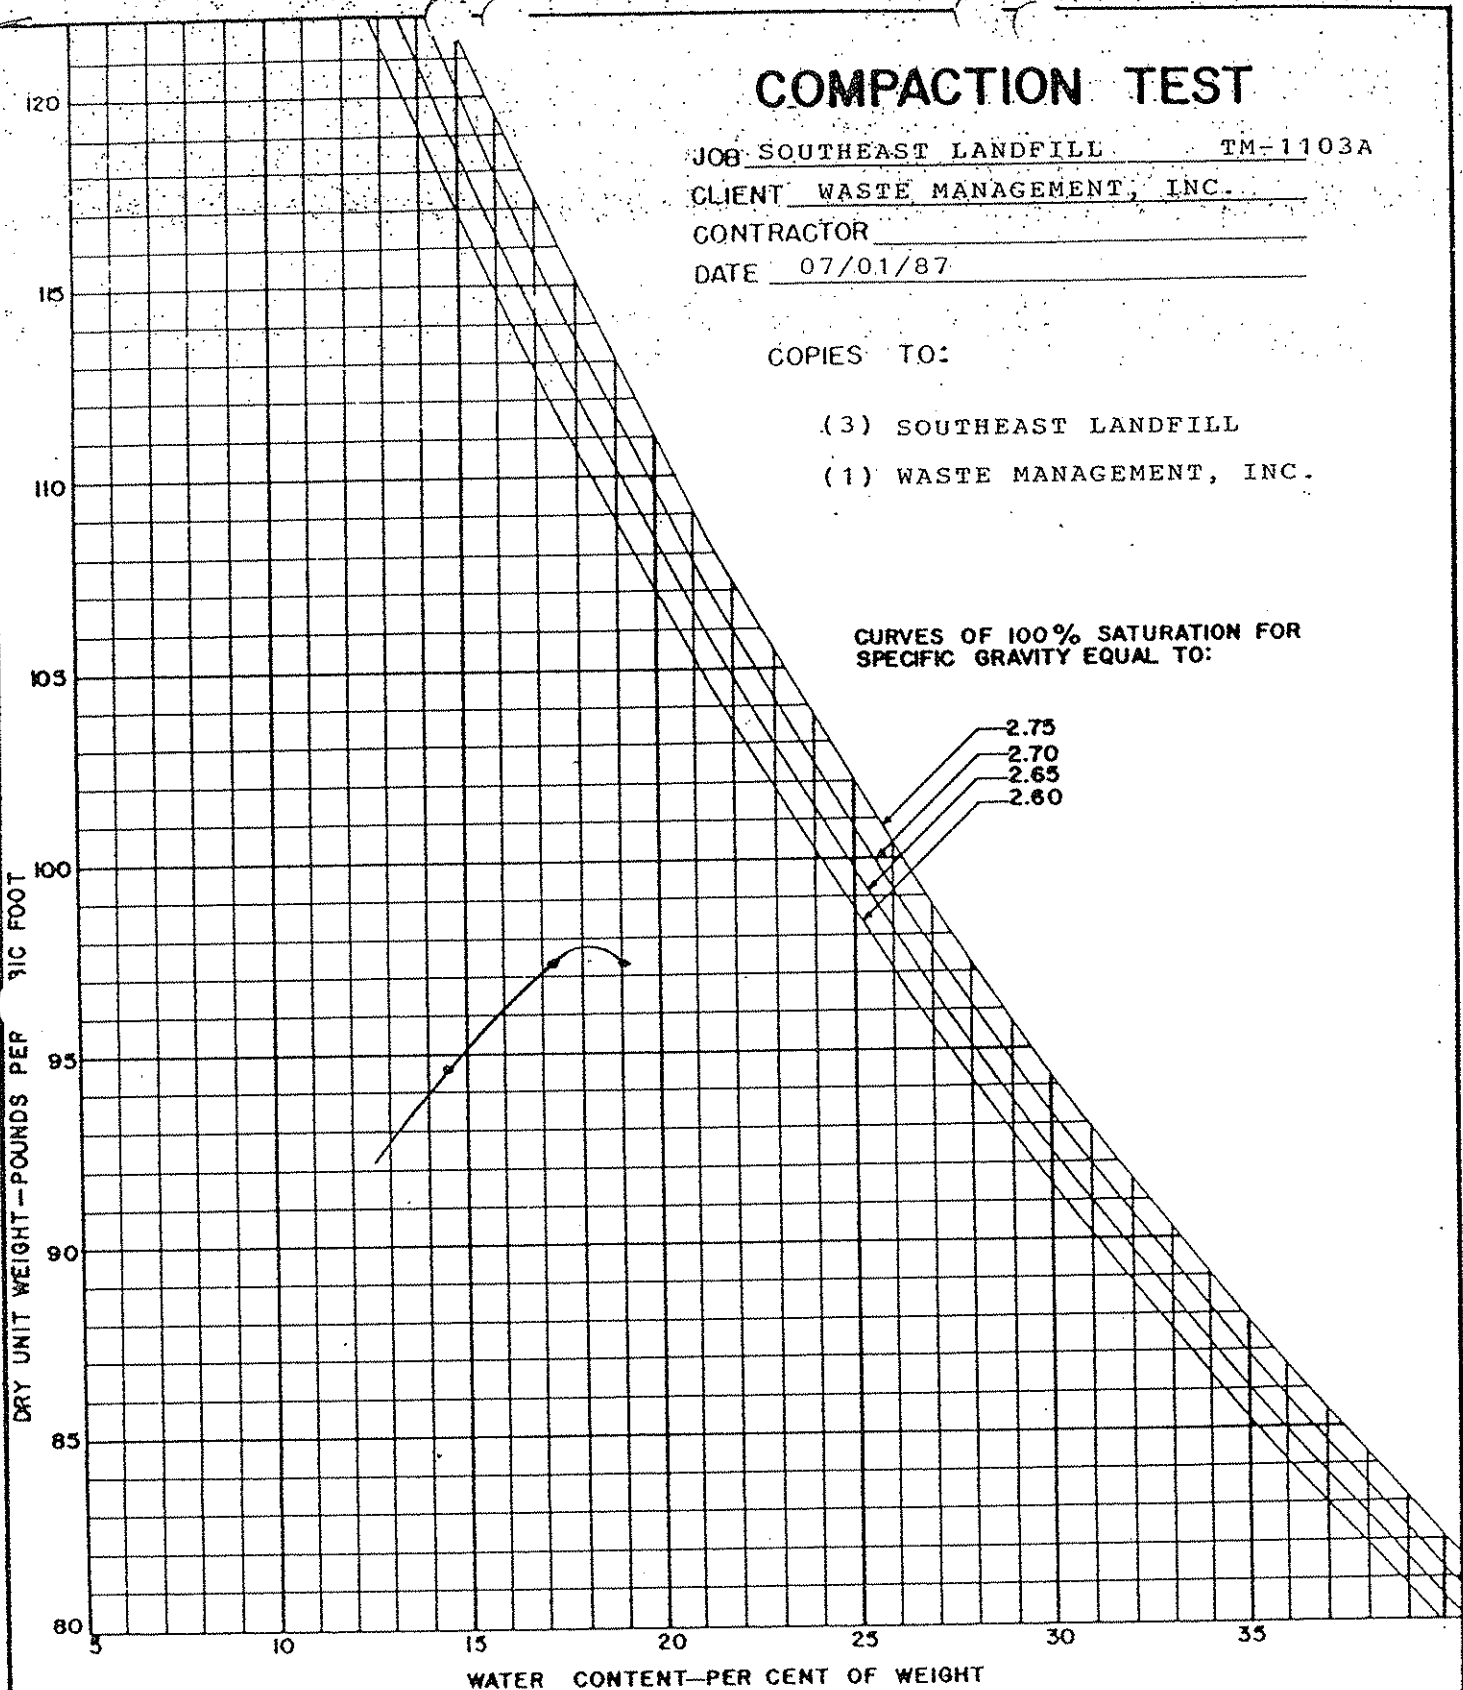
| MOISTURE DENSITY RELATION | METHOD OF TEST | MAX. DRY DENSITY PCF | OPTIMUM MOISTURE CONTENT % | SOIL DESCRIPTION OR CLASSIFICATION AND SAMPLE LOCATION |
|---|---|---|---|---|
| | ASTM D-1557<br>Method C | 97.8 | 18.0 | DESCRIPTION: Incinerated ash with small pieces of non-combustable debris.<br>LOCATION: Buried material @ the Landfill |

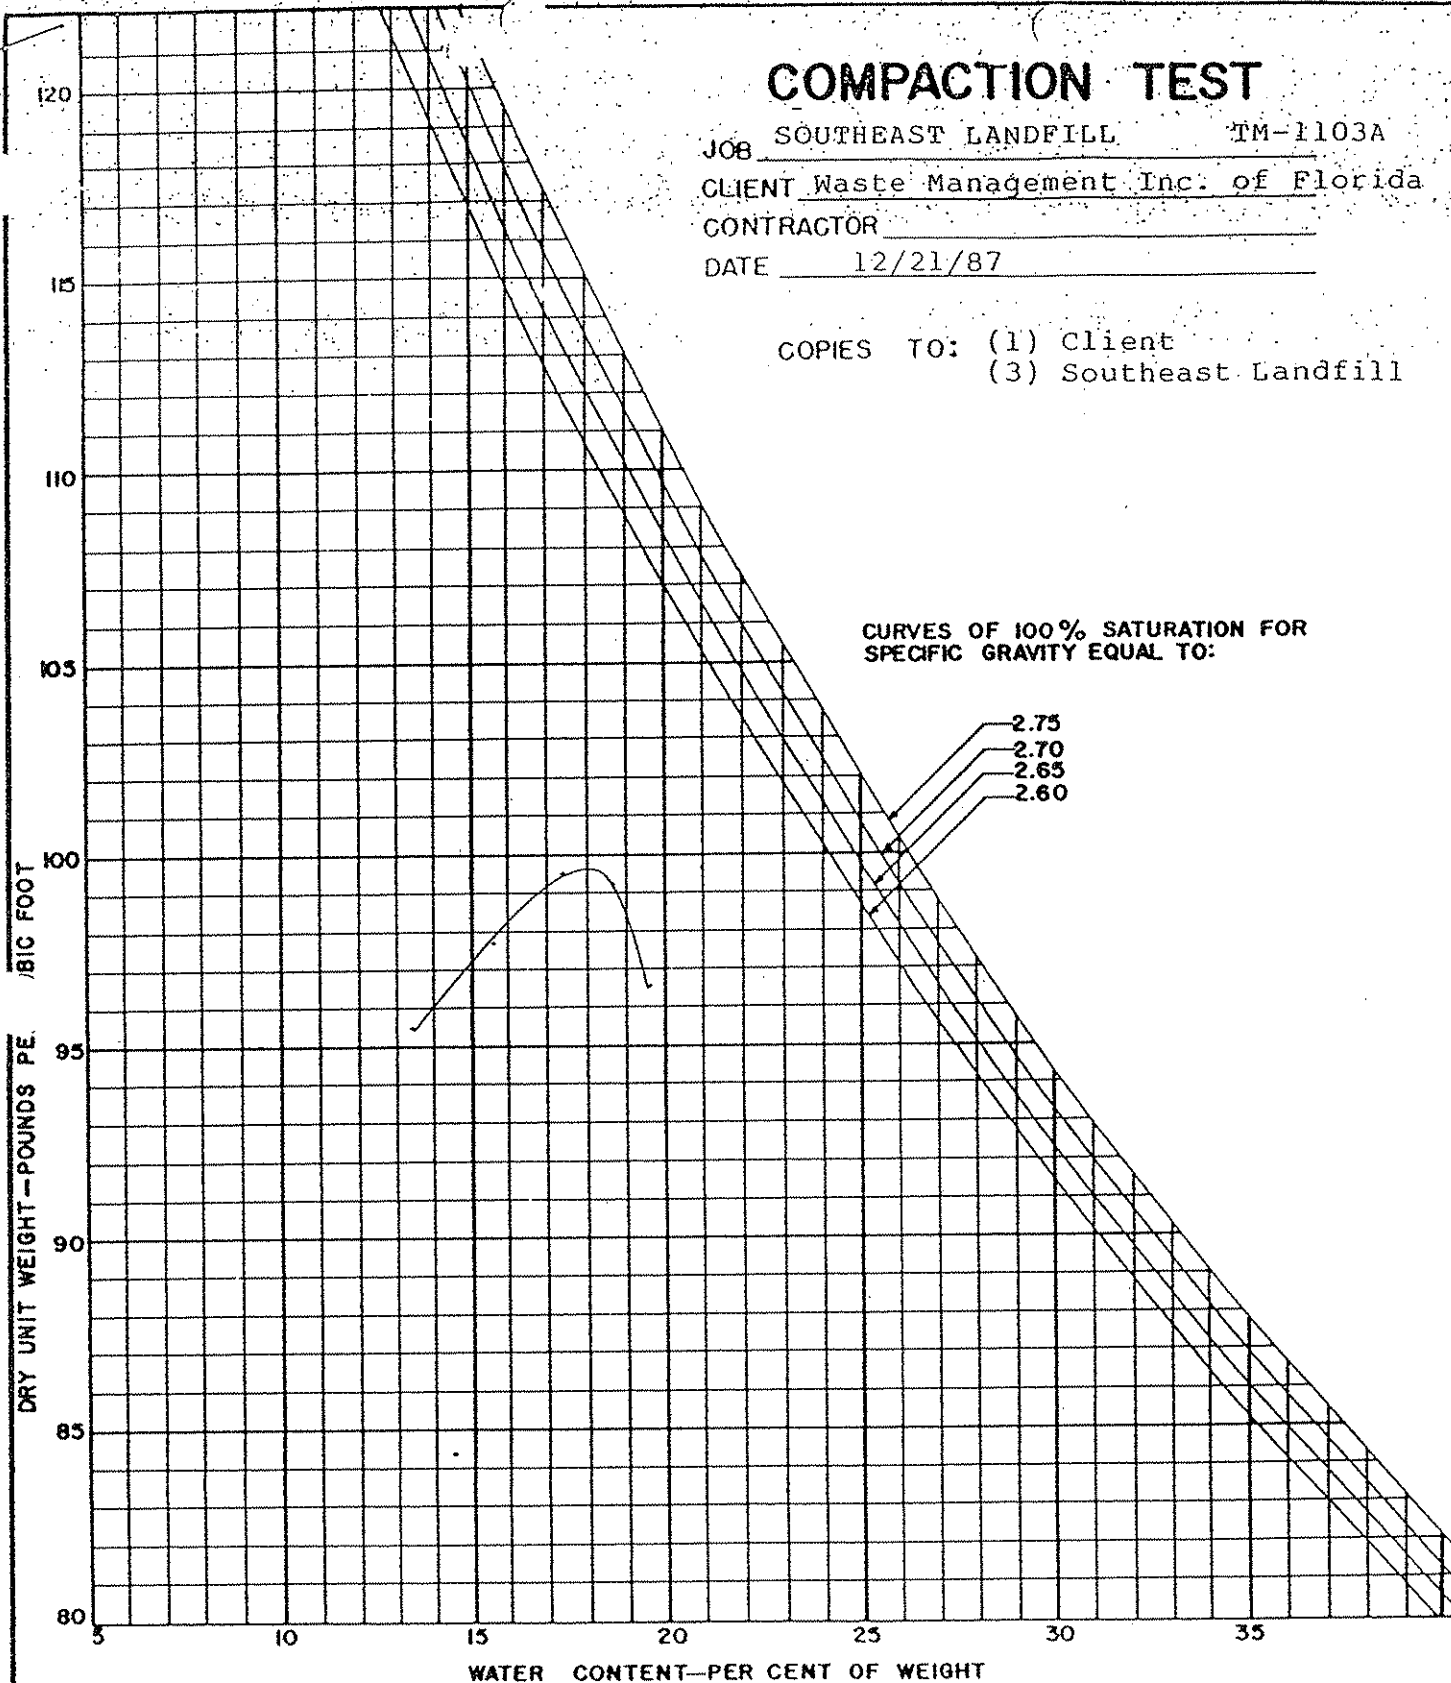
| MOISTURE DENSITY RELATION | METHOD OF TEST | MAX. DRY DENSITY PCF | OPTIMUM MOISTURE CONTENT % | SOIL DESCRIPTION OR CLASSIFICATION AND SAMPLE LOCATION |
|---|---|---|---|---|
| #3 | AASHTO T-99 Method A | 99.7 | 18.1 | Description: Tan to grey sand to clay material<br>Location: Sta. 33+00 |

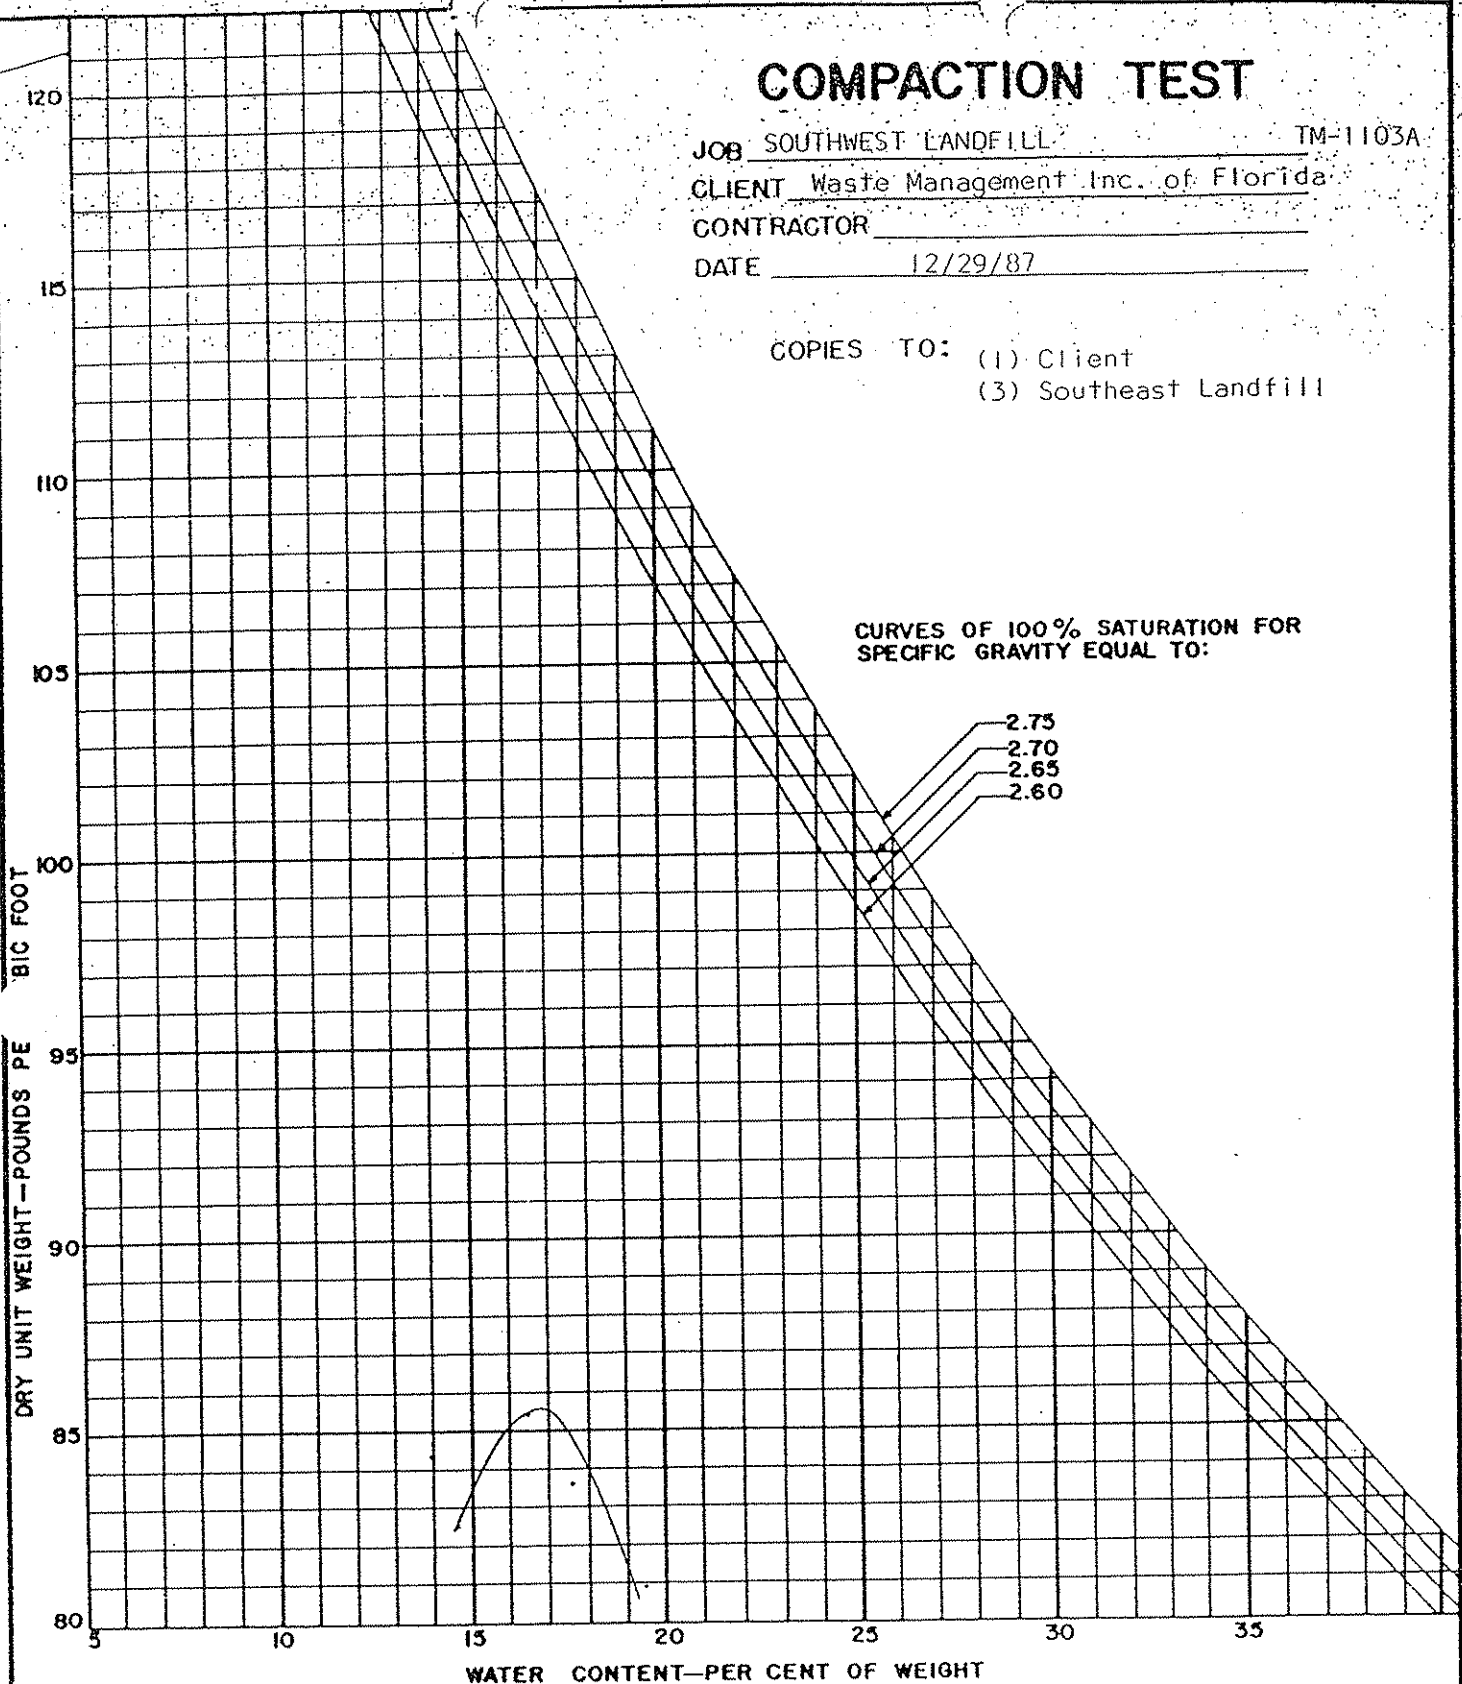
| MOISTURE DENSITY RELATION | METHOD OF TEST | MAX. DRY DENSITY PCF | OPTIMUM MOISTURE CONTENT % | SOIL DESCRIPTION OR CLASSIFICATION AND SAMPLE LOCATION |
|---|---|---|---|---|
| "4" | AASHTO T-99 Method A | 85.6 | 16.8 | Description: Grey to tan sandy clay<br>Location: Stockpile at Sta. 4400+00 |

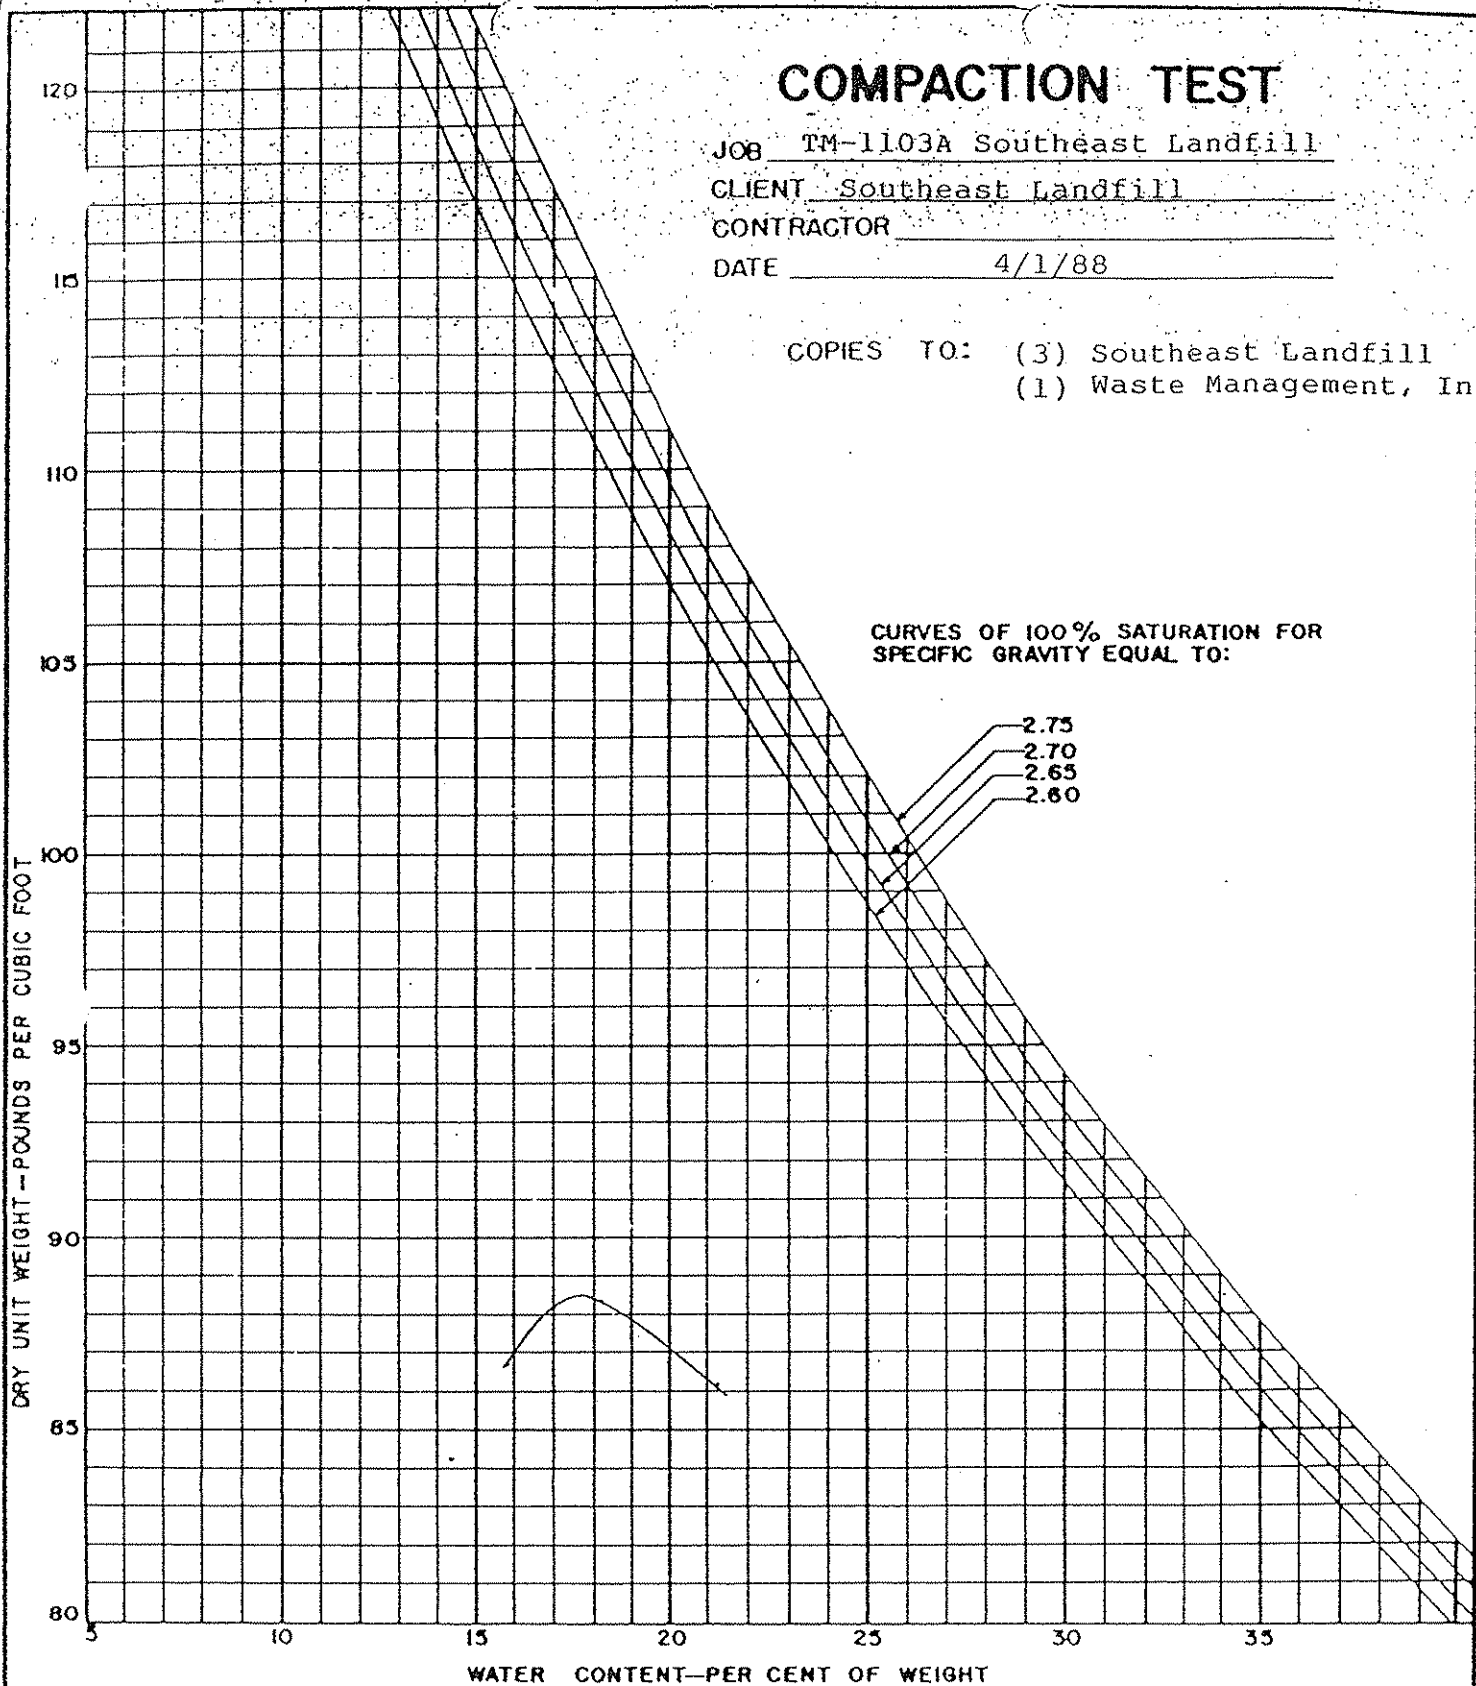
| MOISTURE DENSITY RELATION | METHOD OF TEST | MAX. DRY DENSITY PCF | OPTIMUM MOISTURE CONTENT % | SOIL DESCRIPTION OR CLASSIFICATION AND SAMPLE LOCATION |
|---|---|---|---|---|
| "C" | AASHTO T99 Meth. A | 88.5 | 17.7 | Location: Sta. 31+00 to 33+00<br>Description: Tan to brown clay |

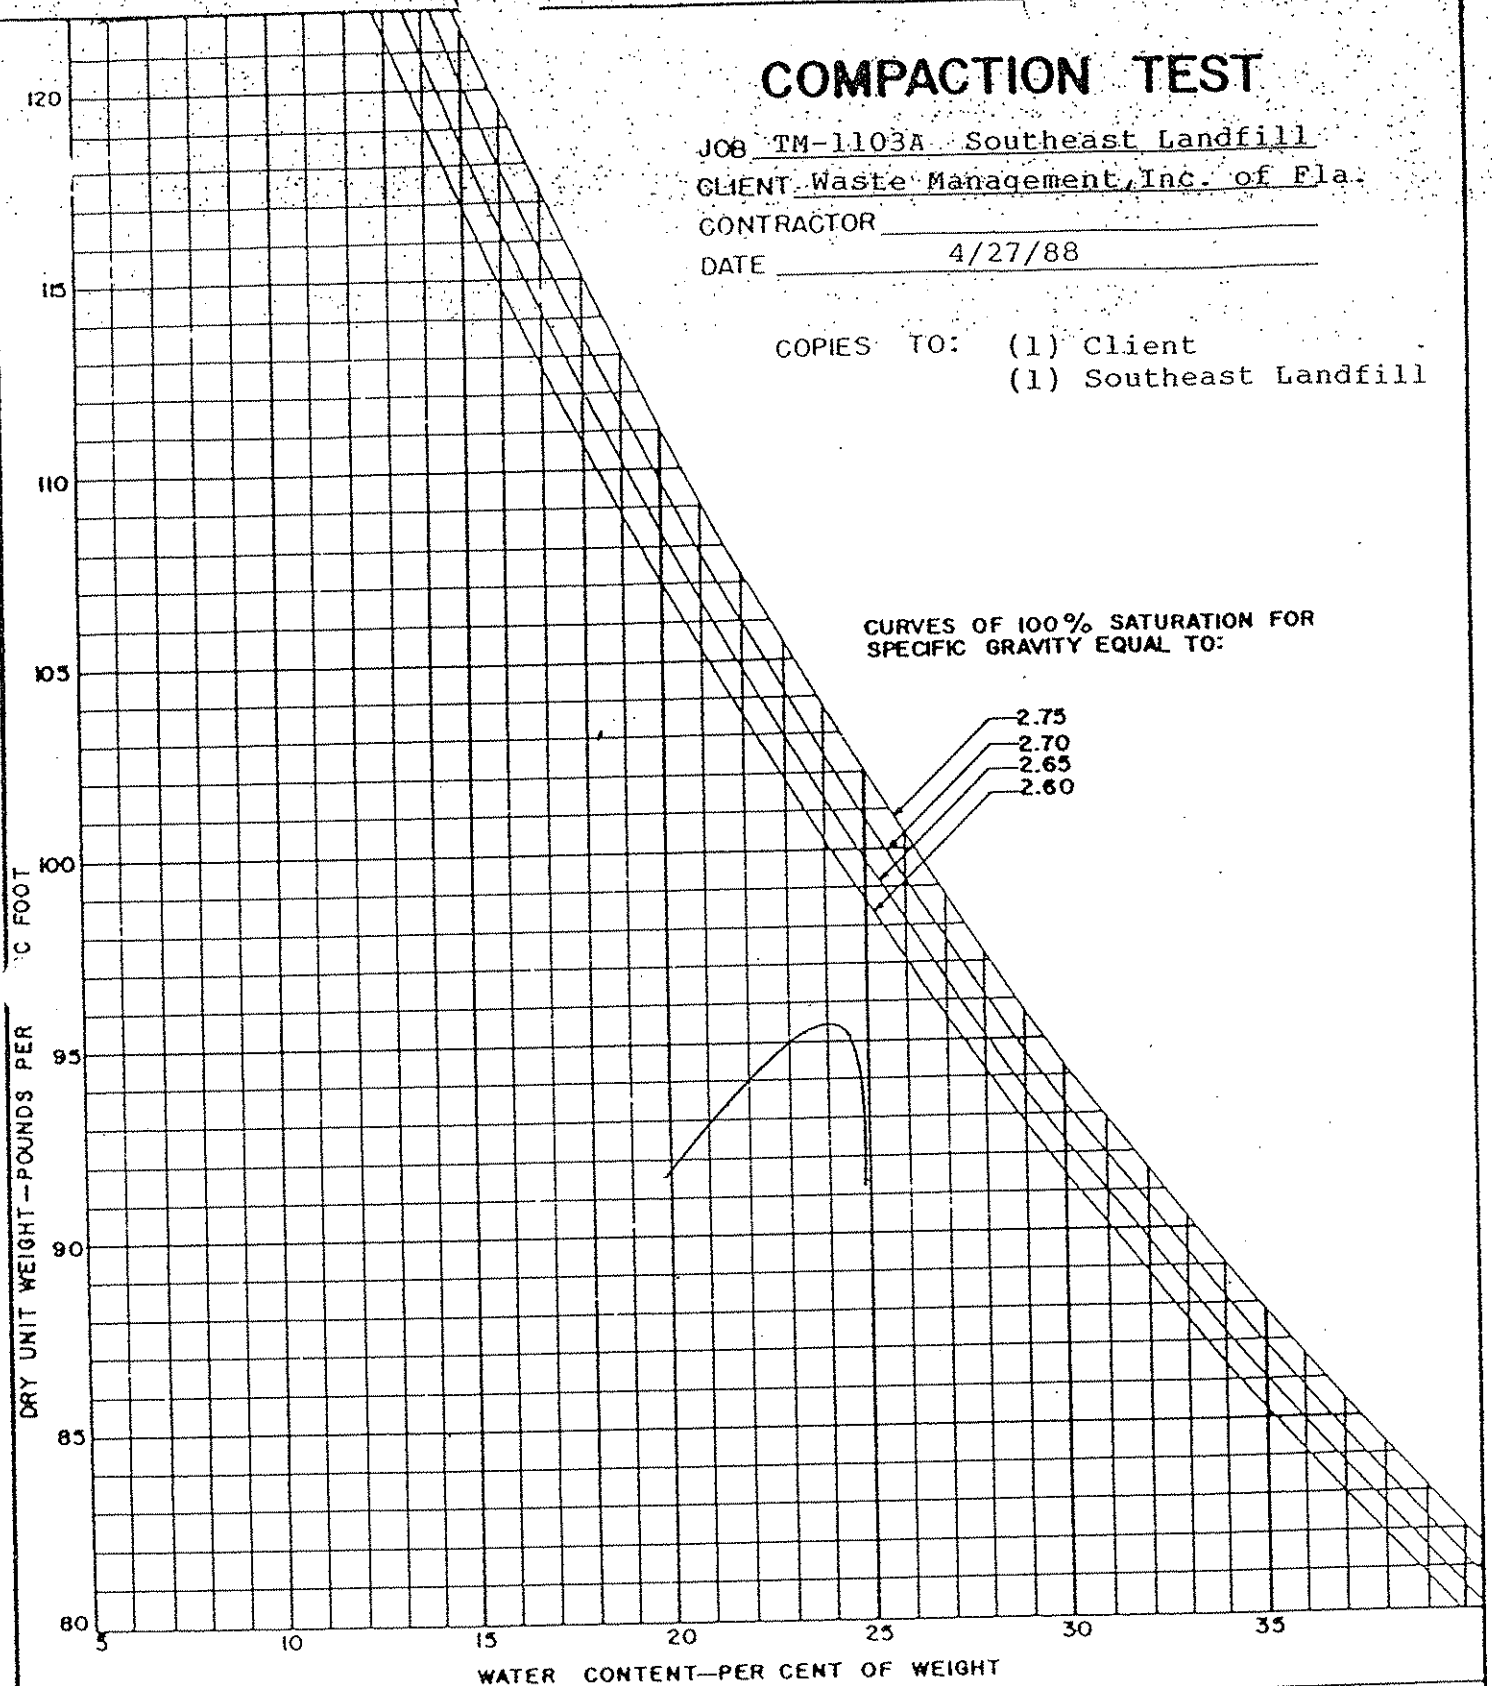
| MOISTURE DENSITY RELATION | METHOD OF TEST | MAX. DRY DENSITY PCF | OPTIMUM MOISTURE CONTENT % | SOIL DESCRIPTION OR CLASSIFICATION AND SAMPLE LOCATION |
|---|---|---|---|---|
| | AASHTO T99 Meth. A | 95.4 | 24.1 | Location: Between station #'s 3000+00 to 3900+00, South end, Acres 11, 12 & 13<br>Description: Tan snady clay |

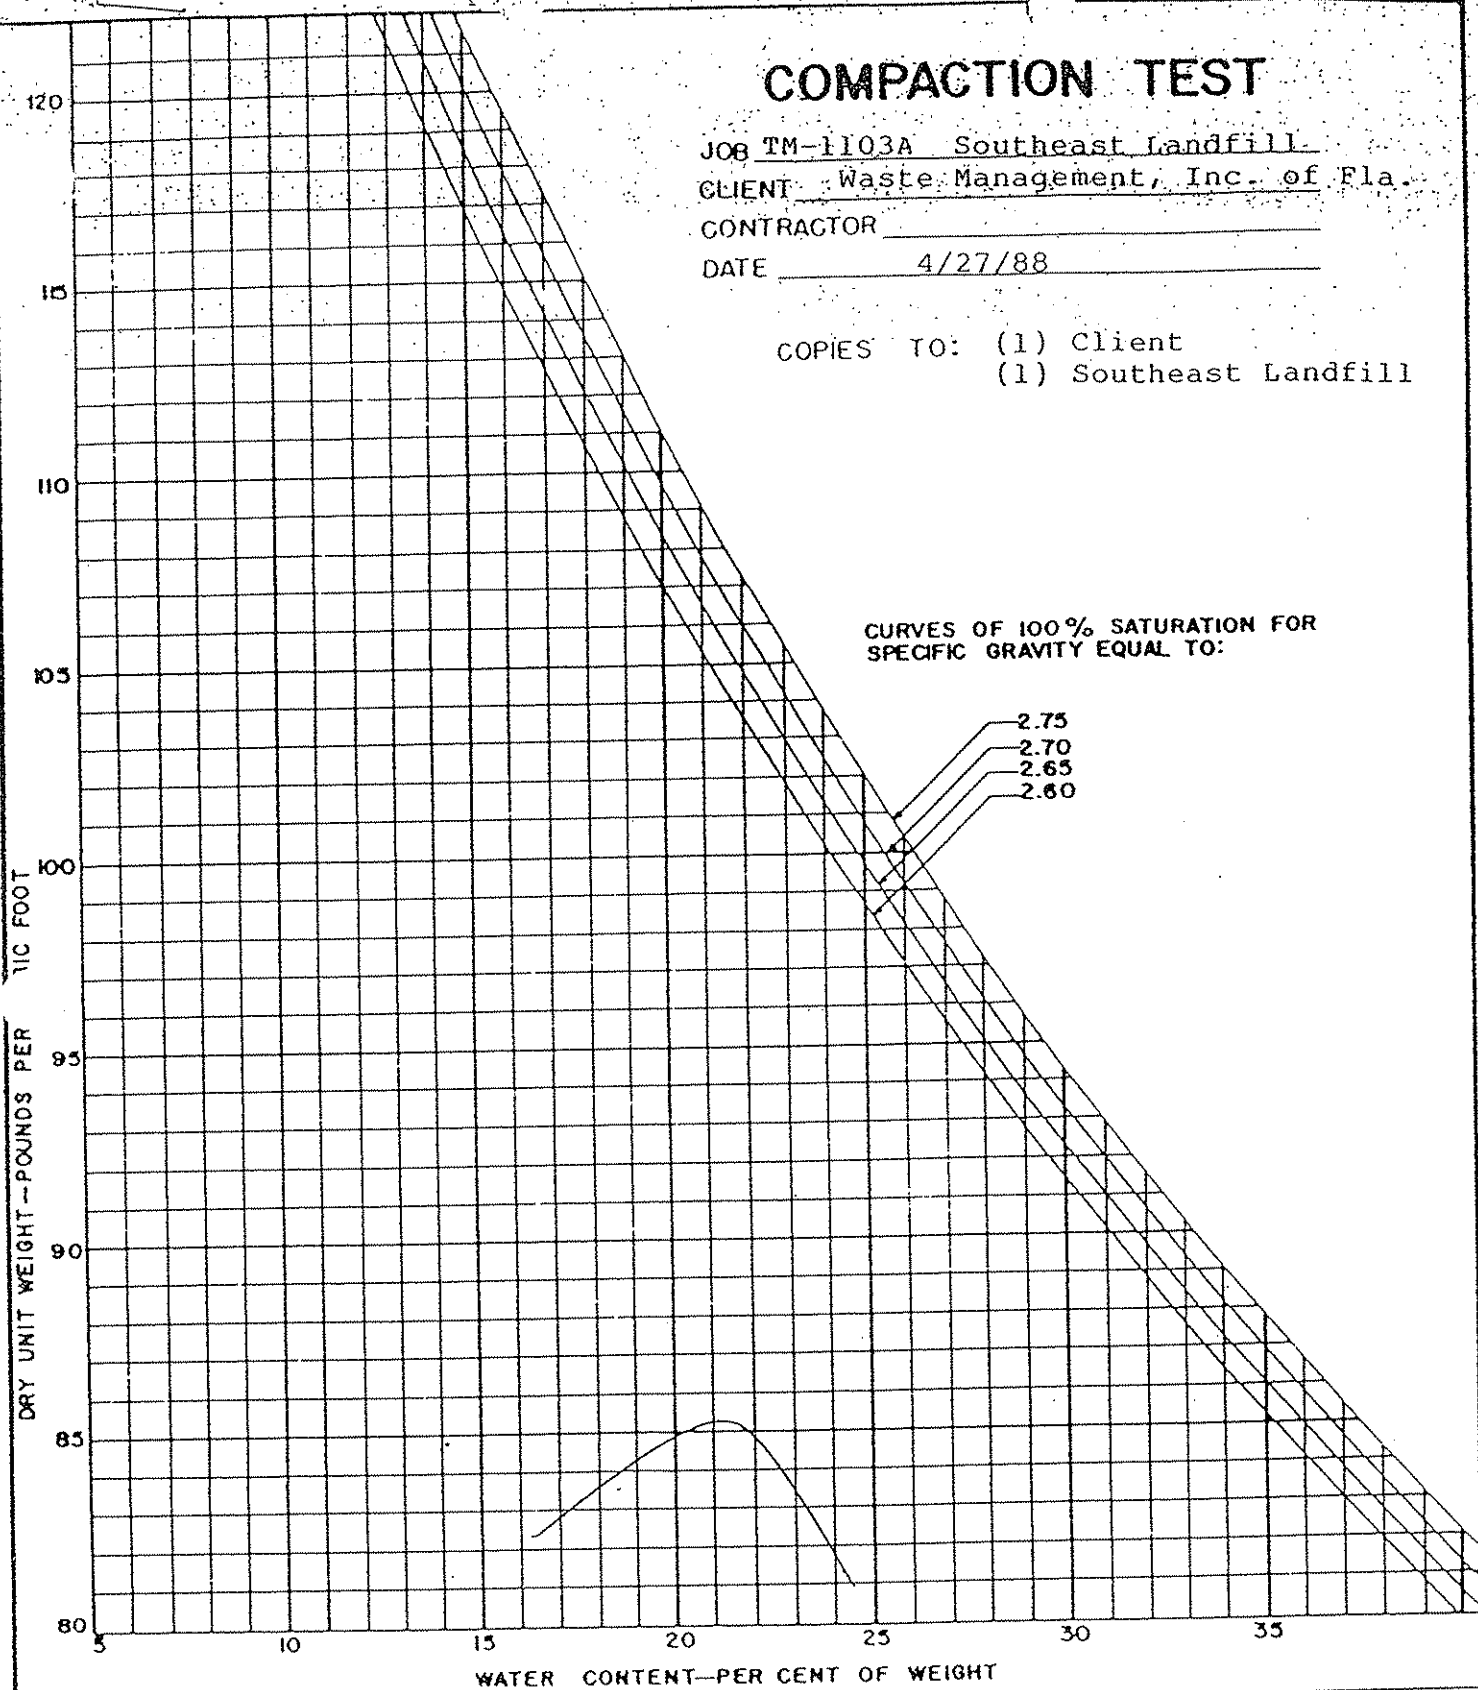
| MOISTURE DENSITY RELATION | METHOD OF TEST | MAX. DRY DENSITY PCF | OPTIMUM MOISTURE CONTENT % | SOIL DESCRIPTION OR CLASSIFICATION AND SAMPLE LOCATION |
|---|---|---|---|---|
| 7 | AASHTO T99<br>Meth. A | 85.2 | 21.3 | Location: Between station #'s 3900+00 to 4800+00. East side - Acres 14, 15 & 16<br>Description: Tan sandy clay |

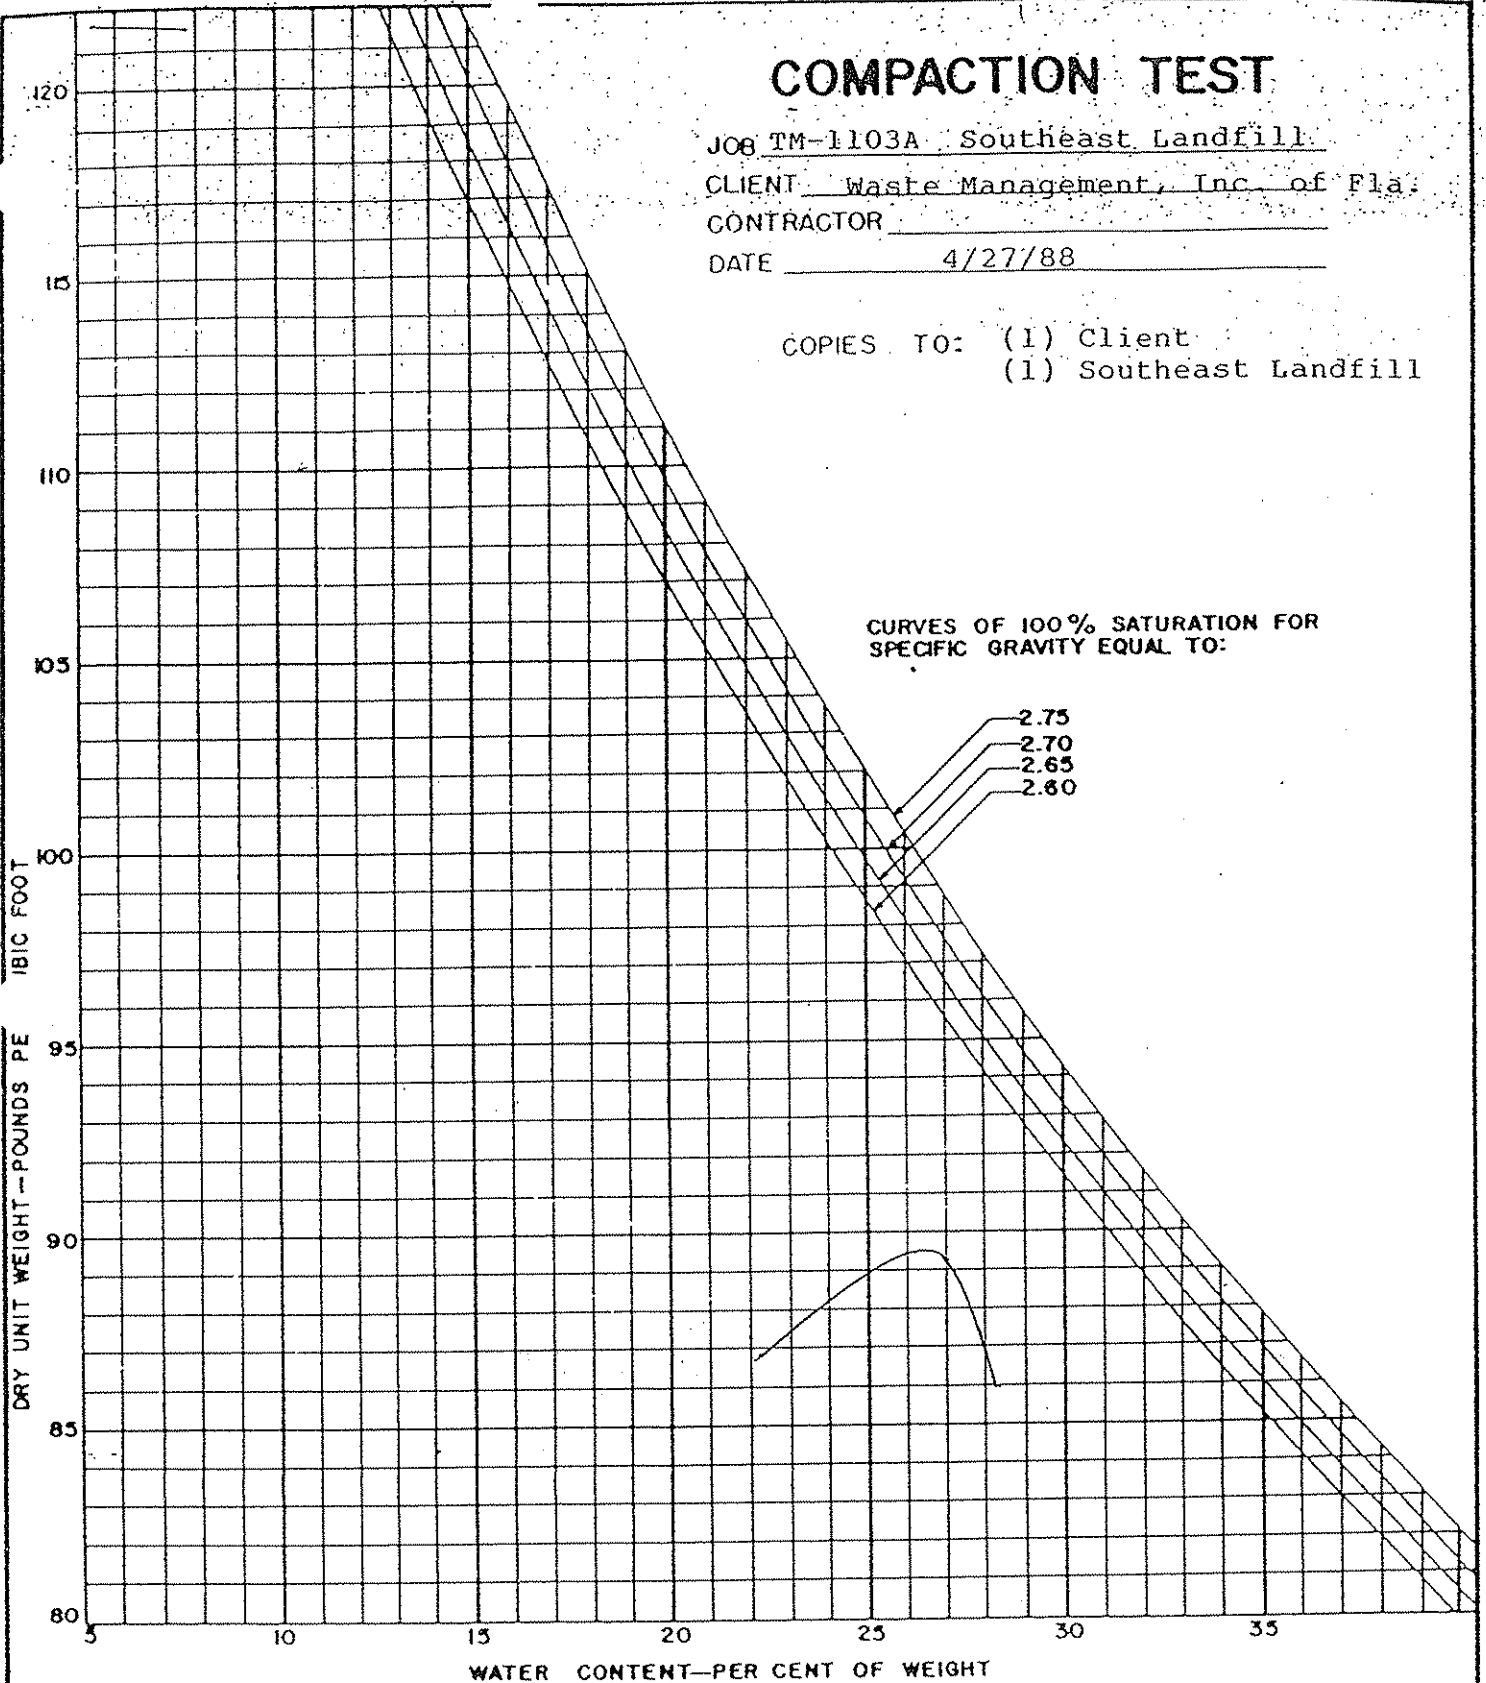
| MOISTURE DENSITY RELATION | METHOD OF TEST | MAX. DRY DENSITY PCF | OPTIMUM MOISTURE CONTENT % | SOIL DESCRIPTION OR CLASSIFICATION AND SAMPLE LOCATION |
|---|---|---|---|---|
| 8 | AASHTO T99<br>Meth. A | 89.6 | 26.2 | Location: Between station #'s 4800+00 to station # 6300+00, Acres 17, 18, 19, 20 & 21<br>Description: Tan sandy clay |
