Florida Department of  
Environmental Protection  
Inspection Checklist

Facility Name: J.E.D LANDFILL (F/K/A OAK HAMMOCK DISPOSAL)

Construction Completion Certification Inspection for Landfill - Class I facility

Cell 9 Construction Inspection:

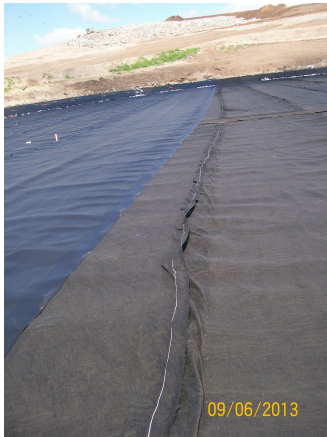
Geomembrane-composite Interface

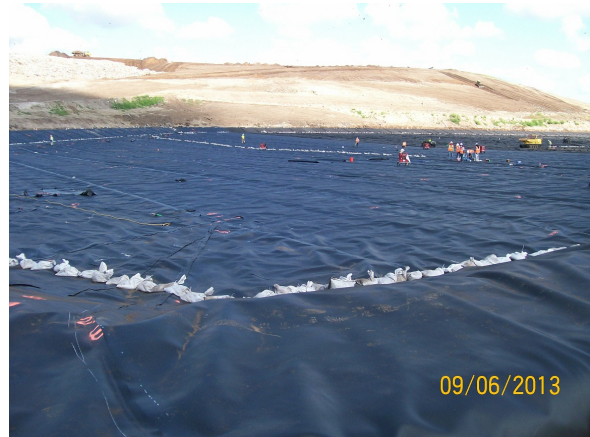
Geomembrane Installation - North

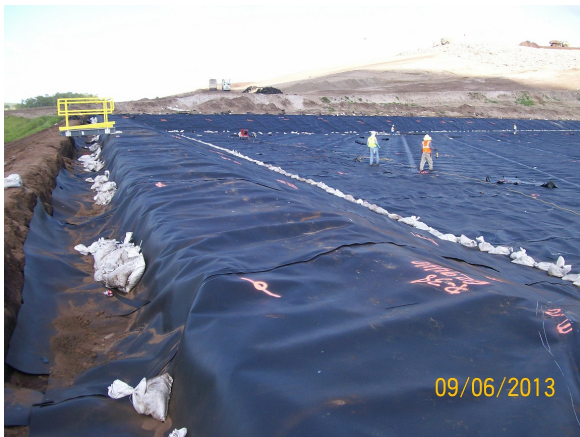
Geomembrane Installation - West

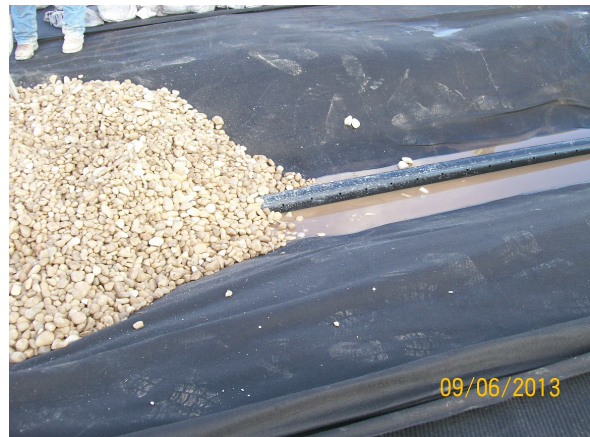
Leachate Corridor - pic 1

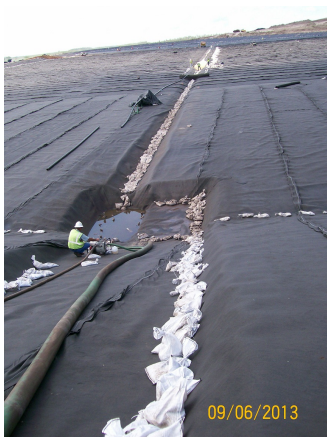
Leachate Corridor - pic 2

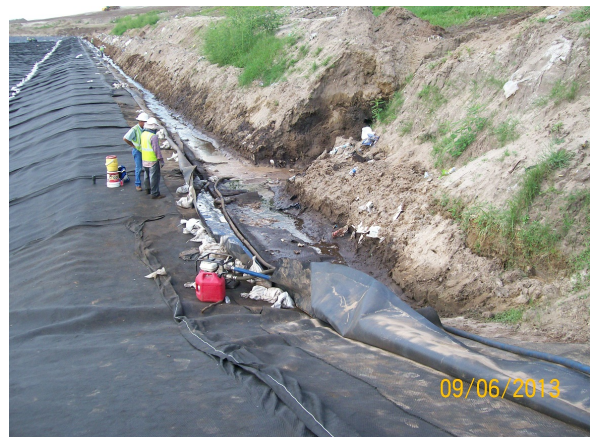
The intercell berm toward Cell 6 was experiencing a leachate back-up issue. The issue was temporarily being dealt with by supplying manpower to remove soil/silt from the length of the tie-

in to promote drainage of leachate down into Cell 6 (this was being done at the time of this inspection) and/or pumping it out. The issue was later addressed by installing a geomembrane flap along the intercell berm to restrict the potential cross flow of leachate from Cell 6 into Cell 9 during construction. This corrective action measure is described in the certification report section 7.3 Geomembrane Flap at Intercell Berm, dated October 31, 2013.

Leachate Issue at Intercell Berm

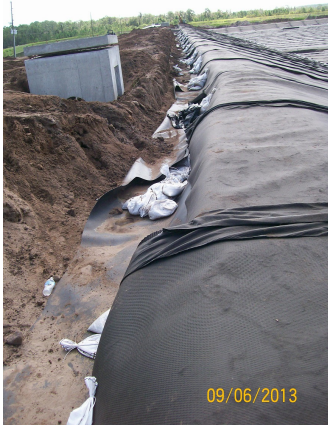
West Side Anchor Trench
