2013 Leachate Quantity Analysis Report Tomoka Farms Road Landfill Class I North Cell

Volusia County Solid Waste Construction Engineer

January 2014

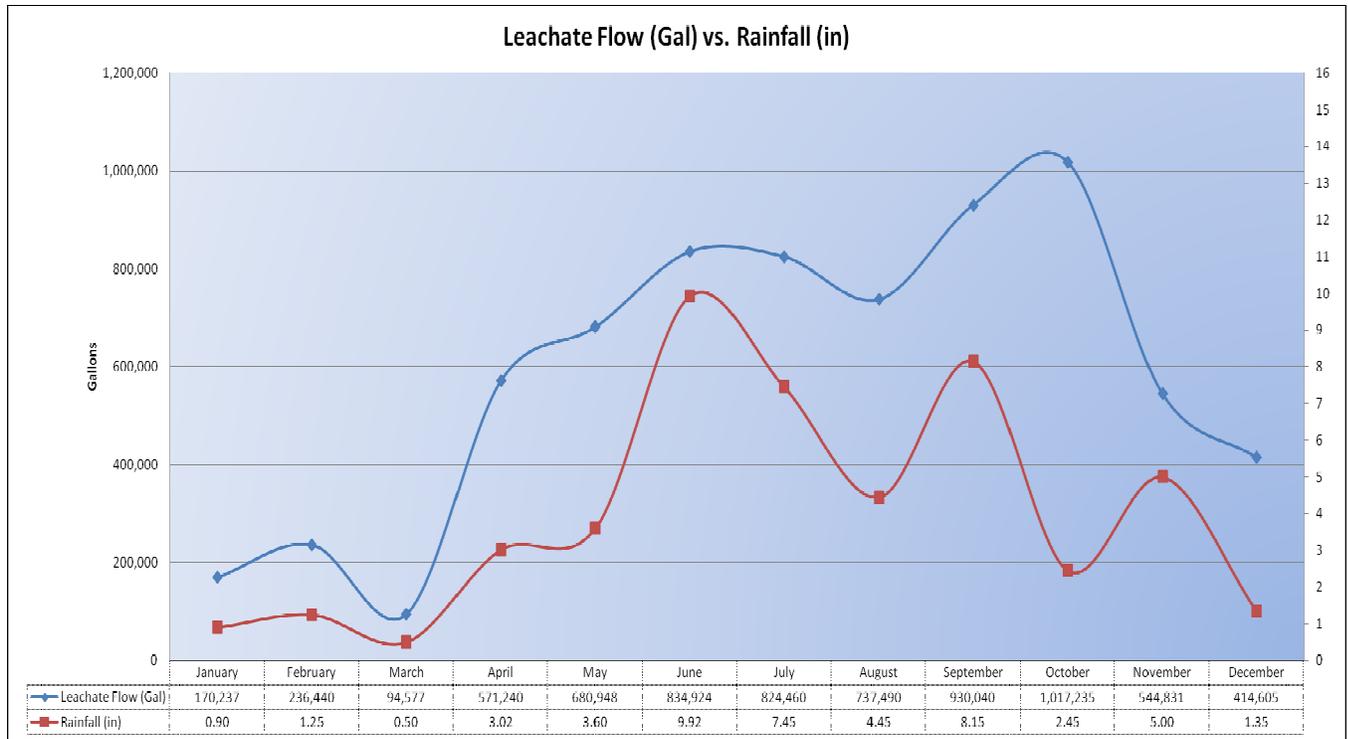
Figure 1 (Leachate Flow vs. Rainfall)

The weekly readings are gathered in the field, then entered into a spreadsheet, tracked throughout the year, compared to the recent rainfall, and analyzed. If the analysis shows an unusual rise or drop in leachate generation as compared to the rainfall for that period, troubleshooting and subsequent repairs to the system are made and documented. Rainfall is recorded daily directly adjacent to the North Cell at the leachate treatment facility. During the reporting period, January 2013 through December 2013, the leachate generation rates tracked very closely with the rainfall trending up with an increase in rain and trending down with a decrease in rainfall. Riser one specifically sees a significant increase in leachate production during rainy periods due to the open toe-drain on the south side, which is connected through a cleanout riser to the leachate collection system for riser one. The toe-drain appears to be working effectively, it is typically dry within two or three days after a heavy rain and there have been limited leachate seeps in the area of the toe-drain. Figure 1 is provided as a graphical representation of leachate generation rates vs. rainfall for the period of January 2013 through December 2013.
