**GEOMEMBRANE REPAIR
CERTIFICATION DOCUMENTATION**

**SOUTHEAST COUNTY LANDFILL
HILLSBOROUGH COUNTY, FLORIDA**

November 8, 1994
Job No. 0990018.35

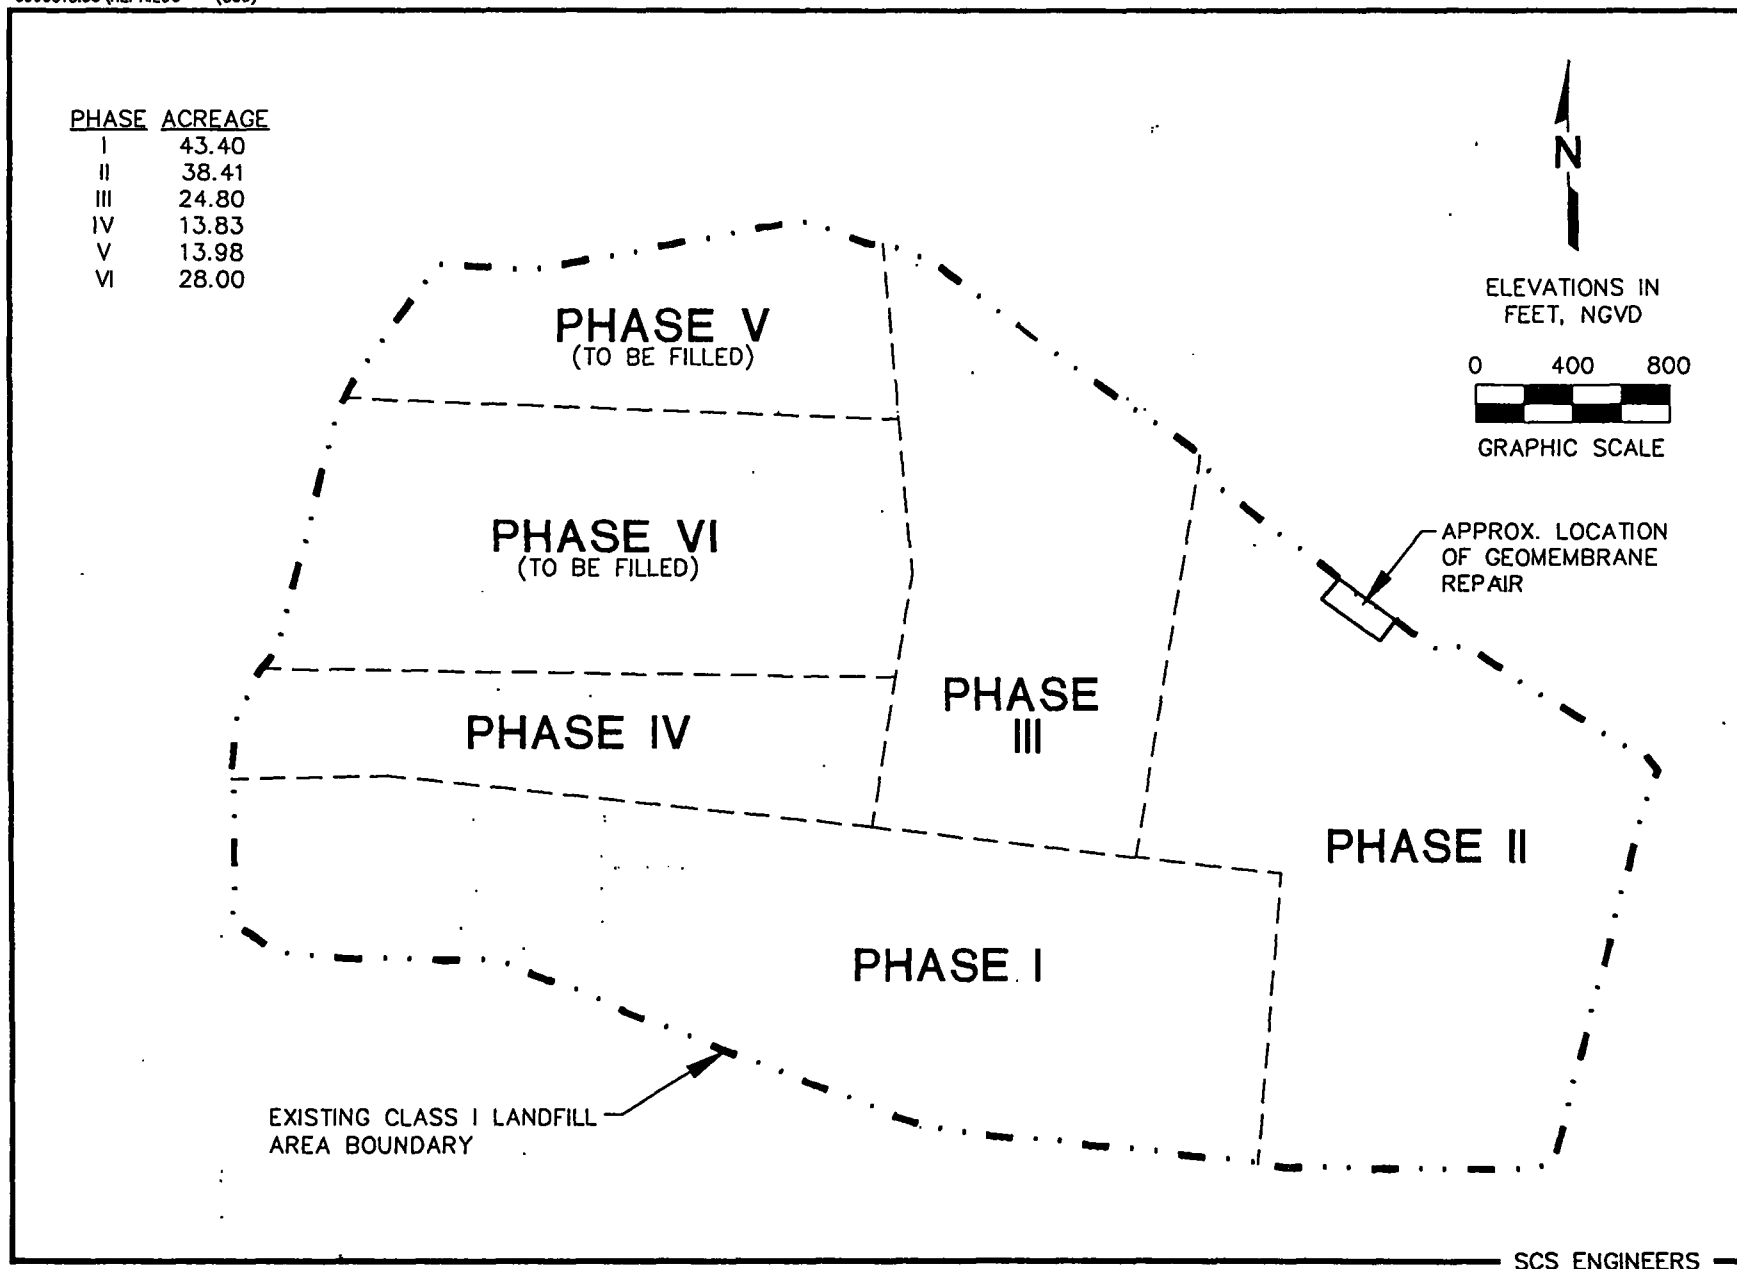
Figure 2-2. Repair Location Map.

The SELF is located on County Road 672, eight miles east of U.S. Highway 301, as shown in Figure 2-1. The location of the repair at the SELF, as shown in Figure 2-2, is at the northern perimeter of Phase II.

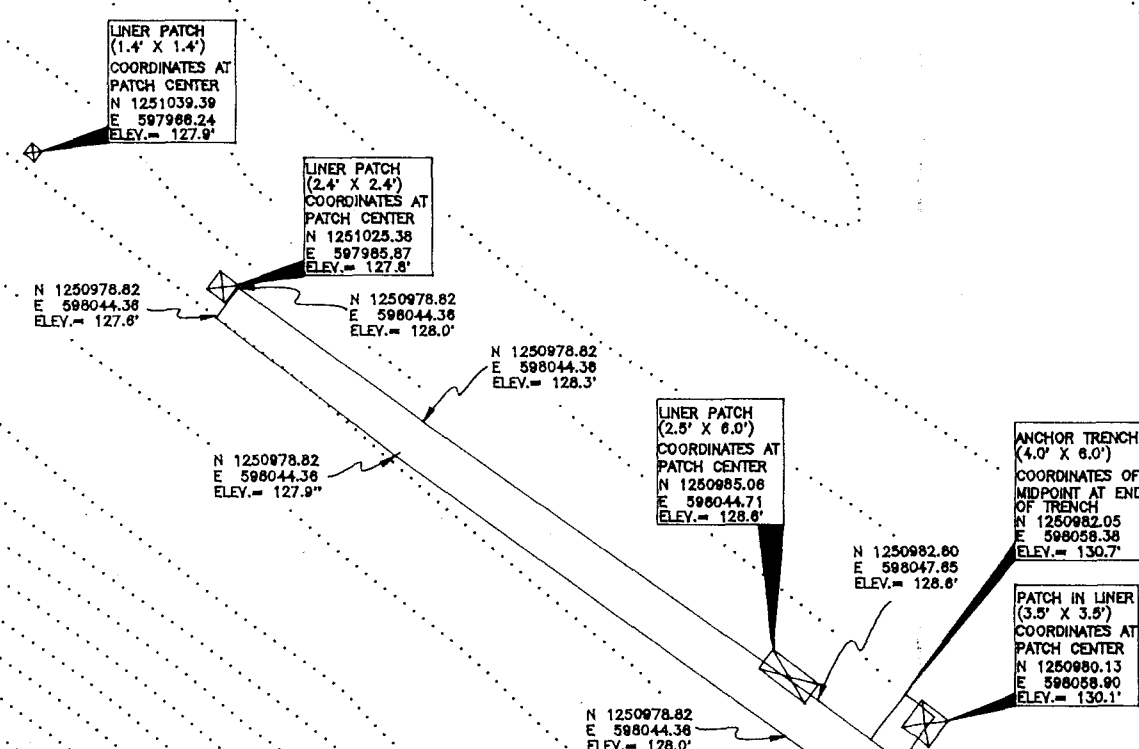
LEACHATE LINER REPAIR AREA

Appendix A contains information depicting the location of the installed geomembrane patches, including horizontal and vertical control. Incidental penetrations through the geomembrane occurring from the process of exposing the liner were documented for repair, and are identified in the as-built drawing.

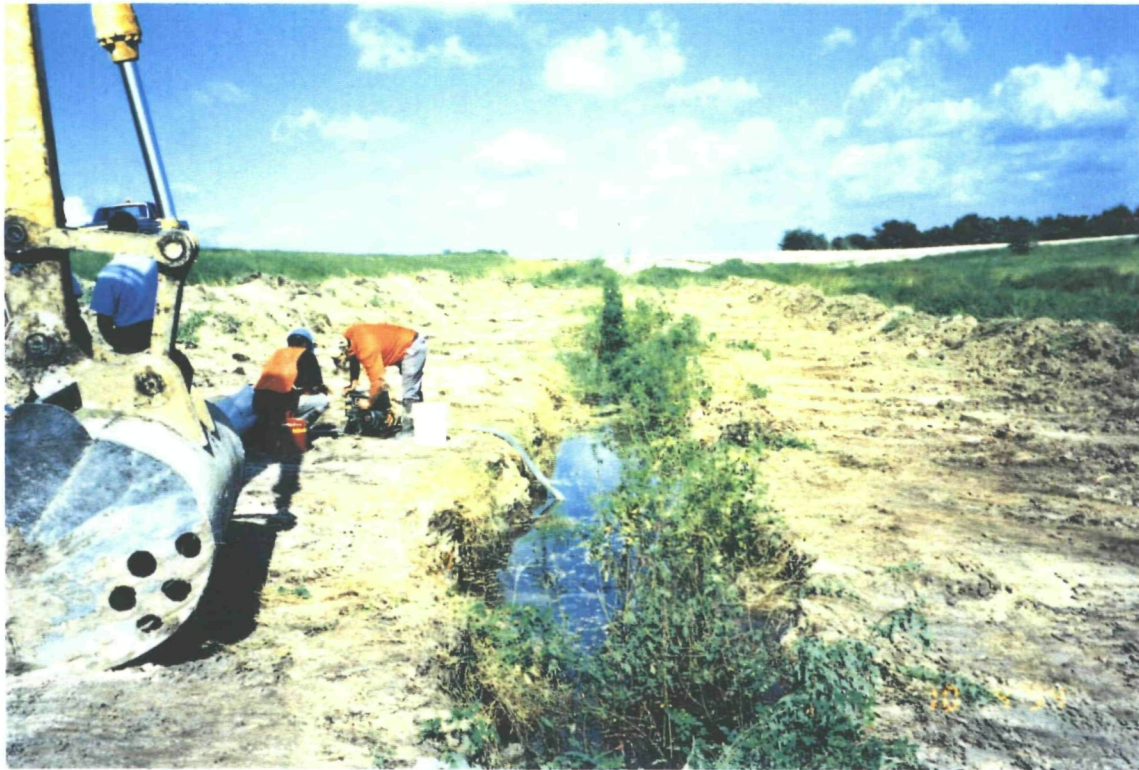
Photo No. 1

Date: October 4, 1994 Location: Southeast County Landfill
Description: Dewatering anchor trench previous to excavation activities (looking west)

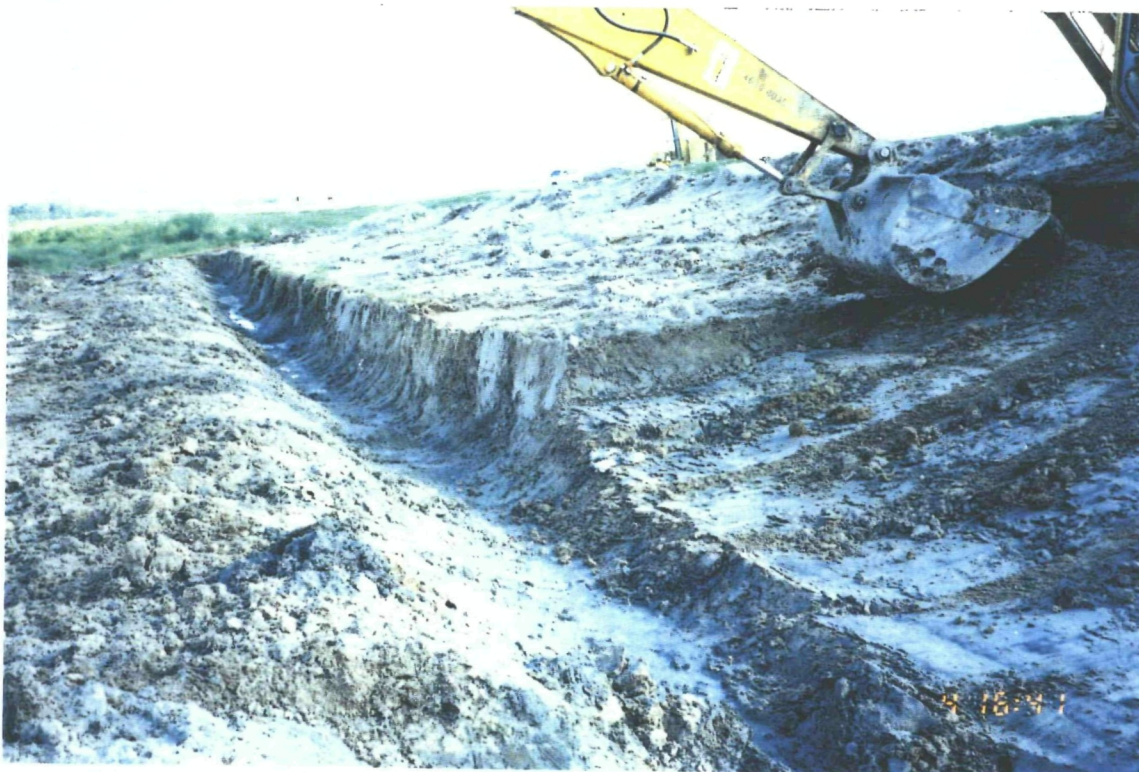
Photo No. 2

Date: October 4, 1994 Location: Southeast County Landfill
Description: After the vegetation was cleared from the vicinity, the clay cap was removed

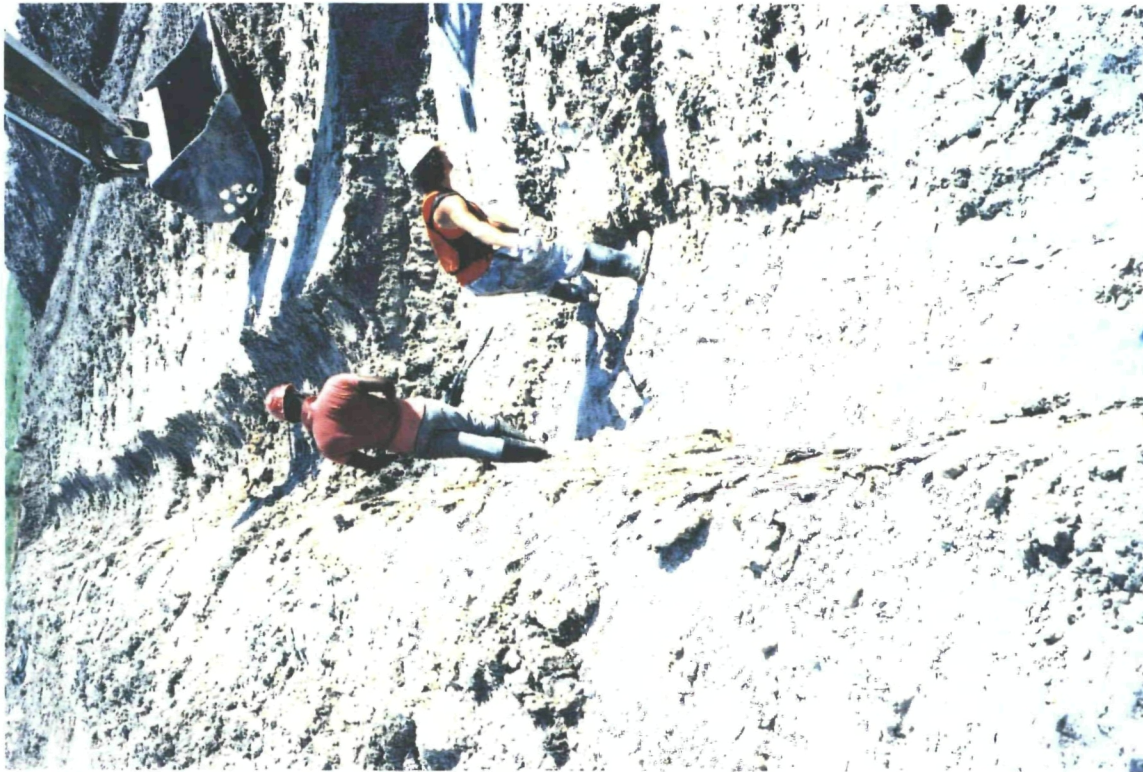
Photo No. 3

Date: October 5, 1994 Location: Southeast County Landfill
Description: After excavating with a backhoe, hand tools were used to expose the liner

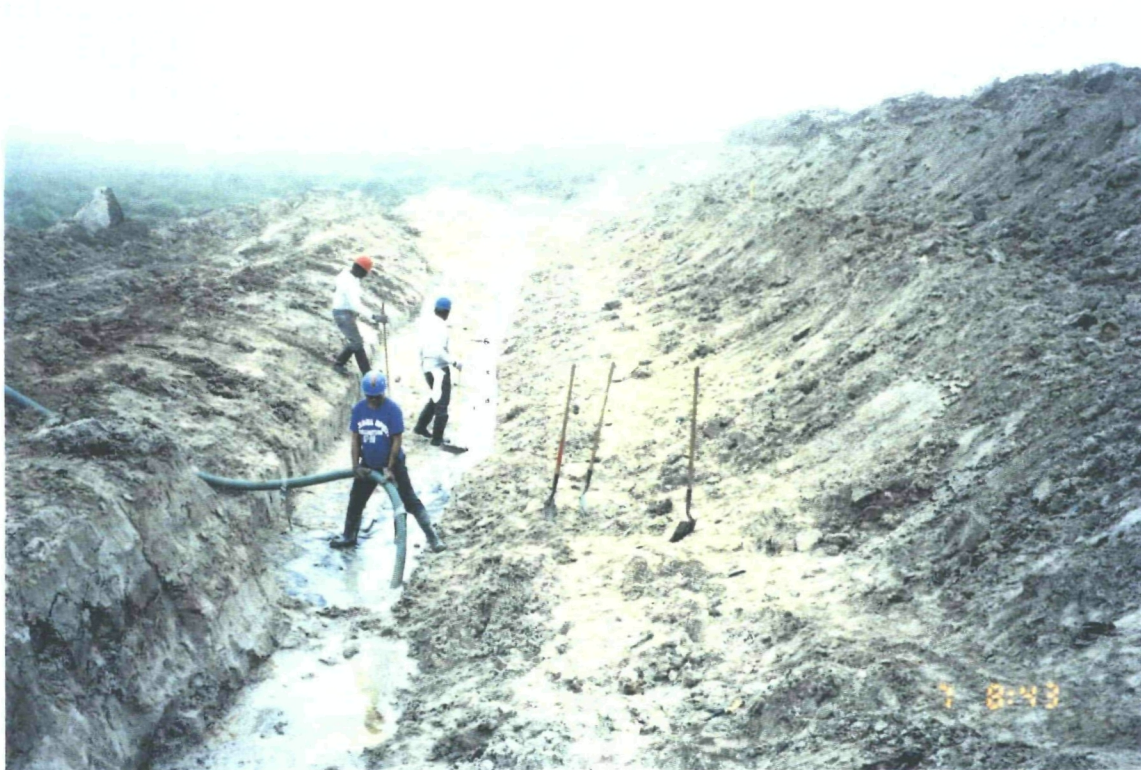
Photo No. 4

Date: October 7, 1994 Location: Southeast County Landfill
Description: Pumping water into a tank for disposal

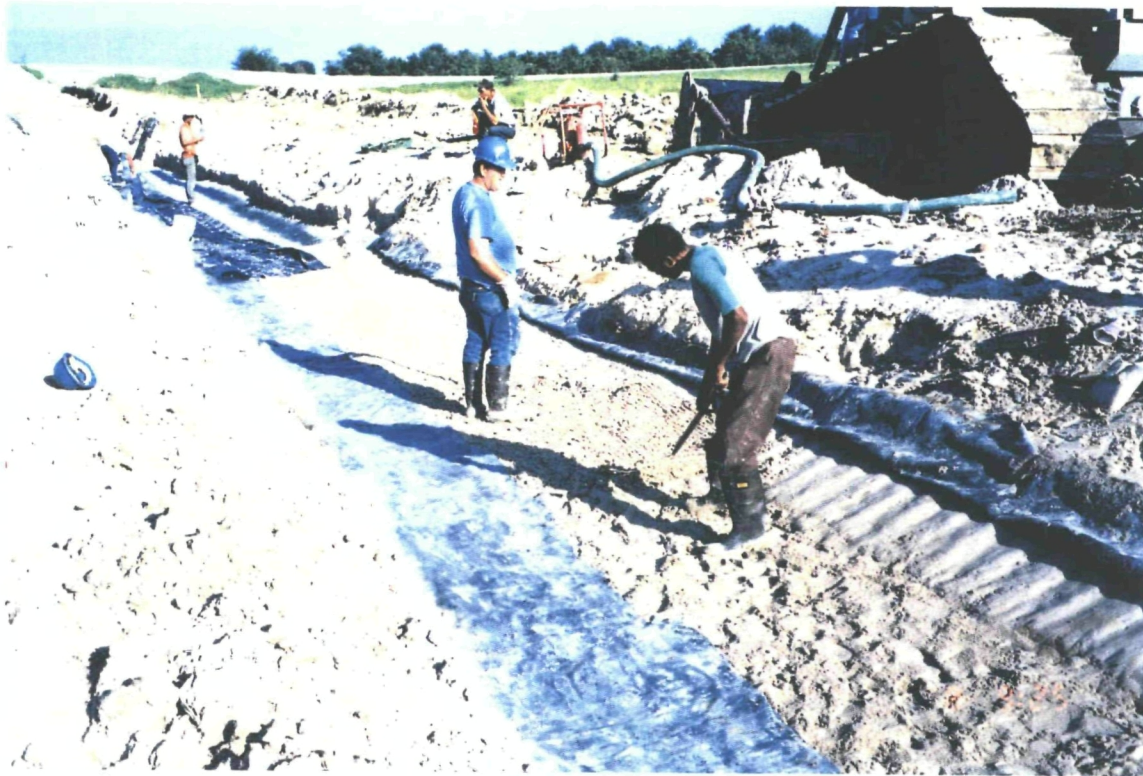
Photo No. 5

Date: October 8, 1994 Location: Southeast County Landfill
Description: The subgrade for the patch is prepared

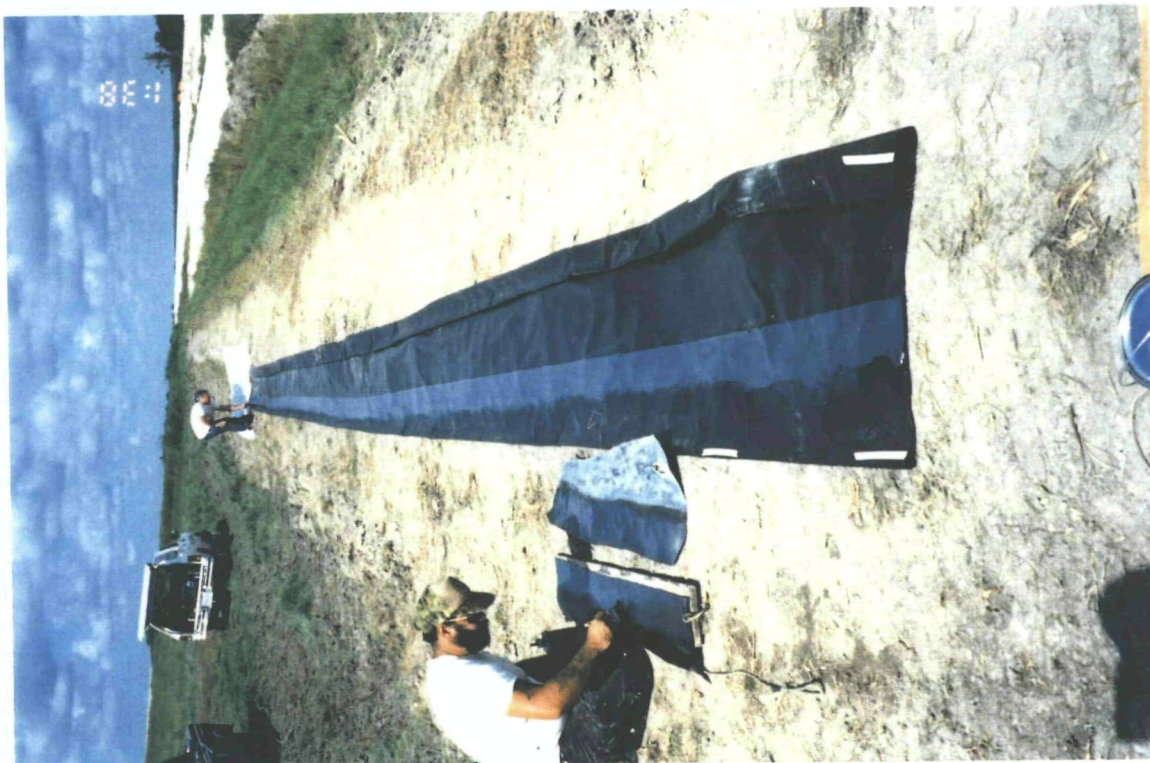
Photo No. 6

Date: October 7, 1994 Location: Southeast County Landfill
Description: Patch being prepared for placement and seaming with first coat of adhesive

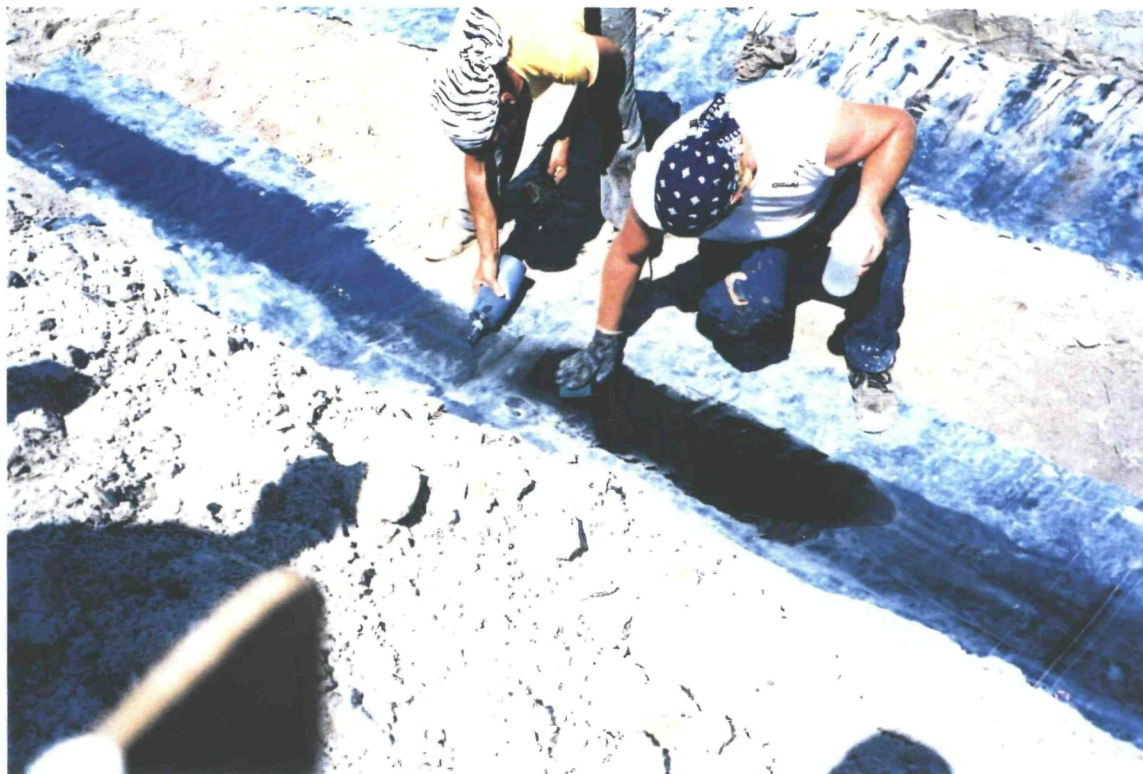
Photo No. 7

Date: October 7, 1994 Location: Southeast County Landfill
Description: In-place geomembrane is cleaned and prepared with first coat of adhesive

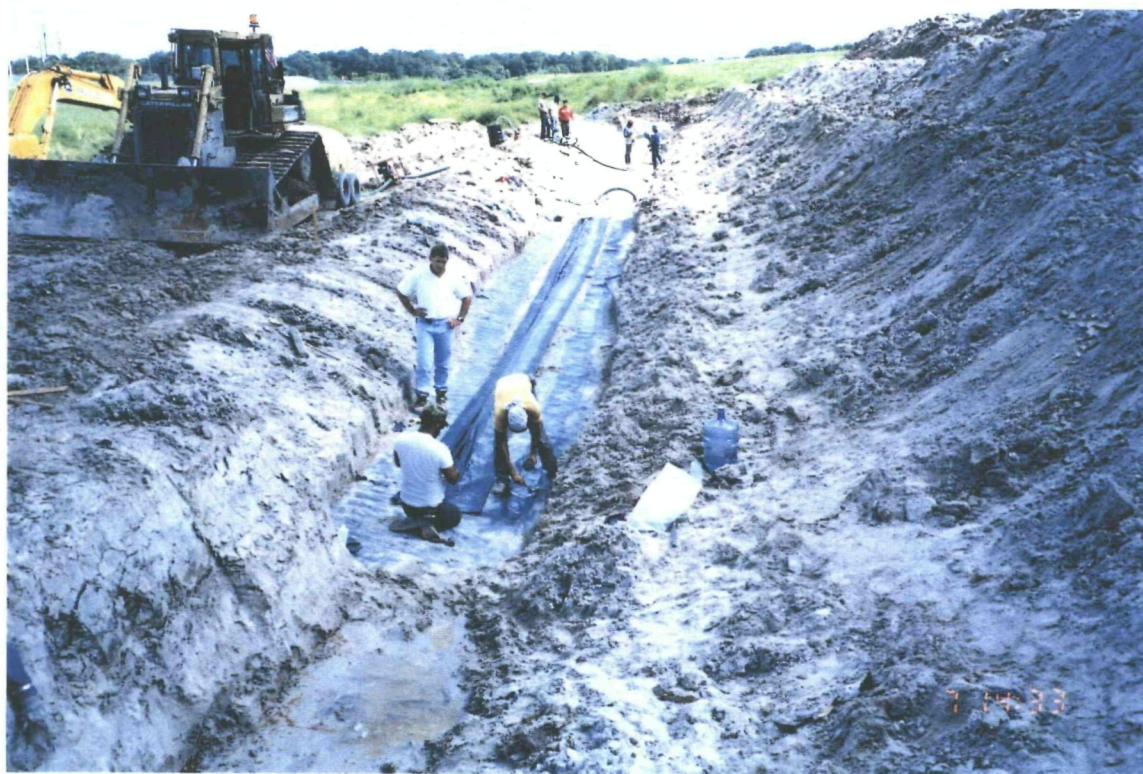
Photo No. 8

Date: October 7, 1994 Location: Southeast County Landfill
Description: Patch is carefully positioned (NOTE: tank for water disposal standing by)

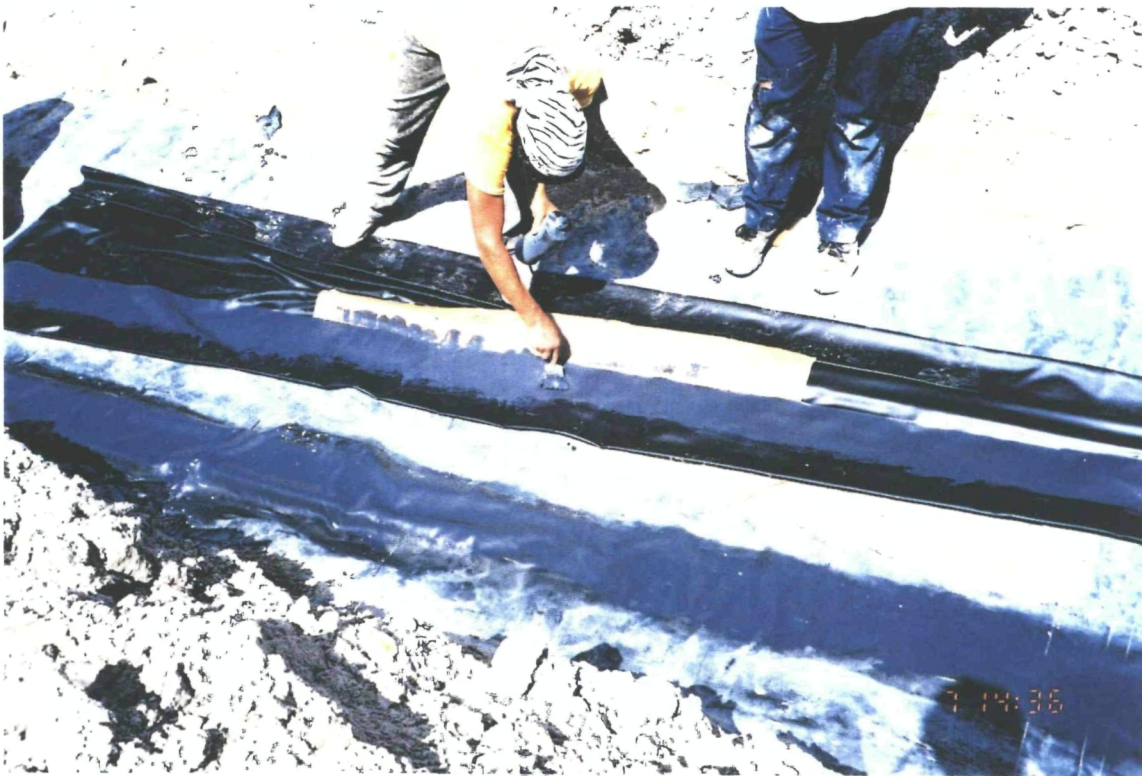
Photo No. 9

Date: October 7, 1994 Location: Southeast County Landfill
Description: The seam area receives a second coat of adhesive prior to bonding

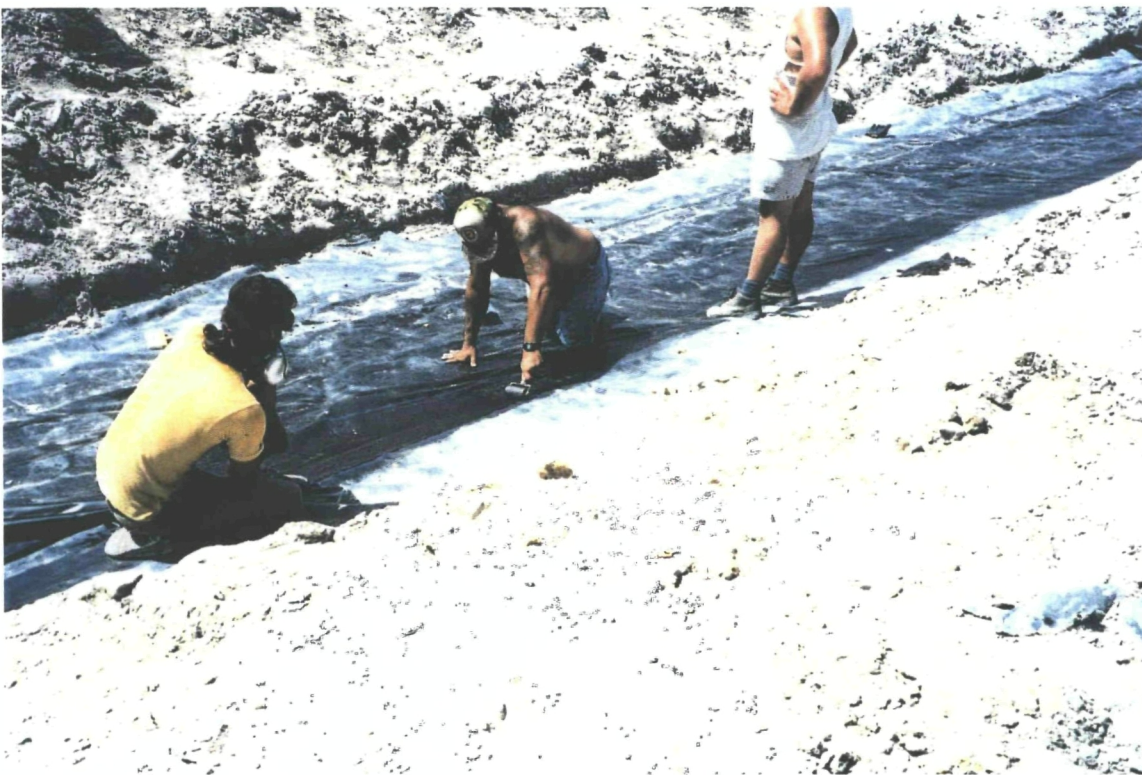
Photo No. 10

Date: October 9 1994 Location: Southeast County Landfill
Description: Geomembrane is bonded together and rolled

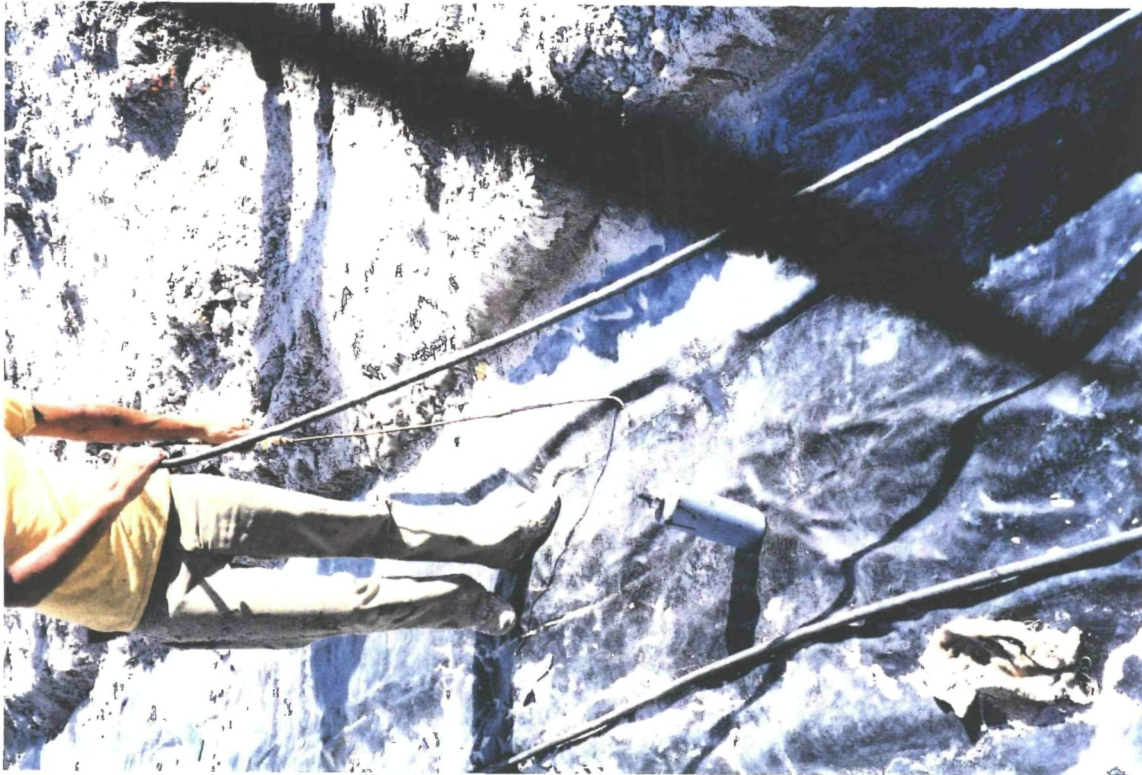
Photo No. 11

The entire length of each field seam, including patches, were tested in a non-destructive manner using air-lancing at 50-60 pounds per square inch directed perpendicular to the edge of the field seam. Areas needing repair were identified when air passing across a seam would expand or vibrate the geomembrane. In the areas that indicated a problem, bonding was completed by cleaning the geomembrane surfaces, adding adhesive, re-rolling the seam, and re-testing. There were no seams where the entire width failed.

Date: October 9, 1994 Location: Southeast County Landfill
Description: Non-destructive test on seams with high-pressure air

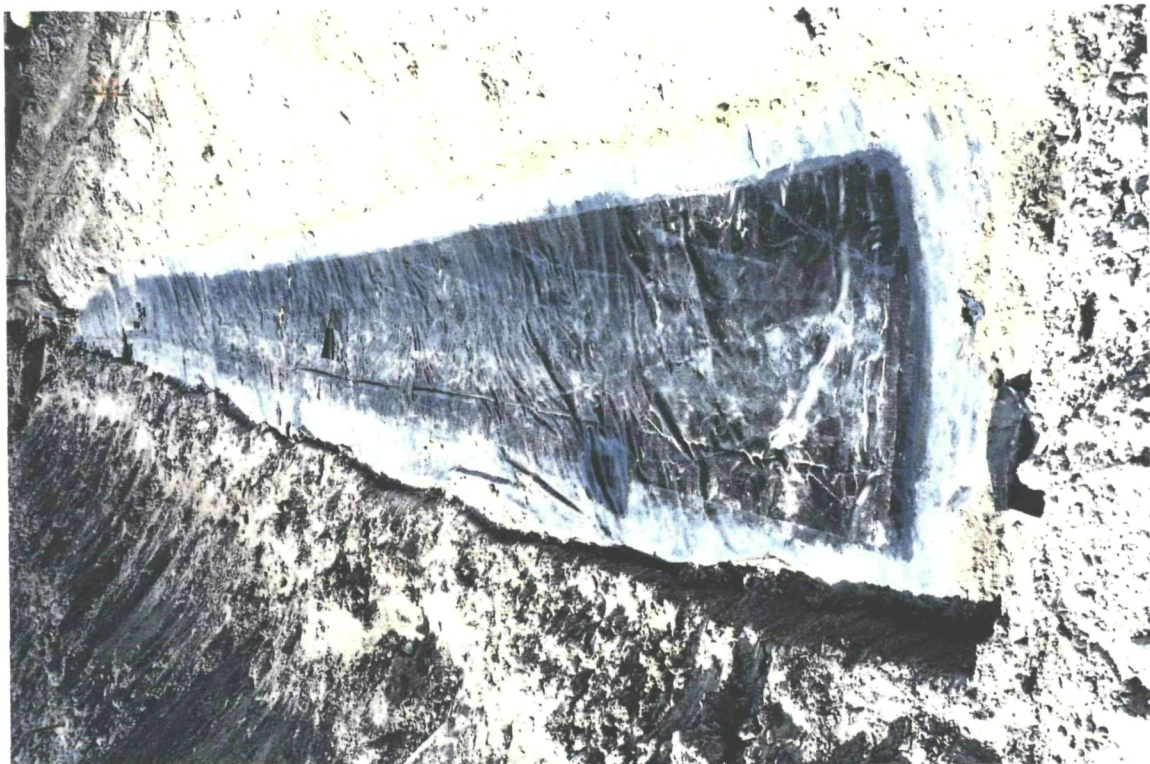
Photo No. 12

Date: October 9 1994 Location: Southeast County Landfill
Description: The complete geomembrane repair (looking west)

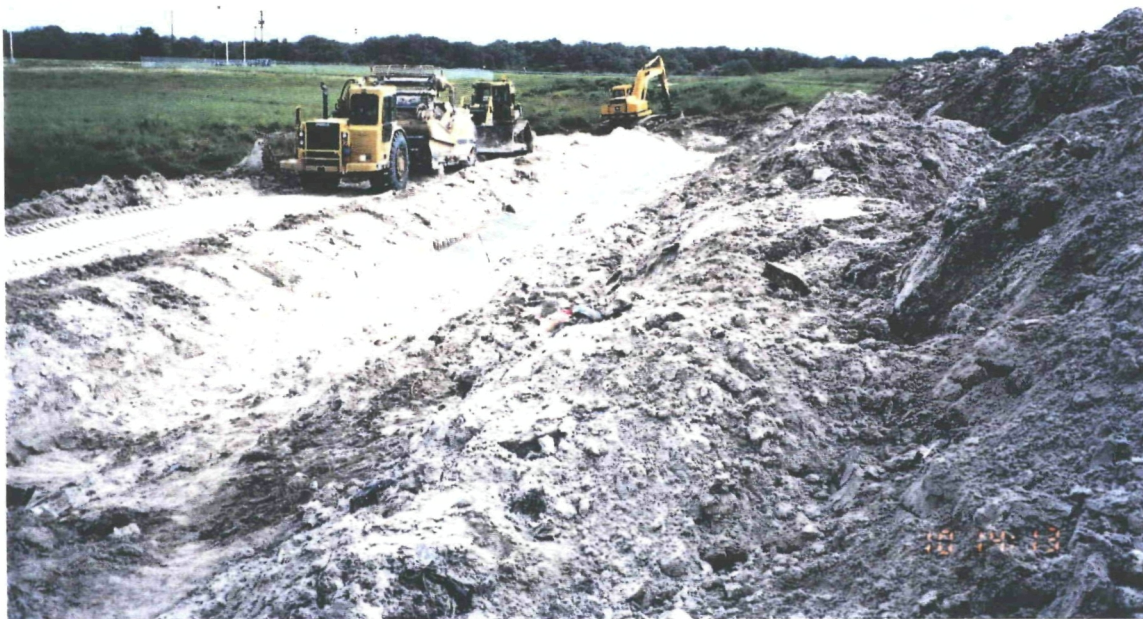
Photo No. 13

The SCS CQA Monitor observed the placement of the initial soil over the geomembrane. The protective soil was not allowed to have objects that may potentially damage the geomembrane (i.e., sticks, rocks, shells, refuse). The source of the protective soil was from on-site stockpiles.

Date: October 10, 1994 Location: Southeast County Landfill
Description: Protective soil is initially placed in a 12 inch lift

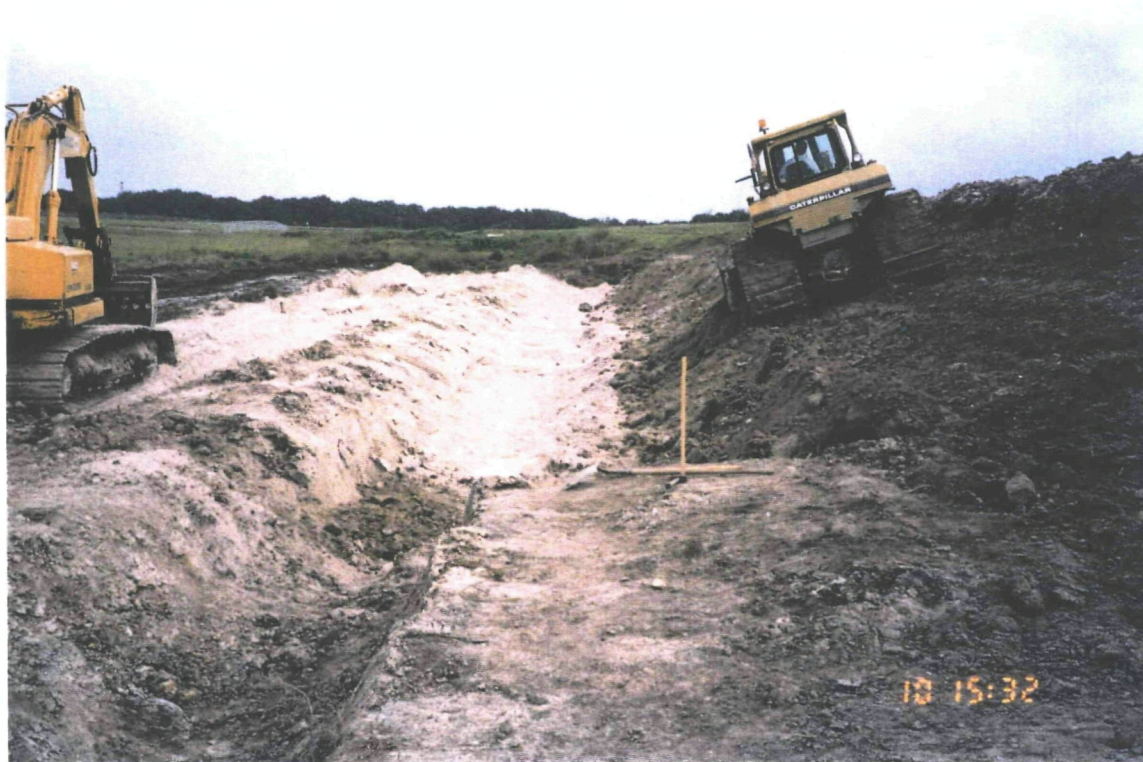
Photo No. 14

Date: October 10, 1994 Location: Southeast County Landfill
Description: After protective cover is placed, the capping system is reestablished
