SITE INSPECTION REPORT

INSPECTION DATE: 5/31/2011

LOCATION: Tomoka Farms Landfill, 1990 Tomoka Farms Road, Port Orange FL

5 31 2011 JURISDICTIONAL SITE VISIT
P. AMMON, D. BAGGETT
TOMOKA FARMS LANDFILL SPRAYFIELD

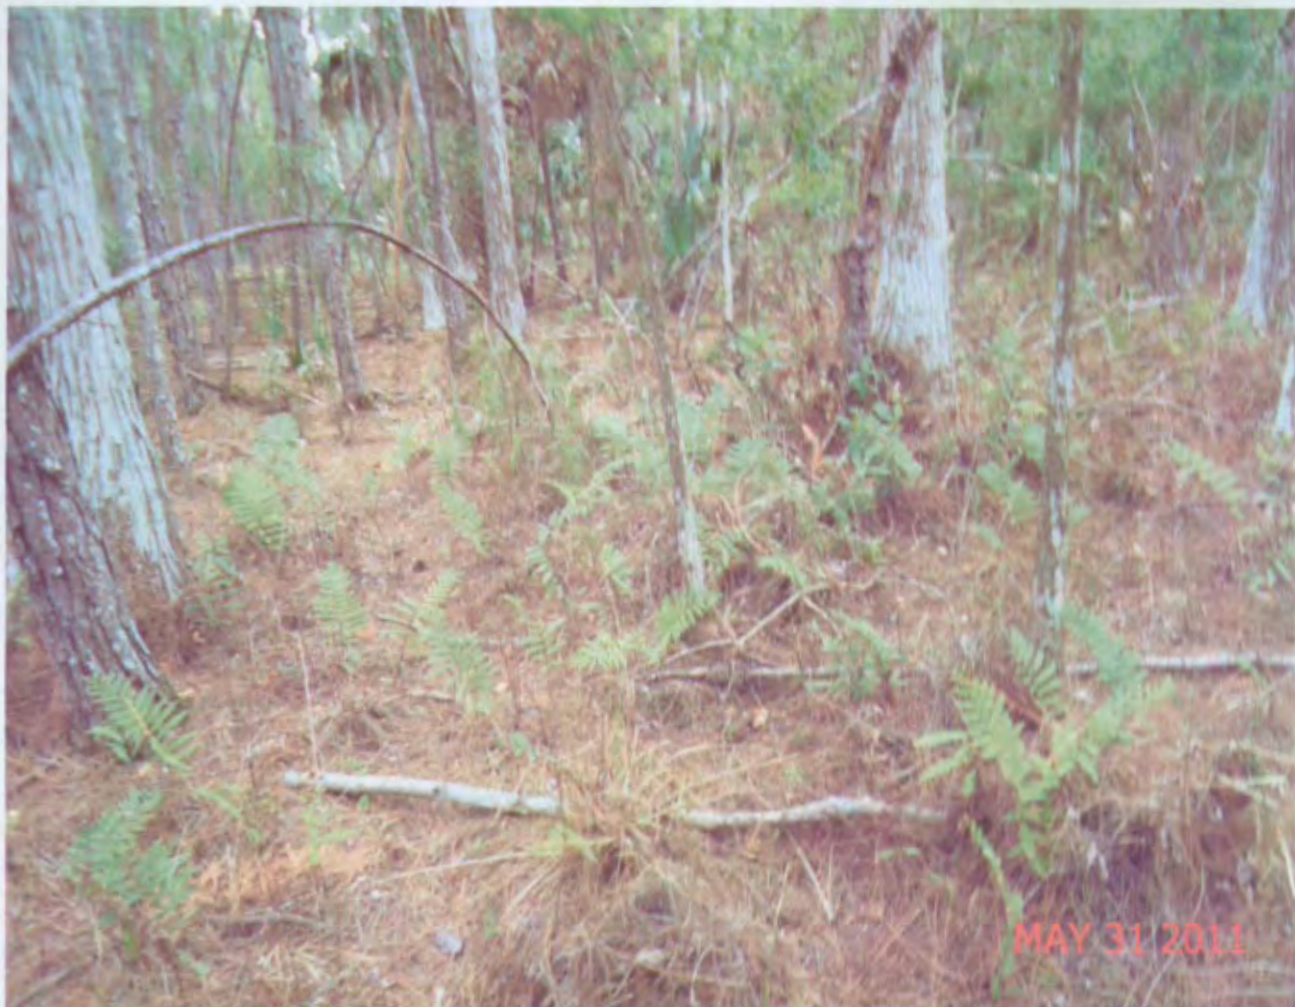
Insp 1 ↗

Staff walked the berm and eventually into the forested system to a point labeled on the attached aerial as "Insp 1". This pine / cypress system appears to have been intact and not replanted or previously altered. Staff did not find typical rows & furrows which one would see in a replanted system. Staff also noted the persistence of larger, older growth, pines. Staff identified the vegetation (native and exotic), hydric soils and hydrological indicators.

Hydric Soils: none, approx 3 inches of leaf litter, followed by 2 inches of gray soil, then white soil.

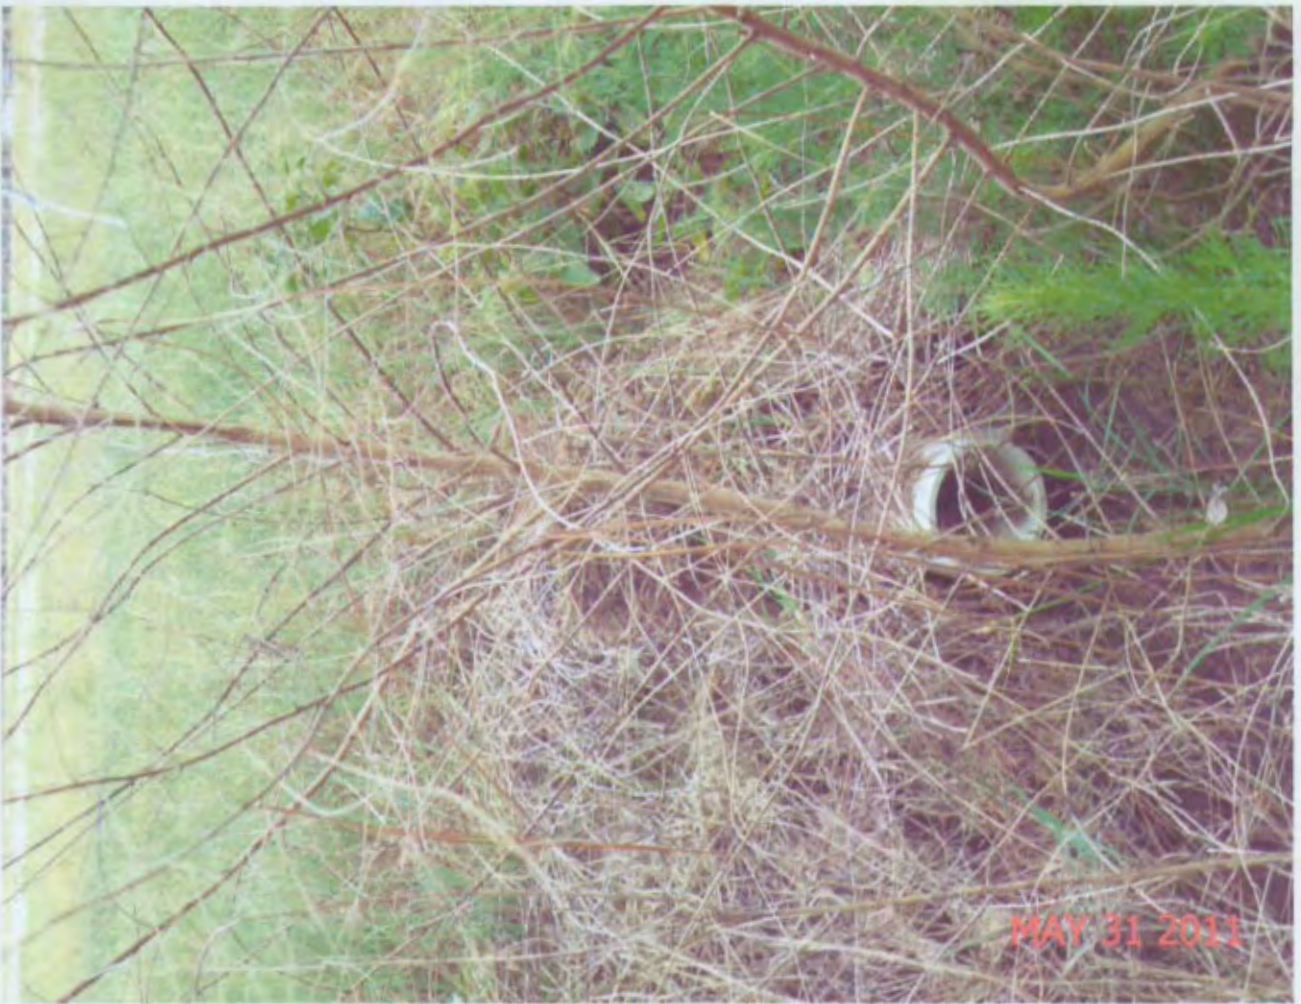
Staff left this location and while walking north along the berm noticed the previously explained relief pipes extending through the berm and into the wetlands (noted as "Relief pipe assessment"). Staff noted the vegetation outside of the sprayfield within this area was more representative of a wetter ecosystem. In reviewing the soils, there was very little leaf litter and non jurisdictional redox within the lower two inches of the plug. Staff believed the difference within this area is the influx of water from the relief pipes.

relief pipe in berm ↗
↘

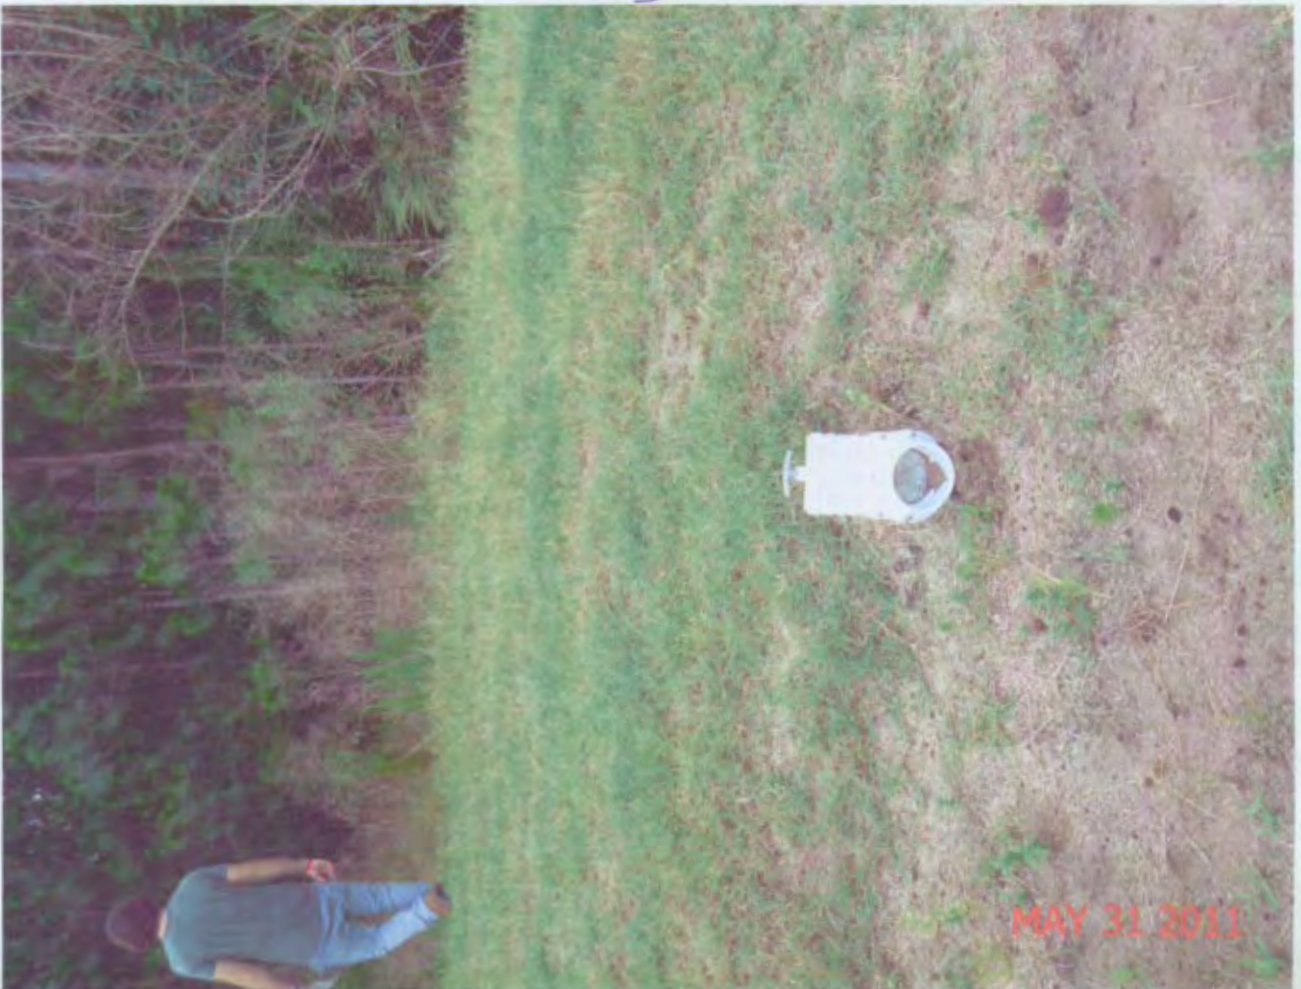
A rudimentary "roadway" through the wetlands was utilized to access the monitoring wells. This approx. road location is labeled red on the attached aerial. While the roadway did not appear to have had any road bed material placed, the wetlands within the roadway were experiencing an impact. Vehicles tracks were easily seen and there was a significant lack of subcanopy and canopy vegetation. Staff questioned the frequency of use and were told quarterly and then monthly. VCUD Staff said they utilize the road to inspect equipment, ensure operation, and gather samples. Everyone continued to drive out of the wetlands on the "roadway" which eventually made a loop to

"road" into
wetlands

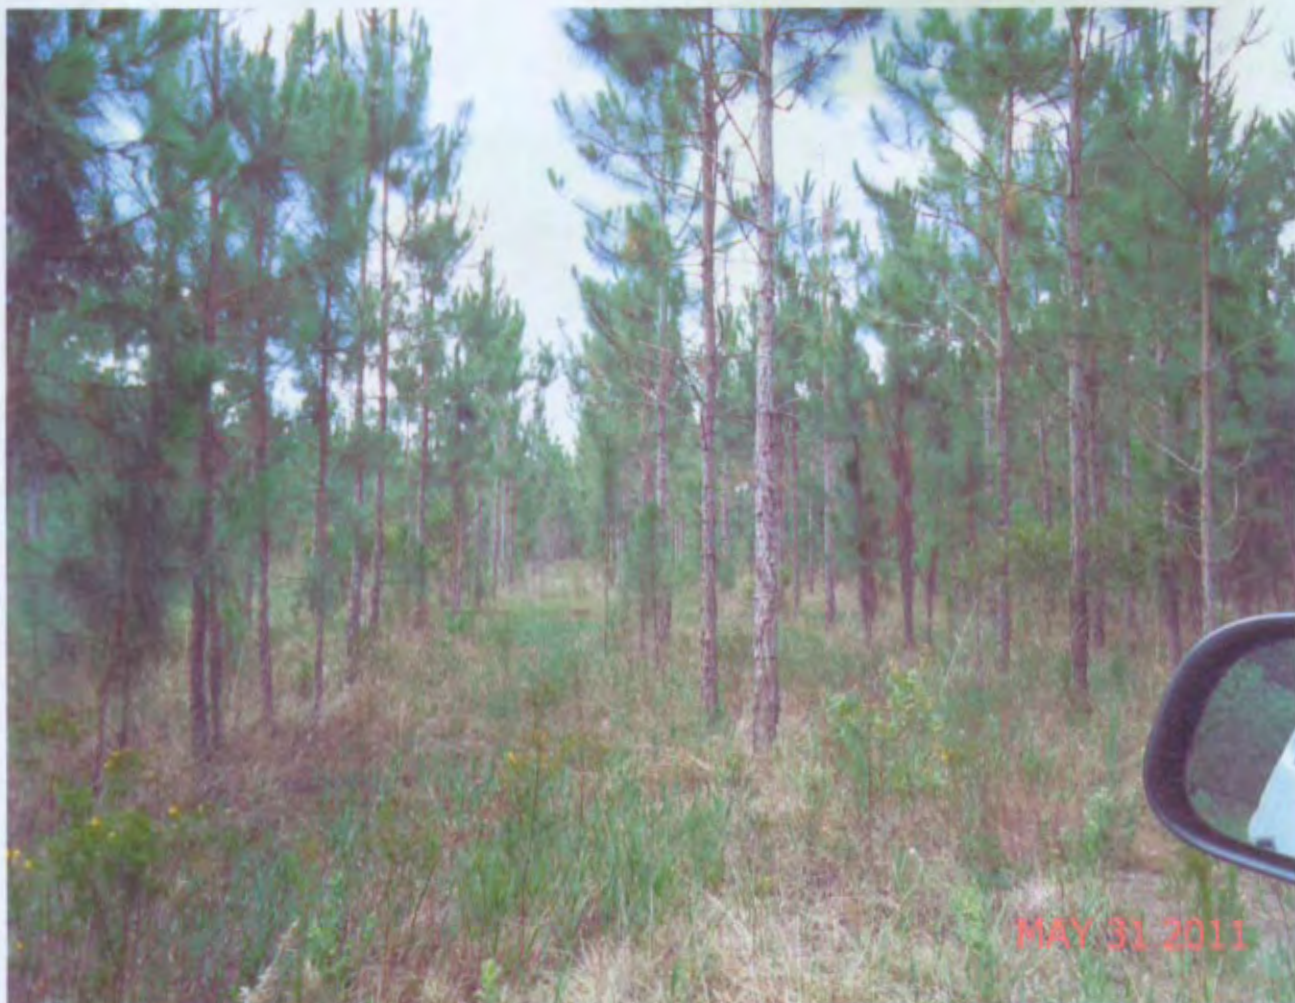
Staff left this area and went to "Insp 3." While at this location it was noted that areas south of this location had been cleared, replanted, rowed, and furrowed, while the north area had not. Rows of slash pines were easily identifiable with sparse scattered ground cover. Staff identified plants within this area, but prior to identifying hydrological indicators and investigating the soils, it was suggested all parties drive east into the property (wetlands) to inspect the ground monitoring wells.

planted pines near transpec 3 from "road", S side

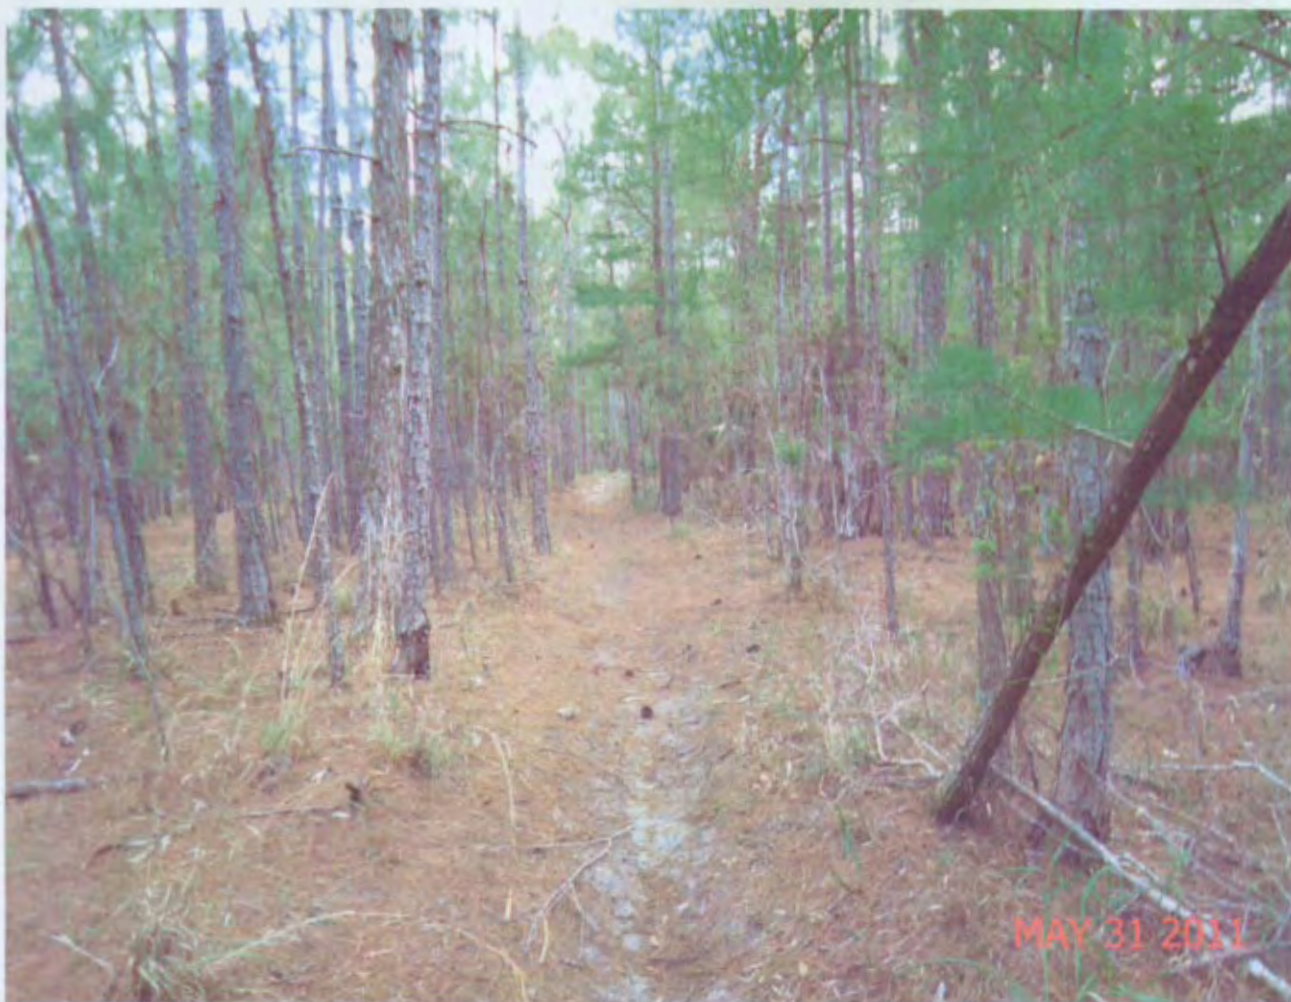
Staff entered from the NE corner of the spray field into two ecosystems: one appeared to have been altered while the other had not. Staff followed a ditch and ATV path into a cypress / bay canopy to “Insp 5.” This location appeared to have more diversity within all three levels of vegetation (canopy, sub canopy, & ground cover). There also lacked signs from replanting. The soils appeared to be more indicative of a natural wetland system, however they still lacked jurisdictional hydric indicators.

ATV & ditch going toward Insp 5

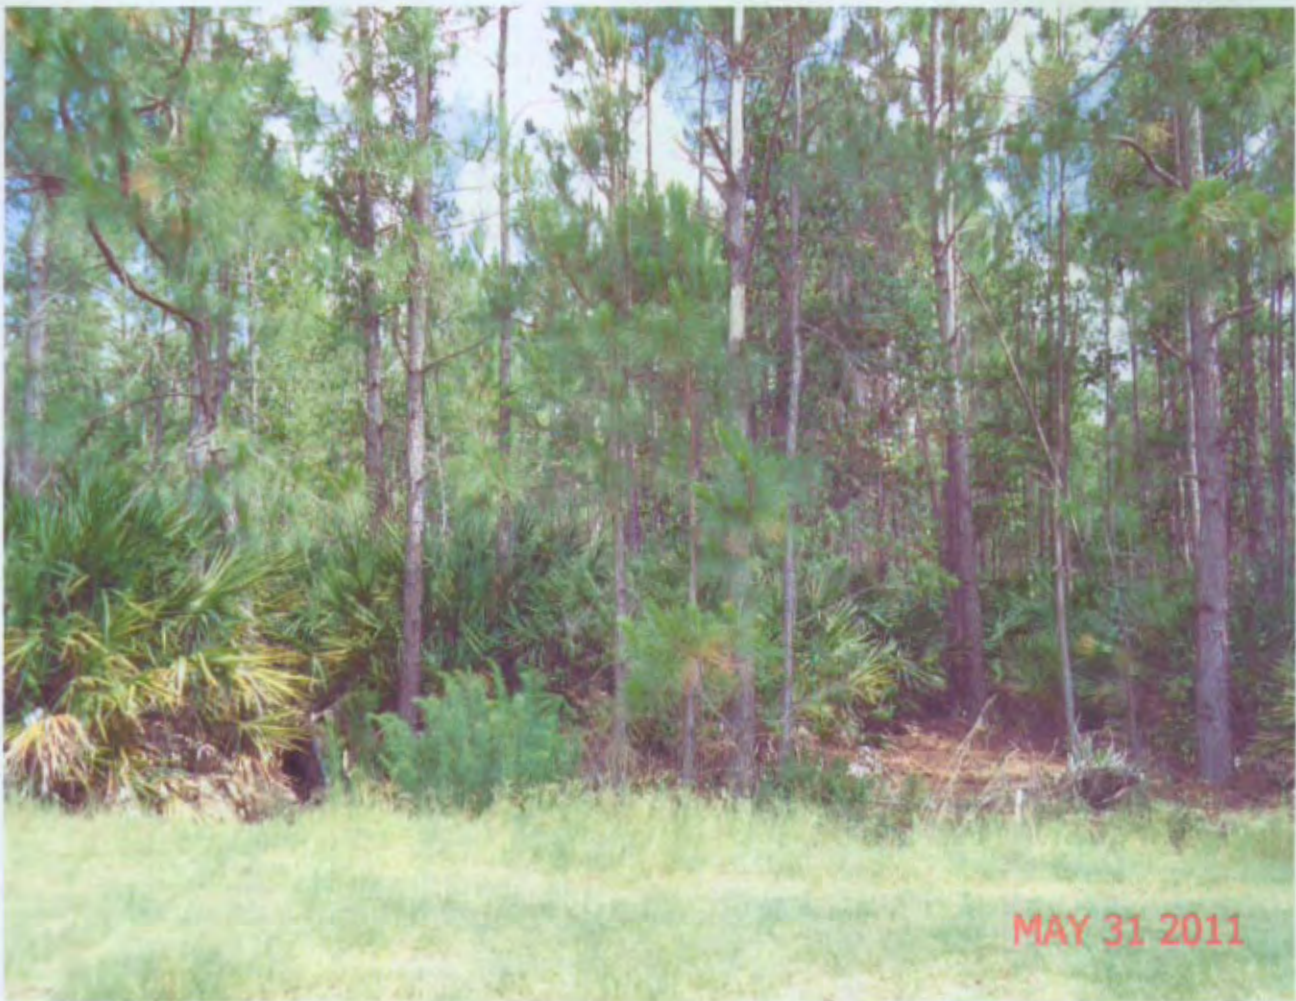
Staff proceeded to “Insp 6” and noted that it appeared to be uplands as previously identified in 1993. This area lacked signs of alteration (rows, furrows) and had significant diversity within all levels of vegetation (canopy, sub canopy, & ground cover).

uplands
Insp 6

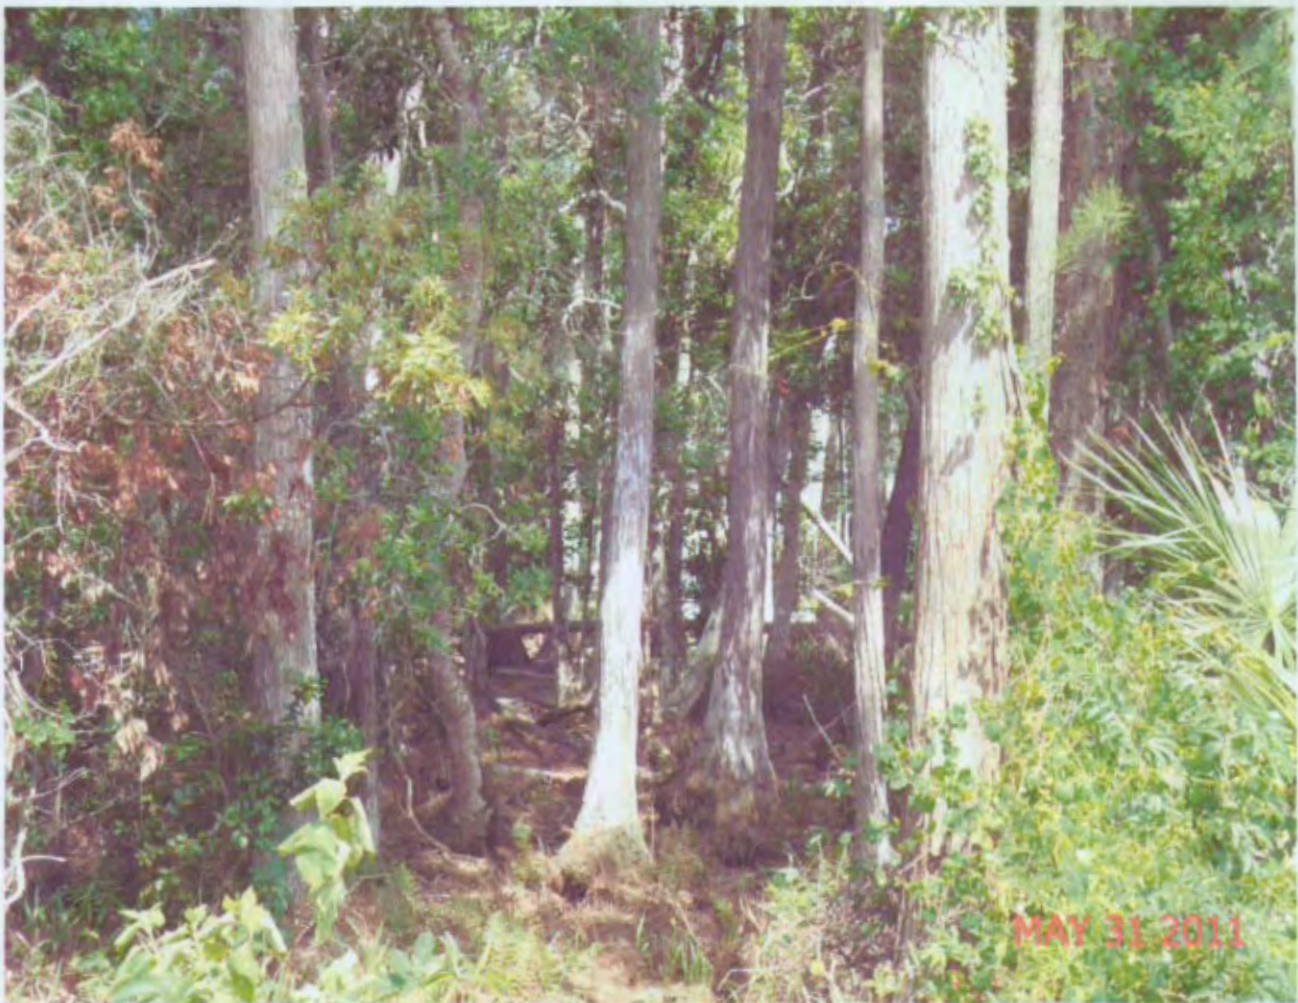
Staff proceeded to “Insp 7” and noted the presence of wetland vegetation, deep flow channels and hummocking. This area was also identified as wetlands in 1993 and 2009. This area appears to have not been altered.

Imp 7
wetlands

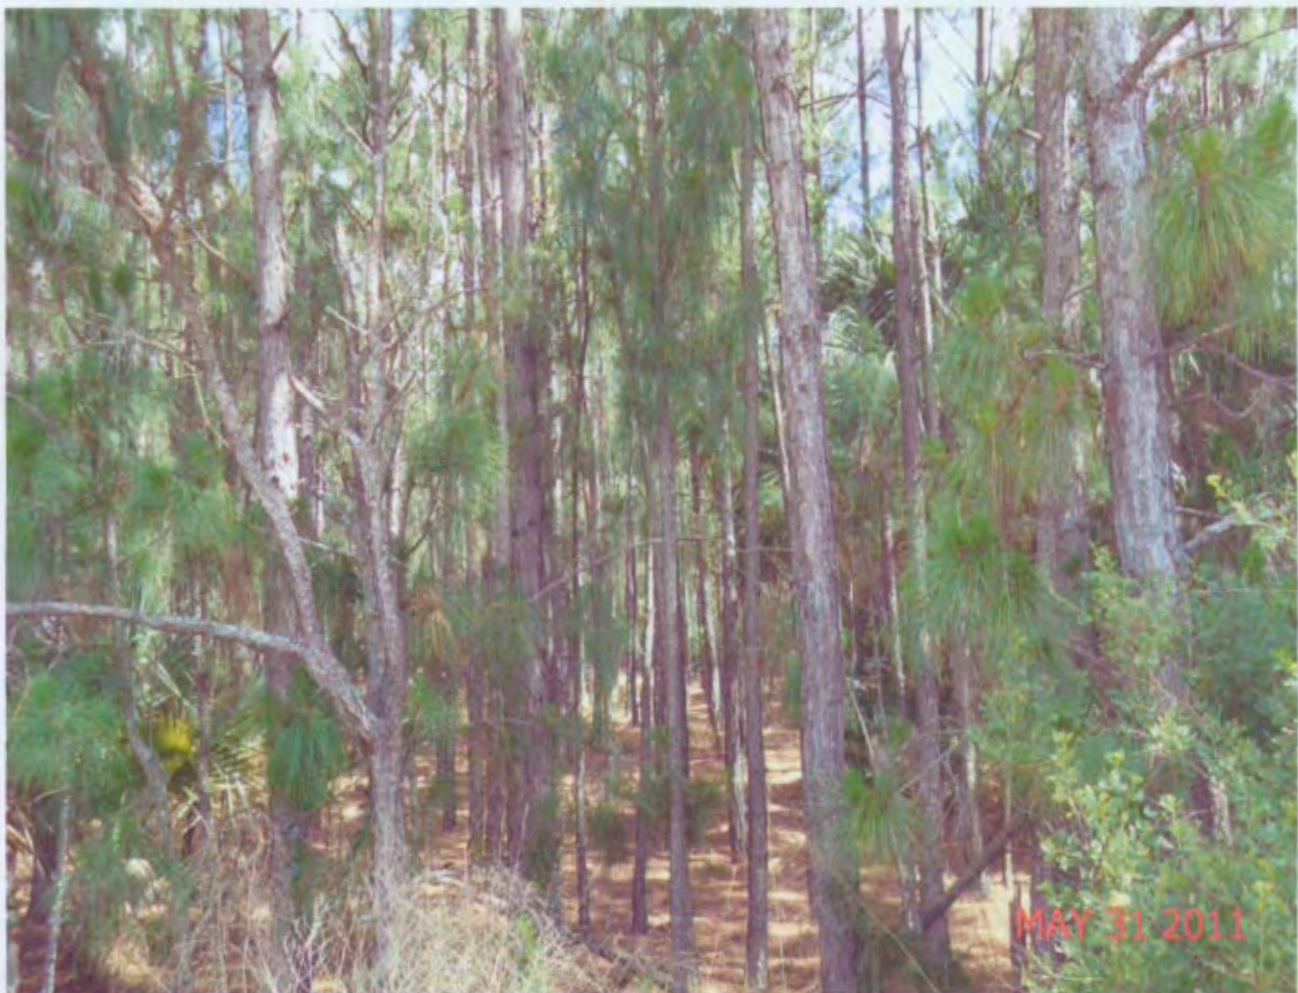
Imp 7
wetlands

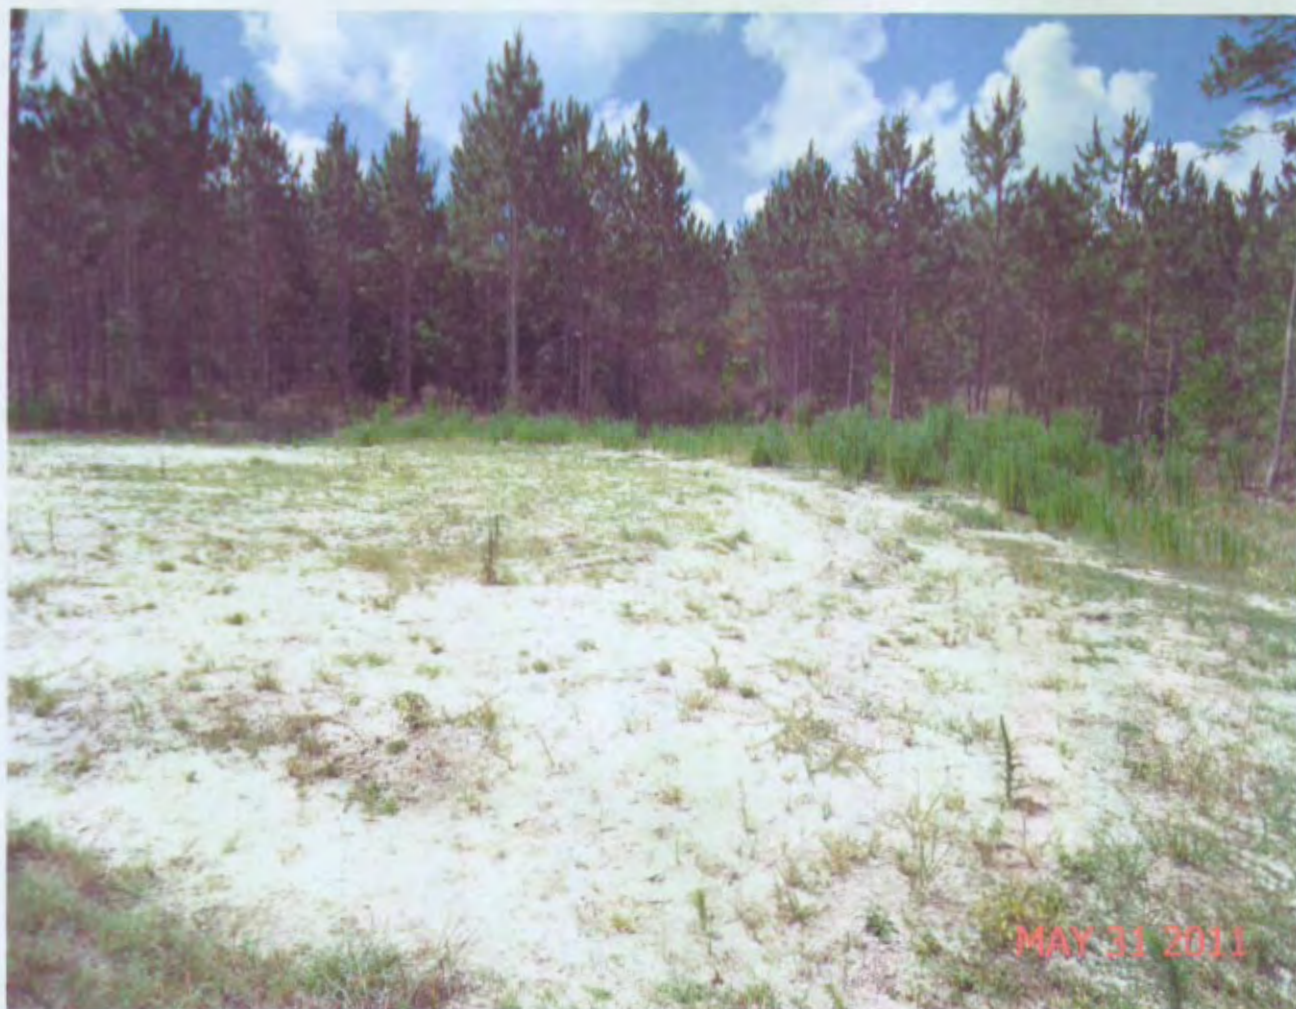
Staff spoke with VCUD Staff about the history of the site. In approximately 2009/2010 the surrounding ditch and pond were filled in, the bomb shelter was relocated, the ground was leveled, and a berm was constructed which surrounds the spray field. Also during that time, relief pipes were

Area
of old
bomb shelter
(removed, leveled,
filled)

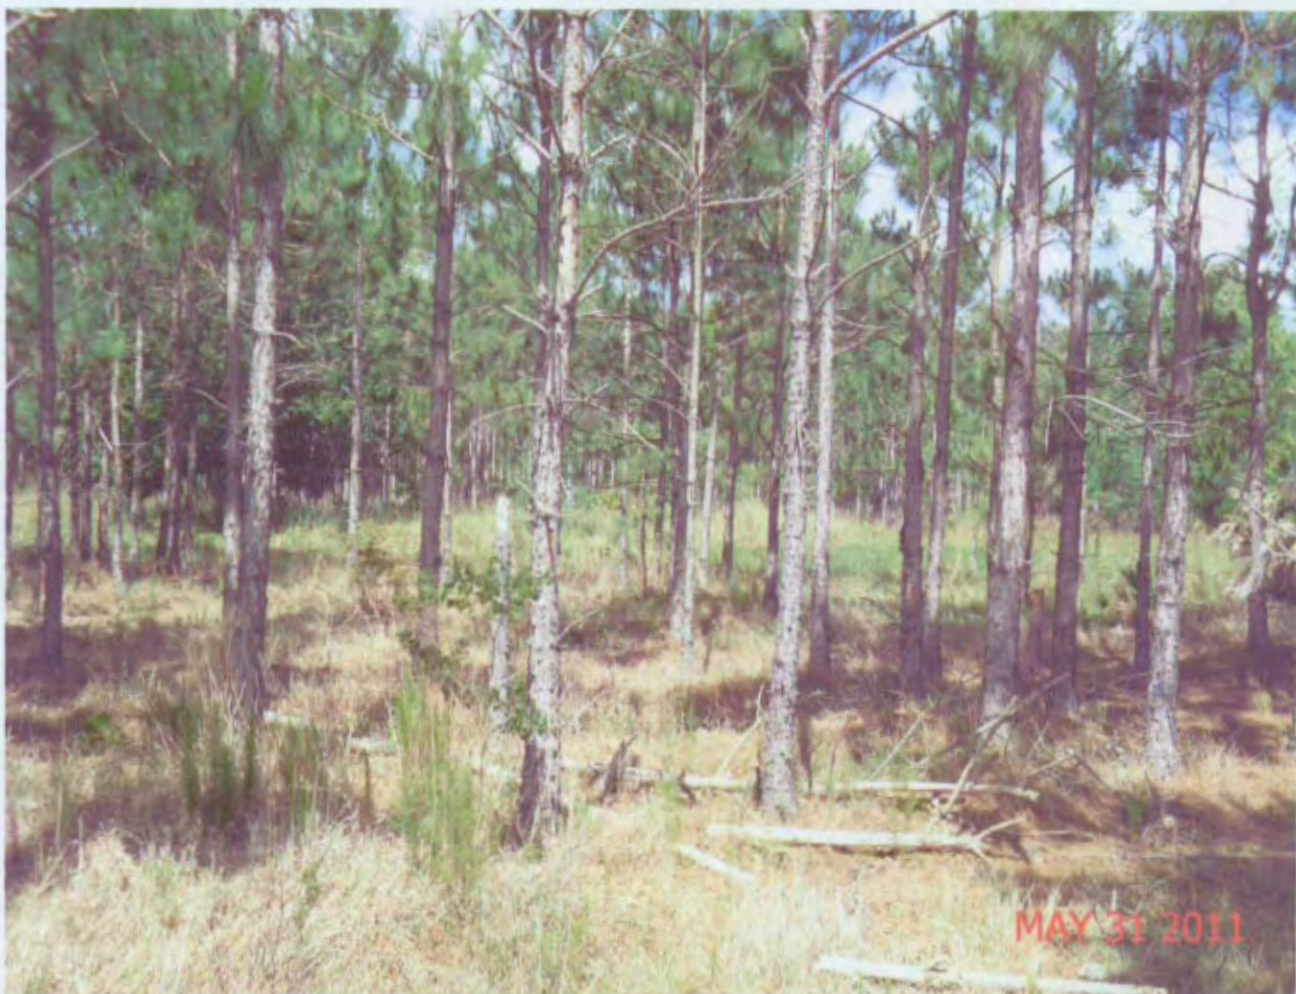
Tree 8

Staff proceeded to “Insp 8” and noted that it appeared to be replanted with slash pine. This area showed signs of alteration (rows, furrows) and lacked diversity within all levels of vegetation (canopy, sub canopy, & ground cover).
