Florida Department of  
Environmental Protection  
Inspection Checklist

**Facility Name:** TOMOKA FARMS ROAD LANDFILL  
**On-Site Inspection Start Date:** 10/02/2014  
**On-Site Inspection End Date:** 10/02/2014  
**WACS No.:** 27540  
**Facility Street Address:** 1990 TOMOKA FARMS ROAD  
**City:** PORT ORANGE  
**County Name:** VOLUSIA  
**Zip:** 32128

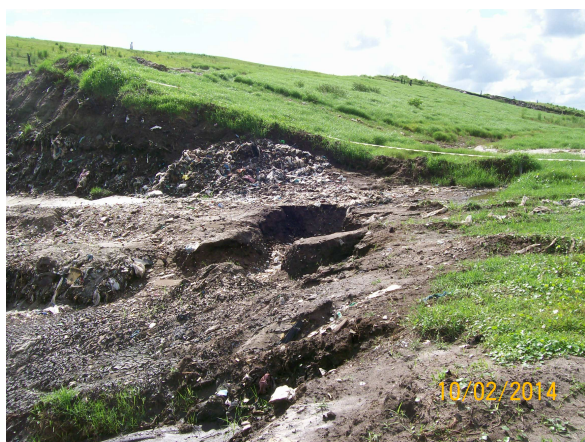
1: E view of leachate sump 3

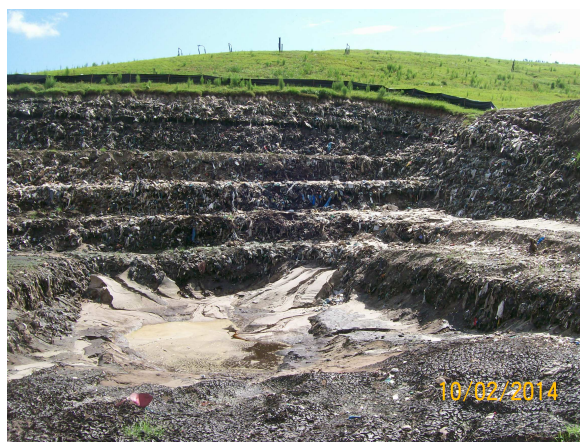
2: E view of sump 3

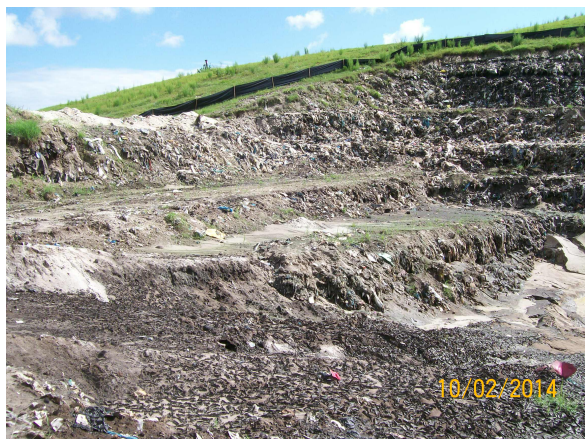
3: E view of sump 3

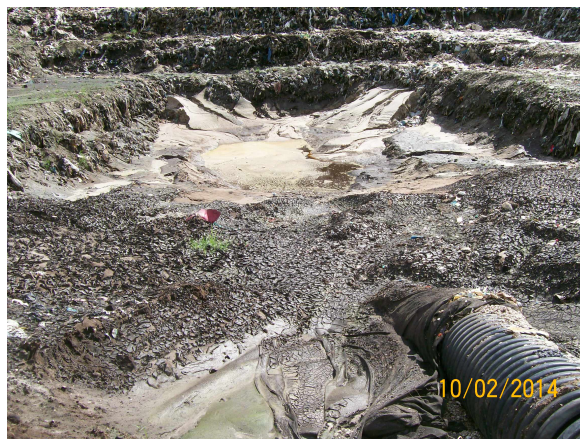
4: bottom of sump 3

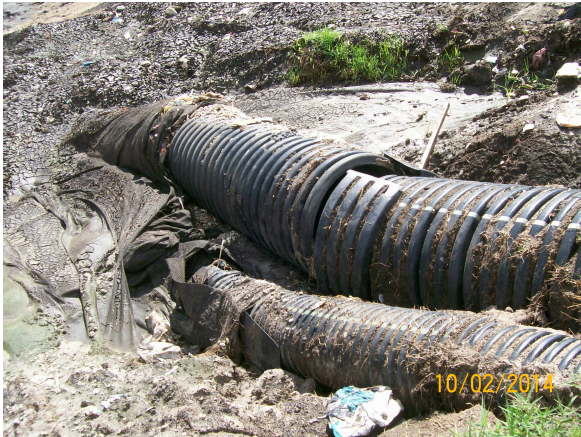
The facility is in the process of replacing the corrugated HDPE pipe within sumps 2 and 3 located on the west edge of the North Cell. This action addresses Specific Condition C.12.f of Permit Modification 0078767-031-MM issued 4/17/14, which requires the facility to complete

The facility had completed waste excavation at both sumps, exposing the corrugated piping. A temporary pump in leachate sump 2 (southern-most sump) was operating at the time of this inspection because piping was no longer connected to the leachate system. Collected leachate from sump 2 is being directed to the south leachate pond. Sump 3 was still connected to the leachate system at the time of this inspection. The facility is currently waiting on delivery of liner material to the site.

5: Corrugated piping at sump 3

replacement of sumps 2 and 3 within 12 months from the date of permit issuance.

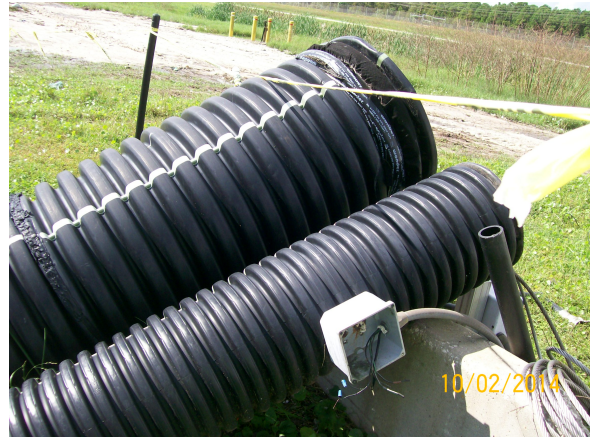
6: Corrugated piping at sump 3

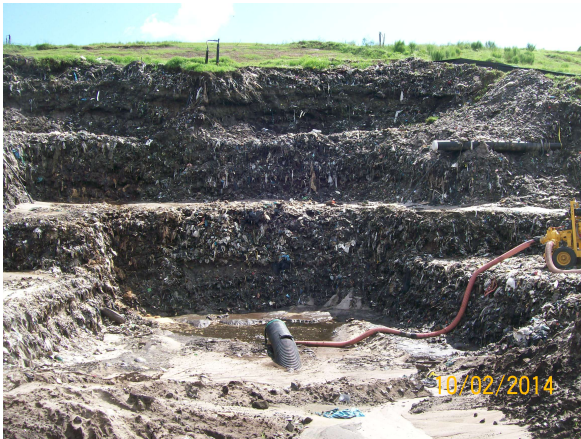
7: E view of leachate sump 2

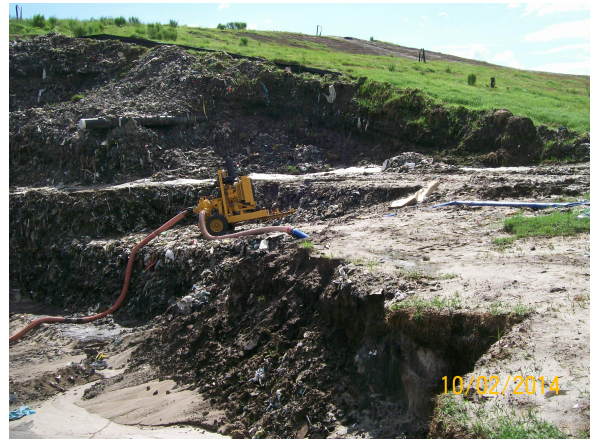
8: leachate sump 2

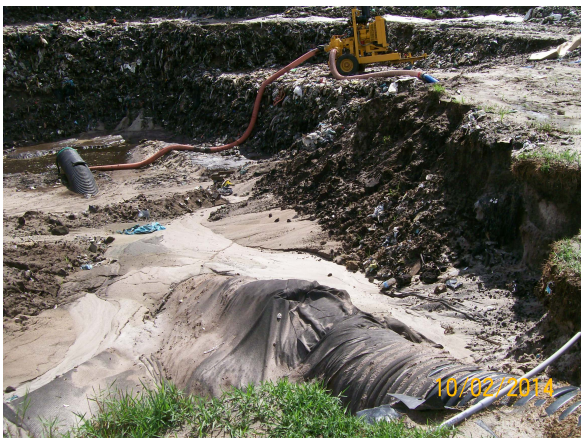
No significant odors were emitting from the exposed waste at the construction sites. No litter was observed at the time of this inspection.

9: excavation at sump 2

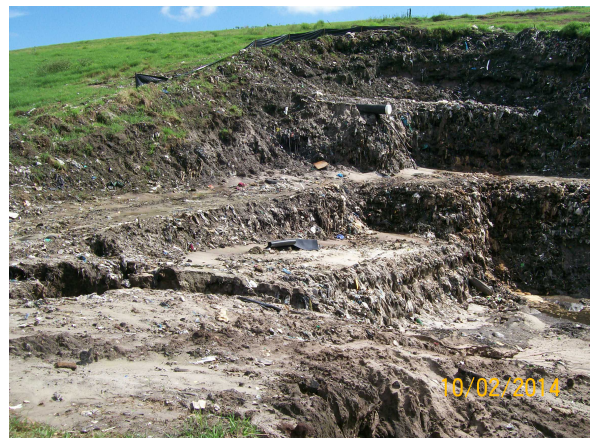
10: excavation at sump 2

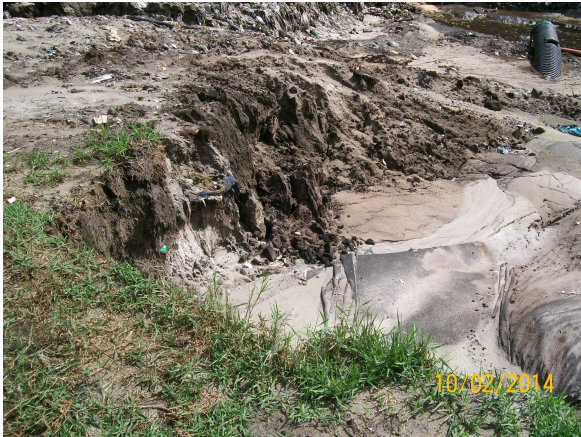
11: excavation at sump 2

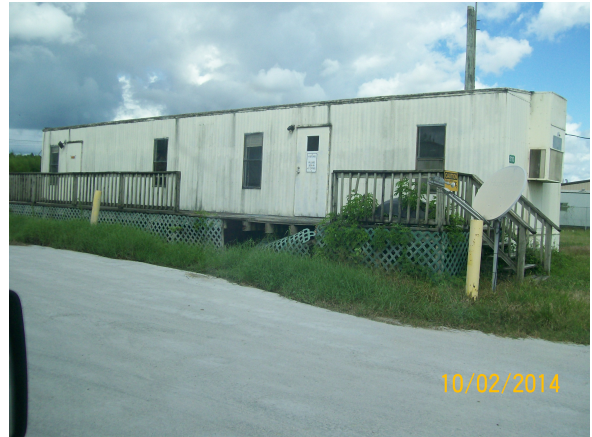
The same report indicated that the N-Viro facility trailer was not monitored because the facility is no longer operating and N-Viro has no employees on site. The trailer rests on a wooden platform aboveground. Everyone agreed that the trailer could be removed as an ambient monitoring point based on its location and elevation aboveground. The trailer will be locked or removed for disposal as soon as possible. Ms. Stirk will address the N-Viro sampling location removal along with the MW-5 re-testing results.

12: N-Viro facility trailer
