Subject: Followup from 01/23/2015 Air & Solid Waste inspection at Pasco County Resource Recovery Facility

I hope you are doing well. It was good meeting you at the Pasco County Resource Recovery Facility on 01/23/2015. I had a few followup items that I noted to you and Mike (SW Operator) during the inspection and I wanted to verify if you have addressed them:

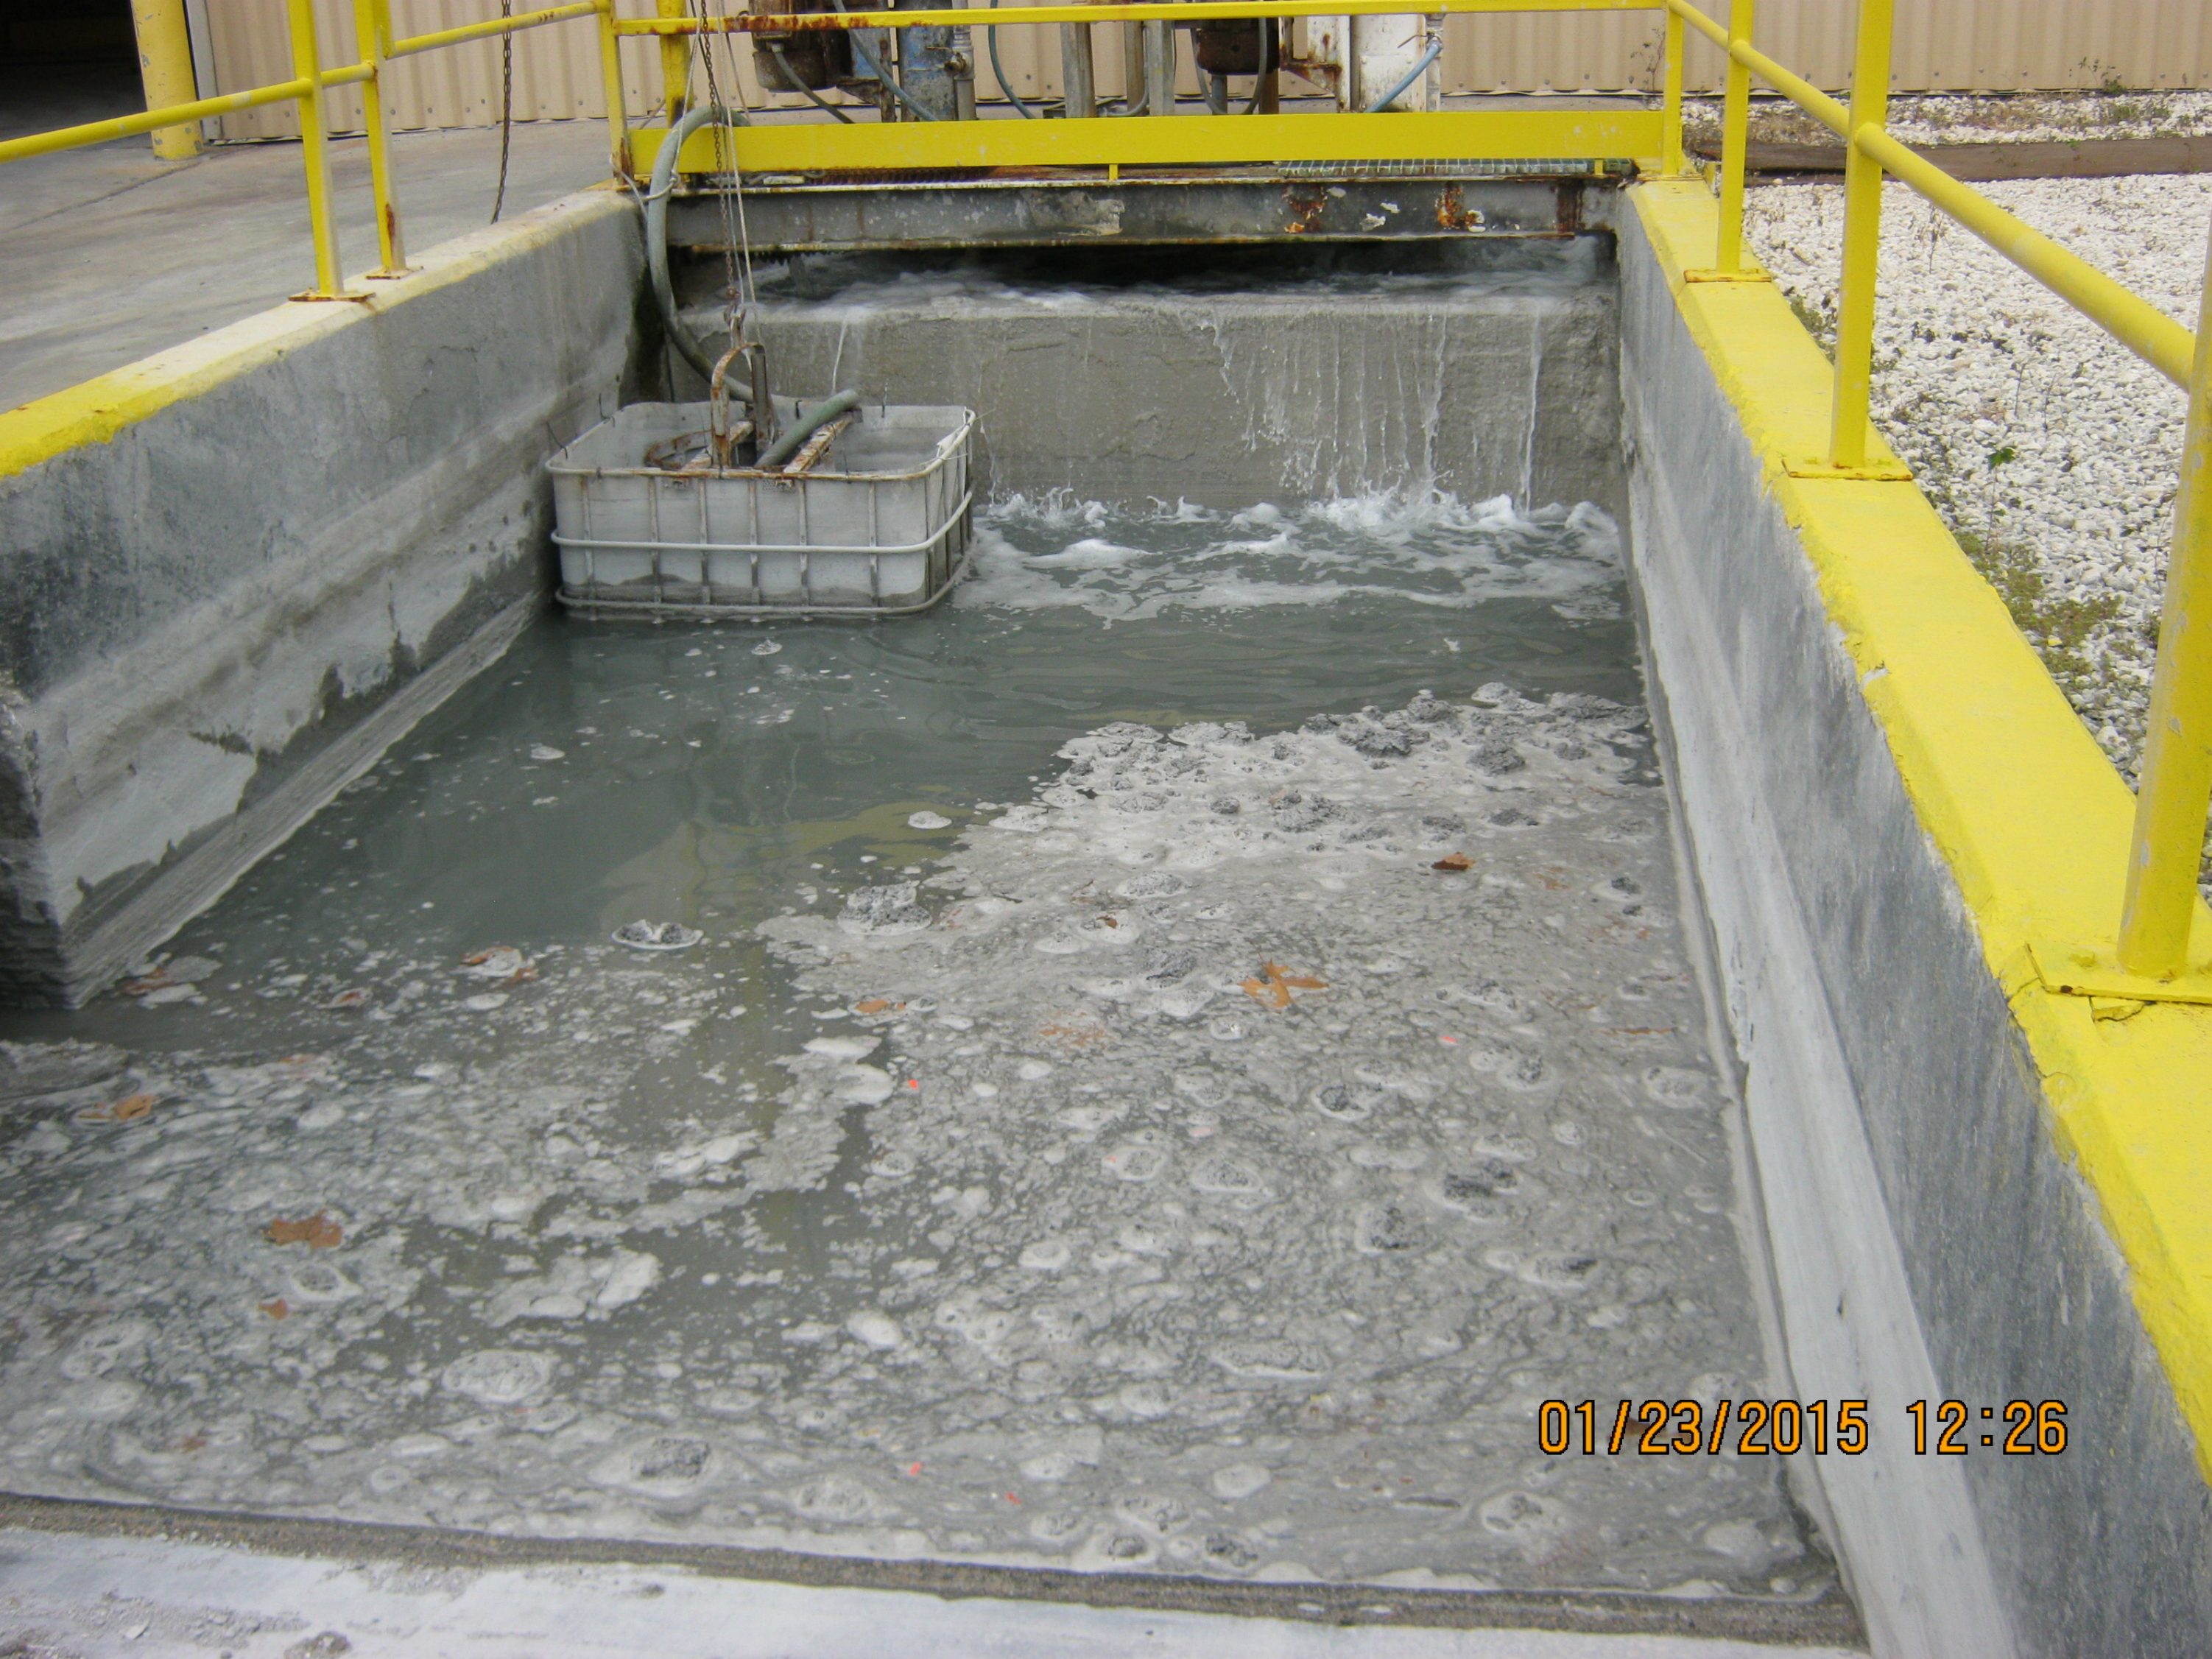
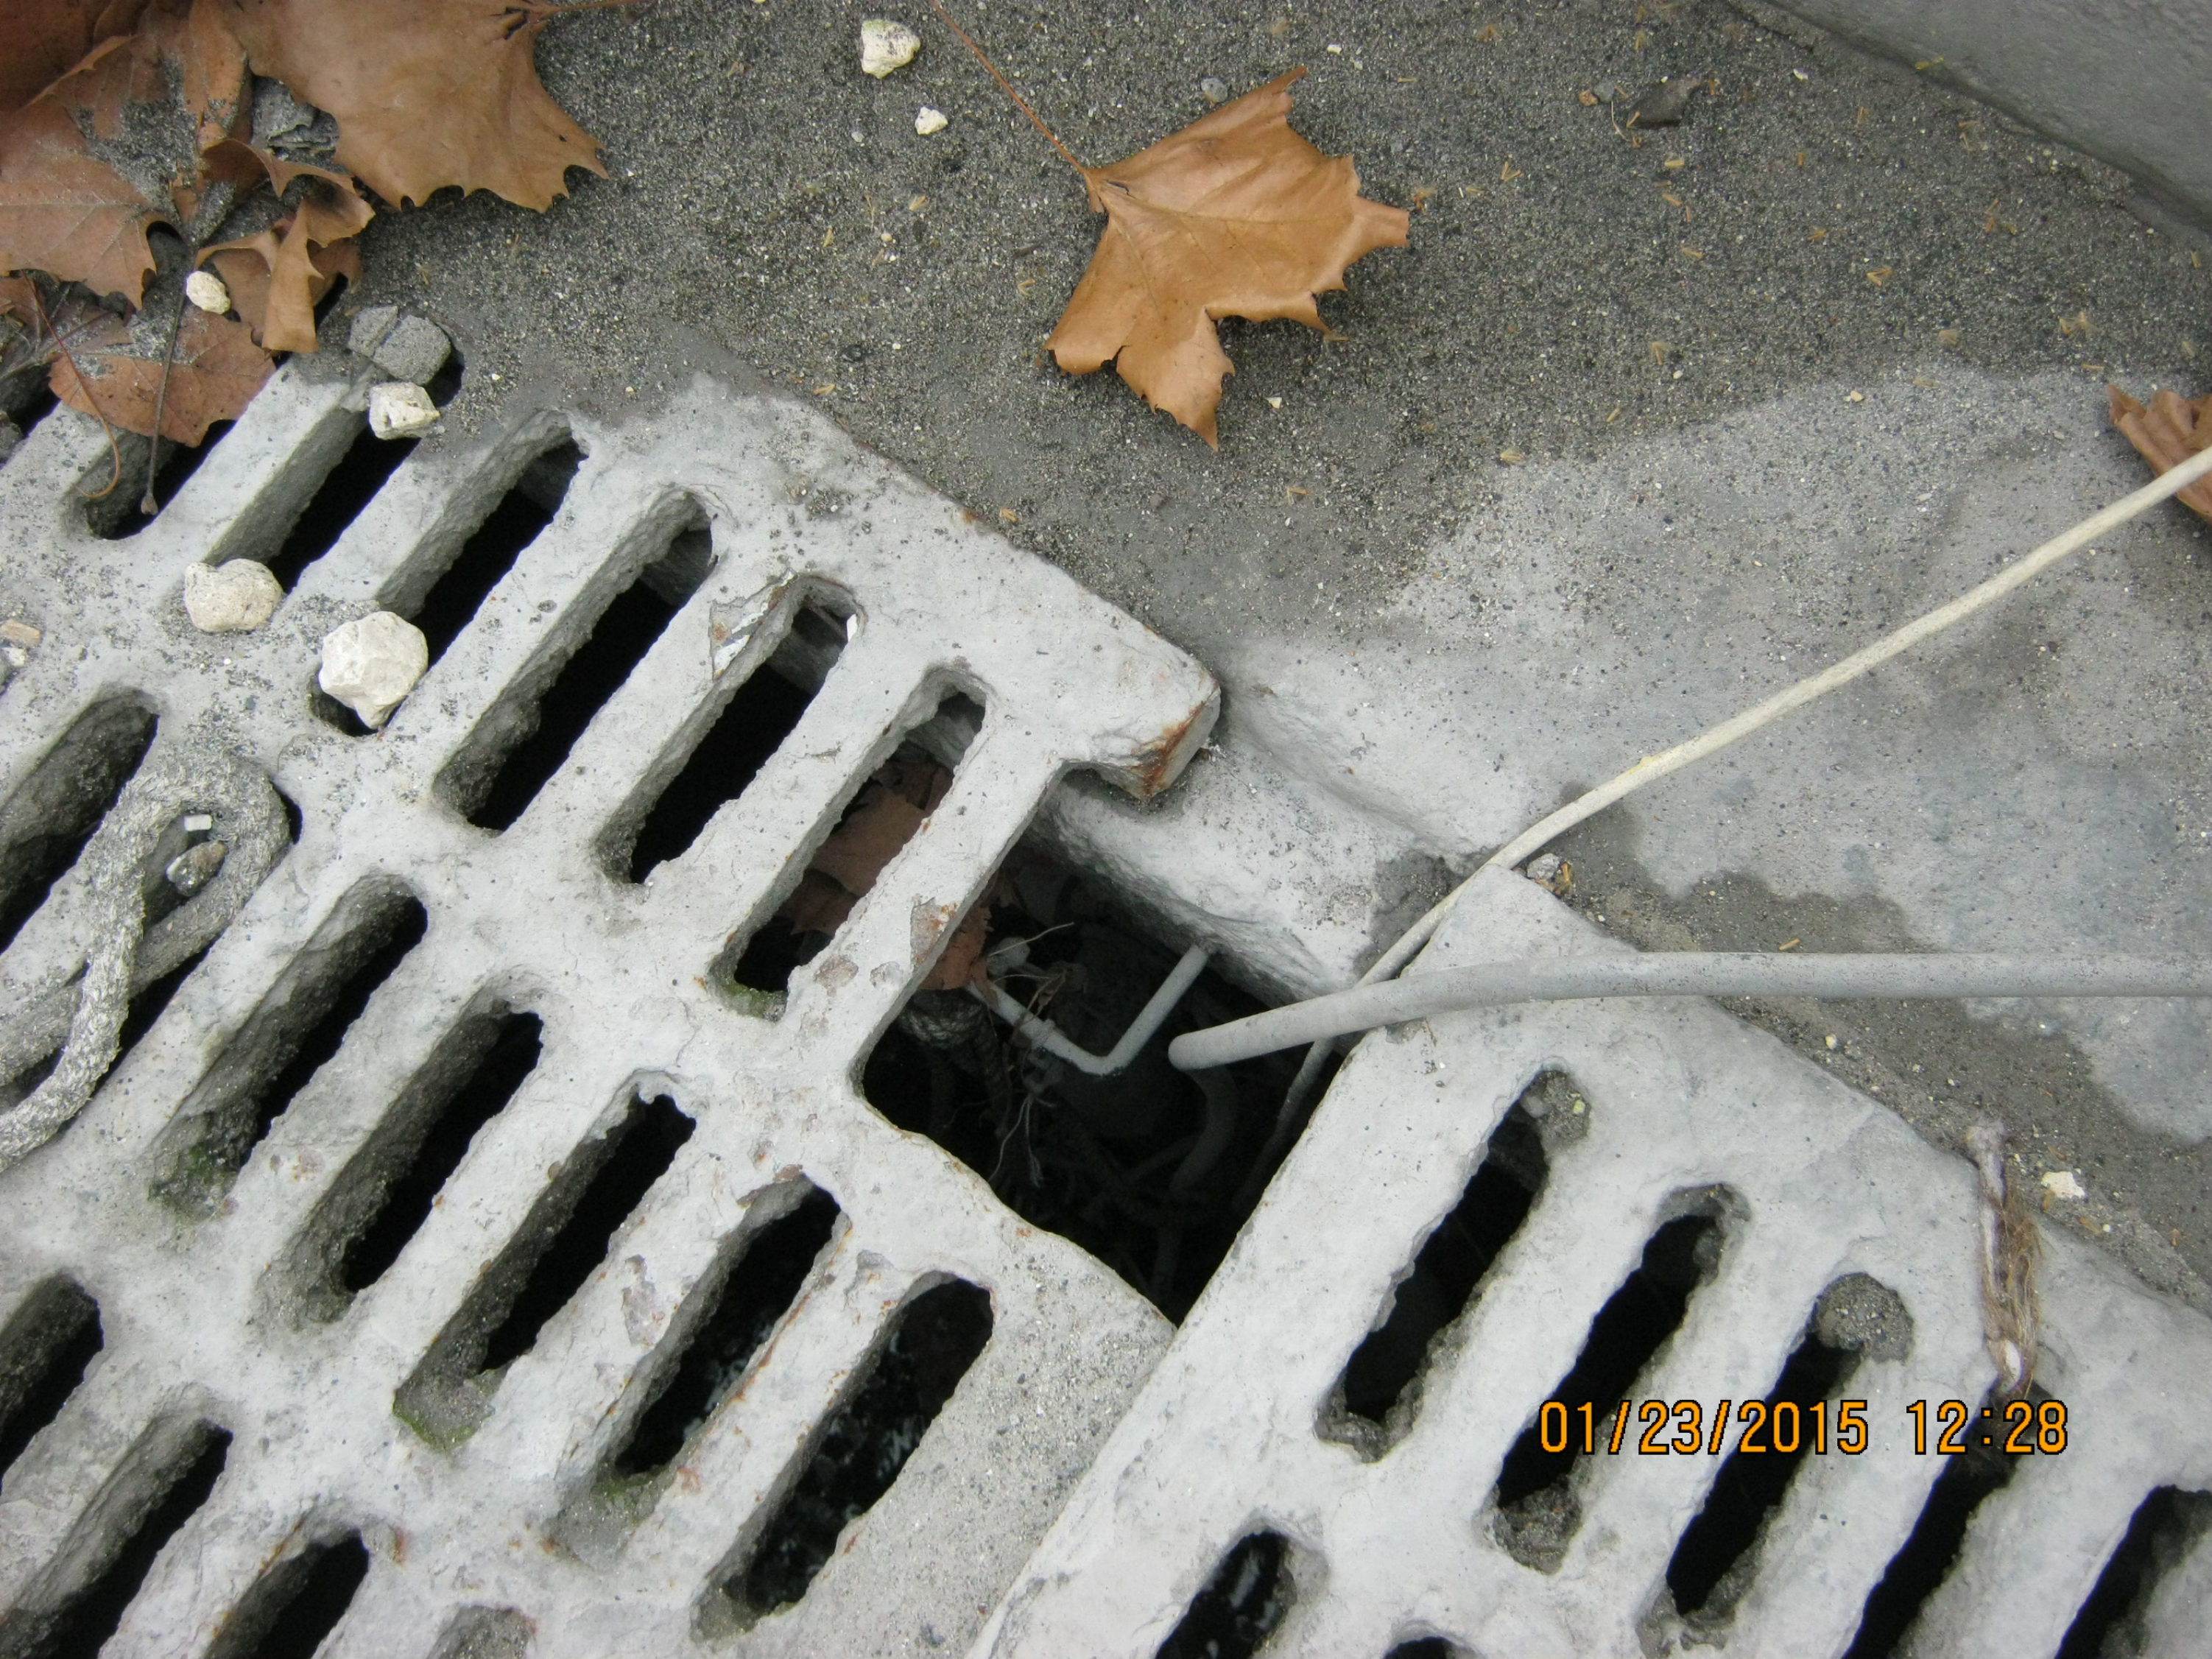
- (2.) Check ash leachate drain for broken float apparatus. During the walkthrough (see attached photographs), we noted the ash leachate drain alarm float appeared to be trapped under a broken steel girder. The float area was cleaned and is working according to design.

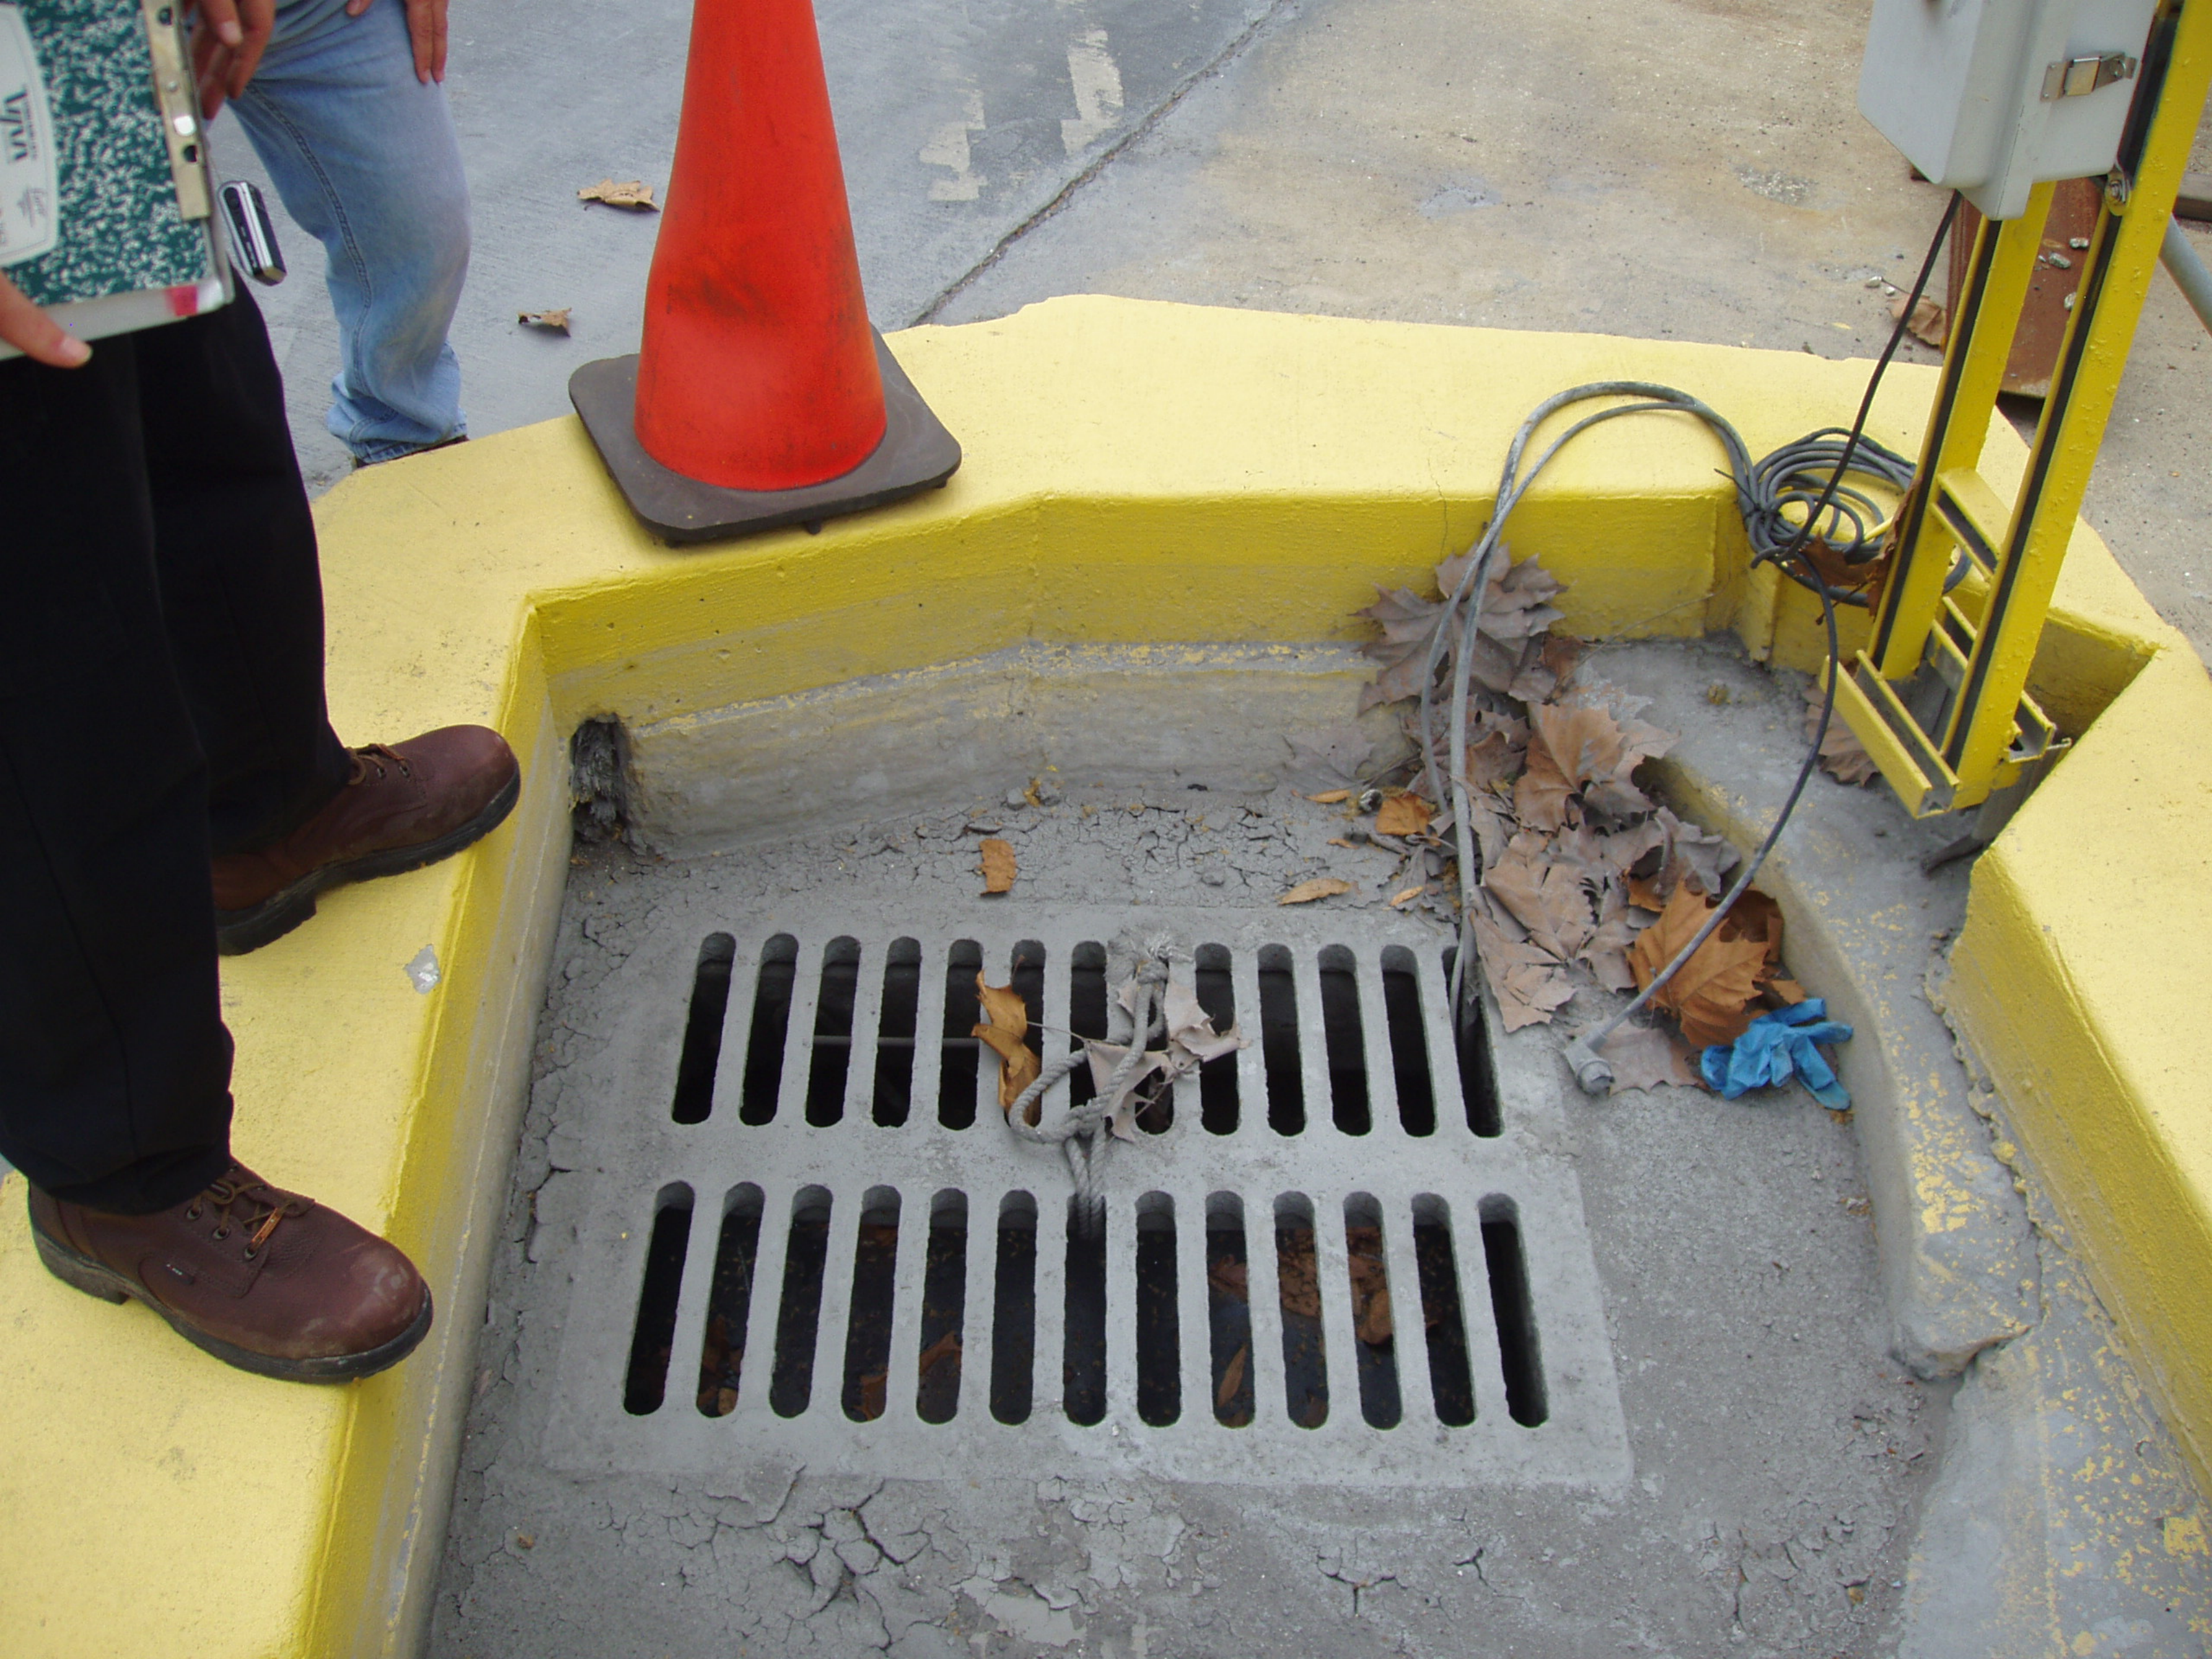
A picture of the water treatment area is attached and so is a picture of the drain near it.

- (1.) **The drain that needed maintenance was the one by the grizzly, which you stated you fixed. But there is also a drain by the water treatment area, closer to the building, which had some debris in it. Can you please check on this one as well?** Let me get with Covanta to verify.

Hi Amaury,
The debris in the drain has been removed.

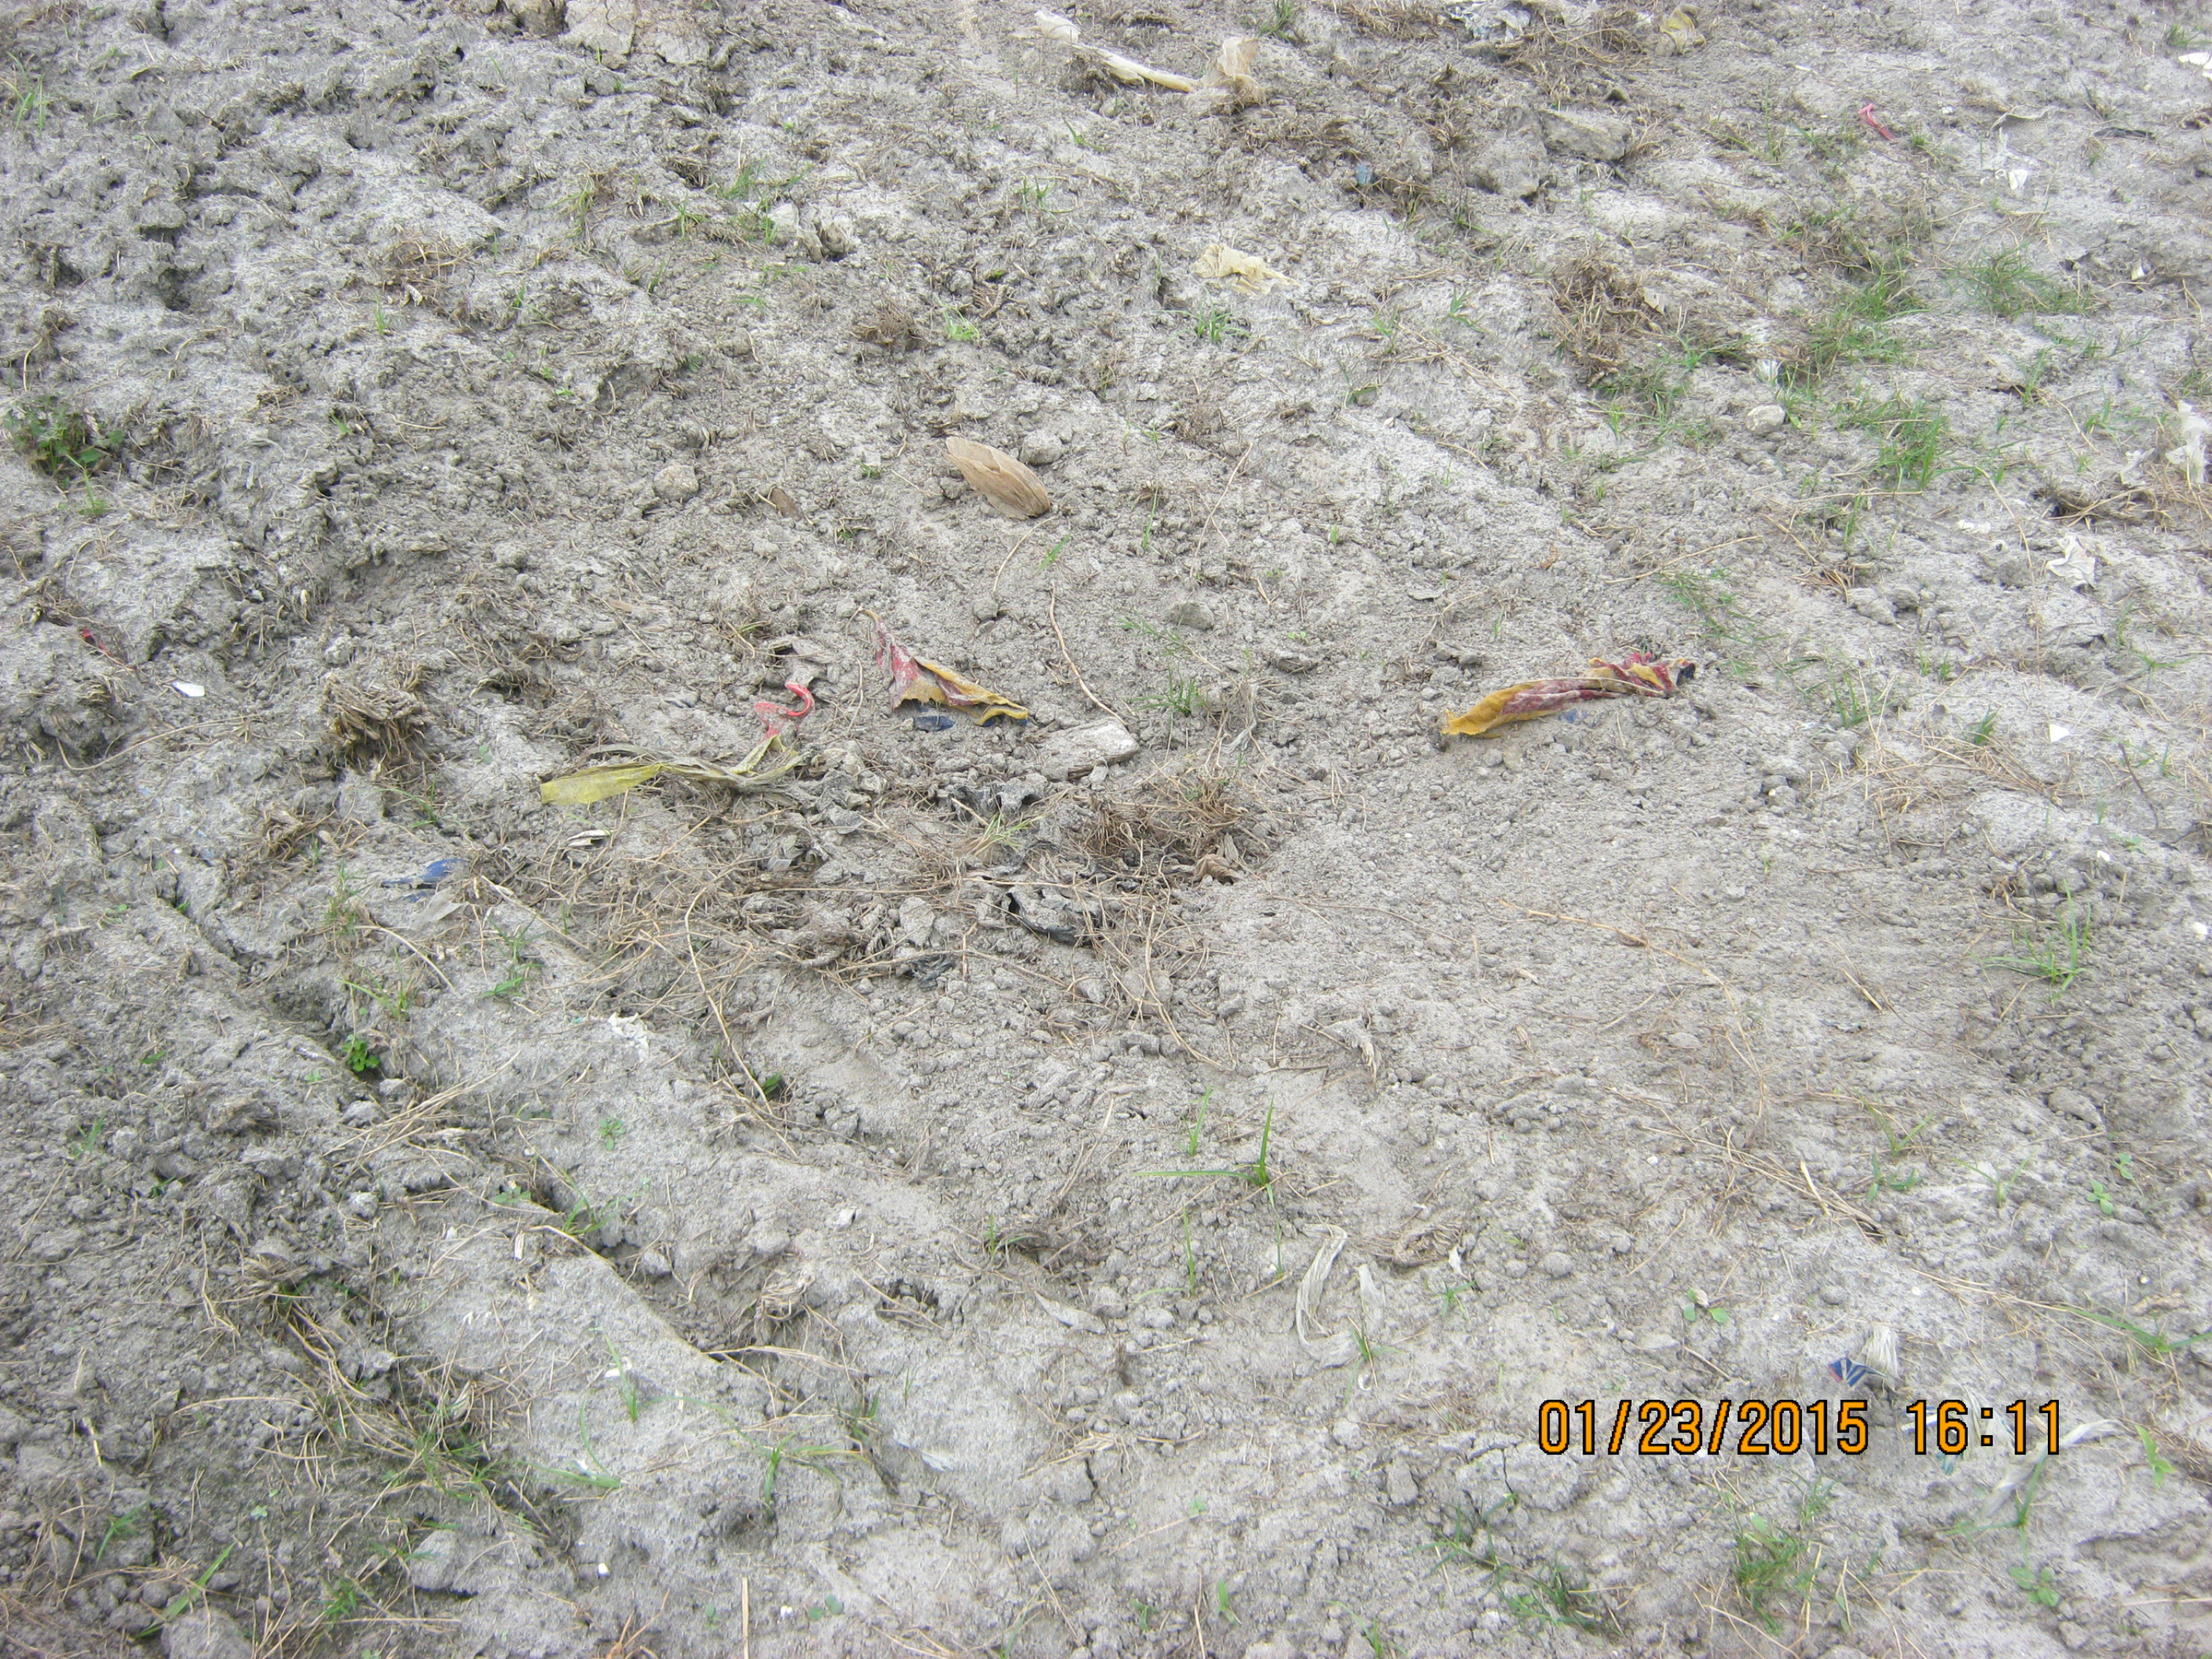
- (5.) The stormwater drain between SW Cells 1 and 2 had significant vegetation, blocking flow. See attached photograph. What is your timetable for clearing this out to restore flow? The cleaning of the vegetation has been completed.

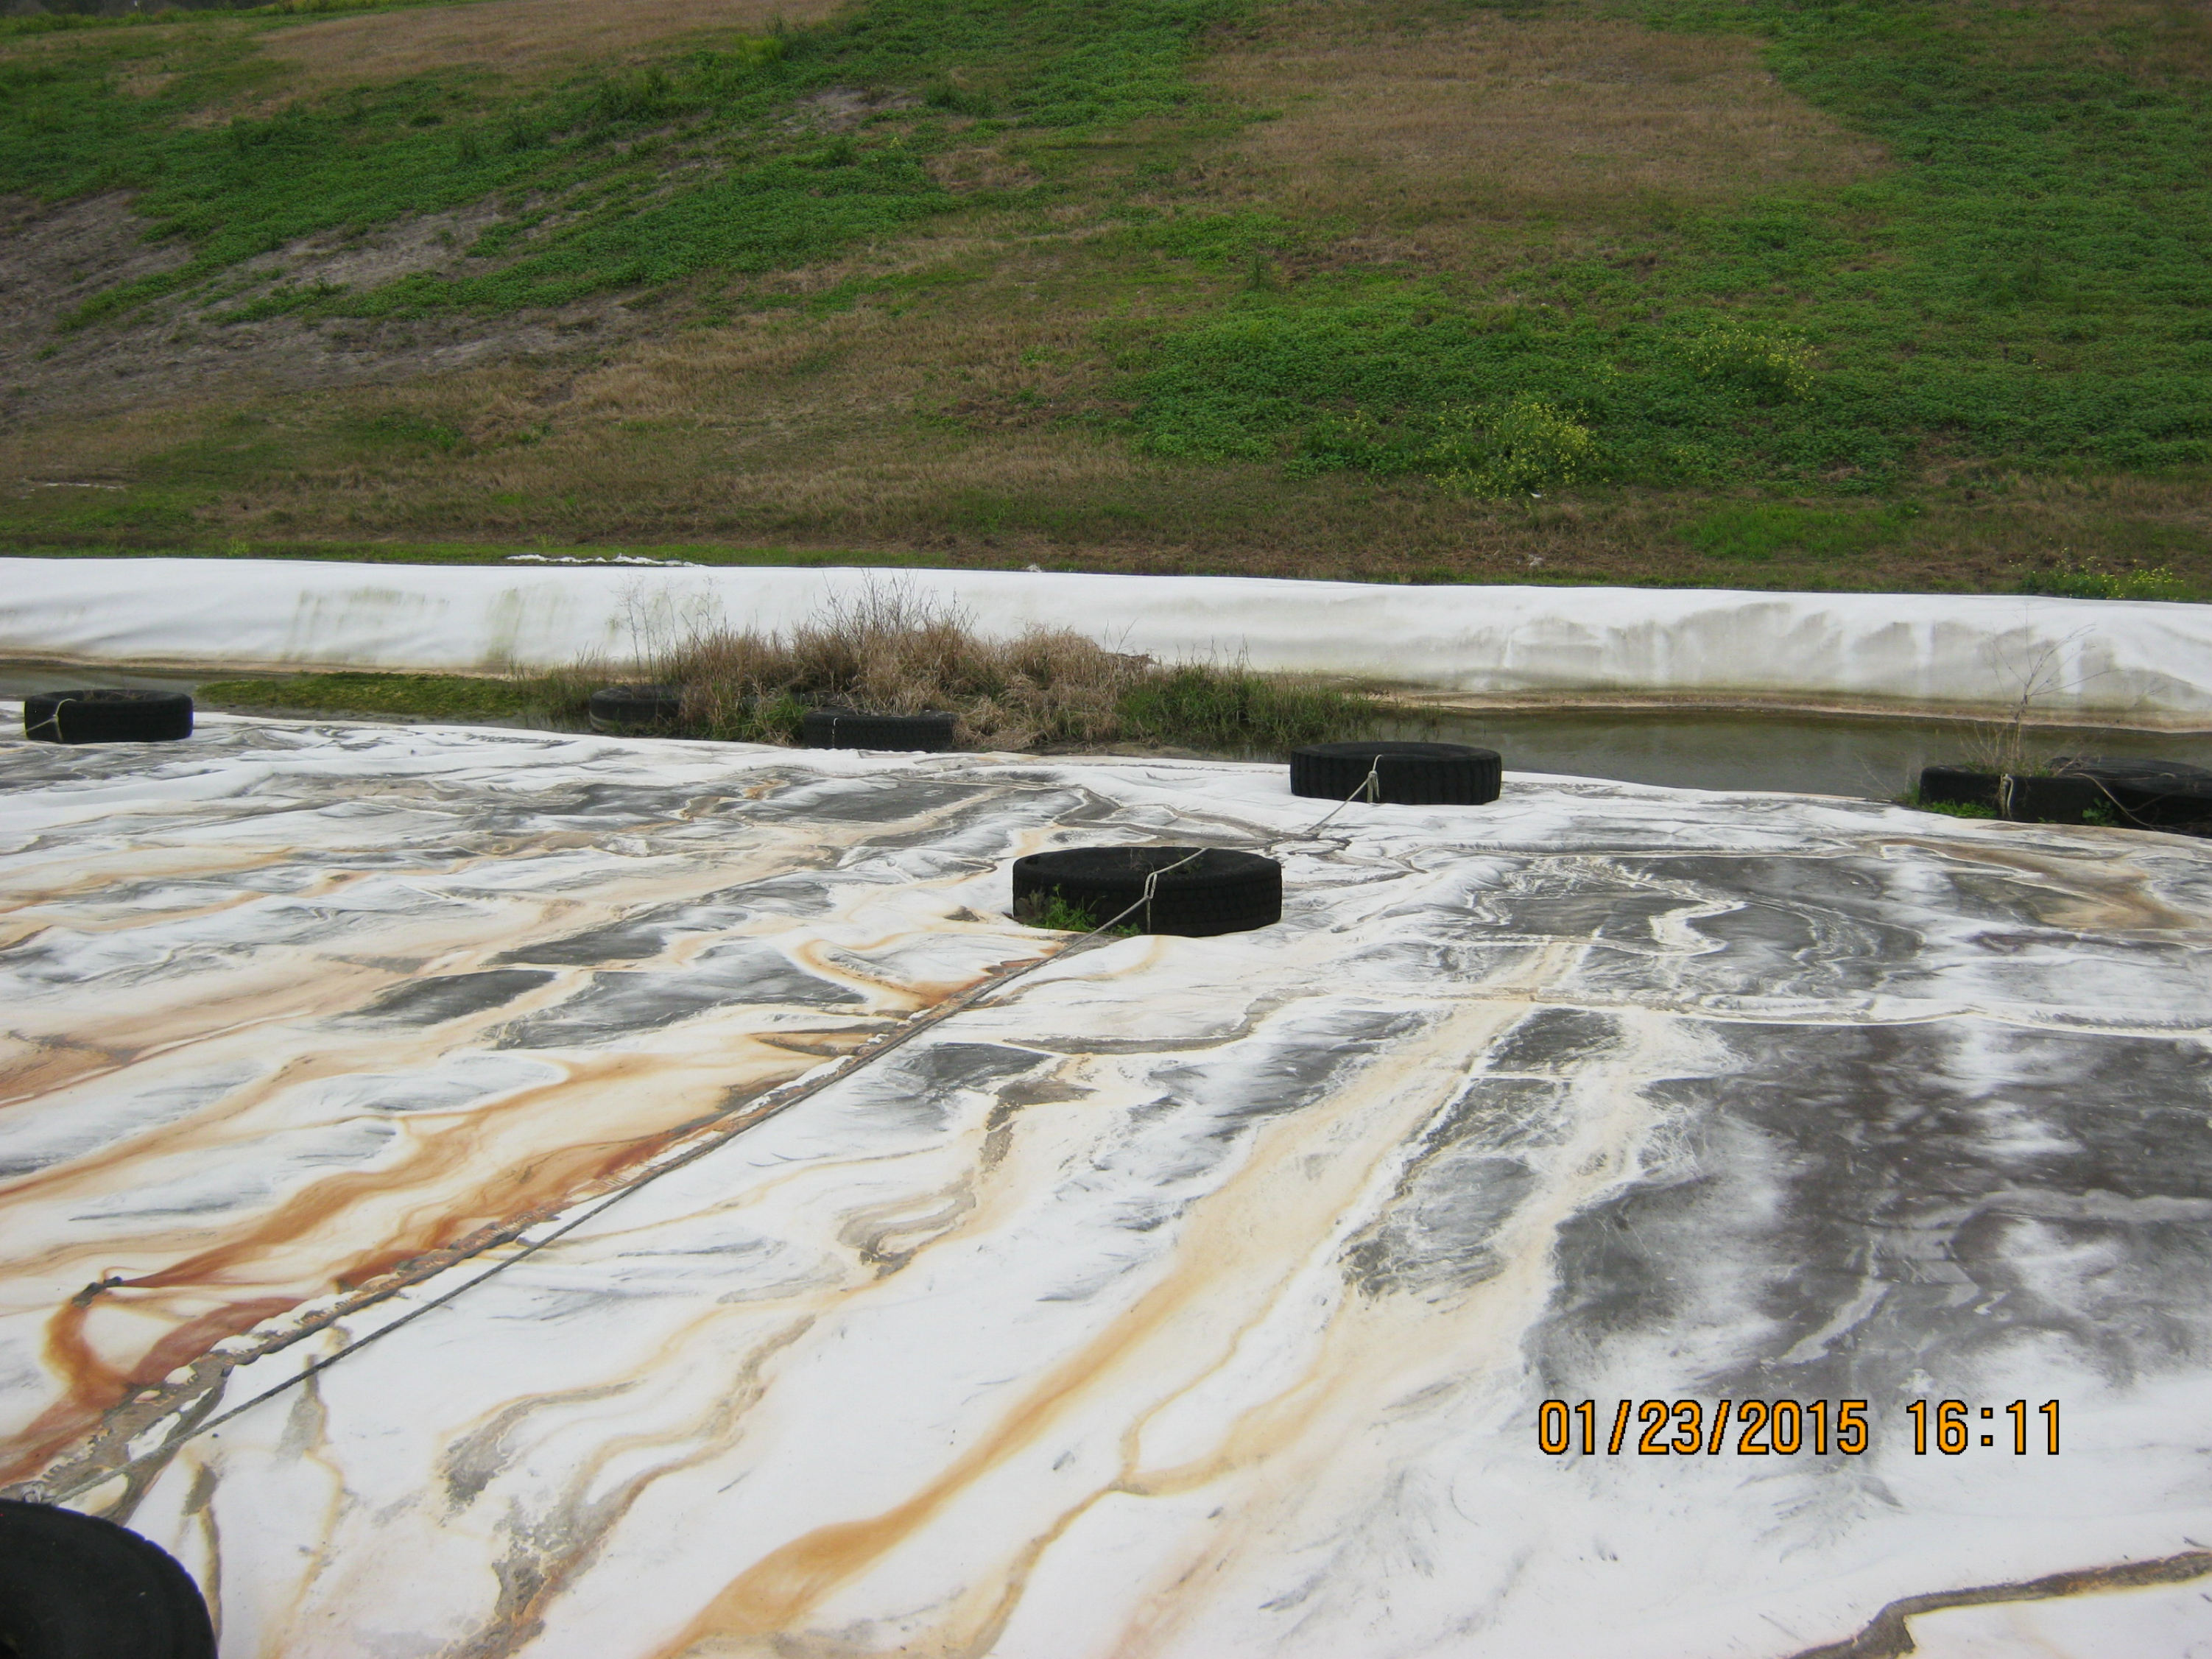
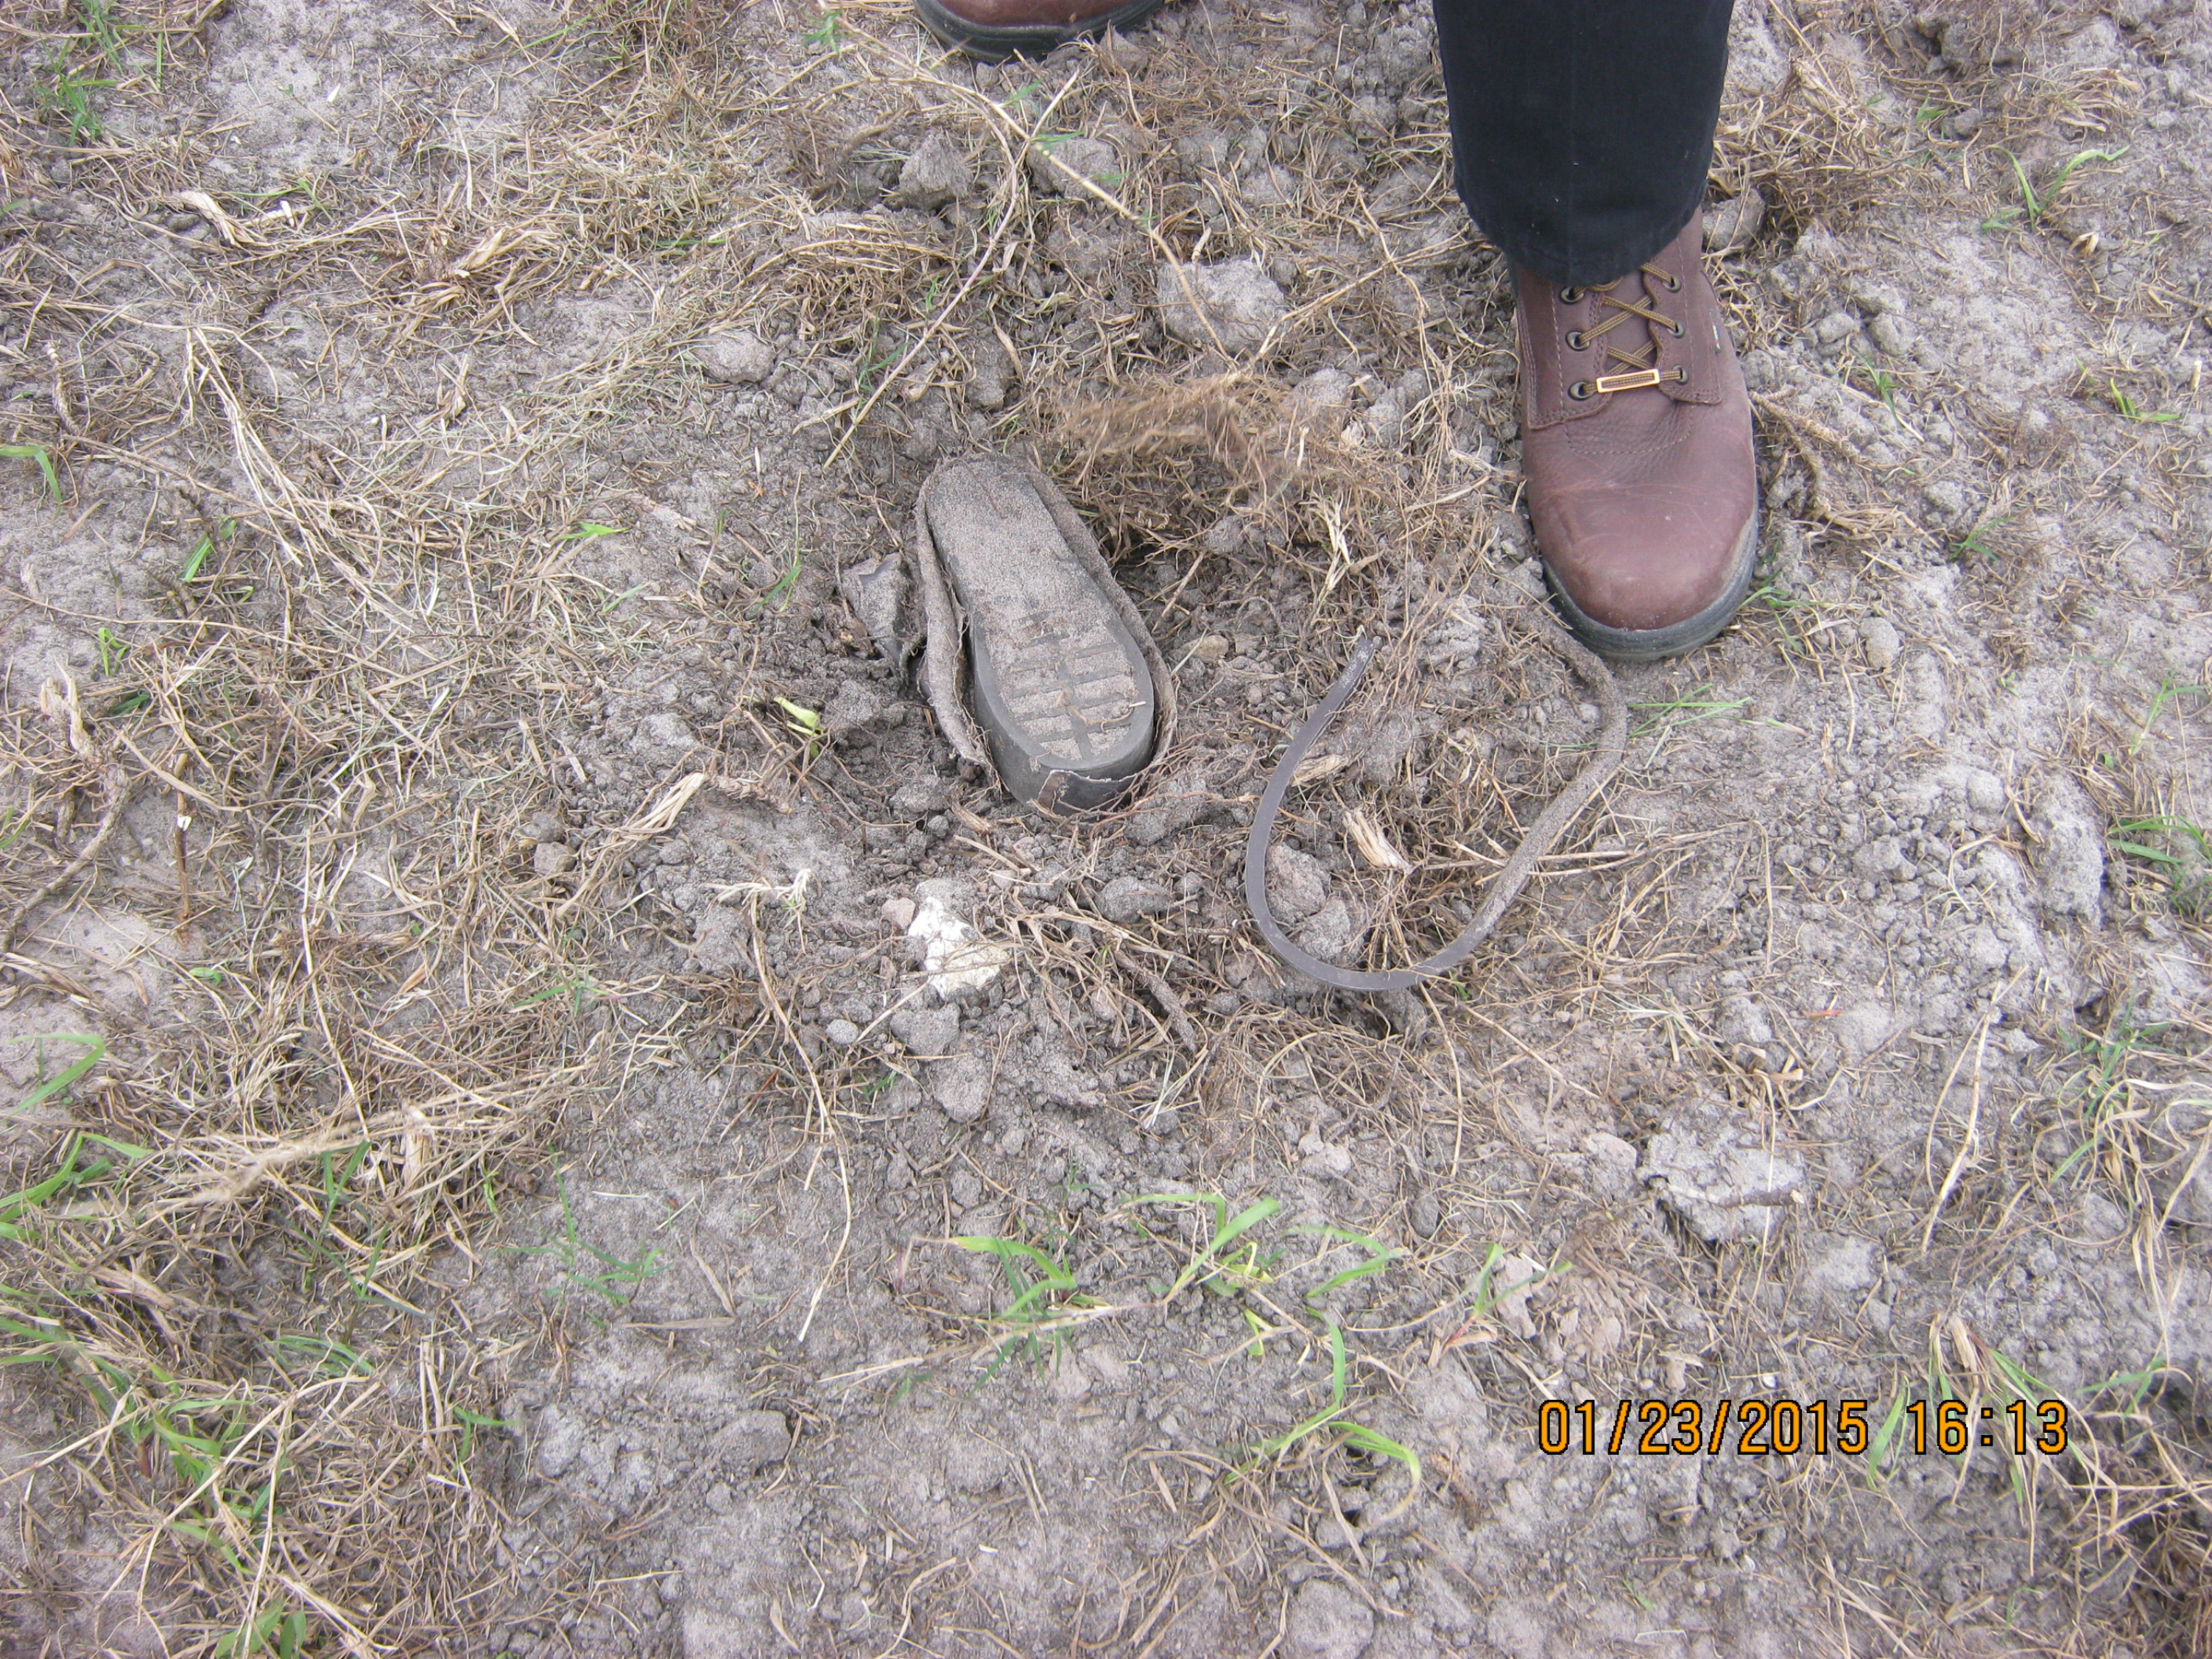
- (6.) Exposed waste was noted on SW Cells 1 and 2. Mike explained that there are hogs that come out and root out waste; however, some of the waste appeared to have tracks from heavy machinery. See attached photographs. Can you send photos of the tops of both SW cells, as well as the South and East faces of SW Cell 1, and the North and East faces of SW Cell 2? Please also verify that all exposed waste on both cells has been appropriately covered. It is apparent that the flagging was due to the tracking of the dozier and this was addressed the following day of the inspection.
