Re: Sarasota County
Central County Solid Waste Disposal Complex
Solid Operation Permit No. 130542-007-SO/01
WACS No. 51614
Leachate Storage Tank Inspection Report

TANK INSPECTION REPORT

**Sarasota County, FL
1.8 MG Leachate Storage Tank
4000 Knights Trail
Nokomis, Florida**

November 27, 2013

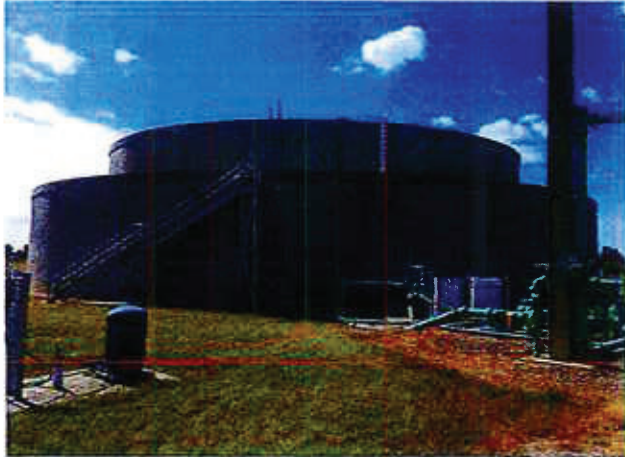
Photo 1

Tank Exterior

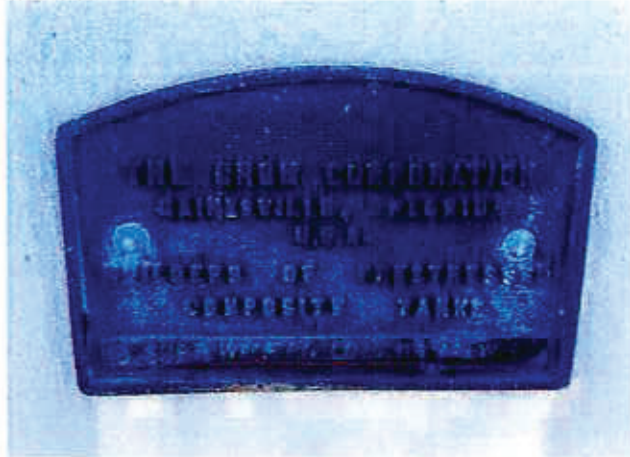
Photo 2

Tank was built in 1997 by Crom

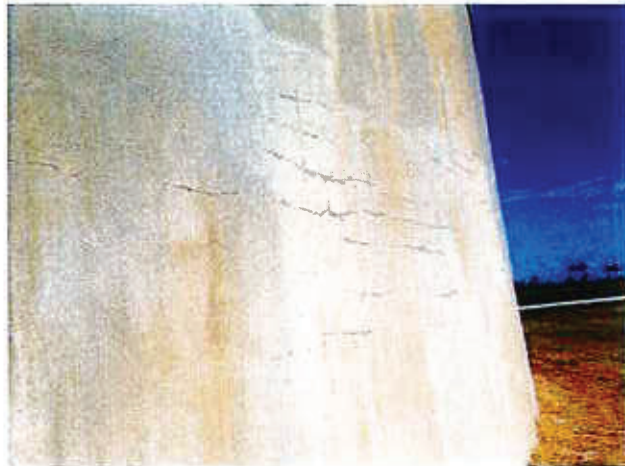
Photo 3

cracks were noted on the exterior of the tank (Photos 3, 4). These did not show any signs of leaking or damp spots. One main crack spanned almost the entire length of the tank wall approximately 15' up the wall (Photos 5, 6). The outer tank is kept empty at all times. These cracks are common on prestressed tanks and should pose no structural concerns for the tank wall.

Cracking in exterior wall of outer tank

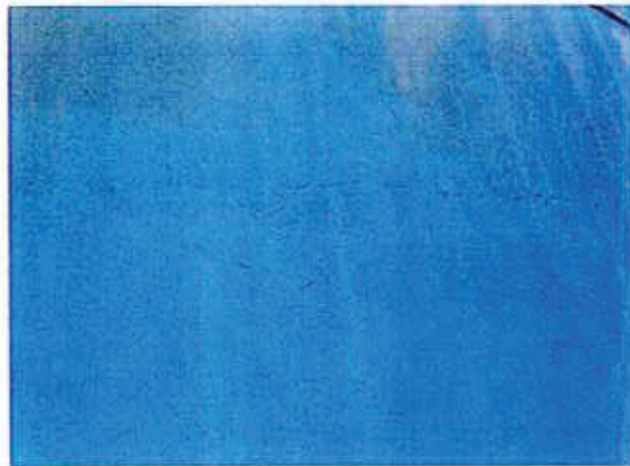
Photo 4

Cracking in exterior wall of outer tank

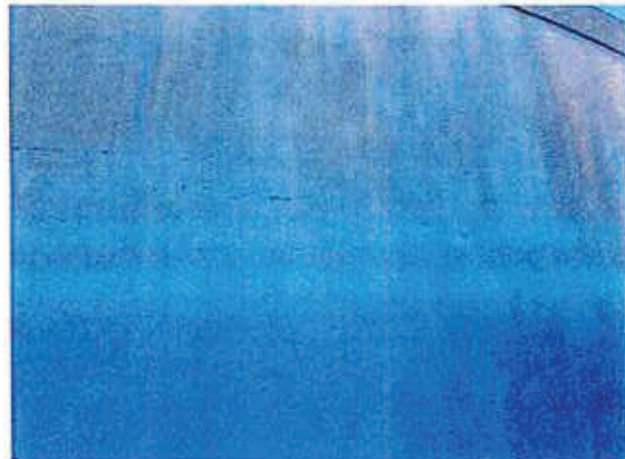
Photo 5

Crack approximately 15' up exterior wall of outer tank

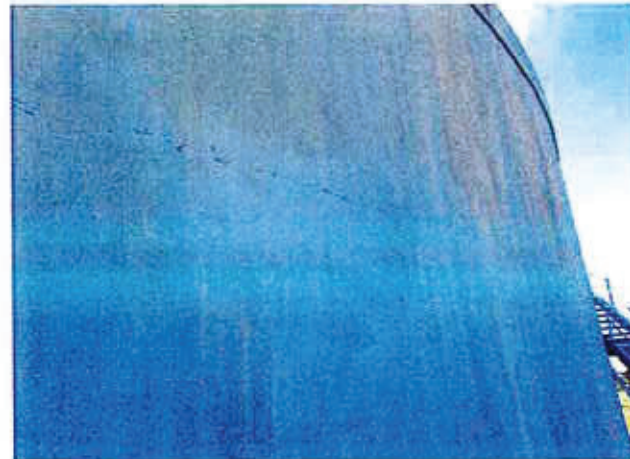
Photo 6

Crack approximately 15' up exterior wall of outer tank

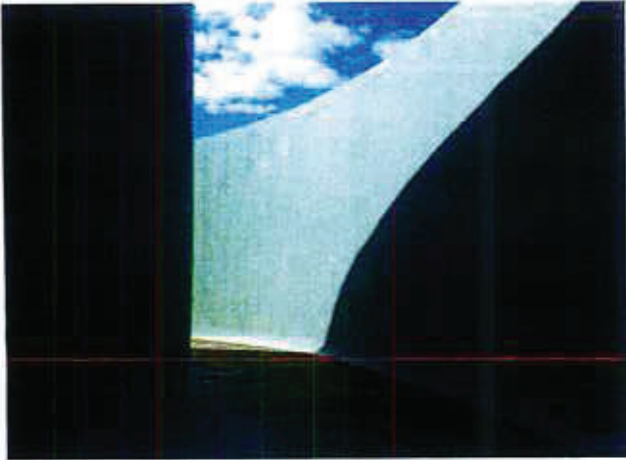
Photo 7

3. Interior Tank Wall (Outer Tank): The interior wall of the outer tank is in good condition. The wall was sounded and no hollows were found. The tank wall is coated and the coating is in good condition (Photo 7). Minor cracking was noted over the entire surface of the wall and this is common on a tank wall with this exposure (Photo 8, 9). These cracks appear superficial in nature and pose no structural concerns for the tank wall.

The interior coatings of the outer wall

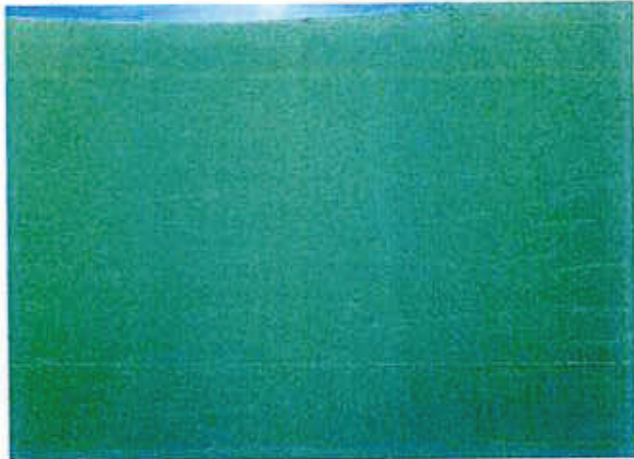
Photo 8

Minor cracking on the interior wall of the outer tank

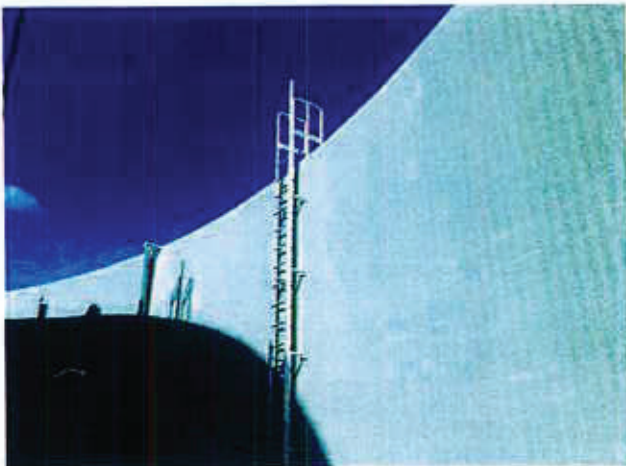
Photo 9

Minor cracking on the interior wall of the outer tank

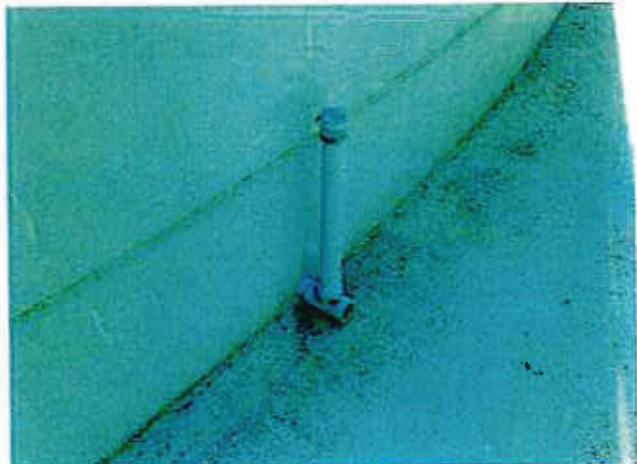
Photo 10

4. Exterior Tank Wall (Inner Tank): The exterior wall of the inner tank was found to be in good condition and no hollows were found when the wall was sounded. Minor cracking was noted at the base of the wall (Photo 10), and one main crack was noted that spanned the length of the wall approximately 15' up the wall (Photo 11). This was very similar to the crack found in the exterior wall of the outer tank and is believed to have the same cause. Several areas, approximately 10' long, of efflorescence was noted along this crack. The efflorescence appears to be from rain getting into the crack and leaching out. This does not appear to pose a problem (Photo 12-14).

Minor cracking at the base of the exterior wall on the interior tank

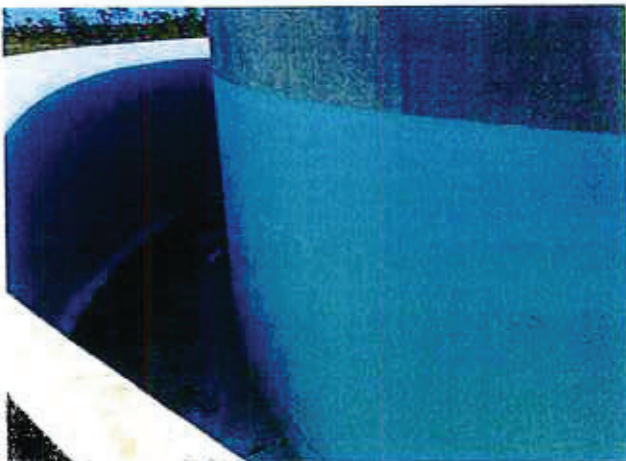
Photo 11

Crack approximately 15' up the outside wall of the inner tank

Precon recommends that this crack be sealed either by injecting epoxy into the crack or applying a coating to the surface. At this time it is not essential that the crack be addressed. If it is not sealed, it should be monitored.

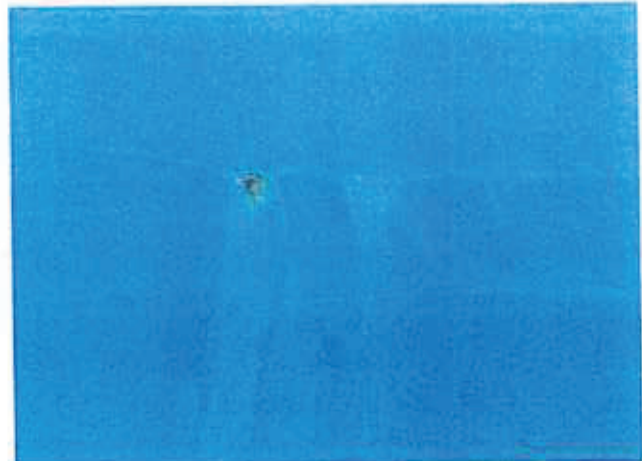
Photo 12

Efflorescence on the outer wall of the inner tank

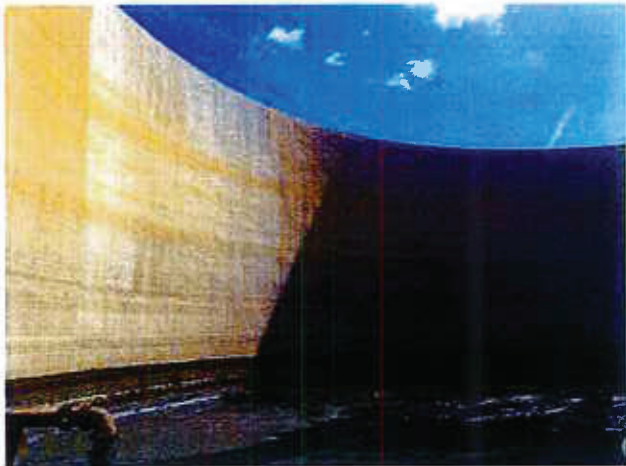
Photo 15

5. Interior Tank Wall (Inner Tank): The interior wall was found to be in good condition. It appears to have a Coal Tar Epoxy coating on the wall just above the monolithic floor wall connection which is also in good condition (Photo 15, 16). Precon noted a bubbling in the elastomeric urethane coating that was installed at the floor wall connection (Photo 17, 18). These bubbles are found along the perimeter of the tank and appear to be between the top coat and the coating beneath it. This does not seem to pose a problem as the coating under these areas appears to be in sound condition. Any repair would involve removing the top coat which would require removing the coating underneath it by abrasive blasting and would have the potential to do more damage to the floor and do more harm than good. Precon recommends inspecting these areas carefully during the next inspection to see if any change to this has occurred.

The interior wall of the inner tank is in good condition

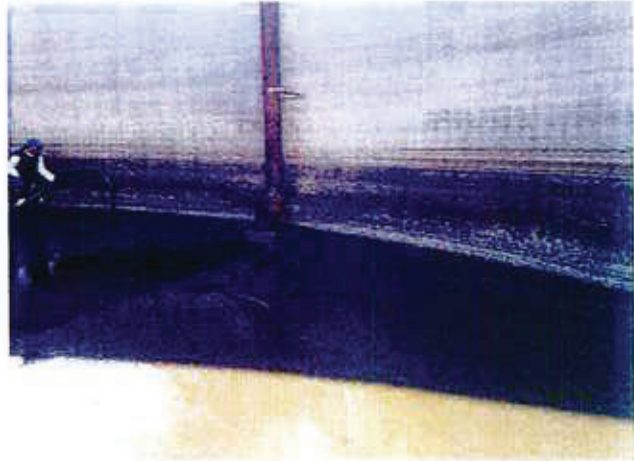
Photo 16

The interior wall of the inner tank

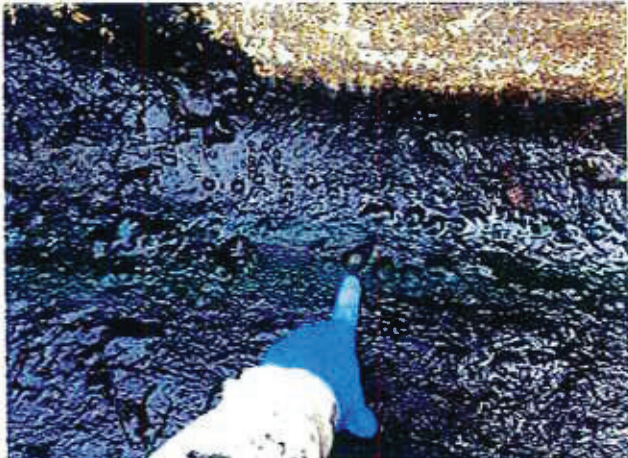
Photo 17

Bubbling of the elastomeric urethane coating at the floor wall connection

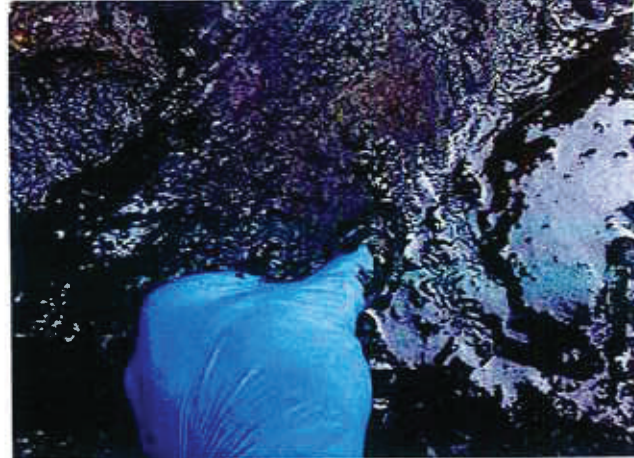
Photo 18

Bubbling of the elastomeric urethane coating at the floor wall connection

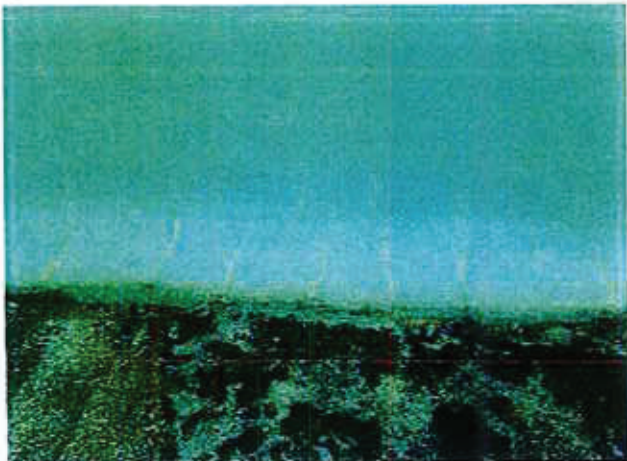
Photo 19

6. Tank Floor (Outer Tank): The tank floor was found to be in good condition and only minor cracking was noted in the cove of the floor wall connection (Photo 19). These cracks are superficial and require no immediate action. The coating on the floor is in good condition.

Cracking in the cove of the interior wall of the outer tank

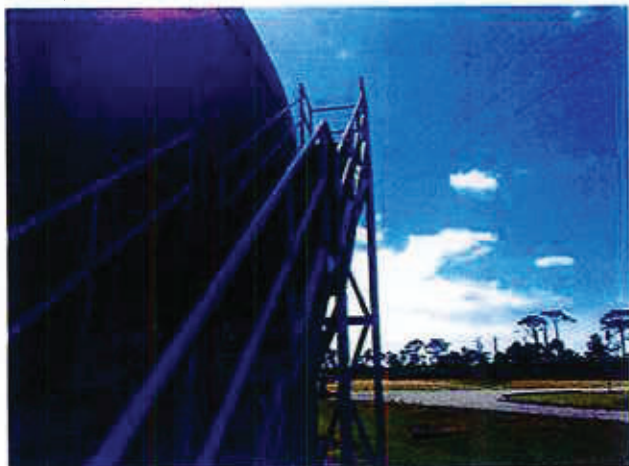
Photo 21

8. Tank Accessories and Piping: The tank accessories and piping were observed and noted.
 - a. Exterior Staircases (outer tank): The three aluminum staircases on the exterior of the outer tank were all found to be in good condition. All hardware was checked and no loose or missing pieces were found (Photos 21-23).

Exterior aluminum staircase

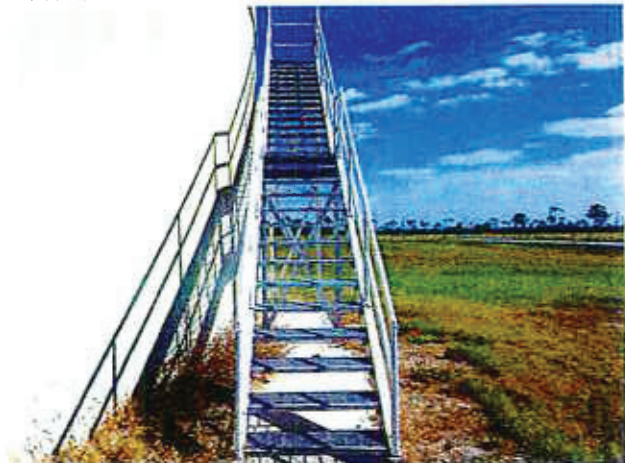
Photo 23

Exterior aluminum staircase

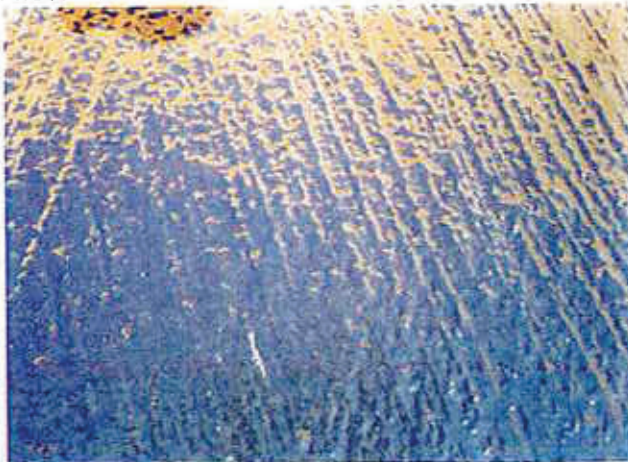
Photo 20

7. Tank Floor (Inner Tank): The tank floor was cleaned and found to be in good condition. No cracking or failures in the coatings were detected (Photo 20).

Coatings on the tank floor were found to be in good condition

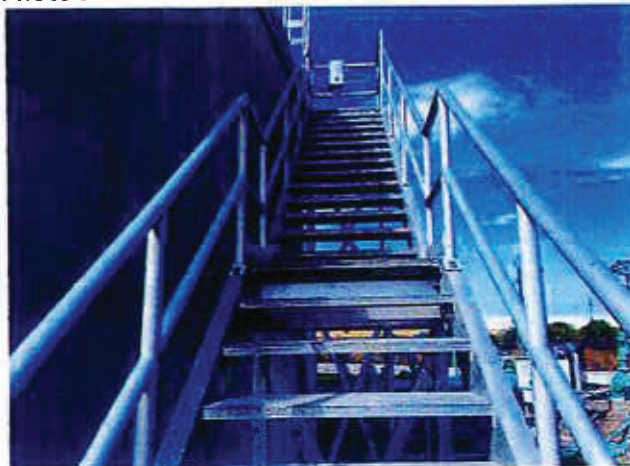
Photo 22

Exterior aluminum staircase

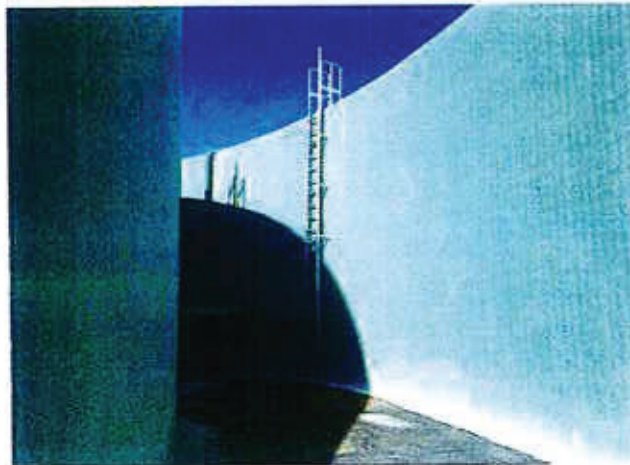
Photo 24

- b. Interior Ladder (outer tank): The interior aluminum ladder was found to be in good condition. The safety climb and hardware were found to be in good working order (Photo 24)

Aluminum interior ladder

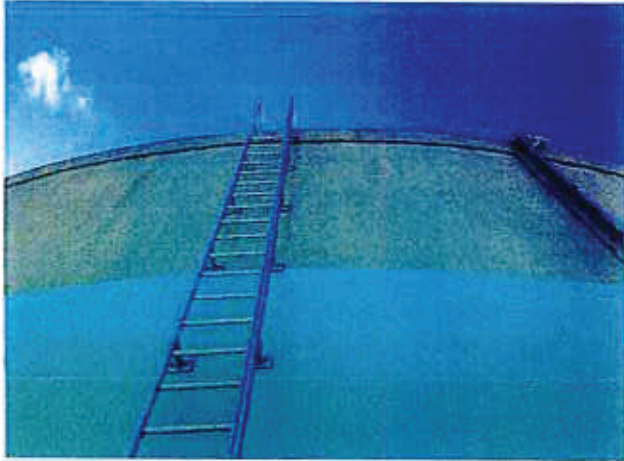
Photo 25

- c. Exterior Ladder (inner tank): The exterior aluminum ladder on the inner tank was found to be in good condition. The safety climb and the hardware were all found to be in good working order (Photo 25).

Exterior ladder on the inner tank

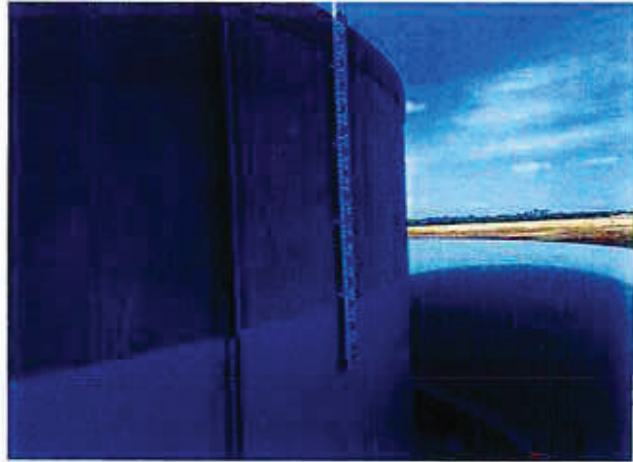
Photo 26

- d. Liquid Level Indicator (inner tank): The LLI was found to be functioning properly. The float and cables were in good working order (Photo 26).
 - e. Tank Piping: The piping was found to be in good condition (Photos 27, 28). All pipe gaskets and hardware were found to be in good condition (Photo 29). One pipe support inside the outer tank was missing the hardware that connects it to the pipe. Precon recommends installing the proper hardware to permanently connect the pipe to its support (Photo 30).

Liquid level indicator is functioning properly

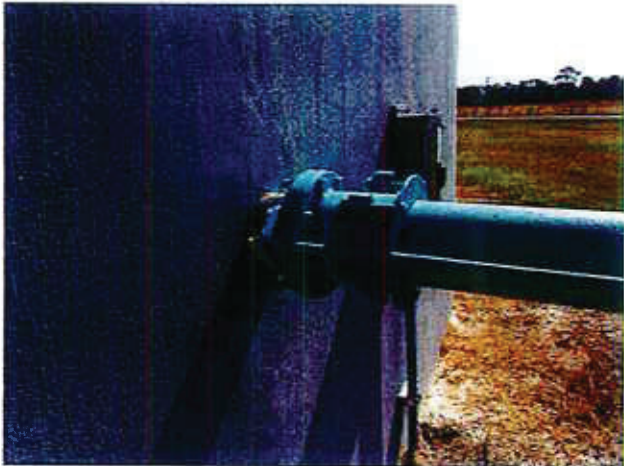
Photo 27

Ductile iron pipe penetration

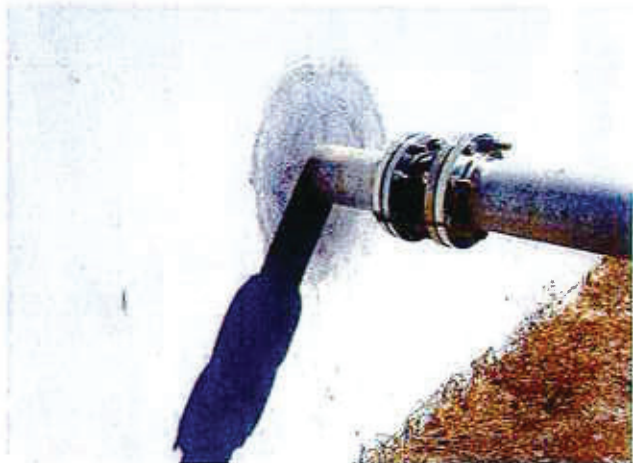
Photo 28

Stainless steel pipe penetration

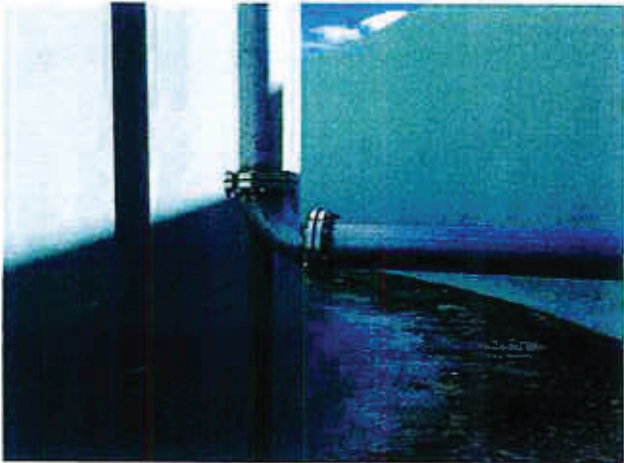
Photo 29

Gaskets and hardware are all in good condition

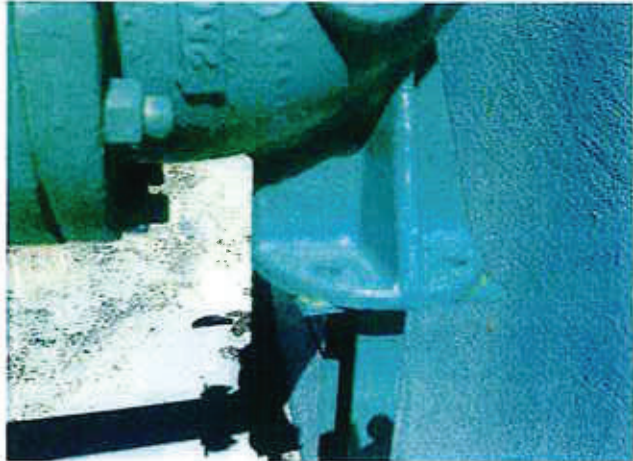
Photo 30

Pipe support with missing hardware

In addition, the County intends to address a few of the minor items listed by the inspector, including Section 5 Item No. 8e recommending installation of hardware for a pipe support and Section 5 Item 4 regarding exterior cracking of the outer shell of the tank,. Since these items are not considered critical or necessary for the integrity or operation of the tank, the County does not have a schedule at this time, but plans to address these items before the next inspection.
